HISTORIC BUILDING RECORD

**‘THE HEMP WORKS’
CHEDISTON STREET
HALESWORTH
(SMR Ref. HWT 028)**

M. Sommers
©May 2007

SCCAS REPORT No. 2007/66
OASIS ref. Suffolkc1-26909

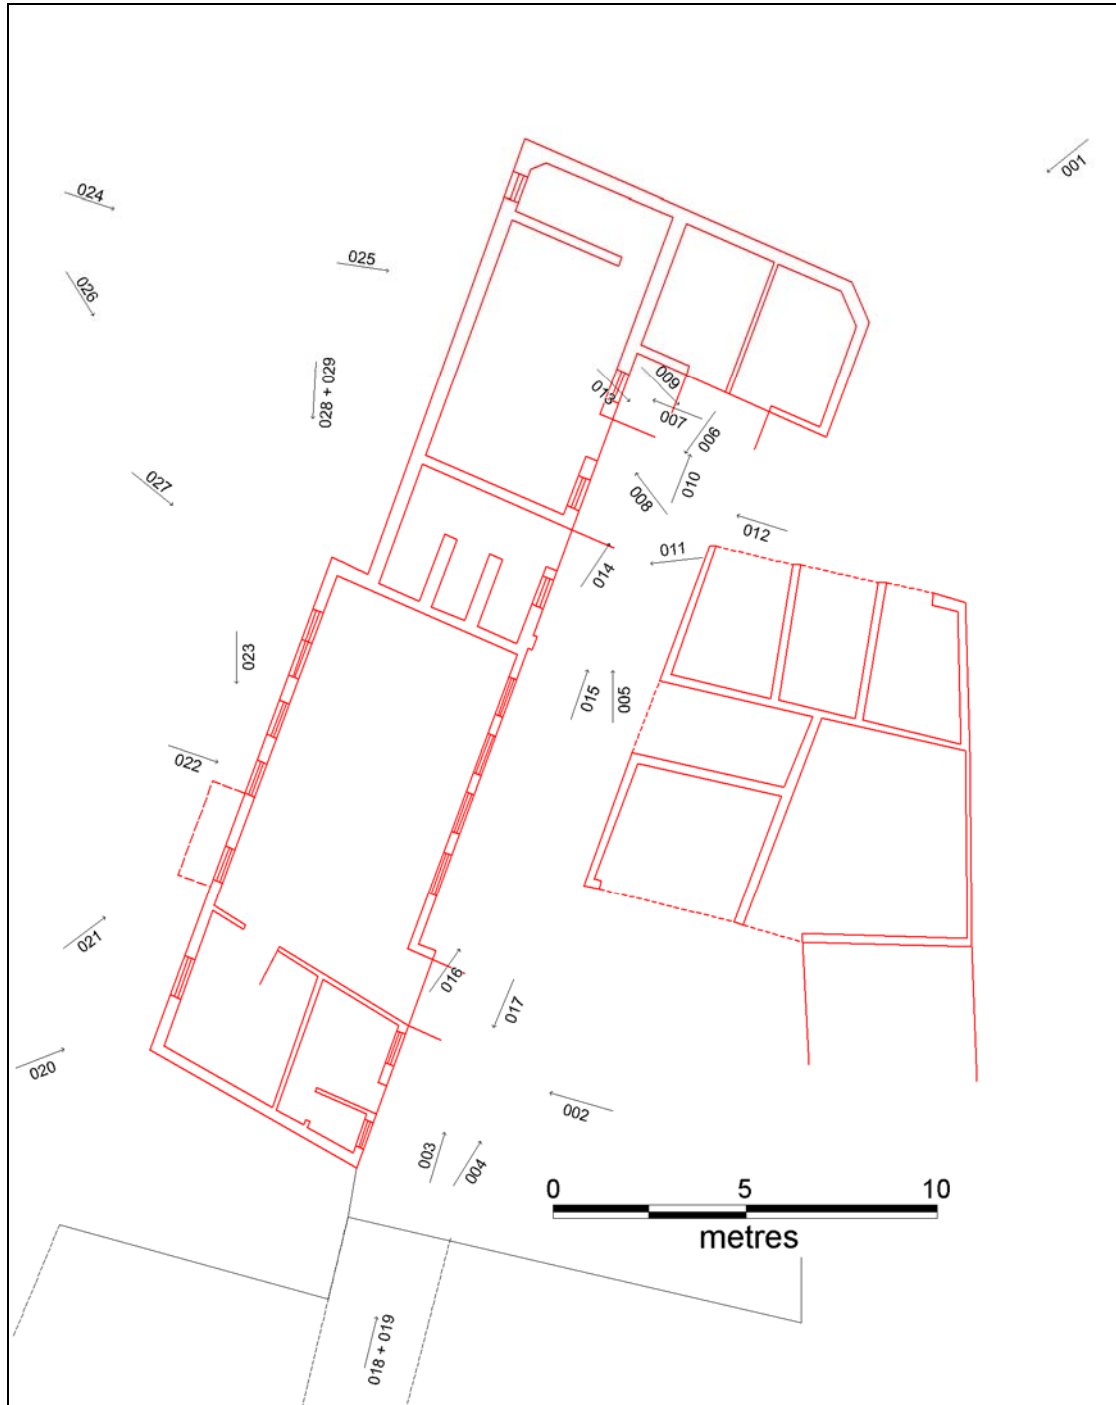
Figure 3: Plan of Ground Floor showing direction and approximate location of camera (photographs 1-29)

A total of 29 photographs were taken of the exterior of the two blocks. The approximate locations and direction of the camera are illustrated in figure 3 below.

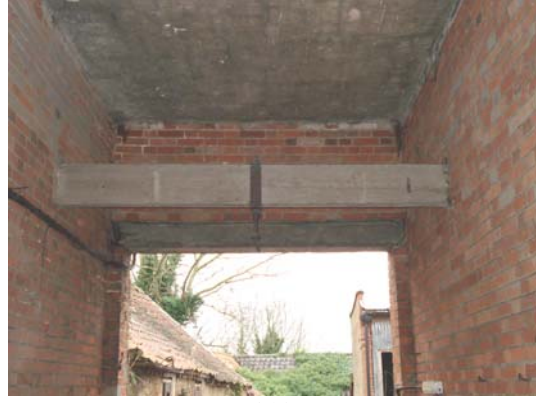
018

Although not actually within the study area a large timber beam with an attached hook was noted towards the northern end of the covered access (18). It is likely this hook would have been used as an aid to loading and unloading in association with activities within the site.

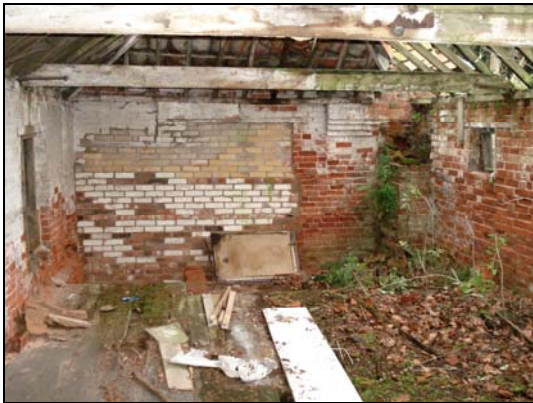
036

7. Adjacent the two arches on the ground floor were the remains of a wooden staircase up to the hayloft. Access to this staircase would have originally been through a doorway from the room to the south although this has been bricked up (36, 77) rendering the stairs useless. It was noted that the wall between the two sections of Block A has been altered with what appears to be the filling in of a window or doorway into the upper floor of the southern section and the blocking of the doorway to the hayloft stairs.

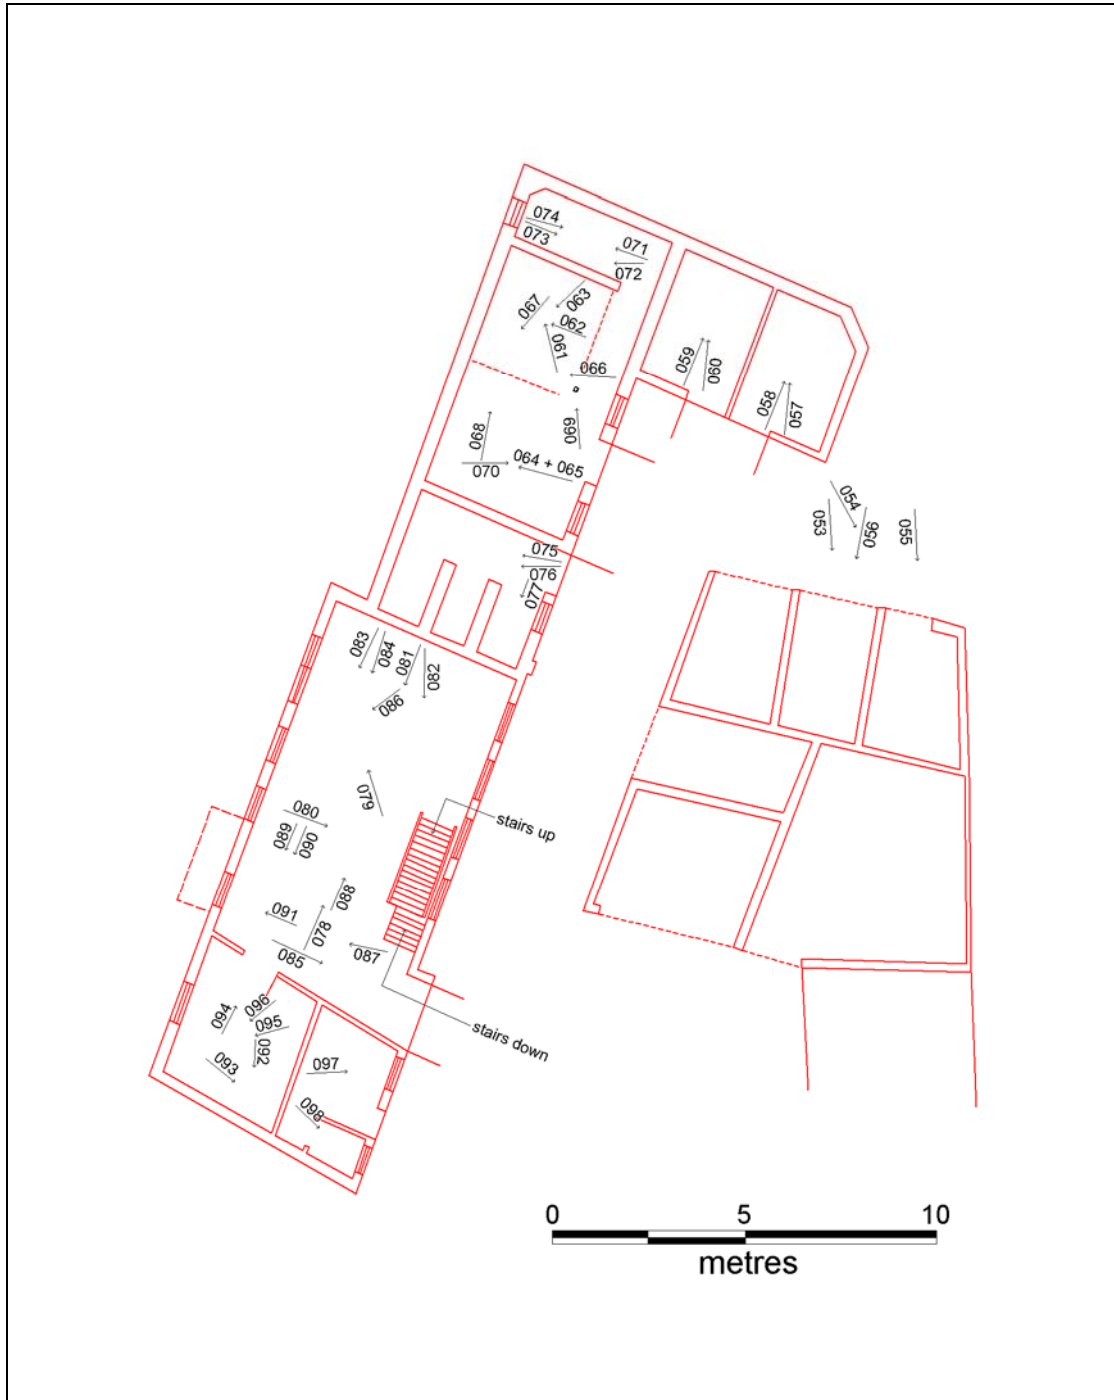
Figure 5: Plan of Ground Floor showing direction and approximate location of camera (photographs 53-98)

A total of 46 photographs were taken of the interiors of the ground floors of Block A and Block B. The approximate locations and direction of the camera are illustrated in figure 5 below.

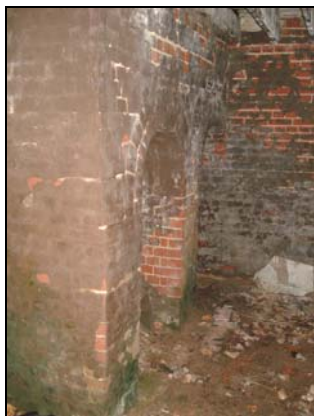
075

6. Within Block A, in the southern end of the stables area, a pair of brick arches running partway across the width of the building were present (75, 76). These are in a similar brick to the stables part of the block and appear to be integral with its construction. Above these arches, on the upper floor, a rectangular depression approximately the same size as the footprint of the arches was visible (36, 37). Although no evidence of pipe work could be seen the most likely purpose for the arches is to support a heavy tank of water for use within the stables.

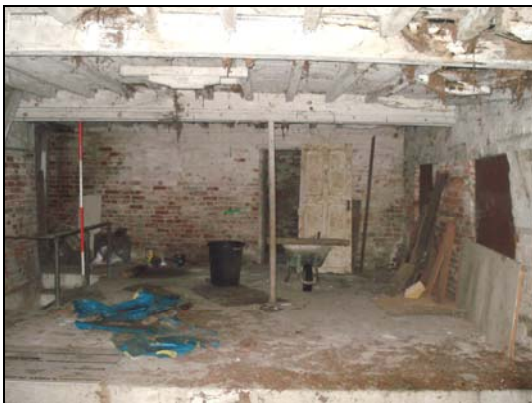
081

The basement within Block A was presumably used for storage although certain alterations indicate it was modified to serve as an air raid shelter (figure 9). The alterations comprise the strengthening of the floor above by covering the original ground floor with a thick layer of concrete (83) and the addition of further support in the form of brick piers spanned by steel girders (104). An entrance into the basement from the gardens to the west of Block A has been created although this is now blocked. A substantial structure formed of concrete slabs had been erected over this entrance to provide protection from the direct blast of a nearby explosion (106). Only the southern portion of the basement was converted possibly because it is only this part that is wholly underground. This conversion is presumably related to World War II.

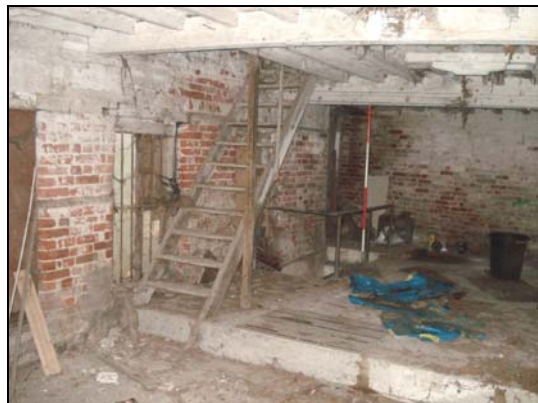
082

5. Between the third main beam supporting the upper floor and the northern wall of the large room within Block A the upper floor above had been removed and a barrier erected to prevent users of the upper floor from walking over the edge (84). This is clearly a later alteration as evidence for floor joists spanning this area were visible on the beam. Its purpose was either to facilitate the movement of goods between the ground and upper floor or to allow for a greater headroom on the ground floor either for machinery or storage.

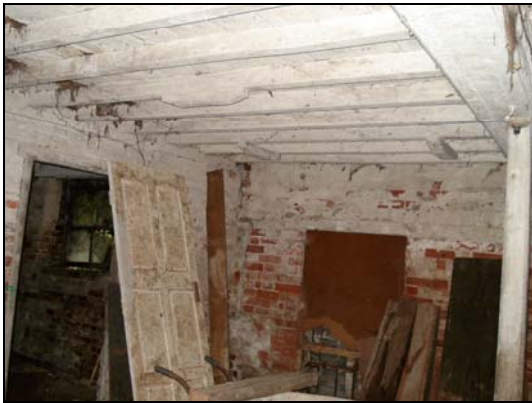
087

3. Within the large room on the ground floor of Block A lengths of shaped timber were attached to the joists supporting the floor above (87, 88, 89). These appeared to be quite specifically shaped although their purpose could not be positively determined. Possible interpretations are that they supported machinery or a framework, possibly for shelves.

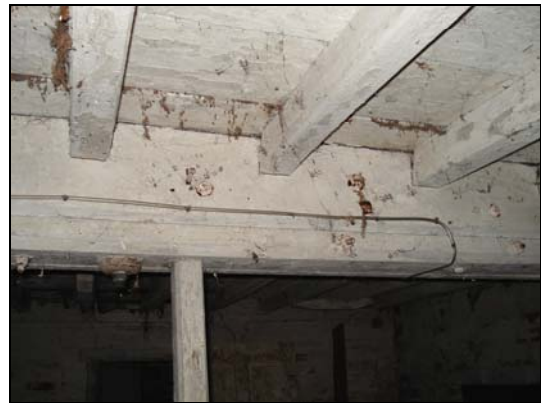
090

4. The southern of the three main beams supporting the upper floor and its joists has been strengthened by bolting lengths of timber to its southern side and base (90). An upright has also been installed. It could not be determined whether this was in response to a weakness in the beam or a need to strengthen it due increased loading of the floor above.

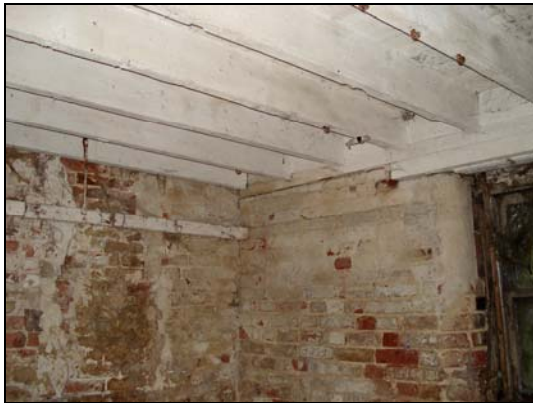
095

2. Within the ground floor room within the southwest corner of Block A a series of small brackets are set into the joists supporting the floor above (95, 96). Within one of these a small segment of timber doweling was present. This suggests that lengths of doweling were supported by the brackets to form a series of rails across the ceiling. This could either be to support a hanging ceiling or more likely used for hanging some product either for storage or possibly for drying.

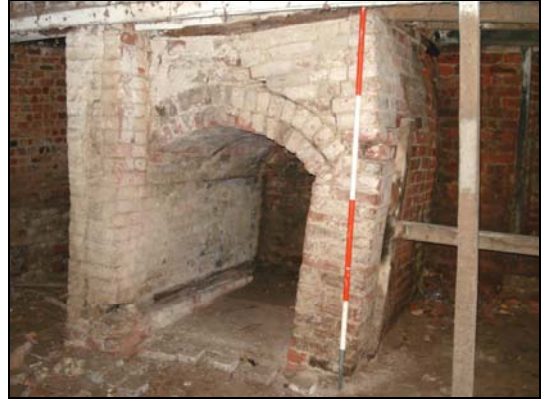
100

A further brick arch was also present within the basement (100, 101 & figure 9). This did not appear to be an integral part of the original construction, as it was not bonded into the north wall of the basement against which it stood. There was no obvious

evidence for its purpose although it was presumably to support something on the floor above but there was no obvious indication as to what this may have been. The area immediately above this arch is coincidental with the removed section of upper floor and this may be associated.
