A report on the archaeological monitoring of groundwork associated with the construction of an extension to 8 High Street, Needham Market Planning application number: 0516/07 Suffolk County Council Archaeological Service Report Number: 2007/100 Dasis ID. No. - suffolkc1-26924

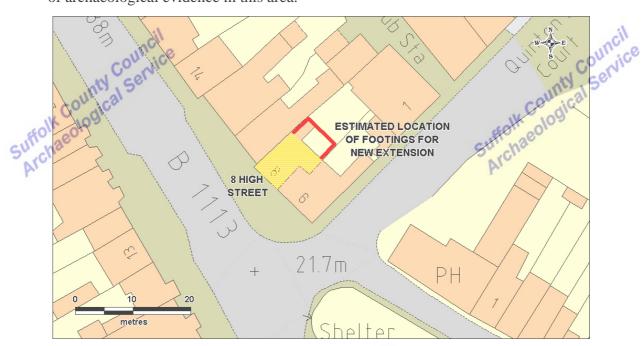
Figure 2: Approximate location of footings

The footings were machine excavated using a mini digger to a depth of c.1.2m. They were, on average 0.6m wide and consisted of c.0.2m of brick rubble, c.0.5m of topsoil, a mid brown soft sand, and the remainder was a natural mid orange brown soft sand with occasional stones. The topsoil was relatively clean to the north-western side with little evidence of modern disturbance.

To the south-east side, immediately adjacent to the house, a layer of dark brown compacted sand with charcoal flecks and chalk lumps was evident. This was below a layer of brick and mortar mixed with sand, which was probably part of the make up of the adjacent flint and brick wall and the rear of the house. The dark brown layer did not appear to form a discreet feature, and was likely to be associated with the construction of this wall, or the house.

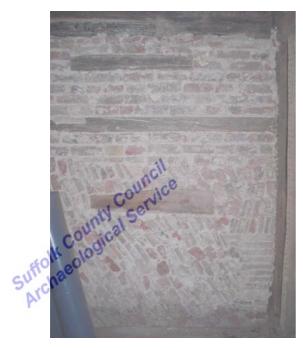
The property itself is partly timber framed in origin and so could date from the late medieval/early post medieval period. It was in a poor state of repair and, at the time of visiting, had been almost completely stripped back to the timber frame, exposing the timbers, brickwork and in places, wattle and daub (plates 2-4). This was to be retained and restored where possible and replaced sympathetically where not. No obvious dating features were evident within the framework of the building but later editions were obvious, such as Georgian fireplaces and an newer (?19th century) cellar. A late medieval/early post medieval origin is presumed for this part of the building.

Plate 3: Stripped wall showing rough Herringbone nogging

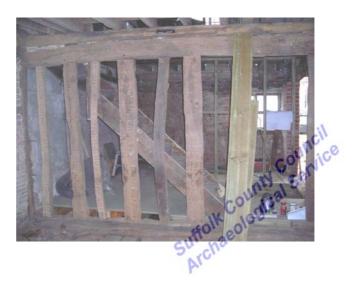
The building was said to have originally been two parts (Harper, pers. Comm. 2007) with the older section adjacent to the listed building at numbers 10 and 12, and a later edition adjacent to number 6. This is evident in the building, with timber framing and old brickwork only present in the part adjacent to number 10. It is probable that the row of terraces ended here, and the south-eastern side, adjacent to number 6, is a later edition. This older section would have been very small, a two-up/two-down construction, immediately adjacent, and perhaps once part of, the listed building next door.

Plate 4: Stripped timber framing of property
