ARCHAEOLOGICAL EXCAVATION REPORT

Erection of a Replacement Farm House, Meat Farm, Clopton Road, Otley (OTY 029)

A REPORT ON THE ARCHAEOLOGICAL DESKTOP STUDY,
EXCAVATION AND MONITORING, 2007
(Planning app. no. C/06/2300)

SCCAS Report No. 2007/105
Oasis Ref. Suffolkc1-27225

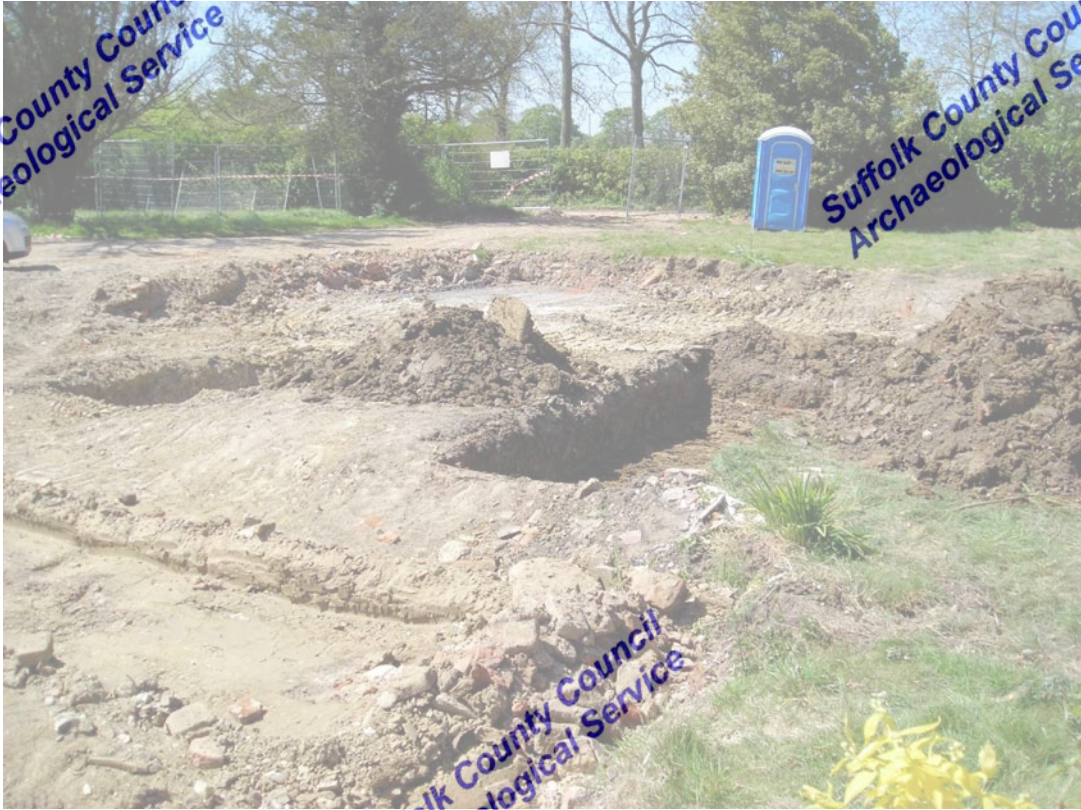
Plate 1: Picture showing north end of Trench 1, Trench 3 and extent of disturbance through former building footprint (looking west)

Moat Farm House was completely destroyed by fire in 2006, with surviving remains subsequently removed to ground level leaving very little on site of this former property. During the fire, 2 oil-fired boilers were destroyed, causing extensive contamination of oil over the plot. This contamination was cleared by a relevant specialist but during this process, a large portion of the site was disturbed through initial trenching across the building area, followed by extraction of two large areas of contaminated ground. Plate 1 gives an indication of the level of disturbance.
