ARCHAEOLOGICAL MONITORING REPORT

Barns adjacent to Hazel Stubb Farm, Burton End, Haverhill HVH 061

A REPORT ON THE ARCHAEOLOGICAL MONITORING, 2006
(Planning app. no. SE/05/02427)

J.A.Craven
Field Team
Suffolk C.C. Archaeological Service

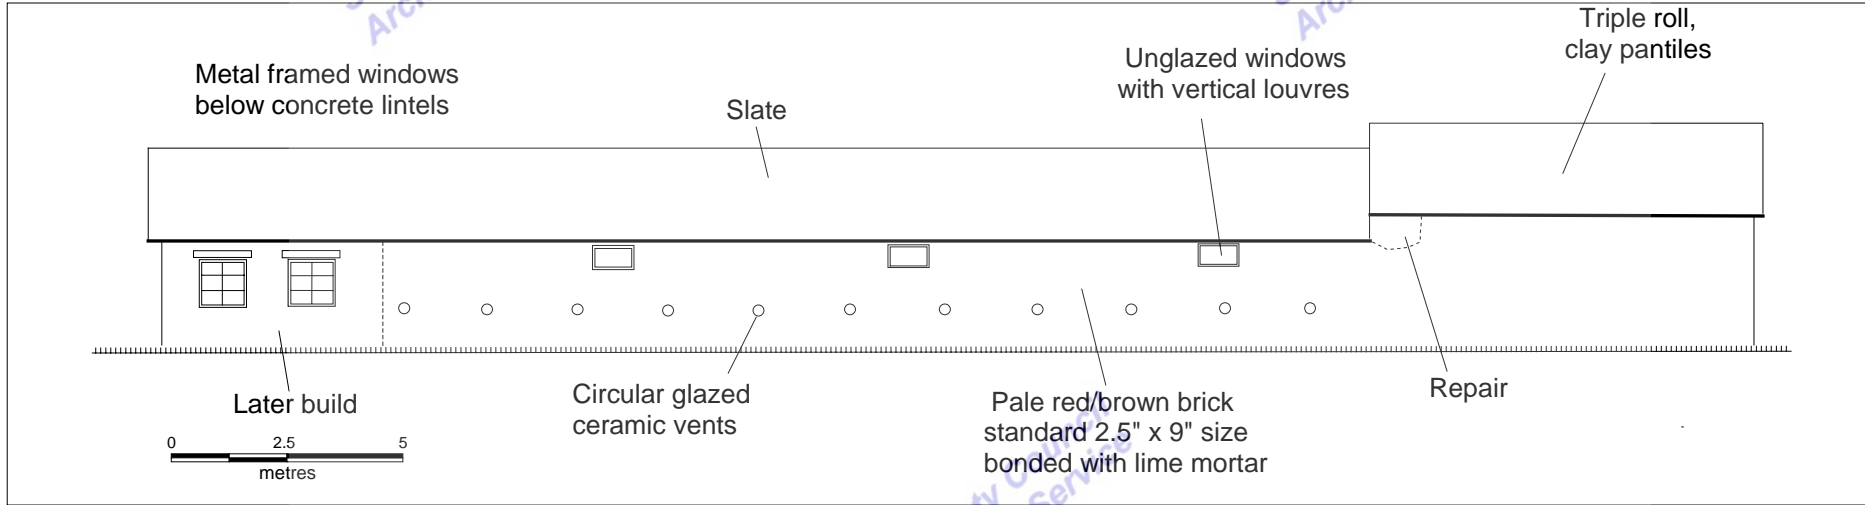
Figure 5. Building 2 North elevation

The main part of the building was a large single space used to house livestock. The rear (north) wall is unaltered, it has three, high level, unglazed louvre windows and is pierced at mid height by a row of eleven cylindrical, glazed, ceramic vents. In the middle of the range, on the inside of the walls, there are opposed pilaster buttresses; two on the north wall but only one remains on the south. There is no relationship between the position of the roof trusses and the pilasters, which may indicate that the roof has been rebuilt.

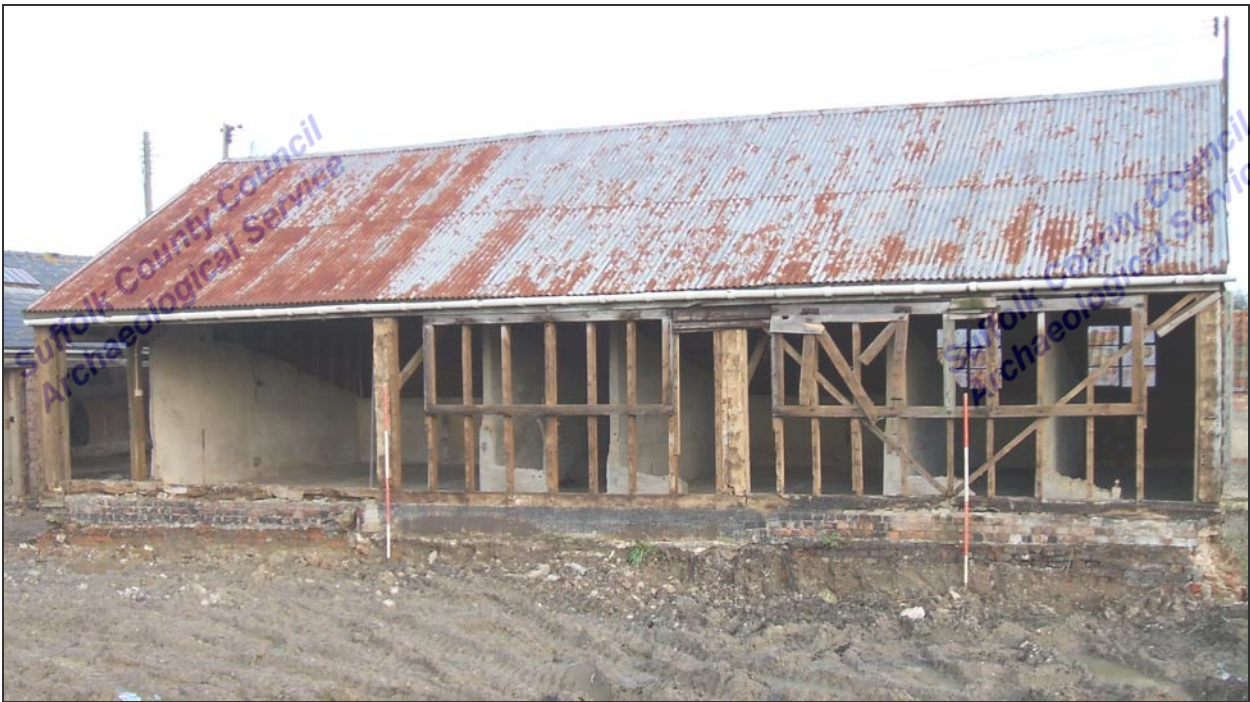
Figure 7. Building 3 West elevation

The evidence suggests that the layout of the building has been changed and it originally had opposed doorways at the mid-point of the long walls. The middle of the western side was a large opening and the original dwarf wall and sill beam do not continue into the central bay. This has

since been infilled using concrete and softwood timber. Opposing this on the east side is a stable door which led to an outshot on the side of the building that had recently been removed. This extension was original to the building and was underpinned with brickwork jointed in to the dwarf wall. Broken bricks where it was cut from the main structure can be seen.

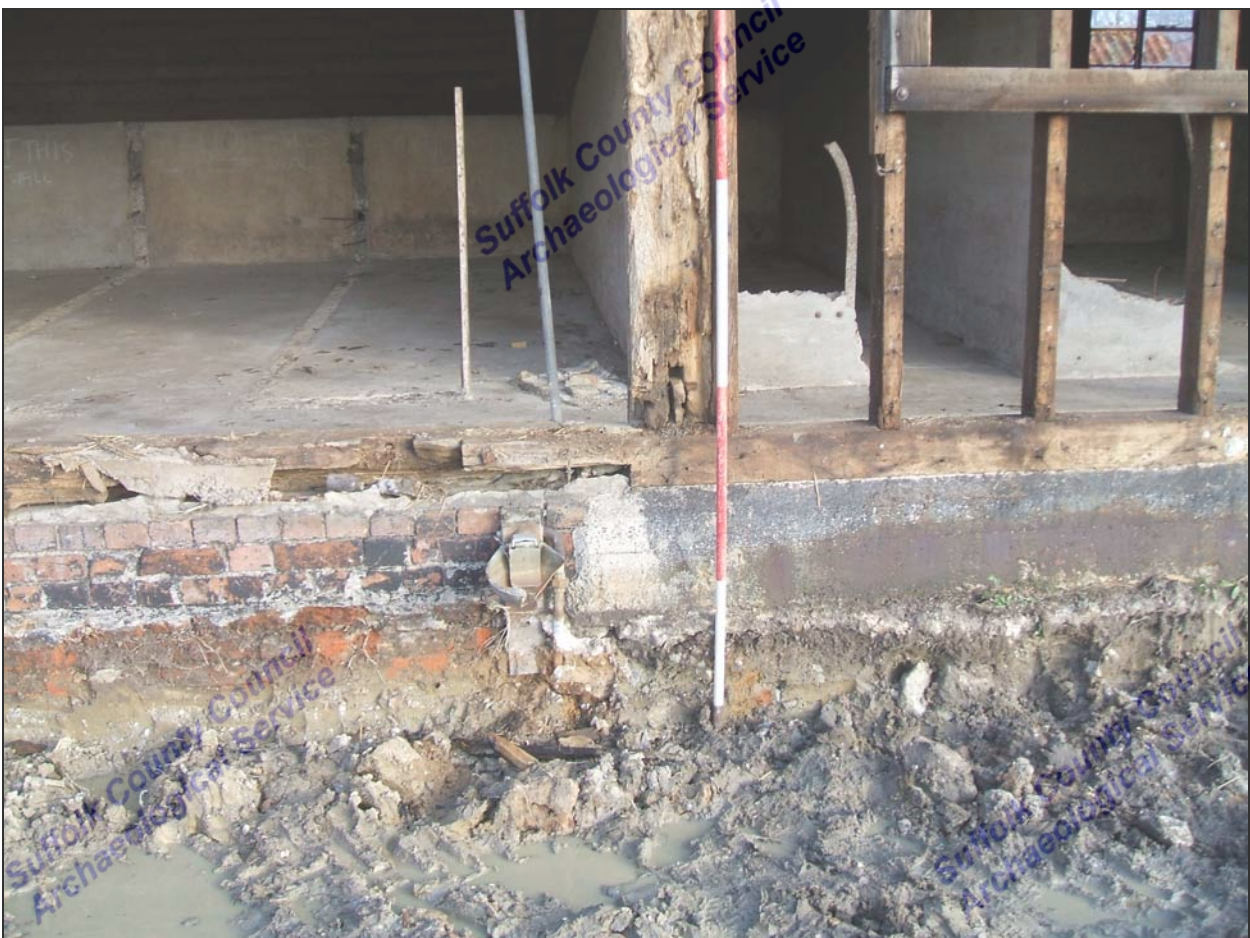
The frame is built in three bays. The sill beams and all but one of the principle posts are in re-used oak with the intermediate studwork, wall plate and roof structure all in mechanically sawn softwood (Figs. 7 and 8). The sill beam is made up of short lengths of reused framing, c.0.12m thick, half-lap jointed together. The mortising for studs show that these were former wall plates. The ends of all but one of the posts have been sawn off, removing the original joints (peg holes and mortises for bracing survive on some), and the posts are now plain, butted against the sill. The original length of the posts is therefore unknown but they measure c.0.2m thick. The post in the south-west corner is jointed to the sill suggesting that these are matched contemporary timbers. The width of the post has been reduced to fit with the current end wall suggesting that they are no longer in their original setting.

Figure 8. Building 3 West elevation – reused oak post and sill beam at junction of north and central bays
