ARCHAEOLOGICAL EVALUATION REPORT

RAF WOODBRIDGE – SKANSKA SITE SUT 199

A REPORT ON THE ARCHAEOLOGICAL EVALUATION, 2004
(Planning app. no. C/03/2371)

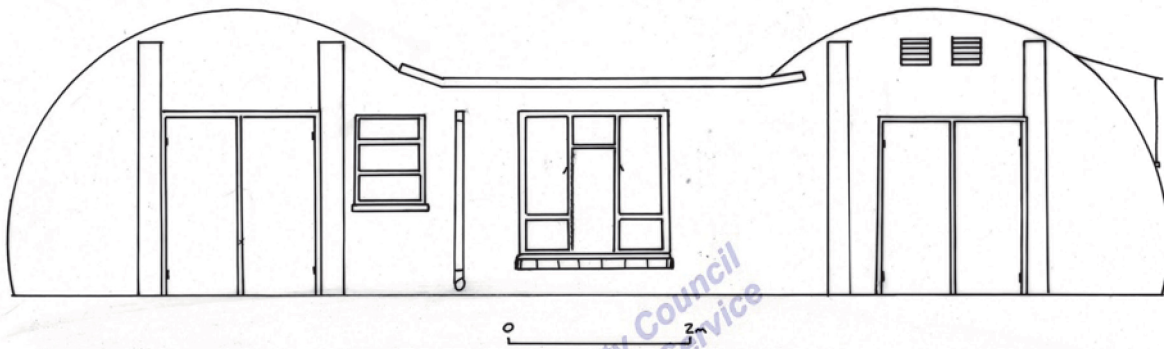
Figure 4. Building 12, front elevation

Building 12 (illustrated below) comprised two adjacent 'Nissen' type huts connected by a brick built flat roofed structure to form a single building. The end walls of each 'Nissen' hut portion is constructed of brick with a cement render on the outside. The long walls and roof comprises corrugated steel sheets approximately 3.5m in length and 1m wide. They are mounted vertically

onto an internal frame with three sheets forming a complete run, two side sheets and a third sheet laid over the roof and overlapping the two side sheets. This pattern is continued for the length of the building with all sheets overlapping its neighbour whilst the sheets at either end overlapped the brick walls. The brick walls are of single brick thickness and have buttresses on the outside face although these were not present on all the 'Nissen' type huts (see Fig. 4). The entrance doors of the majority of the 'Nissen' type huts are in the end walls although Building 10 had a side entrance but this is believed to be a later alteration. The corrugated steel sheet walls are double thickness with presumably a cavity between. The inner wall is again formed of corrugated steel sheets although they are mounted horizontally with the vertical joints between adjacent sheets being covered by thin metal strips which are riveted or bolted to the corrugated sheets. The floors appeared to be cement which was badly cracked suggesting a poor foundation.

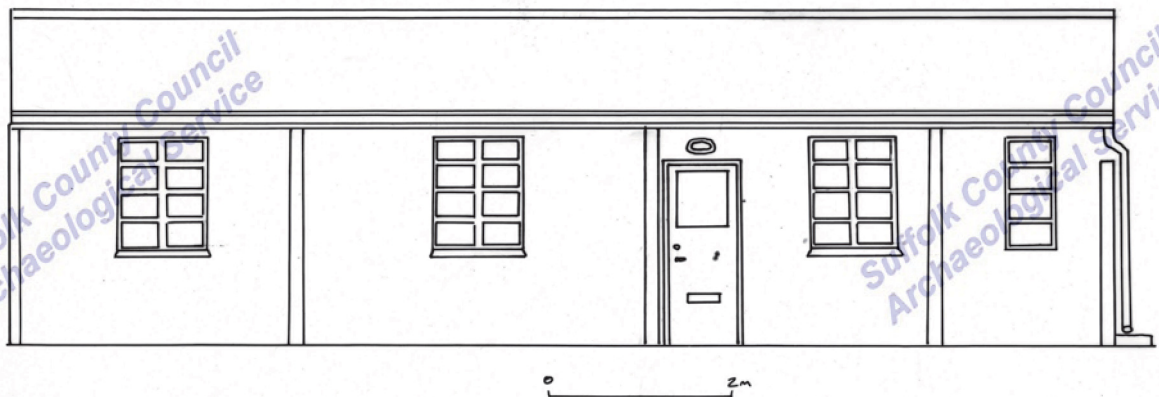
Figure 6. Building 20, side elevation

Building 20 (illustrated below) comprised a brick built single storey hut with a pitched roof covered with asbestos sheets. The walls, which were rendered, appeared to be a single brick thickness with regular buttresses. Internally the building was panelled and decorated. A 'Nissen' type hut was situated alongside and the two were connected by a brick built flat roofed passageway to form a single structure. The floors were linoleum covered.

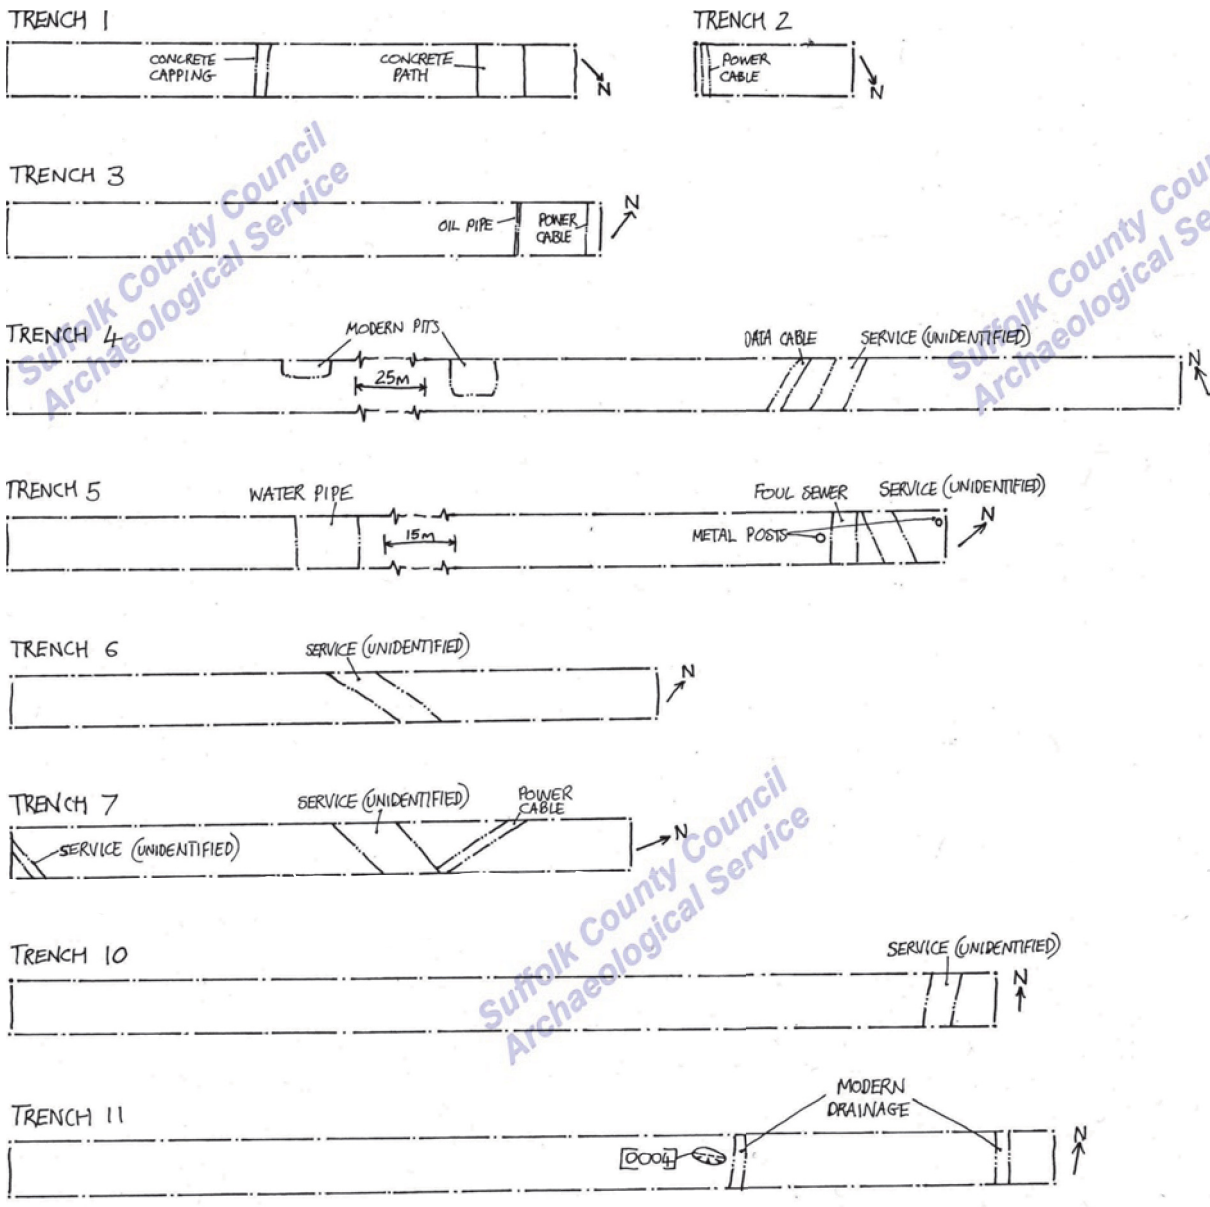
Figure 9. Trench plans and sections

Situated immediately south-west of Building 20 this revealed a uniform 0.55m of topsoil (0002) overlying the natural sands and gravels. Two services were encountered at its north-eastern end (a fuel oil pipe and recent power cable). No archaeological features were observed.

This was adjacent to the north-west to south-east aligned access road running through the centre of the site in order to evaluate the deposits in an area that had been partly occupied by scrub prior to the evaluation. A uniform 0.7m of heavily disturbed topsoil (0002) was recorded throughout the trench, directly overlying natural sands and gravels. Two modern rubbish pits were encountered at 8m and 35m from the north-western end of the trench. Some 9m from the south-eastern end of the trench two service runs were recorded crossing the trench from east to west (one carried a data cable, the other was not investigated). No archaeological features were encountered.

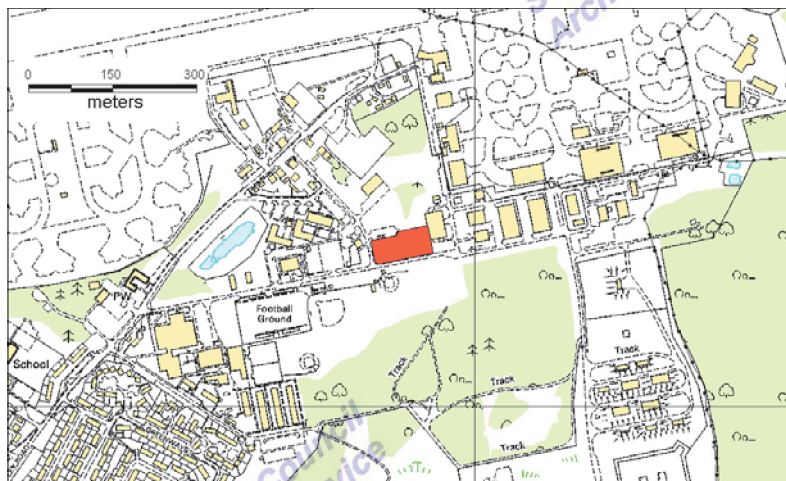
Figure 10. Area requiring archaeological monitoring

However, the southern part of Area 3 was not accessible at the time of the evaluation due to the presence of protected heathland. The single trench (7) located at its margins was insufficient to characterise the nature of the deposits. It is therefore recommended that a programme of monitoring is required when the development next affects the area outlined in Fig 10. In this case it is understood that relocation of this patch of heathland is to be carried out.

The presence of an archaeologist throughout during this relocation is recommended followed by trial trenching of 5% of the area as originally specified.
