St. Nicholas Church, Ipswich (IPS 442), A Record of Archaeological Work Associated with the Reordering and Extension to the Existing Building

Report No. 2005/48, Oasis ID Suffolkc1-3168

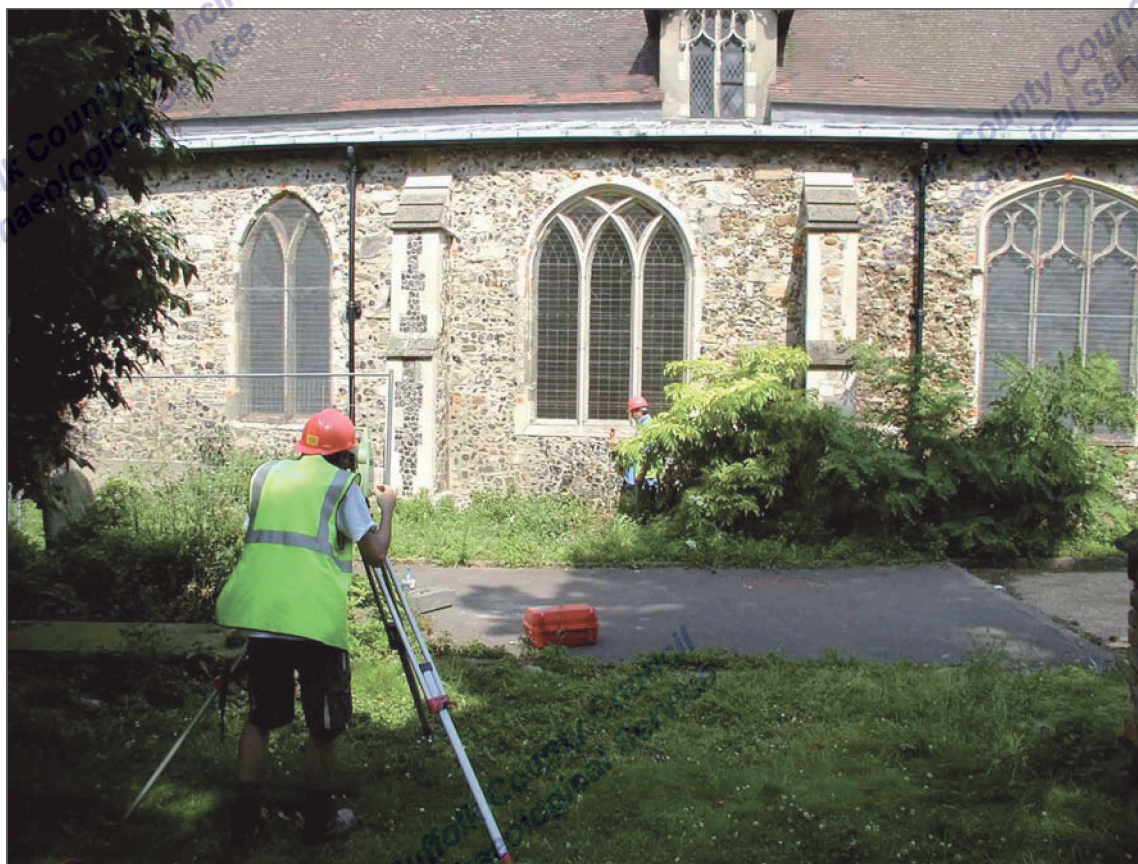
Plate 1: Surveying South Aisle Wall

With a view to carrying out limited photogrammetry using the digital photographs, a series of known points were imposed on the walls of the north and south aisles,

chancel and vestry and were subsequently recorded using total station survey equipment (Plate 1).

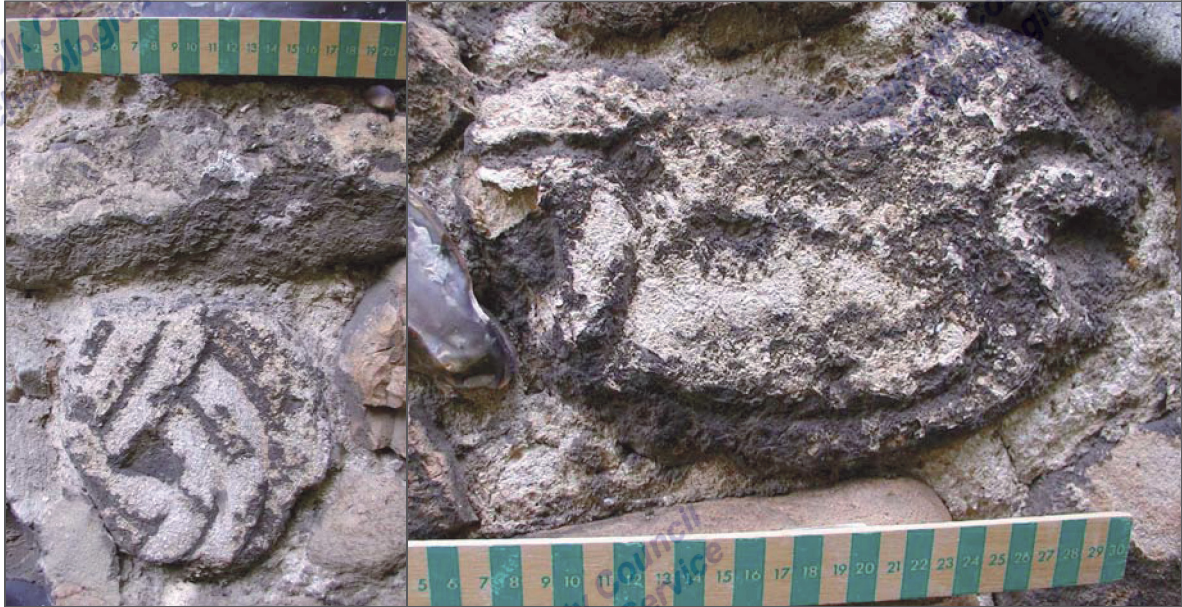
Plate 2: Saxon Grave Marker Fragments in South Aisle Wall

The most striking thing about the earlier wall fabric of the aisle was the materials used rather than features relating to the manner of its construction. Sizes of the individual stones forming the rubble component of the wall varied from small flint chips, introduced as galetting between the larger pieces, through to small boulder-sized lumps measuring up to 0.7 metres across, the latter particularly evident in the west wall. A wide range of material had been used. The following percentages are subjective, based on the overall visual impression rather than formal measurements. The wall fabric comprised: septaria (60%), reused limestone masonry fragments (Barnack 7%, other 6%), unknapped flints (10%), roughly knapped flints (10%), erratics (5%) and brick and tile fragments (2%). The lime mortar used in the construction of the wall was orange in colour (ferruginous) very coarse with extremely common inclusions of marine shell fragments, possibly indicating the locally available Red Crag beds as a source. Lift-lines were visible or, where the wall face had been repointed, could be inferred from the position and alignment of some of the clasts used in the wall facing. Lift-lines were best developed to the west of the porch where they were sometimes irregular and not perfectly horizontal. Coursing was present but had often been disrupted by the variable size of the stones. Only two putlock holes were identified, both framed by limestone masonry fragments, one each side of the window with intersecting tracery. There was also an area of refacing below this window which included two fragments of Saxon masonry, probably parts of grave markers (Plunkett, pers.comm.) (Plate 2).

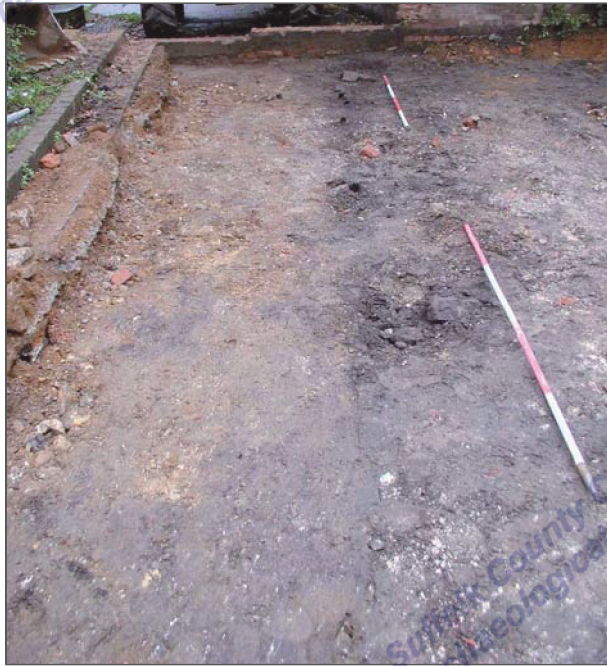
Plate 3: St. Nicholas Church Lane

The lane (0102) survived as no more than a scrappy, c.0.1 metres thick, layer of gravel and small cobbles in sand which, to the north, was covered by a pink layer of ash. The latter was almost certainly introduced as a repair or laid when the ground was icy to reduce slipping (Plate 3). The line of the lane was also marked by a series of iron fence steels on either side. Three other fence posts were recorded to the east of the lane, two (0103 & 0104) comprising amorphous lumps of concrete while the other (0105) was square and constructed from brick and concrete.

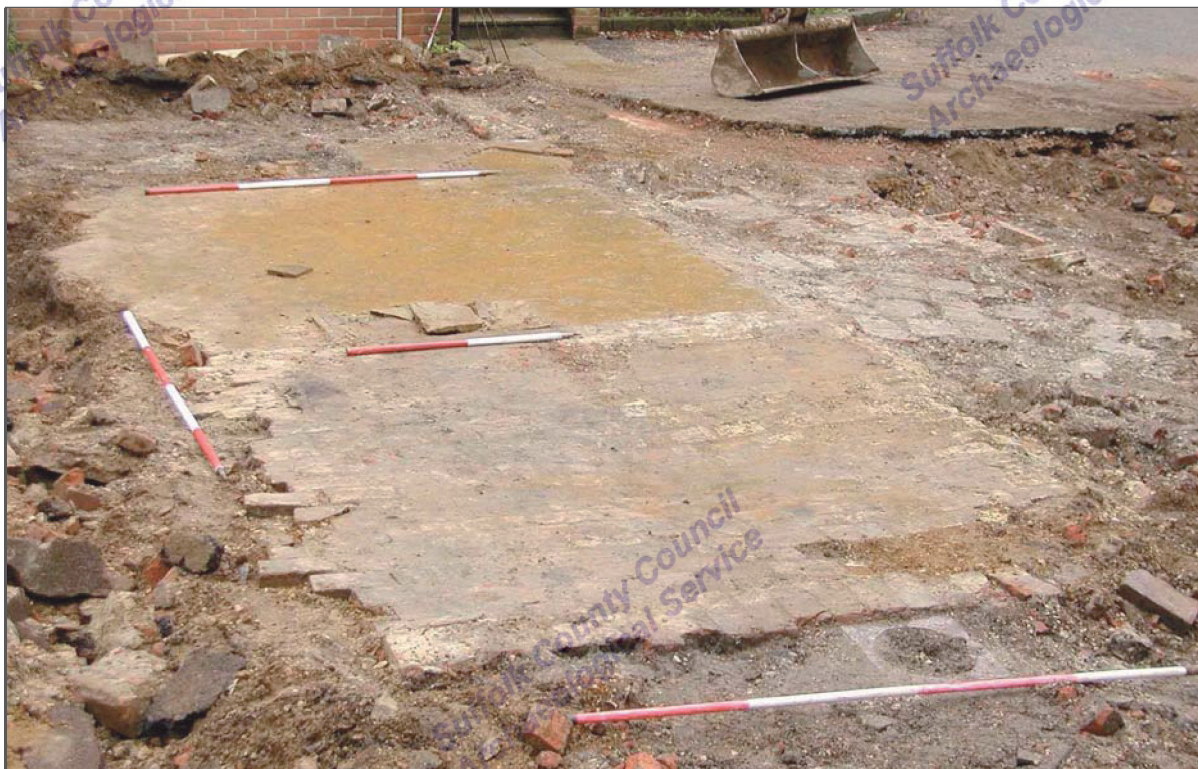
Plate 4: Building 0099

Materials used in the surviving portion of the building (0099) suggested that while it may have originally been constructed during the 17th century, it had undergone later alteration, repair and possibly even wholesale replacement. Truncated by the footing of the retaining wall to the car park to the east of the site, the building comprised three rooms (Plate 4). The northern most room, measuring c.2.8 metres from north to south and an in excess of 2.5 metres from east to west, had an intact floor surface of red bricks at a level of c.4.30 metres OD.

After recording, the remains of the buildings were removed and the reduced level strip continued down towards the proposed formation level. The external redbrick walls of the building were found to be relatively shallow with no formal footing. However, the east to west orientated footing of the north wall of the northernmost room was

entirely different in character. While the wall itself was similar, its footing (0016), which continued down to the surface of the naturally occurring subsoil at *c.*3.00 metres OD, comprised stone and brick rubble set in lime mortar. The rubble component included large lumps of septaria, reused limestone blocks and some brick. There were voids between the lumps of rubble suggesting that mortar and rubble components had been introduced separately.

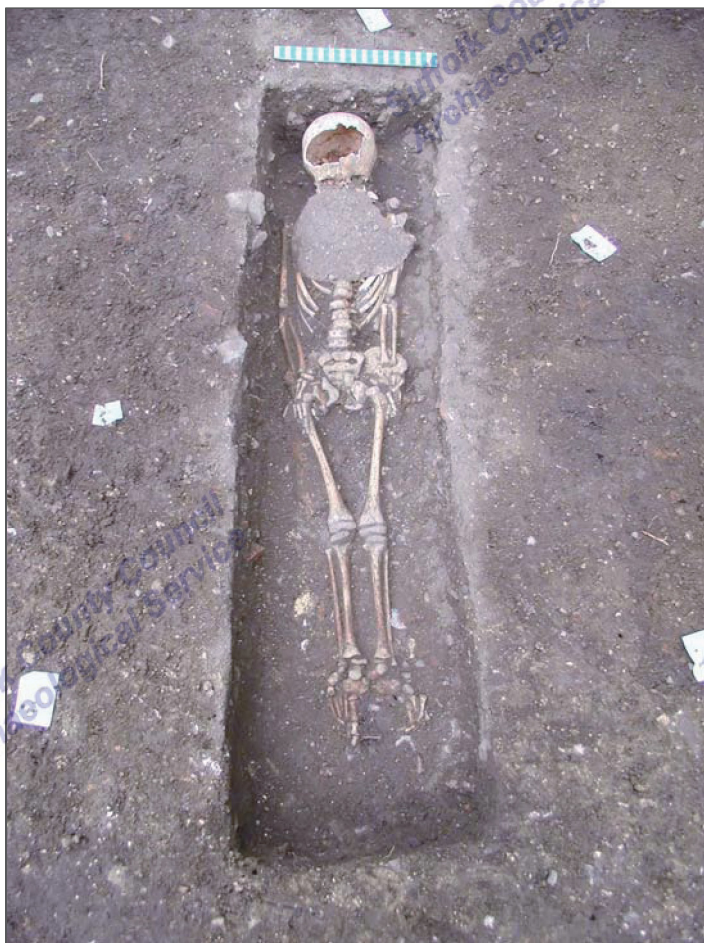
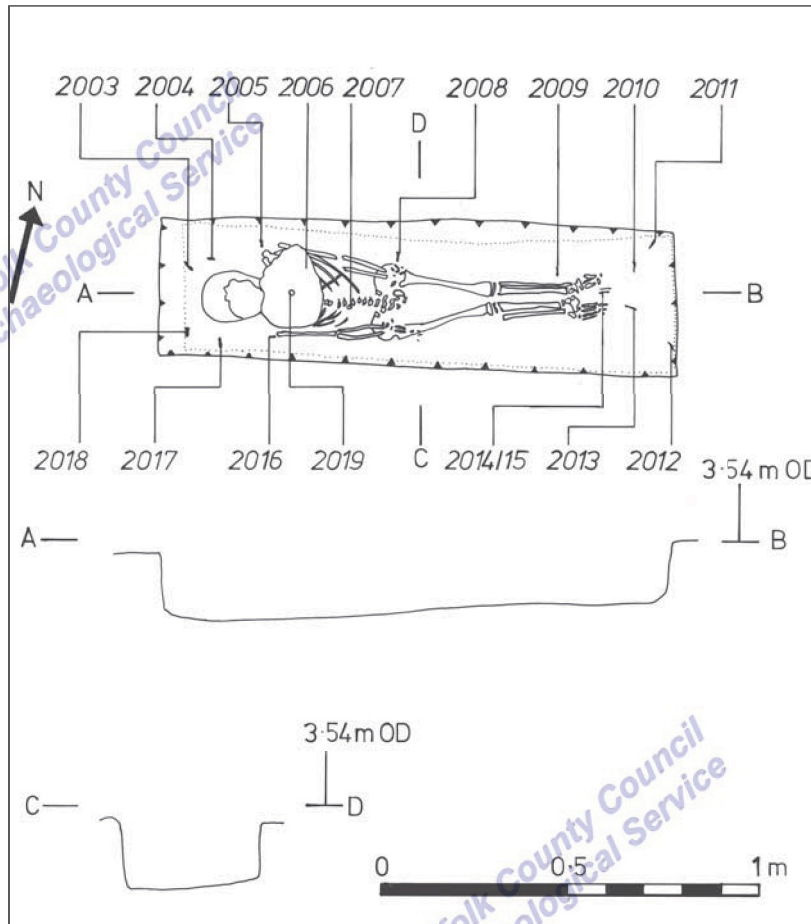
Fig. 4 1:20 scale plan & profiles of Grave 0002, Skeleton 0004

skeleton of a child (0004) that had clearly been contained within a wooden coffin, the furniture for which (nails and a nameplate) was recorded during excavation (Plate 5 & Fig. 4). The highest point of the skeleton, the top of the skull, was recorded at a level of 3.52 metres OD. A detailed description of the skeleton can be found in section 3.5 of this report.

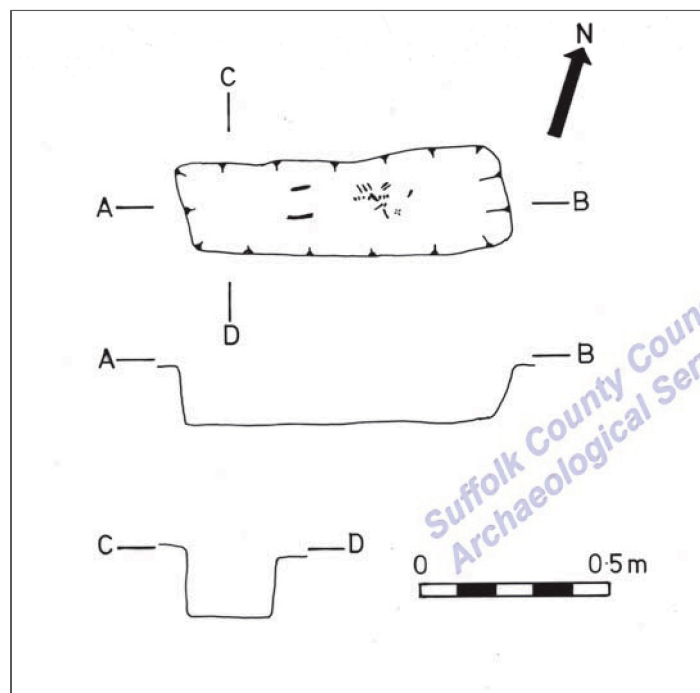
Fig. 5 1:20 scale plan & profiles of Grave 0037, Skeleton 0039

homogenous grey/brown loam with patches of clay. The skeleton (0039), that of an infant of 0-5 years, was very poorly preserved (see Fig. 5 & text section 3.5). The highest point of the skeleton, part of the skull, was recorded at a level of 3.40 metres OD. Unusually, the head of the skeleton was at the eastern end of the grave, perhaps the small coffin was rectangular in shape with no distinguishing characteristics that would inform as to which end was which.

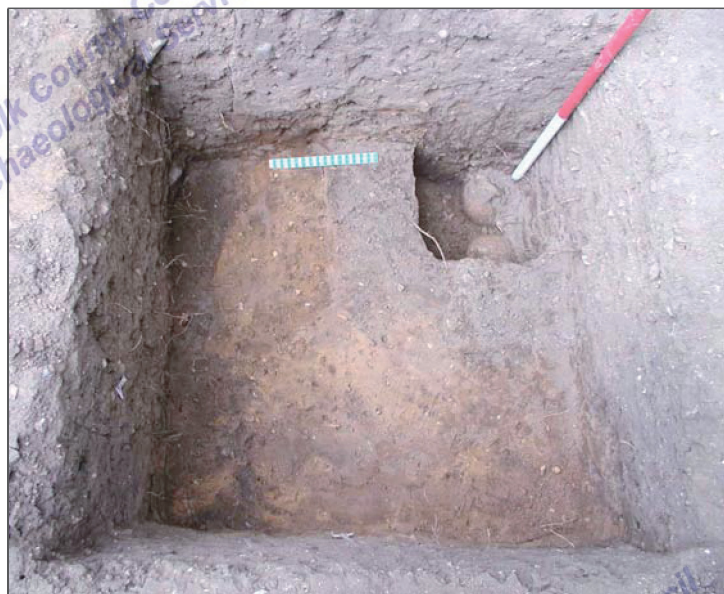
Plate 6: Excavated Footing Pad

square, the pad was excavated down to the naturally occurring sand subsoil at a level of 2.86 metres OD. Four features (0007, 0009, 0011 & 0013) were recorded in the base of the excavated pad, all incised into the natural subsoil (Plate 6). Three of these (0007, 0011 & 0013) were probably graves, the other (0009) a pit.

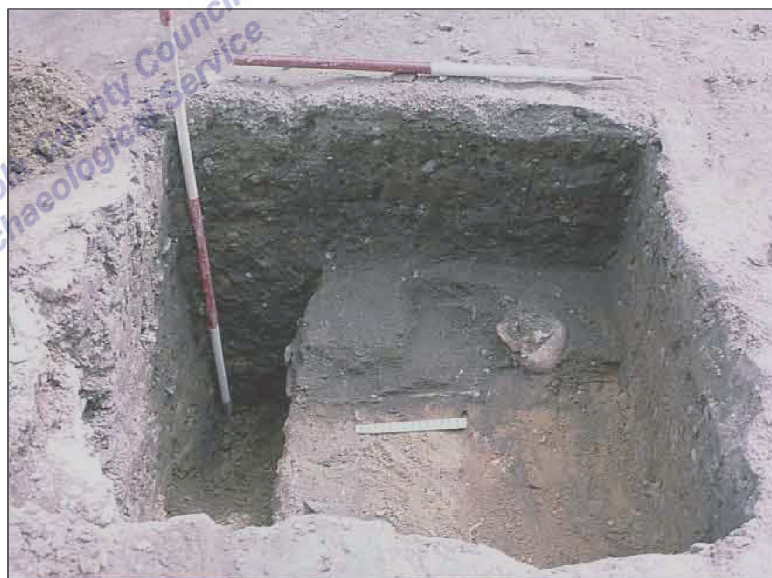
Plate 7: Grave 0017 & Pit 0020 in re-excavated Test-Pit 2

Grave 0017 was recorded on the southern side of the Test-Pit with its legs truncated by pit 0020 (Plate 7). The position of this grave beneath the buildings which had occupied the site at least from the mid 17th century, suggest that it is of some antiquity. If the dating for pit 0020 is correct with the ceramic finds an accurate reflection of the time in which it was filled, then the grave itself must be Late Saxon or earlier and relate to the earliest phase of the church. The poor condition of the skeleton, with even some of the more robust bones reduced to a very fragile state, supports this interpretation. It was not considered necessary to remove this skeleton as it would not be disturbed by the groundworks associated with the development.

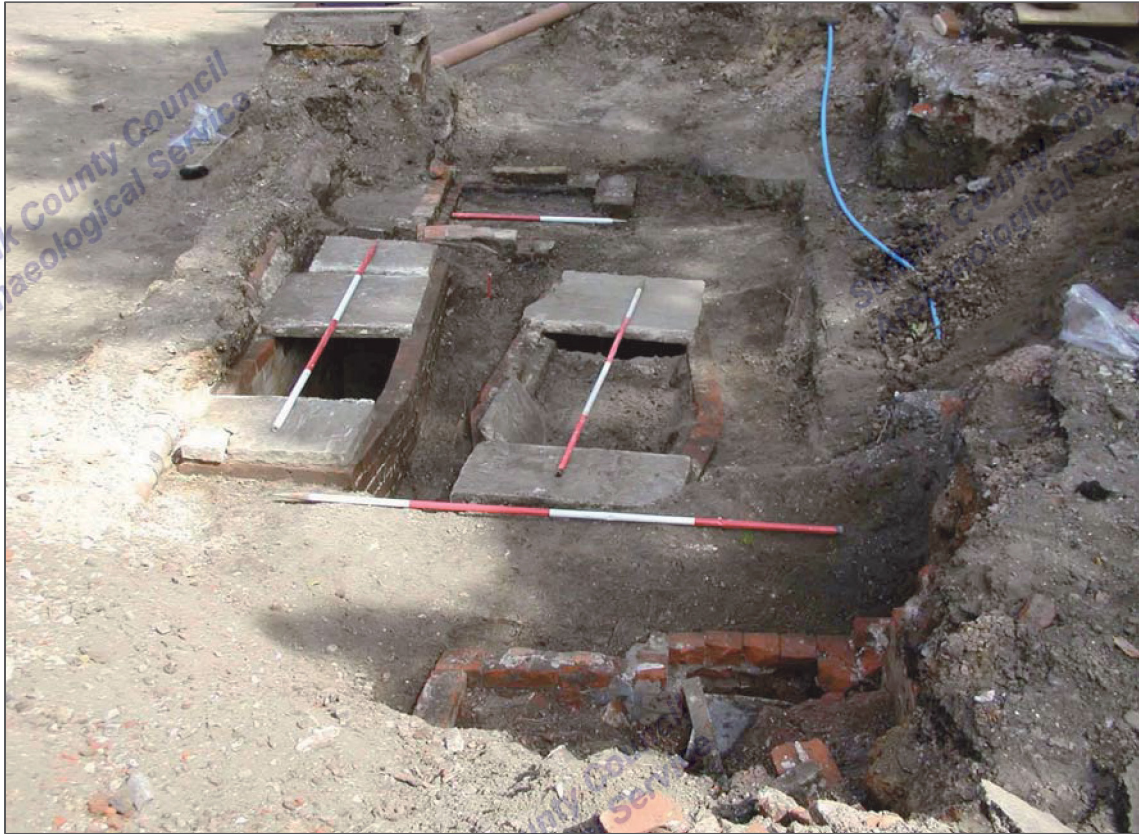
Plate 8: Brick Built Tombs 0022 & 0023

Another factor influencing the decision regarding the foundation design was the presence of eight brick-built tombs, all of which at least partially encroached into the footprint of the proposed building, and other articulated burials recorded at a similar level (Fig. 3 & Plate 8). None of the tombs were marked at the surface, although almost certainly they would have been when originally constructed. However, their presence had been predicted from the results of both the Geophysical Survey (GSB Prospection, 2003) and Test-Pitting (Gardner, 2004). All are thought to date to the first half of the 19th century as the cemetery was closed for burial in 1855 (Breen, 2004). The information recovered regarding these tombs is presented in Table 2.

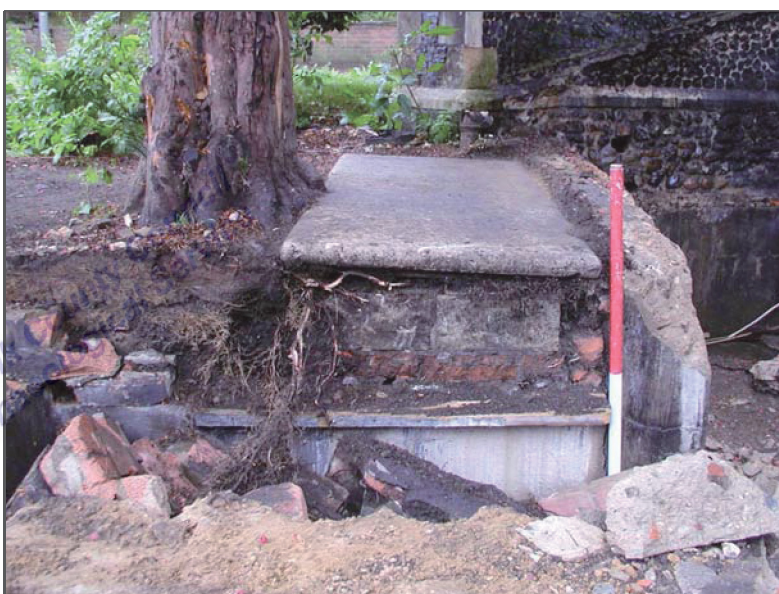
Plate 9: Tomb Seen in Side of Boiler Room Steps

During the first quarter of the 20th century, a system of heating was installed which required the provision of a space to hold the fuel tank and other associated machinery that could not be accommodated within the body of the church. To this end a 3.5 metres by 12 metres, approximately 2 metres deep, rectangular concrete lined and

floored pit was excavated on the north side of the church at the junction between the north aisle and nave (Fig. 6). Access to the pit was afforded by a set of steps on its northern side.

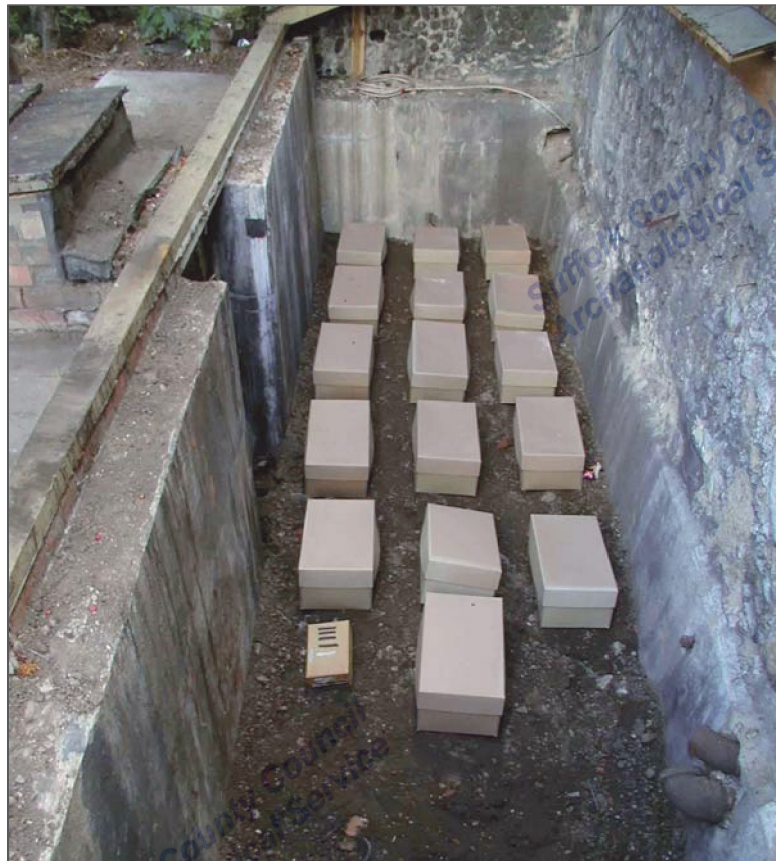
Plate 10: Reburied Skeletal Remains in Boiler Pit

skeletons from the reduced level strip. The bones were put into cardboard finds storage boxes and placed in the bottom of the pit (Plate 10). The reburial occurred on the 21st of September, 2004 and was accompanied by a short service and a blessing.

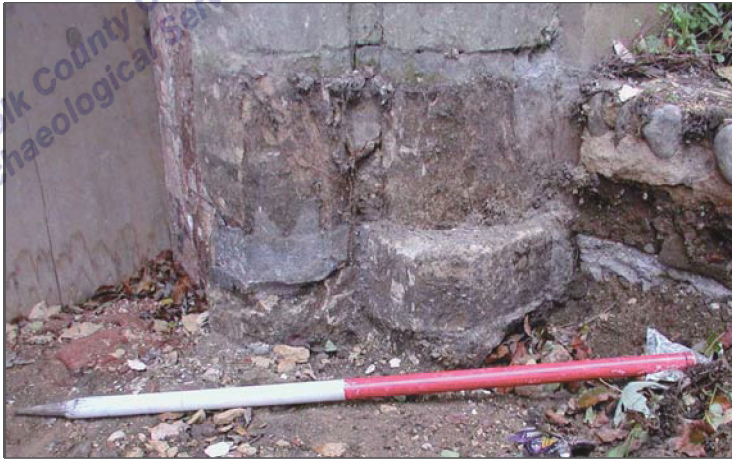
Plate 11: Detail of Moulding, West Side of North Doorway

(Plate 11). These would originally have been exposed, but the progressive raising of the ground level, a result of the successive excavation of the soil for burials and its location within a town, where overburden levels tend to build up over time, have led to their being covered.

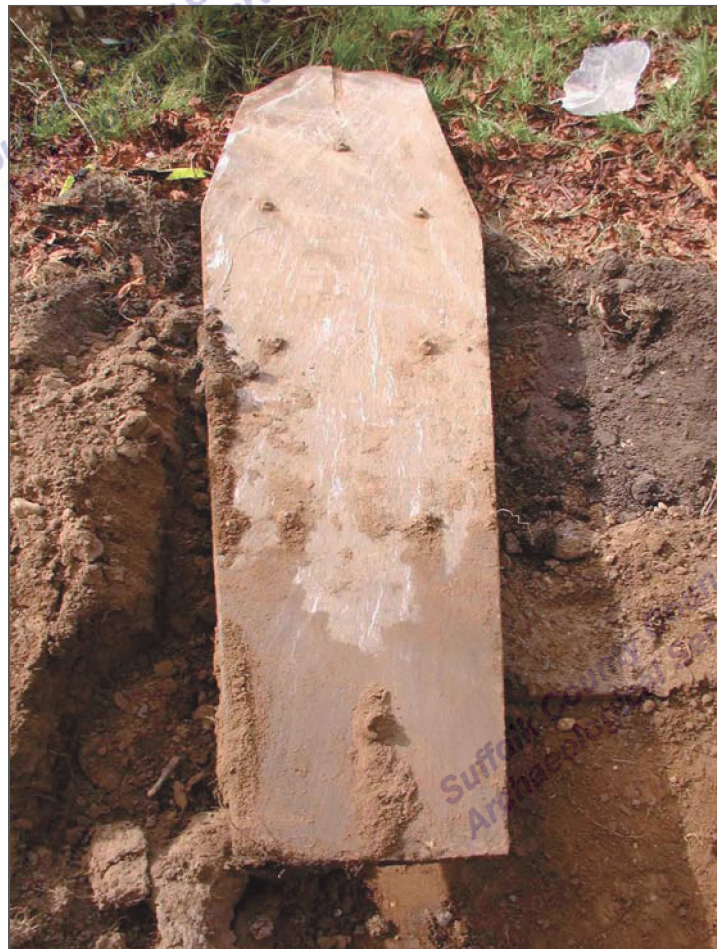
Plate 12: Slate Slab Revealed During Landscaping

During soil-stripping to facilitate the parking area on the west side of the driveway two 'coffin-shaped' slate slabs with associated iron fittings were uncovered at the interface between the thin topsoil layer and the underlying subsoil (Fig. 6 & Plate 12). The long axis of both slabs was approximately north to south which suggests that they were not in situ. This was confirmed when moving the slabs revealed no underlying grave-cut. It is likely that these formed part of one or more tombs that were dismantled during an earlier reordering and landscaping of the churchyard.

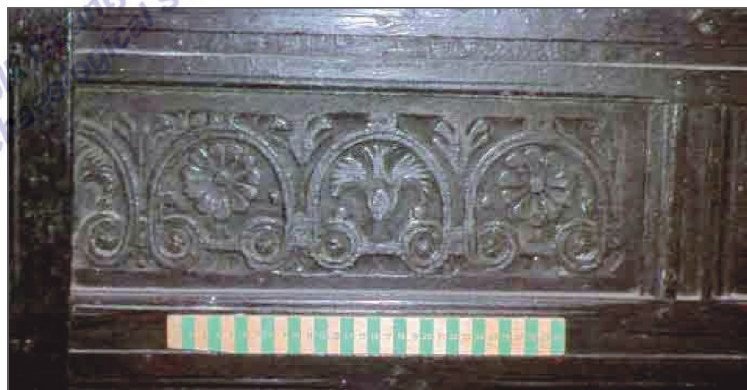
Plate 13: Detail of Panel N.29

The oak panelling is of a kind typically associated with the seventeenth century. This form of high quality work was, during that period, produced by joiners, a trade which at that time covered a far more specific range of skills. The individual quarter sawn oak panels are held within a framework of mortice and tenon joints which are secured

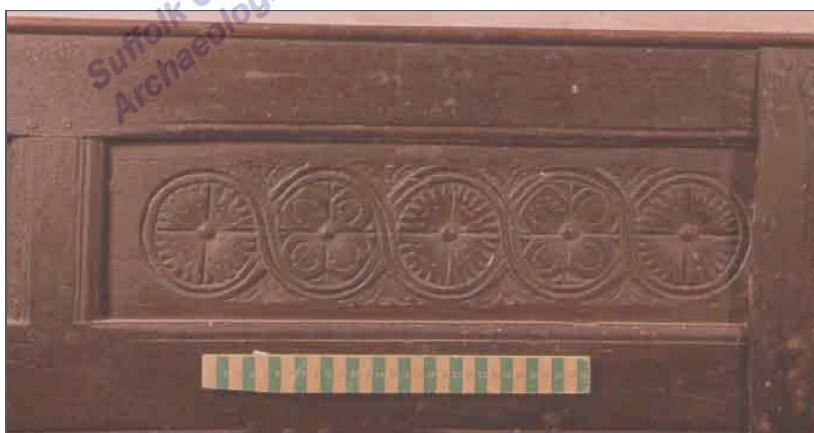
Plate 14: Detail of Panel N.24

The extensive evidence of adaptation includes the existence of decoration on the reverse side of the panelling and laborious efforts to cut-down sections of panelling in order to

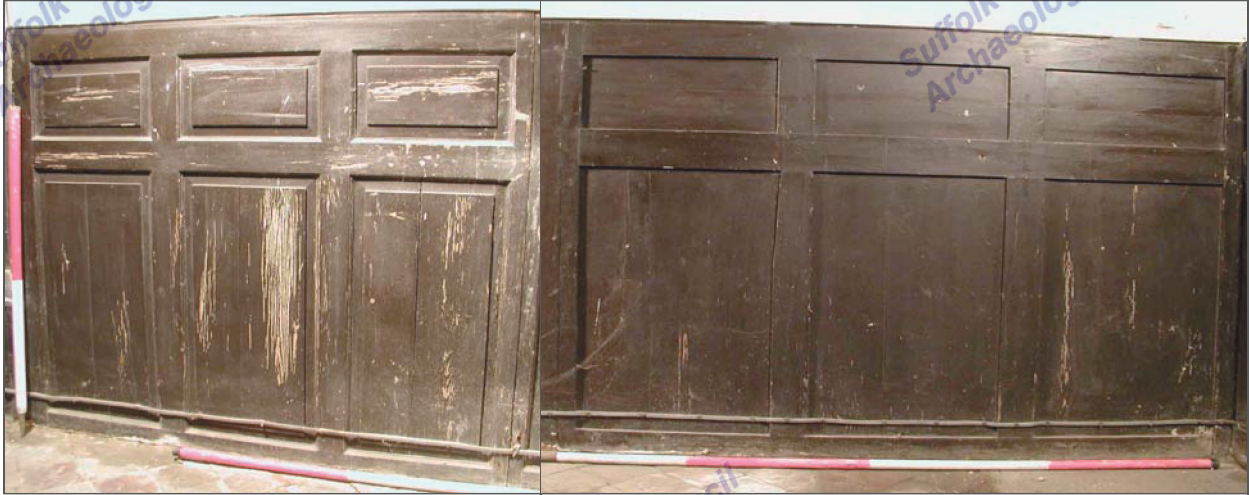
In contrast to the oak panelling, the sections of pine panels display virtually no decoration, although it remains possible that earlier painted finishes may have existed. The inner edges of the frame have small ovolo mouldings, while the panels are fielded (Plate 15 {A}).

{A} N15; Fielded Panels Exposed

{B} NW3; Fielded Panels Reversed Against Wall

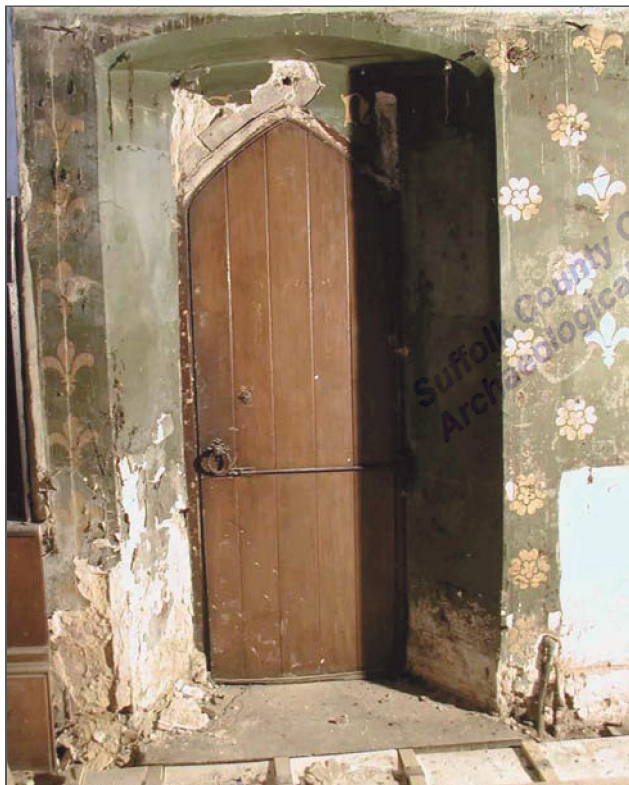
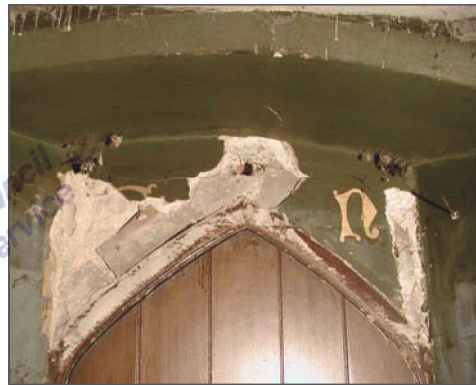
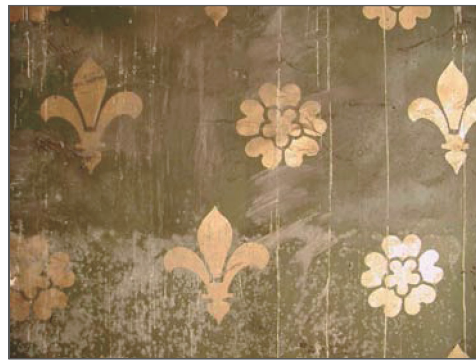
Plate 16: South Chancel, Wall Paintings

By far the most impressive of the wall paintings revealed during the reordering were on the wall surrounding the door which, until its demolition during this project, serviced the small kitchen extension to the south. Originally this door and its surrounding panelling were not going to be disturbed during the building work, but the change in the formation level of the external new build led to a change of plan.

The removal of the panelling revealed a painted olive green background with alternate motifs of fleur-de-lis and tudor roses, all in gold leaf (Plate 16). The continuation of the olive green background into the door splay, with some additional lettered designs around the door itself, indicates that the painting post-dates the insertion of the doorway which almost certainly occurred during the first half of the 19th century.

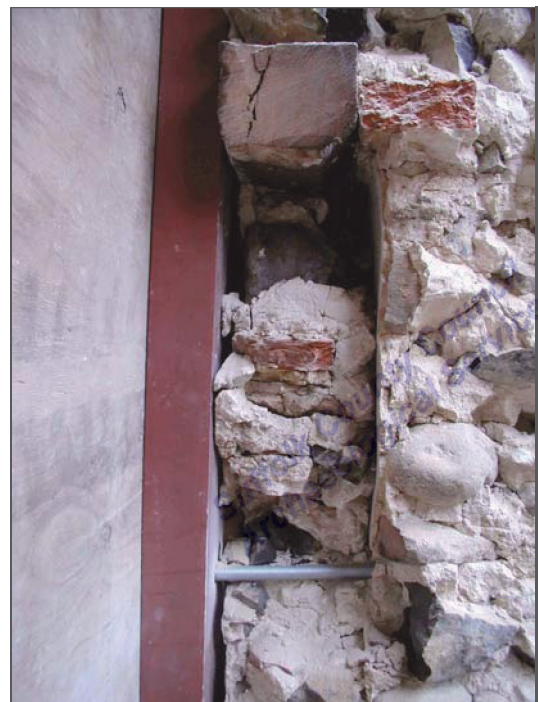
Plate 17: Detail of Filled Recess, South Aisle East Wall

Inserting the new doorway through the east wall of the south aisle involved the removal of wall fabric representing material used to block a large perpendicular window and also some original wall fabric of the south chapel (c.16th century in date). Removal of sections of wall plaster in the area of the new door had previously revealed that the window blocking material included significantly sized fragments of limestone masonry. Given that pieces of Anglo Saxon stone carving had been found reused in the walls elsewhere in the building then particular care was to be taken when removing this material.

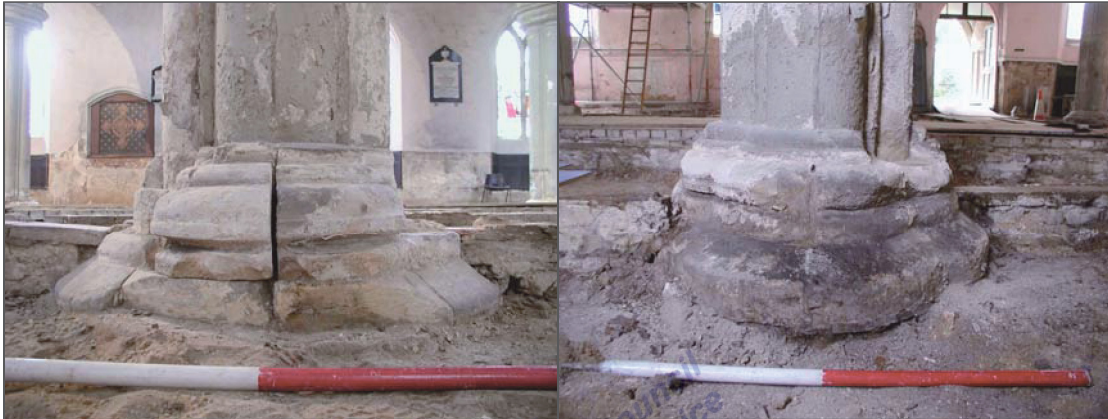
Removal of the existing wooden floor in the nave and aisles revealed the bases of the aisle pillars. The masonry of the decorated moulding of the pillar bases had deteriorated badly and a decision was made to repair the worst sections as part of the overall reordering project. Prior to the removal of the damaged masonry a photographic record (digital only) was made. Plate 19 shows two of the pillar bases which are broadly representative of the condition of the others.

{A} South Aisle; 2nd from west, aisle side

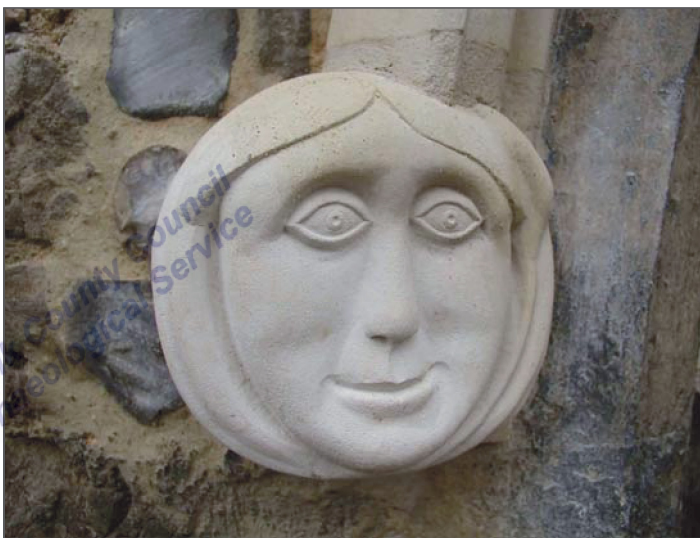
Plate 20: North Doorway; Replacement Label Stop

A number of site visits were made in order to photographically record minor masonry repairs to the mouldings of windows, doors and buttresses. Included was the replacement of a stop (Plate 20) and sections of the hood mould around the north doorway.

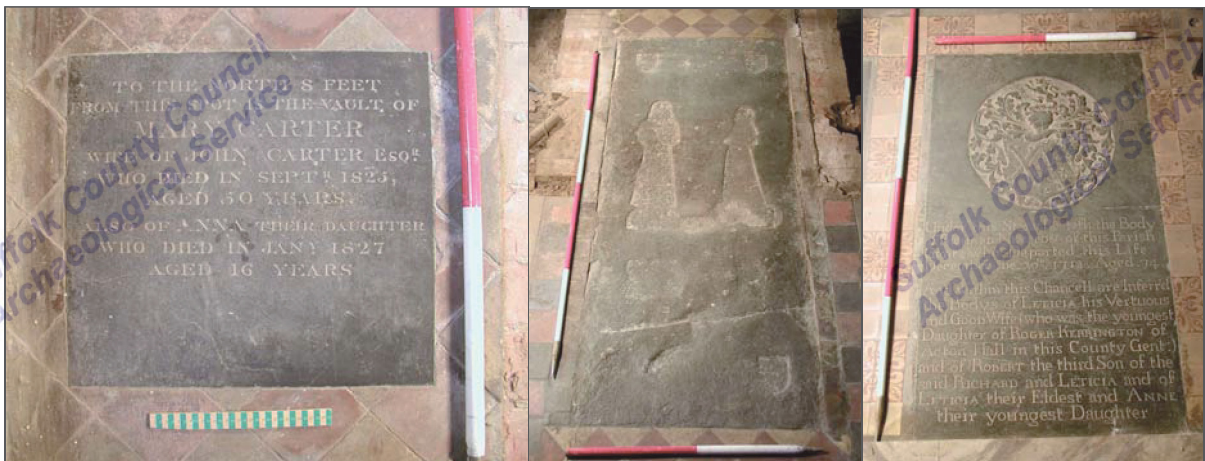
floor. It was not considered necessary to take detailed transcriptions as these had already been done in the past. However, names and location were noted and are recorded in Table 4, along with the relevant photo archive codes (D = digital, S = colour slide, M = monochrome print), while their position within the church is shown as Fig. 9. Examples of three of the internal grave markers are shown in Plate 21.

{A} Monument No. 4

{B} Monument No. 5

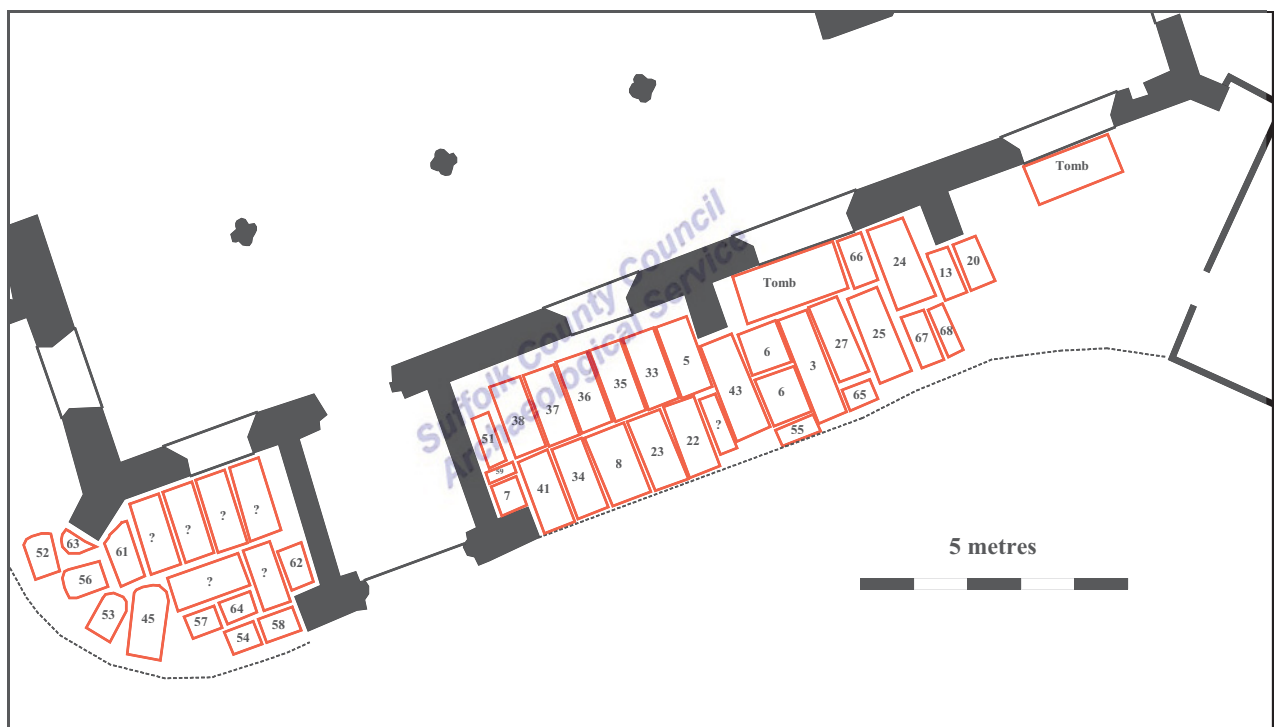
Fig. 10 Plan of the Re-Set Grave Markers

Many of the slabs still carried inscriptions that were photographed digitally as part of the archaeological recording process. The more complete of the gravestones and those with legible inscriptions were incorporated into the new landscaping scheme in a strip of ground immediately to the south of the church and are listed in Table 5. All the slabs had been numbered during the recording process and details of the inscriptions, limited to names and dates where legible, were noted for each stone (see photo archive). Fig. 10 is a plan showing where each of the retained numbered slabs were lain. Plate 20 shows three examples of the external grave markers.

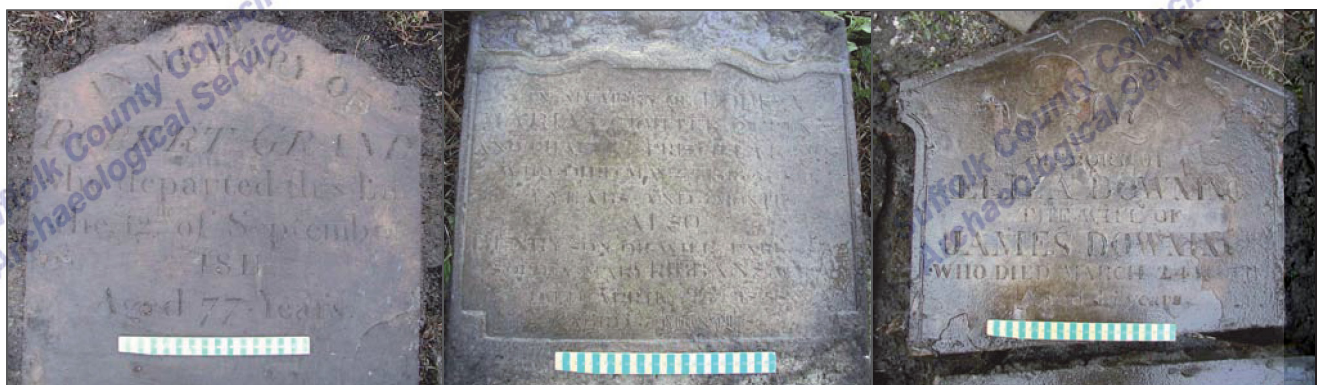
{A} Grave Marker No. 8

{B} Grave Marker No. 13

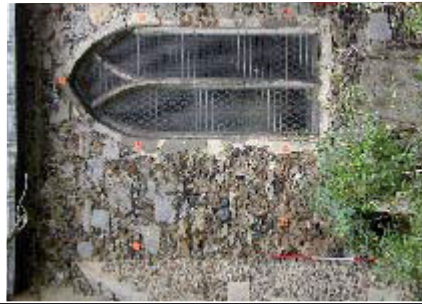
South Aisle

The westernmost *c.*18 metres of the wall, corresponding with the first four bays of the arcade inside the building, can be dated by the Y and intersecting tracery of the three windows to *c.*1300. While much repaired with hard grey cement filling, the original window tracery was usually present, but had been replaced in some areas. A small, roughly rectangular window high up in the west wall may represent a later insertion. The remaining *c.*6 metres, corresponding to the fifth bay of the nave arcade, was almost certainly added as a chapel. The perpendicular style window in its south wall is contemporary with its surrounding wall fabric and from the depressed nature of its arch and the bricks included in the wall itself, is likely to be of late 15th or 16th century. A small perpendicular window inserted into the eastern end of the nave roof may be of similar date. In addition, the scar of another window, known from drawings to be similar to that in the south wall and blocked during the 19th century to
