ARCHAEOLOGICAL MONITORING REPORT

BRICK KILN COTTAGE, WINSTON (SMR ref. WNT 052)

A REPORT ON THE MONITORING OF GROUNDWORK
ASSOCIATED WITH THE EXTENSION AND CONVERSION OF A
REDUNDANT INDUSTRIAL STRUCTURE TO RESIDENTIAL USE
(Application No. 0346/07)

INCLUDES:
BUILDING RECORD REPORT
by L. Alston MA (Oxon)

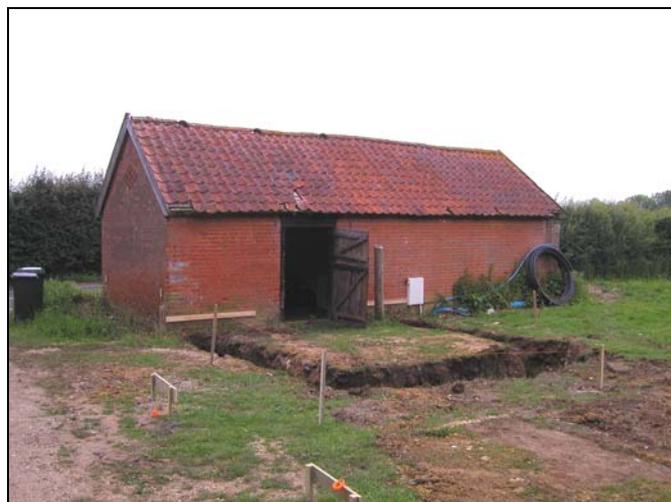
Plate I: Structure and footings
(7-6-2007)

The site was visited on the 7th June 2007 to inspect the footings for part of the new extension (Plate I). Immediately adjacent to the building being extended the trenches were excavated to a depth of 1.3m and revealed approximately 0.4m of rich dark loamy topsoil over a natural subsoil comprising clean yellow silt/sandy clay (Plate II). See figure 2 for a plan of the monitored footing locations.

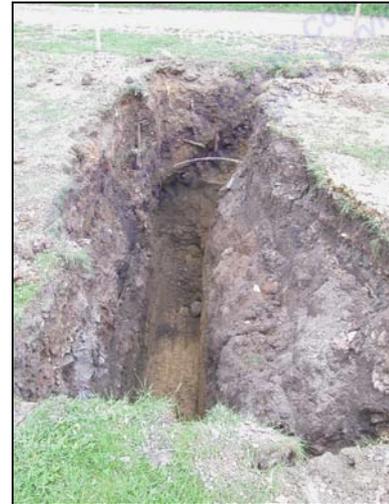
Plate III: footing showing area of deep excavation

excavation was encountered running the full width of the proposed extension and parallel with the existing structure (Plate III). The northeast side of this large excavation sloped steeply. This was the only side visible as all the others lay beyond the excavated footing trenches. The excavation was found to be approximately 2.8m deep and appeared to be sloping off towards the southwest.

The fill comprised distinct layers of topsoil and dirty yellow silt/clay all of which contained large amounts of relatively modern debris (glass bottles, rags, plastic water pipe, fragments of scrap iron, etc.) which was also present in large quantities on the spoil tip. No other features or deposits were noted.

The large excavation noted within the monitored footings is coincidental with what appears to be a roughly rectangular pit or pond marked on the 2nd Edition Ordnance Survey 1:2500 scale map of c. 1904 (see figure 3 - the thicker boundary line on the north and west sides is a normal OS convention to indicate a water filled feature). This feature does not appear on the 1st Edition of c. 1885 and was therefore created between the two surveys. It is possibly a quarry for brickearth although it appears to be in the middle of the working area of the brickworks with the main quarries and pits located to the south. Consequently its purpose may have been as a pond to provide a readily available water supply for use within the brickworks, possible to provide a reservoir of water for fire fighting in the kiln area. There is a pump over a well situated just to the north of this feature (marked with a dot and the letter P) but this may have been just for drinking water. The feature was undoubtedly a hazard with its great depth and steep sides and the fact that it appears not to have been filled until the second half of the 20th century (as indicated by the debris within its fill) suggests that it had some purpose requiring it to be kept open.

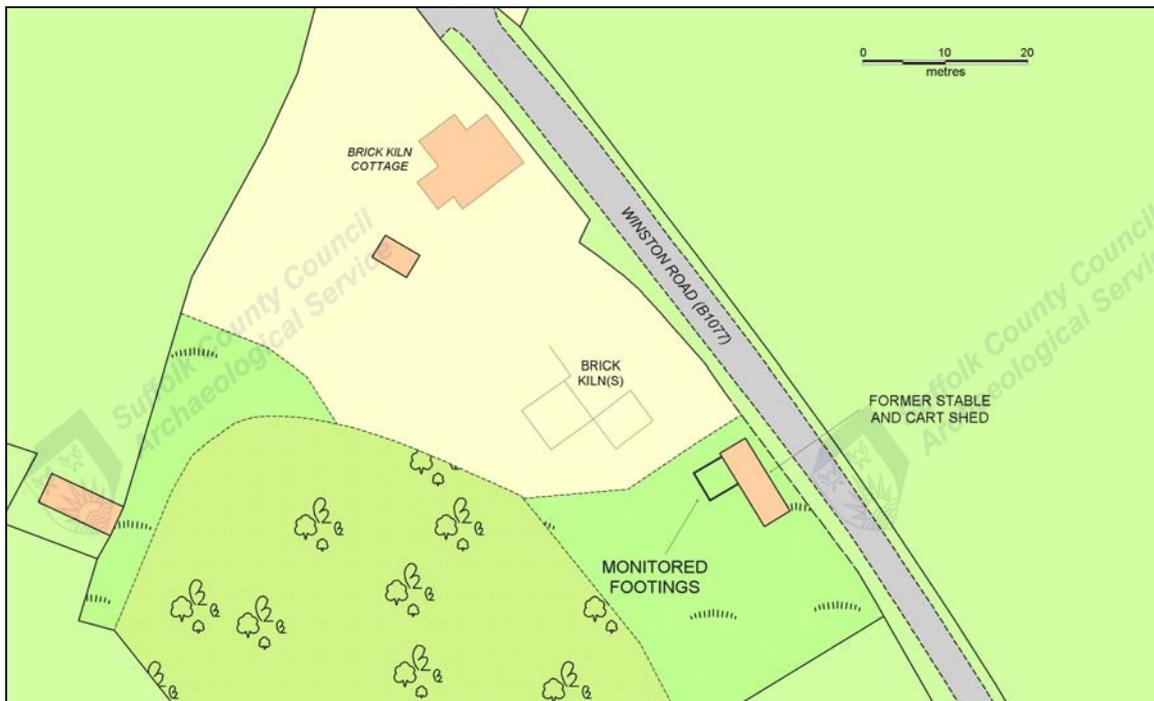
Figure 2: Location of Monitored Footings

The monitored footings represent only the first cell of the extension and further rooms were to be added to the southwest. The on-site contractors indicated that due to the presence of the large pond/pit the remainder of the extension would be built on a raft foundation.

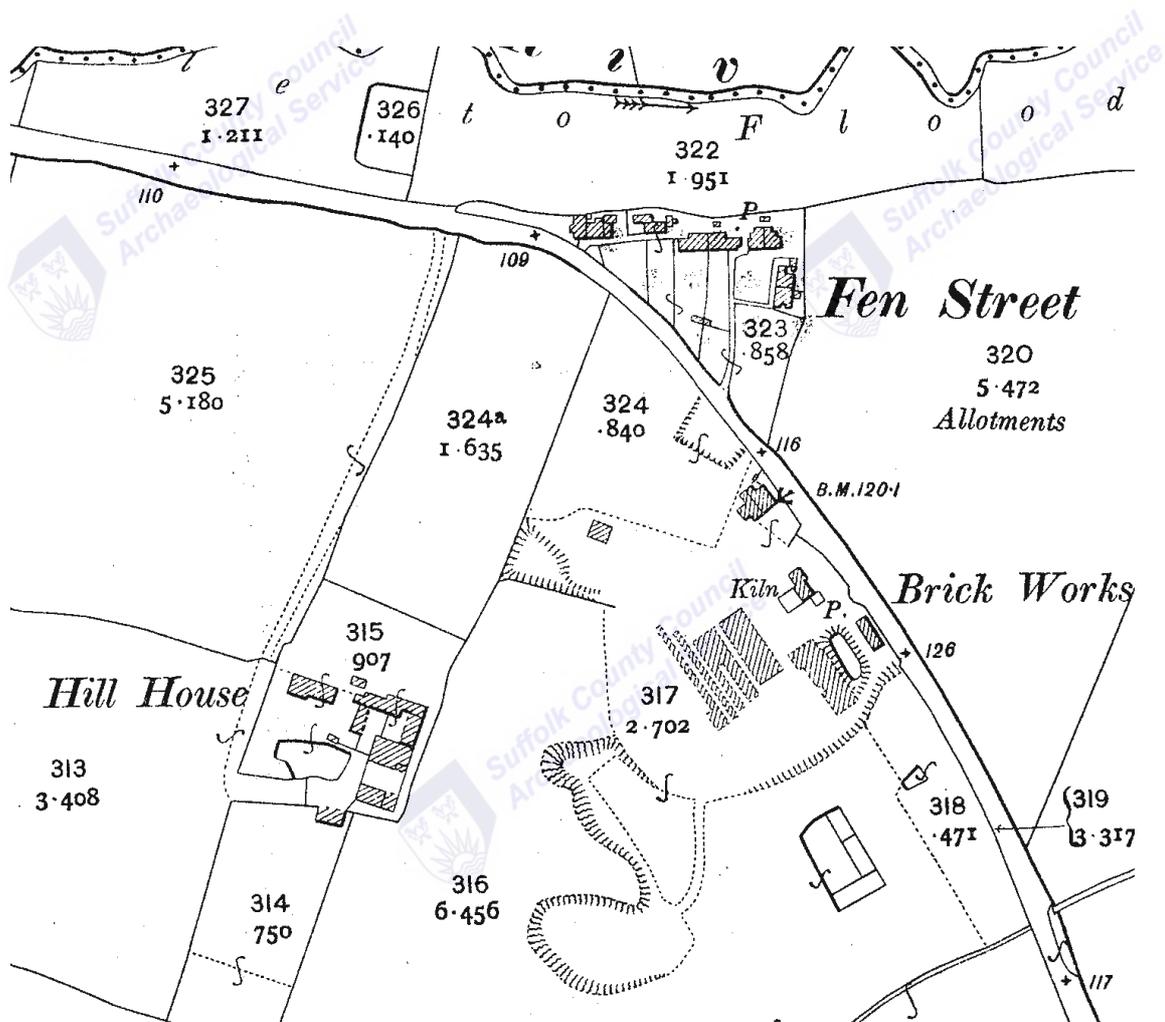
The Second Edition Ordnance Survey of 1904, showing the newly built structure which forms the subject of this report and an oval-shaped depression to its west which probably represents a horse pond.

The brick-built shed which forms the subject of this report is shown on the Second Edition Ordnance Survey of 1904 but not the First Edition of 1880, and may therefore be dated to *circa* 1900 (which date is entirely consistent with its structure).

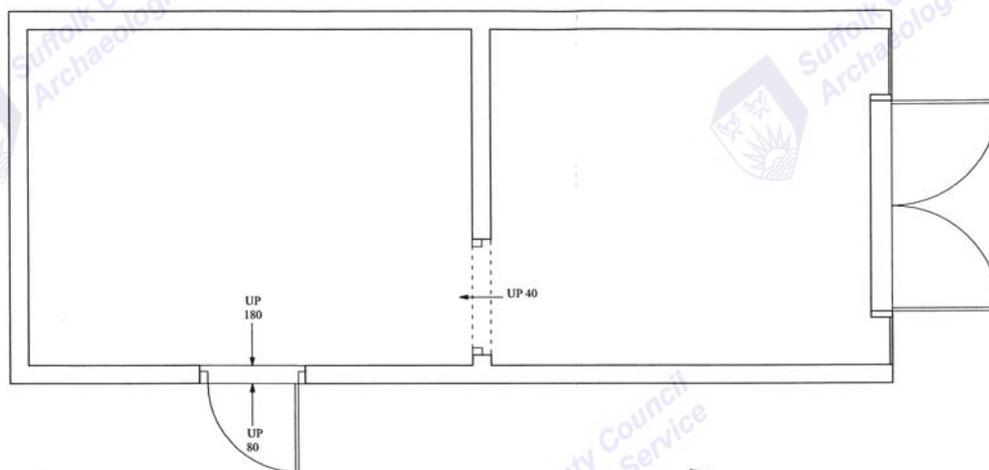
Existing Barn

Ground plan of the shed as existing, showing salient original features (the internal door has been widened by approximately 30cm, and the gable entrance narrowed by the same degree). Scale in metres.

The shed is 4.25 metres wide and 10.5 metres long, rising to 2.3 metres at its eaves, and is aligned approximately north-south. It is divided by an original brick partition into two unequal compartments of which the larger to the north is entered by a half-hung stable-type door in the centre of its western wall. The smaller compartment to the south is entered by wide double-doors in its timber-framed gable. These double-doors have been renewed but the arrangement is original as a primary timber jamb survives to the east and the brickwork respects the framing. The weather-boarding and much of the framing has been replaced. The treble-tiled roof structure retains a layer of reed and plaster flecking that is probably original, and is pierced by three unusual ventilation apertures that are formed by arched ridge-tiles placed at right-angles to the ridge.

The red bricks of its walls are consistently 9 inches by 2.75 by 4.5 and resemble those of the nearby kiln. There is no evidence of frogs. Until their recent removal to a nearby stack the similarly proportioned bricks which (laid on edge) formed the floor of the northern compartment contained a shallow axial drain (as reported by the builder on site) and the shed appears to have been designed as a stable with adjacent cart shed. The two spaces were always linked internally, although the doorway in the dividing partition has been slightly enlarged by cutting into its eastern jamb. The partition rises only to the eaves and the cart shed is now floored over to create a loft, but this floor is lodged on the walls and appears to be a slightly later insertion. The stable is also ventilated by a brick grill in its northern gable. Unlike their 17th and 18th century predecessors stables of the late-19th and 20th centuries were normally open to their roofs and well ventilated in this manner. A long, oval shaped depression shown immediately to the west of the building on the 1904 Ordnance Survey was probably a horse pond, and at 5.25 metres in length internally the stable could

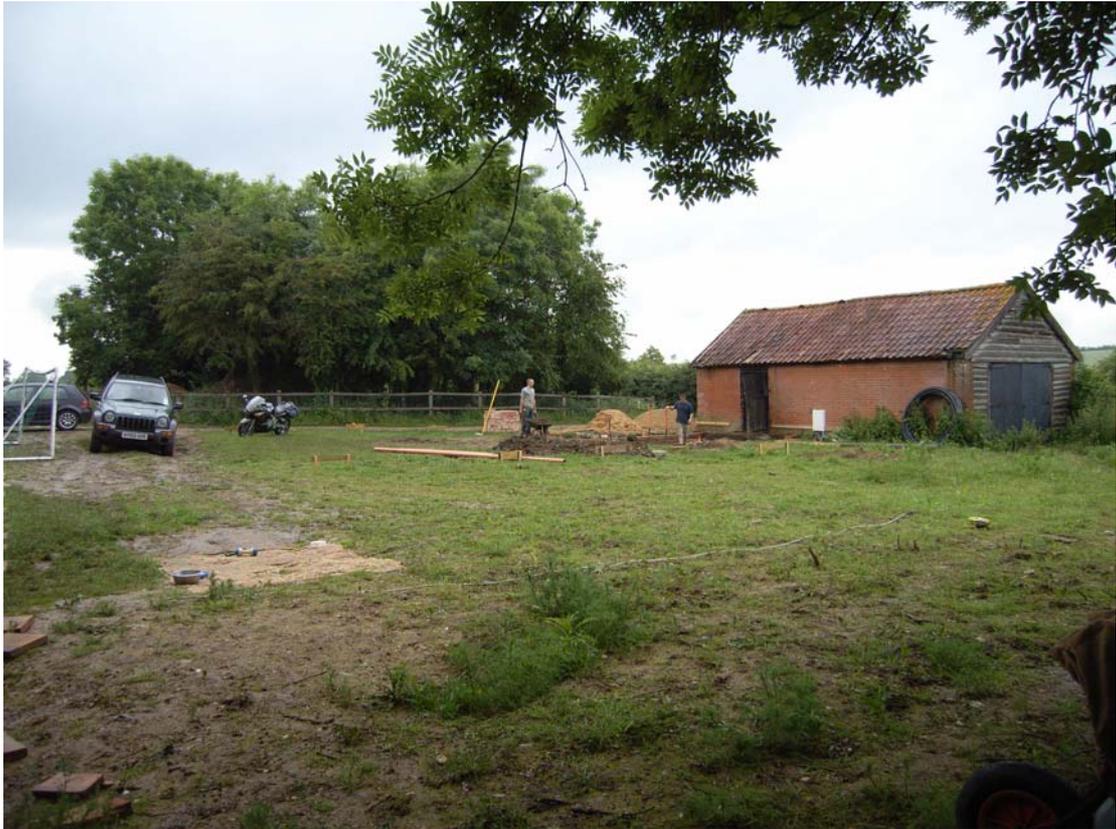
A2.1 General view of site from south across site of former brick sheds as shown on early plans. The brick kiln lies in the trees to the north.

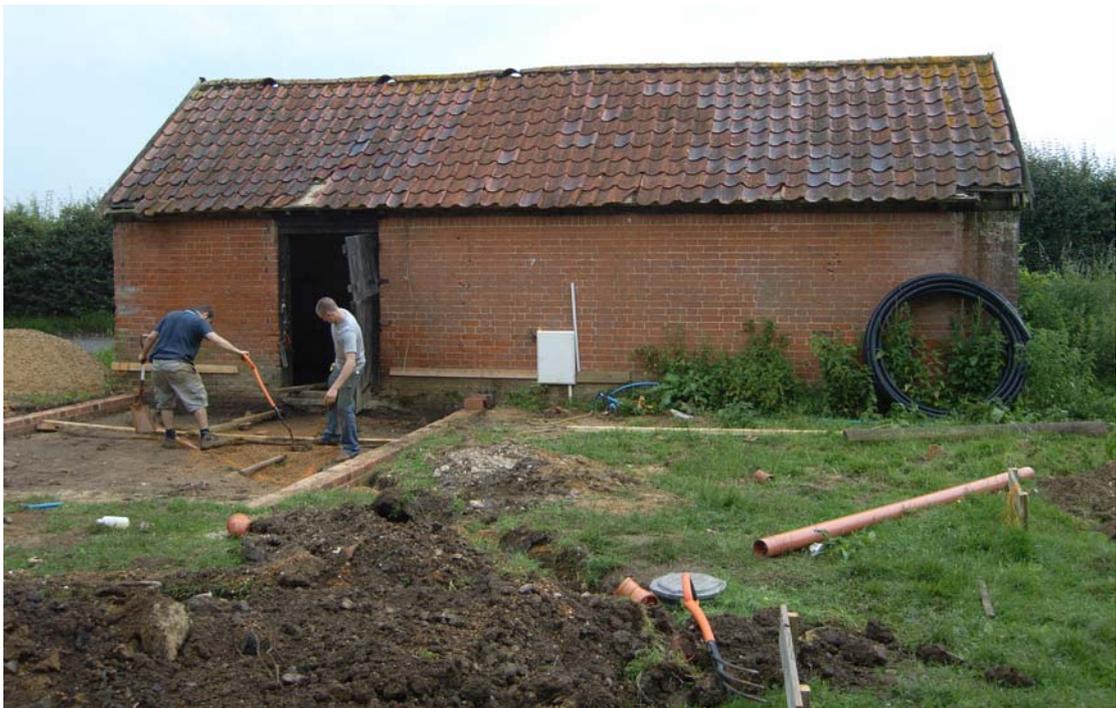
A2.2 The external western elevation, showing stable door.

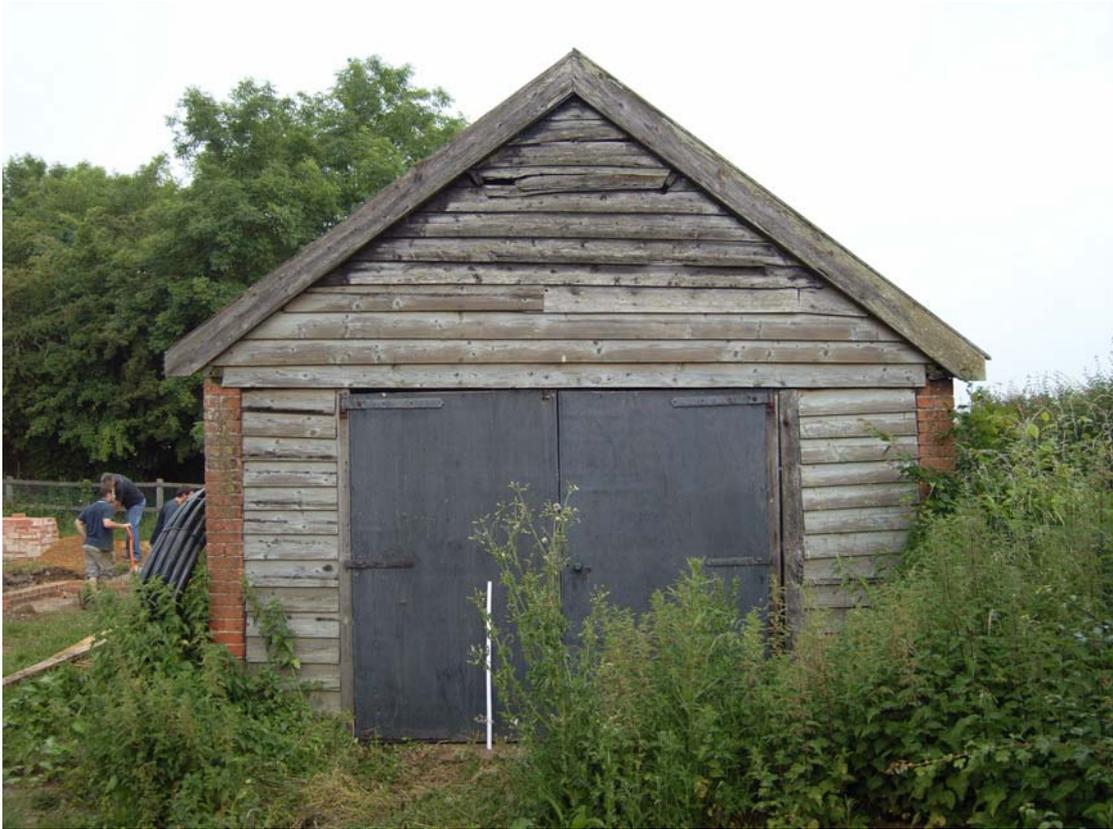
A2.3 External view of southern gable showing replaced double doors to cart shed

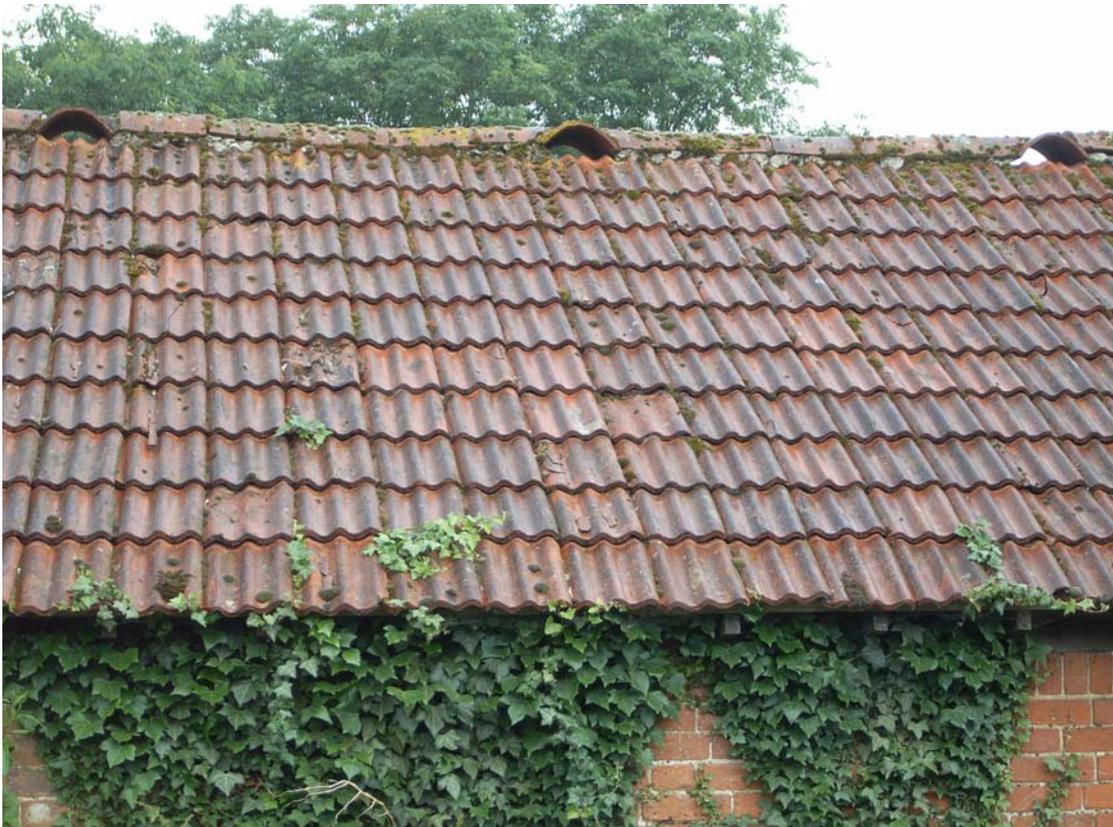
A2.4 Ventilation tiles on the ridge of the stable roof, seen from the road to east.

enlarged. The cart shed is now floored over, but this floor is probably a later insertion, and the stable is ventilated by a brick grill in its northern gable and by three laterally set ridge tiles on the treble-tiled roof.

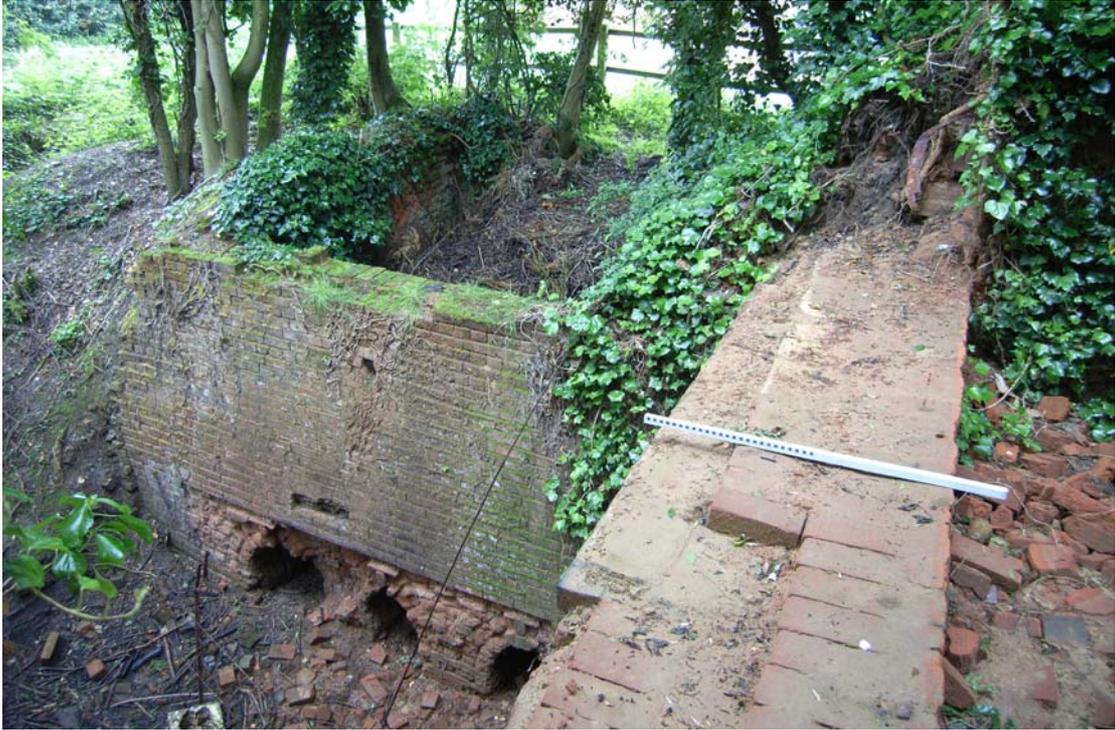
A2.5 The Brick Kiln in the trees shown in A2.1, viewed from the north (the building to be converted lies in background approximately 10 metres away). Included for site context.

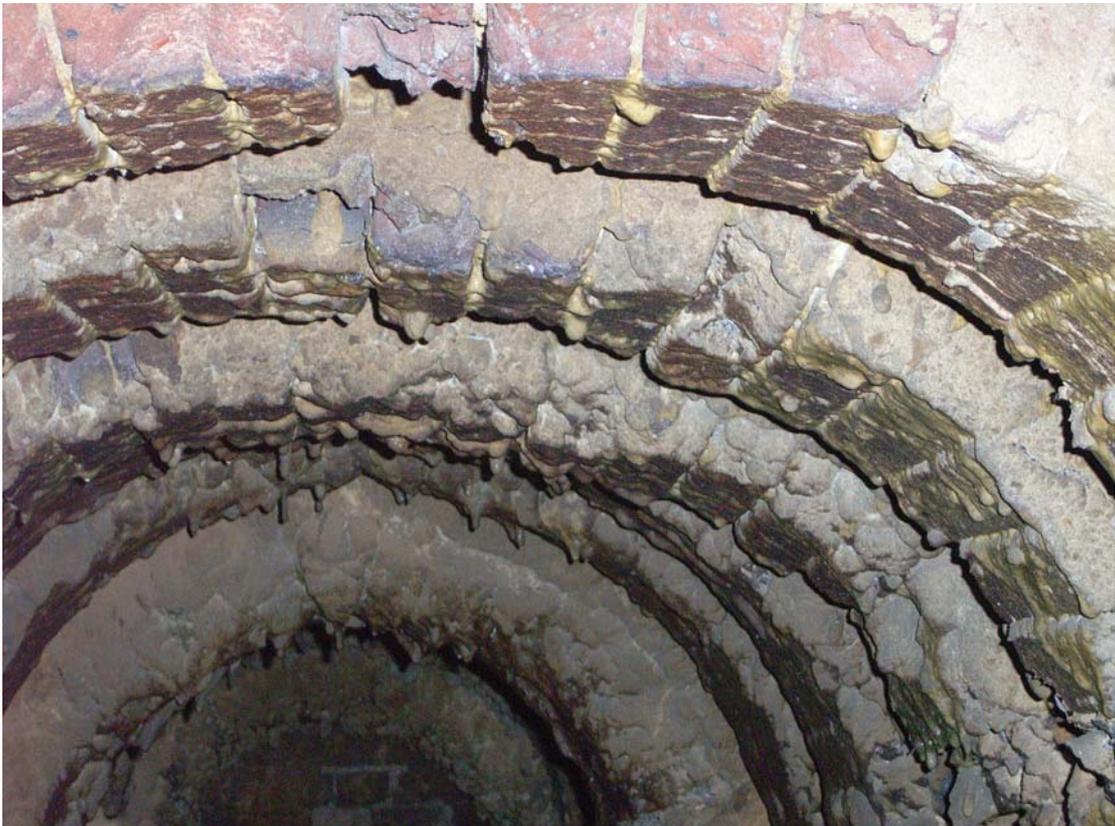
A2.6 Internal detail of one of the vaulted tunnels beneath the kiln, showing vitrification caused by intense heat (included for site context).
