SUFFOLK COUNTY COUNCIL ARCHAEOLOGICAL SERVICE

The Church of St. Mary, Great Bealings (BEG 016); A record of Archaeological Monitoring associated with the insertion of a new toilet into the base of the tower.
SCC Rpt. No 2007/188; Oasis No. suffolkc1-32719

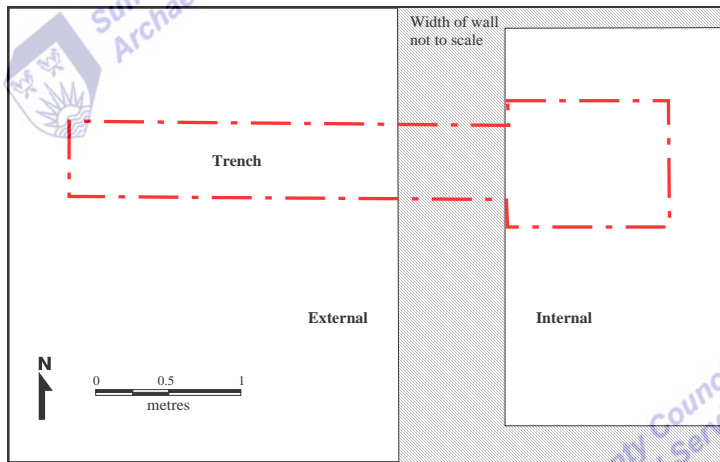
Fig. 2 Location of the excavated trench in the tower

A plan showing the location of the excavated trench appears as Figure 2. The internal excavation measured *c.*1.10 metre by *c.*0.90 metres while that external was *c.*0.55 metres wide and *c.*2.0 metres long. The tower wall was found to have a *c.*0.1 metre projecting toe, both internally and externally, occurring from a point *c.*0.30 metres up from its base (Fig. 3 & Plates 1, 4 & 5). Internally, the floor surface was found to be *c.*0.80 metres higher than that external to the tower. A series of essentially horizontal layers were visible in the sides of the trenches; these are described below with reference to the numbered section drawing (Fig. 3). These are also visible in Plates 2 and 3.

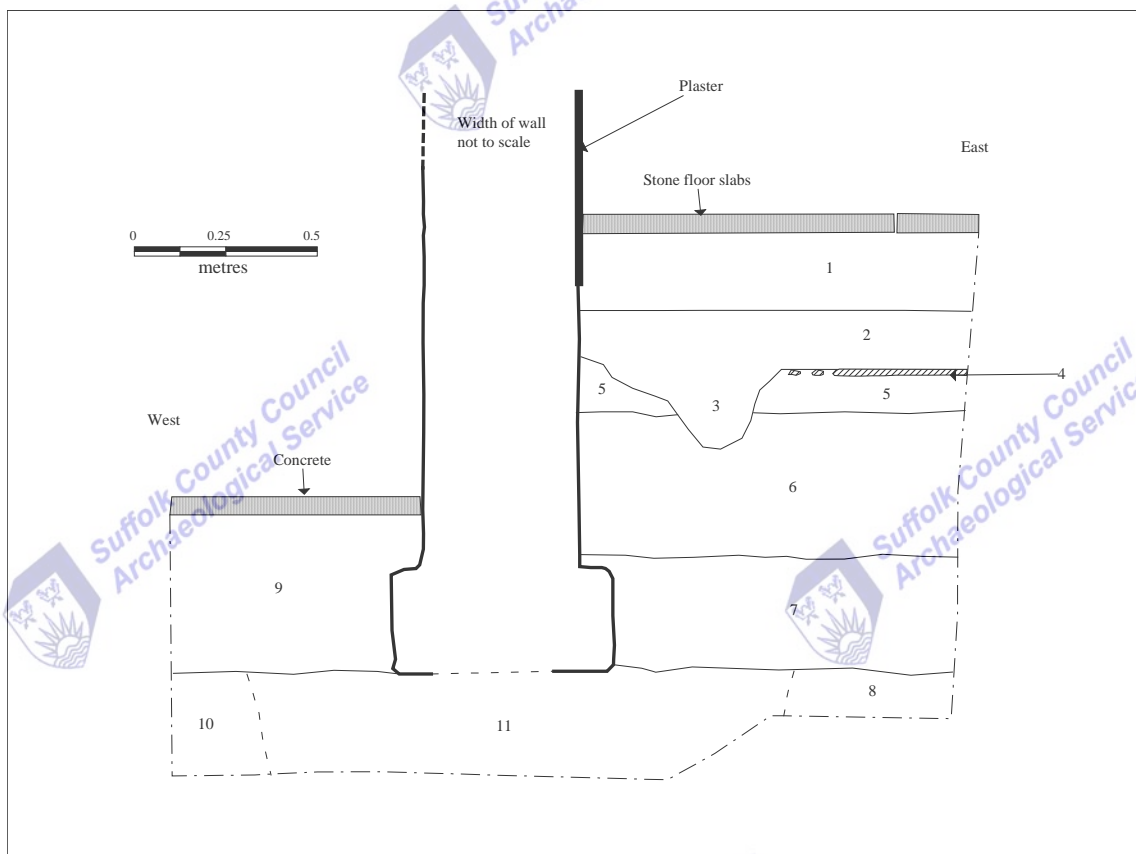
Fig. 3 Detail of the excavated trench.

single course of east to west aligned red bricks (9 inch by 2 inch) were visible (Plate 3), these are interpreted as the support for the joists for an earlier wooden floor. Layer 1 gave way to *c.*0.16 metres of mixed sand, lime mortar and flint rubble (2). This layer was laterally consistent on the southern and eastern sides of the trench, but was essentially indistinguishable from fill (3) on the north side where it appeared in the drawn section. Fill (3) was recorded within what appeared in section to be an incised feature cutting layers (4), (5) and (6), although it may actually represent no more than a localised area of disruption. Layer number (4) was again continuous around the southern and eastern sides of the

trench, but had been truncated in the north face where it was recorded in section. The layer comprised consolidated lime mortar between 1 and 2 centimetres thick and was interpreted as the bedding surface for an earlier, probably tiled floor. Underlying the mortar layer was a c.0.1 metre of loosely compacted sand and lime mortar (5) which, in turn, lay on c.0.4 metres of dark brown coloured sticky clay rich sand (6). Below this, coinciding roughly to a point immediately above the protruding toe of the wall and continuing down to its base, was layer (7) comprising loose sand with some yellow lime mortar and occasional flints. At the eastern end of the internal trench layer (7) overlay a dark brown sand (8). However, from a point c.0.5 metres from the base of the wall the material underlying (7) contained frequent flints and loose lime mortar, a mixture of material that was also seen running under the wall and filling up to a near vertical cut in the external trench (11). This fill has been interpreted as being within a cut footing trench for the tower wall, although its internal edge was fairly conjectural.

The remaining two fills were seen only in the external trench (Fig. 3 & Plate 5). Immediately beneath the concrete path, a c.0.45 metre thick layer of dark brown loam with localised patches of lime mortar and inclusions of roof-tile (9) was recorded continuing down to a similar level as the base of the tower wall. Below this was a layer of clean brown very silty sandy loam (10) through which the vertical cut for the wall footing (11) was seen (Plate 5).

No intact earlier floor surfaces were encountered in the excavated trench internal to the tower, but evidence for two did survive. The most recent of these would have been lain on wooden joists which in turn were supported by the formally lain line of bricks running from east to west through the tower on what would have been its centre line. The depth that these bricks were lain suggests that this floor would have been at approximately the same level as the existing stone floor which was, itself, elevated above that of the nave by c.0.15 metres. The bricks suggest a 19th or 20th century date for this floor.

The evidence for the second floor level was provided by the thin layer of consolidated mortar at a depth of c.0.40. It is likely that this formed the bedding for a tile floor, the tiles of which were subsequently removed. While there is no dating evidence for this floor level, there is no reason why it could not represent the towers original medieval floor level set on deliberately introduced material imported to reconcile the floor level here with those in the body of the church. This process would have been deemed necessary due to the natural slope of the ground down to the watermeadow to the west.
