(SEC 002) Batemans Barn, South Elmham Hall, Report of Building Recording & Monitoring of Groundworks

SCCAS Report No. 2006/138; Oasis ID suffolkc1-34991

Batemans Barn

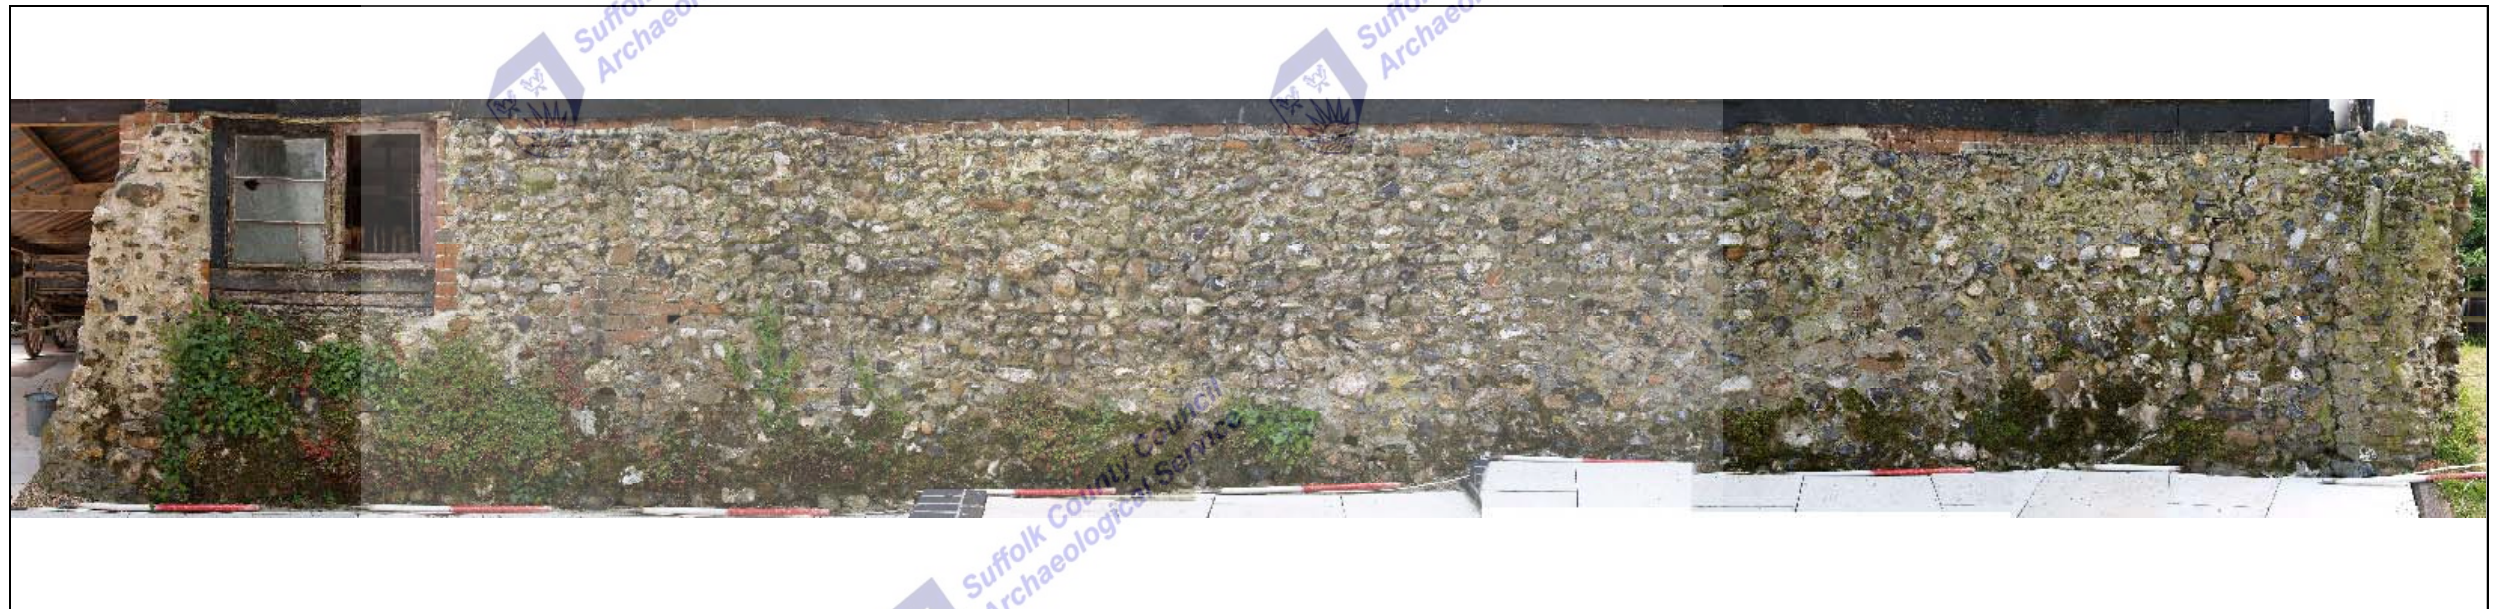
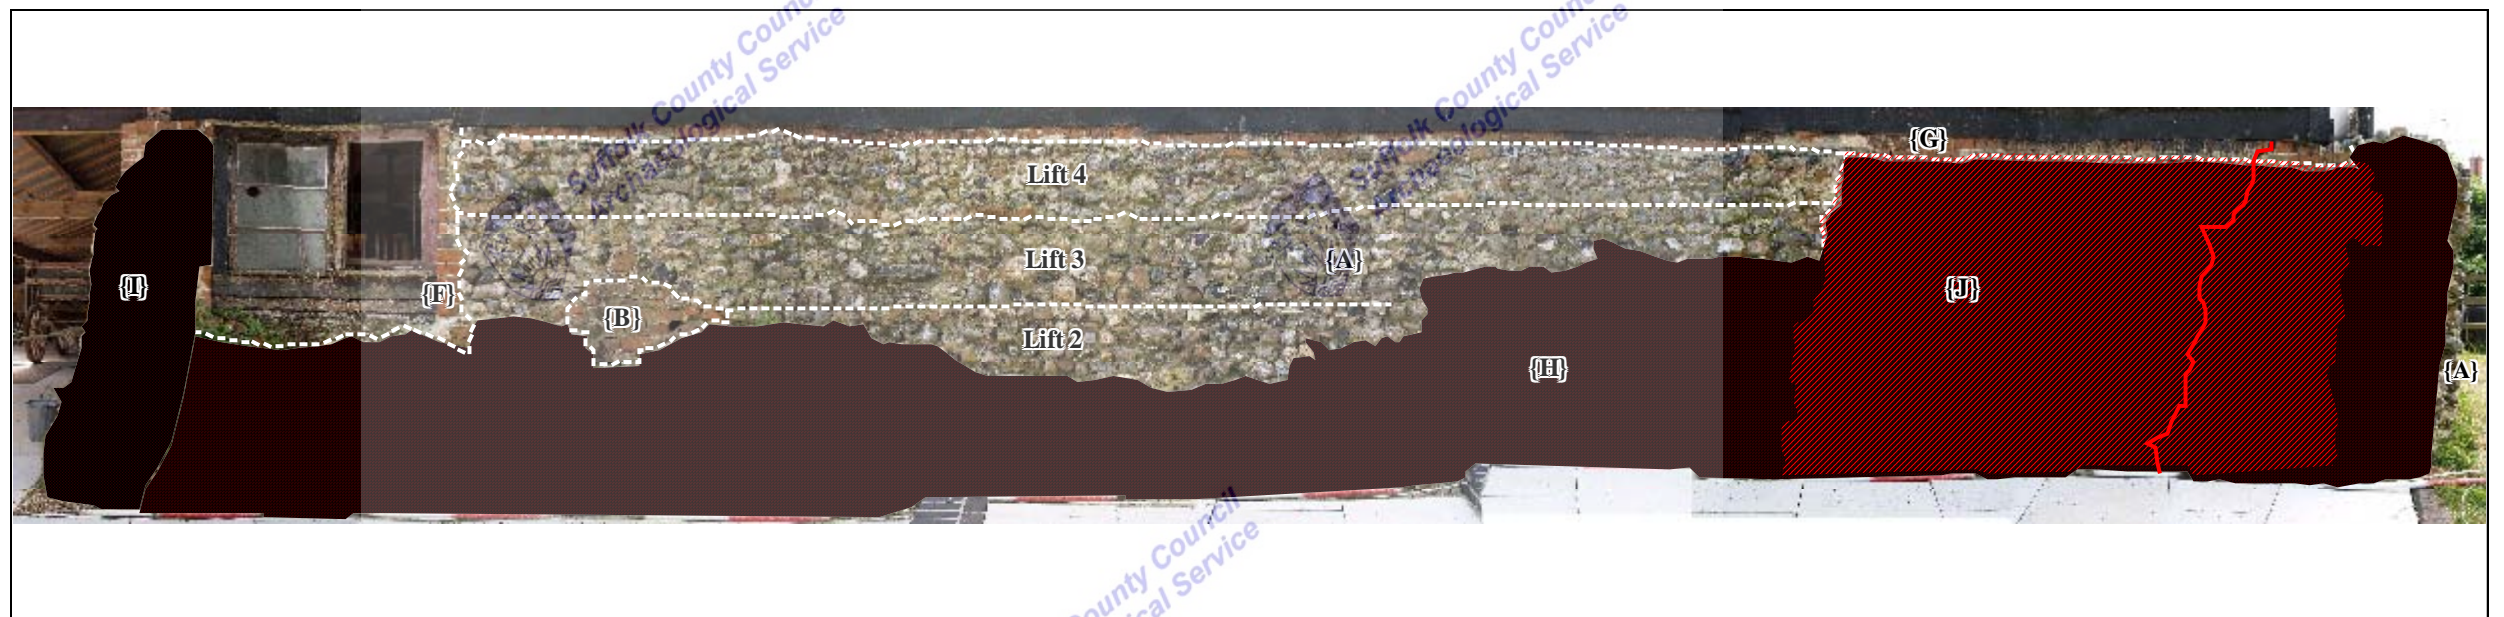
Plate 1: Batemans Barn, North Wall, External Elevation

The examination of the external elevation of the c.12.5 metres long north and shorter (c.1 .5 metres) west walls revealed that while the majority of the fabric belonged to one phase of construction, there was evidence for a number of alterations and repairs (Plates 1 & 3 & Fig. 2).

- {A} Original wall fabric (see previous text and Plates 1, 2, 3,4 & 5)
- {B} Brick patching, 18th-20th century date, includes blocking of hole right through wall (Plates 1 & 2)
- {C} Hard white lime mortar patching (Plate 2)
- {D} Clay, straw & horsehair layer, surface covering surviving over a limited area of the internal wall face (Plate 2)
- {E} Plaster packing at top of wall, seen internally (Plate 2)
- {F} Inserted window, includes brick of c.18th-19th century date
- {G} Two courses of bricks capping flint and mortar north wall of barn provides a level surface for wooden frame and roof above (Plates 1 & 4)
- {H} Layer of hard lime mortar repointing extending for the entire c.12.5 metre length of the north wall to a height of between 1 and the full 2 metres. Covers both wall fabric {A} and {J}. Includes imprint of earlier gatepost at west end

of north wall. Includes some small flints and brick/tile fragments within it (Plate 1)

- {I} Recent lime mortar repointing at east end of north wall, undertaken as part of present project? (Plate 1)
- {J} Rebuilt section of north wall, or blocking of earlier entrance. Includes large crack towards west end (Plates 1 & 4)
- {K} Recent brick patching (Plate 4)

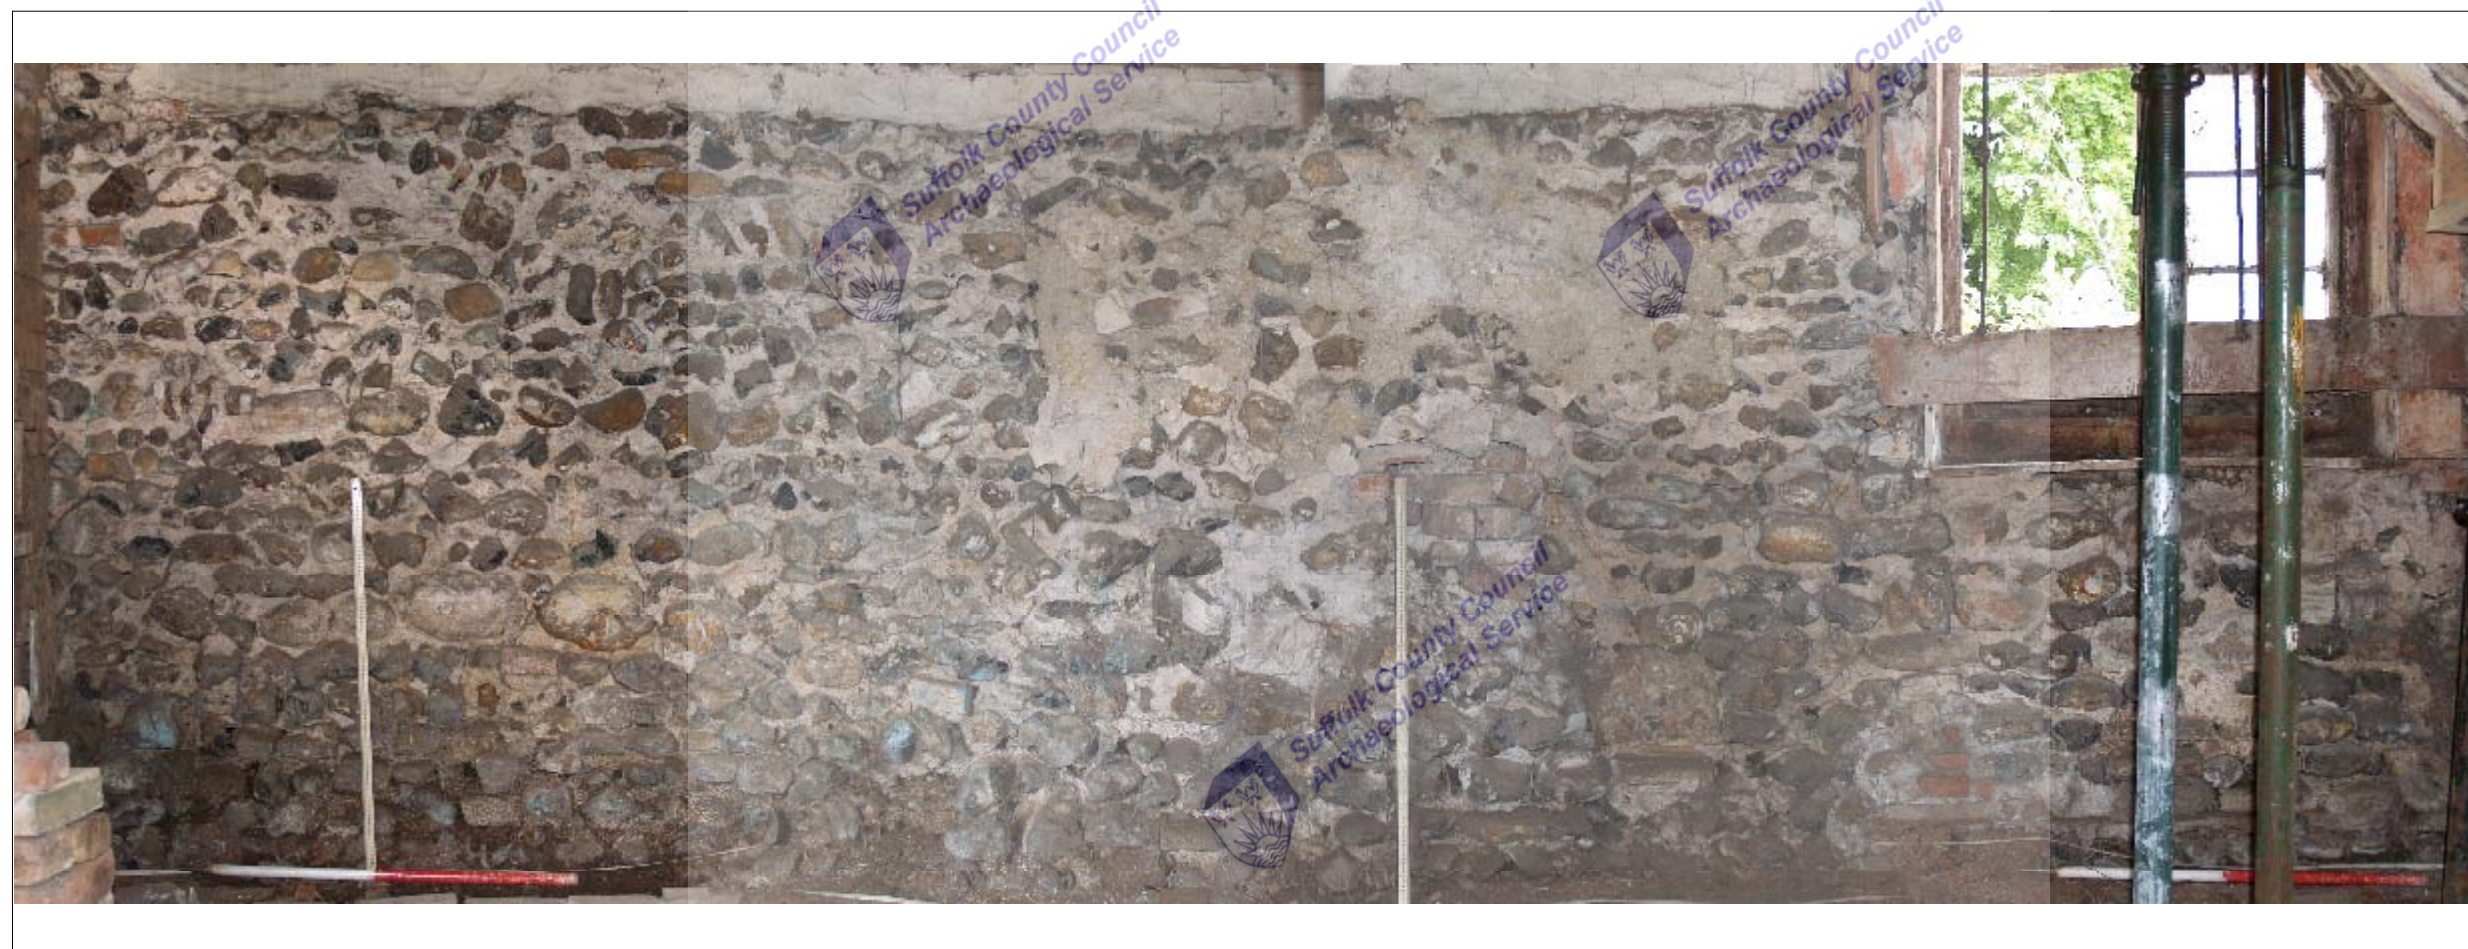
Plate 2: Batemans Barn, North Wall, Internal Elevation (East End)

Original fabric ({A} on Plates 1, 2, 3, 4 & 5) was best represented in the internal elevation at its eastern end (Plates 2 & 5). Standing for a height of c.2 metres, the wall was clearly divided into four distinct lifts of c.0.5 metres (c.5 flint courses).

The included flints varied in size from 5 centimetres through to some that were in excess of 20 centimetres. Larger pieces appear to have been preferentially lain as the basal course of each lift (see Plate 2,

Lifts 2 & 3). Approximately 90% of the facing material were flints, mainly unknapped with c.10% comprising sandstone and other erratics. One large red brick, measuring 9¹/₂ by 2¹/₂ inches with an indeterminate width, was clearly incorporated in the original fabric (Plate 6). Similar bricks were included in the fabric of other standing structures and are likely to be of medieval date and locally made.

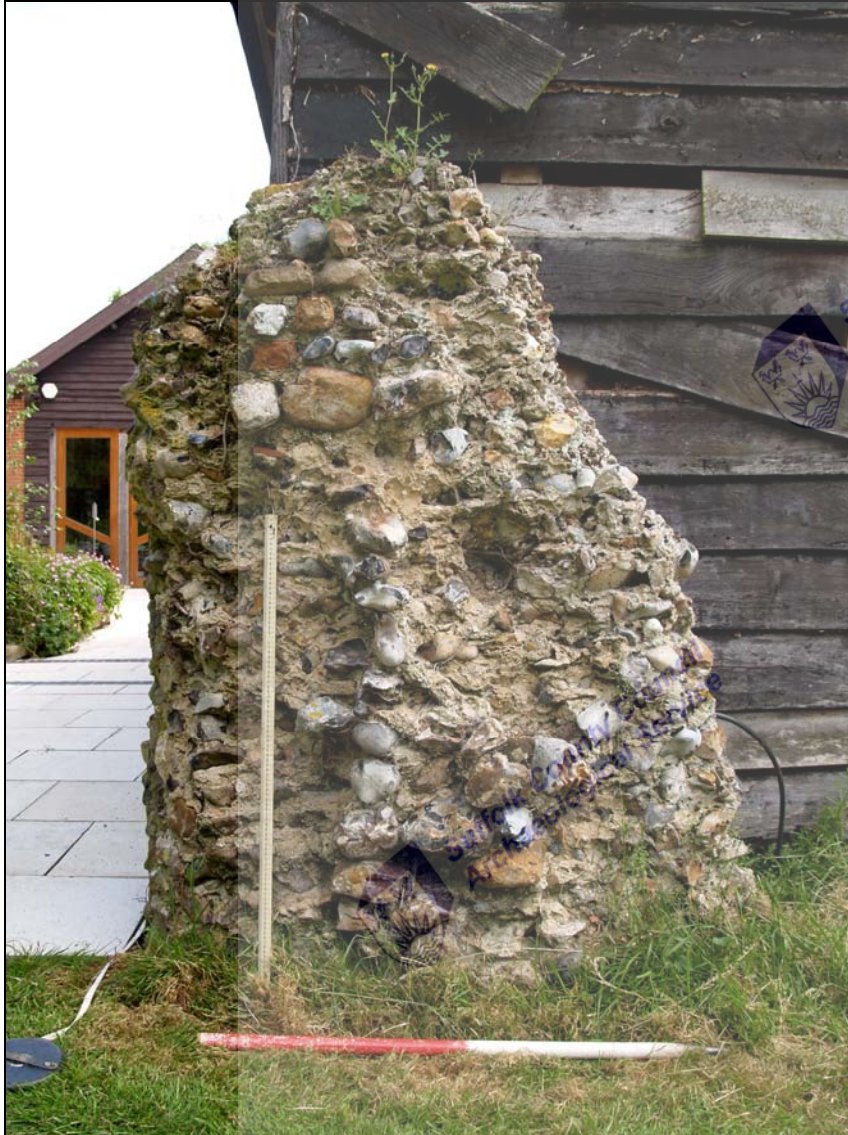
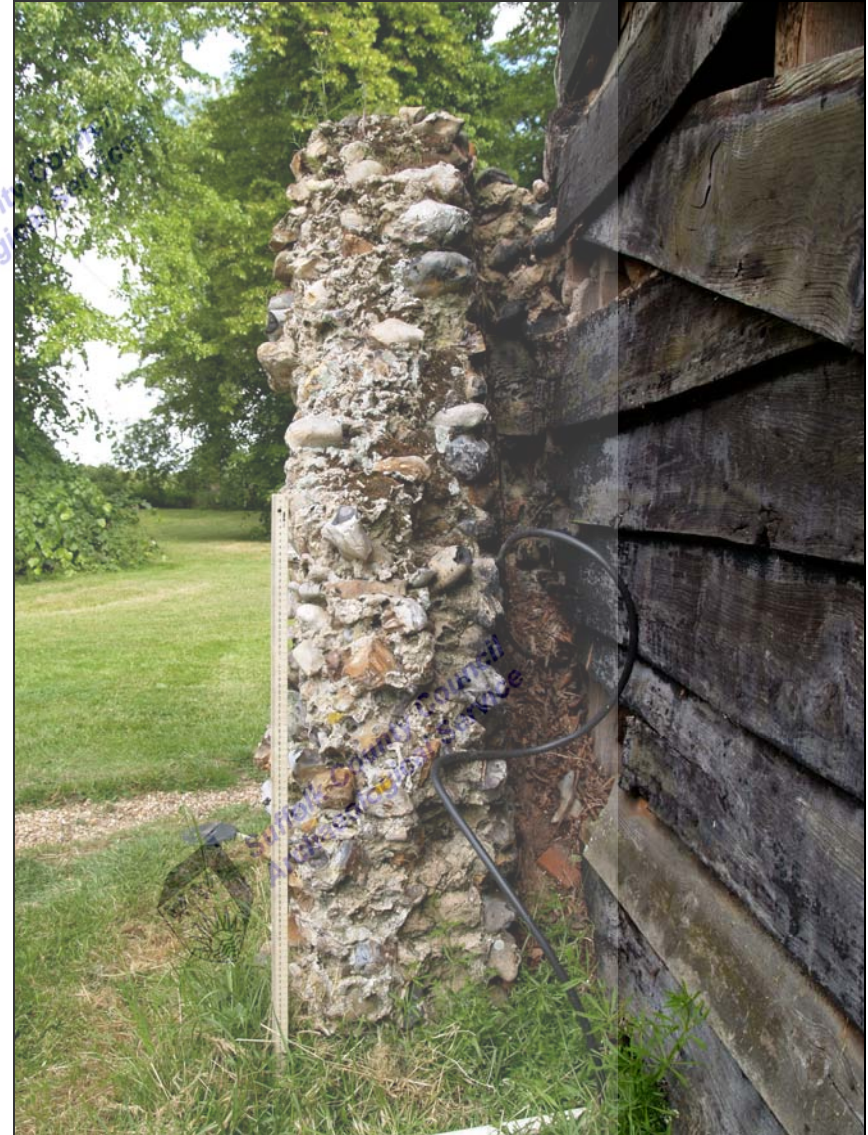
Plate 3: Batemans Barn, West Wall

External elevation; View from the west (all Fabric {A})

View from the south (all Fabric {A})

The lime mortar of Fabric {A} was beige/cream in colour with common inclusions of gravel-sized flint and small pieces of clunch. Examination of the short (c.1.5 metres long) west wall (Plate 3) revealed that it had been constructed from similar materials to the main stretch although no lifts were identified. However, this could have been due to the fact that the majority of the external facing had gone, unlike the north wall which has survived relatively intact, a fact which also accounts for the apparent disparity in thickness (0.4 metres rather than the 0.5 metres of the north wall) and its apparent shape in plan which suggests that it was not exactly at 90° to the north wall.

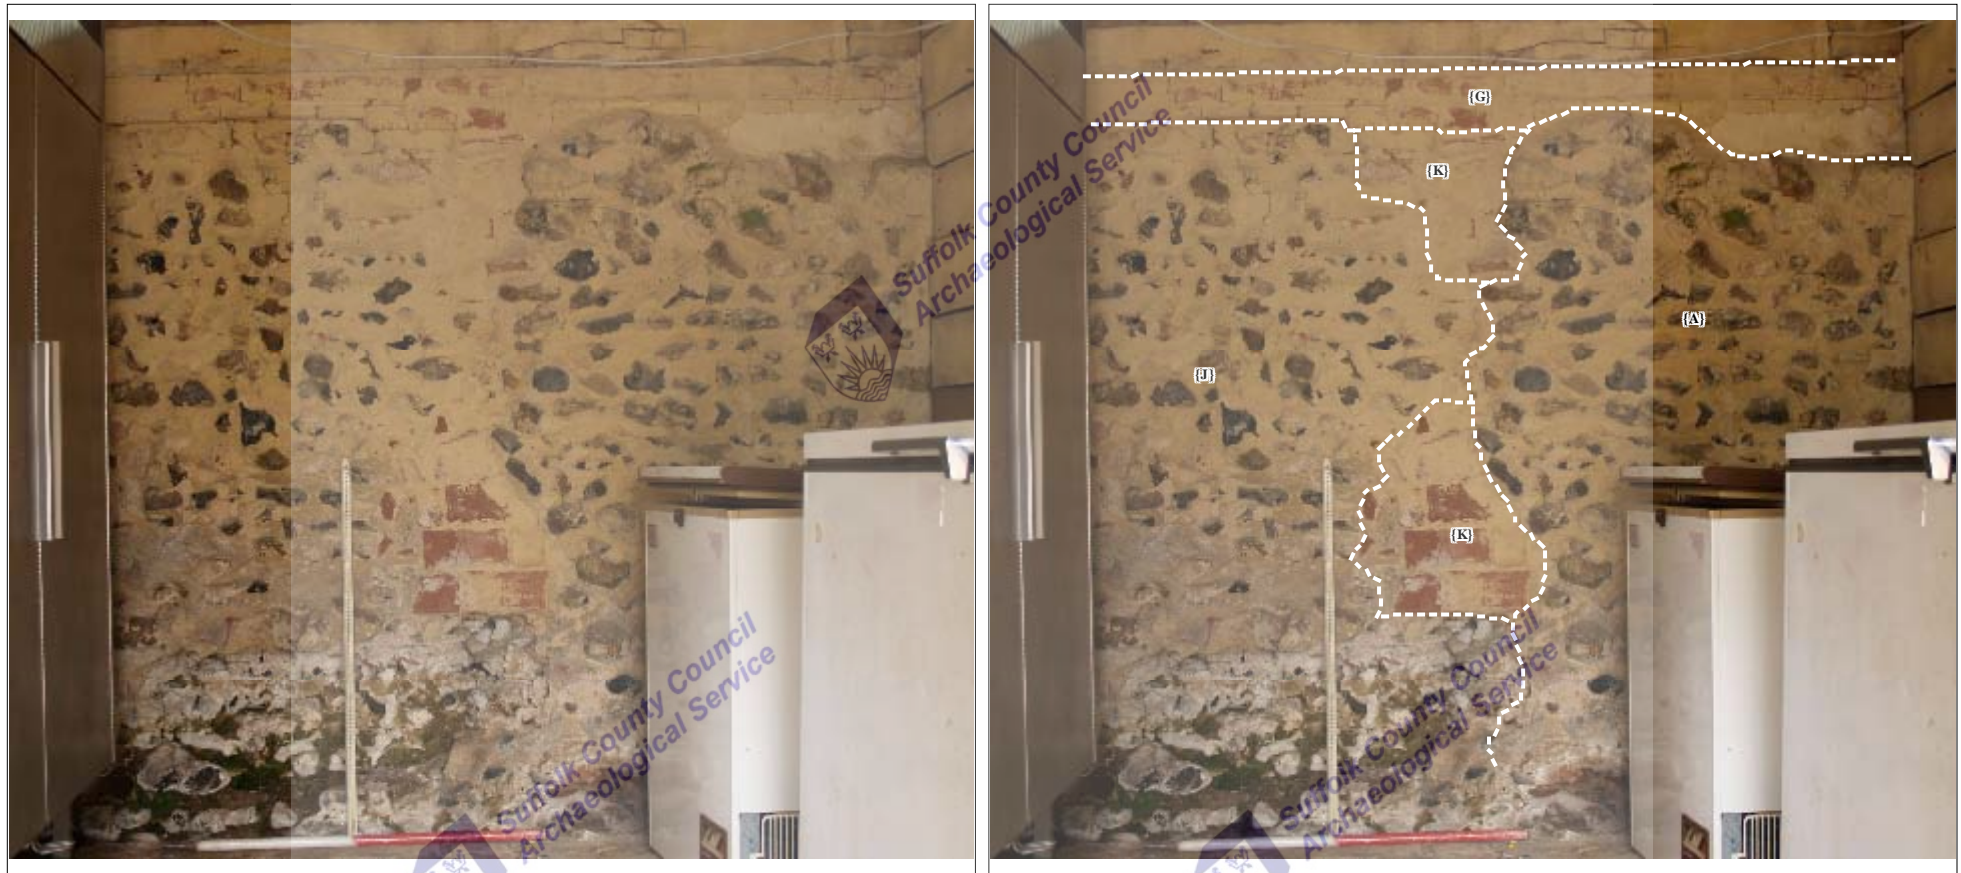
Plate 4: Batemans Barn, Internal Elevation (Western End)

Plates 1 & 4 & Fig. 2). Externally, the facing included more crudely knapped flints than the original fabric {A}. Fabric {J} was more clearly exposed internally in the small room at the western end of the barn and in spite of recent repointing obscuring the upper levels, it was visible at its base where facing had been lost to expose its core. No coursing was visible and the mortar was hard and white with sandy patches and common inclusions of clunch (Plate 4).

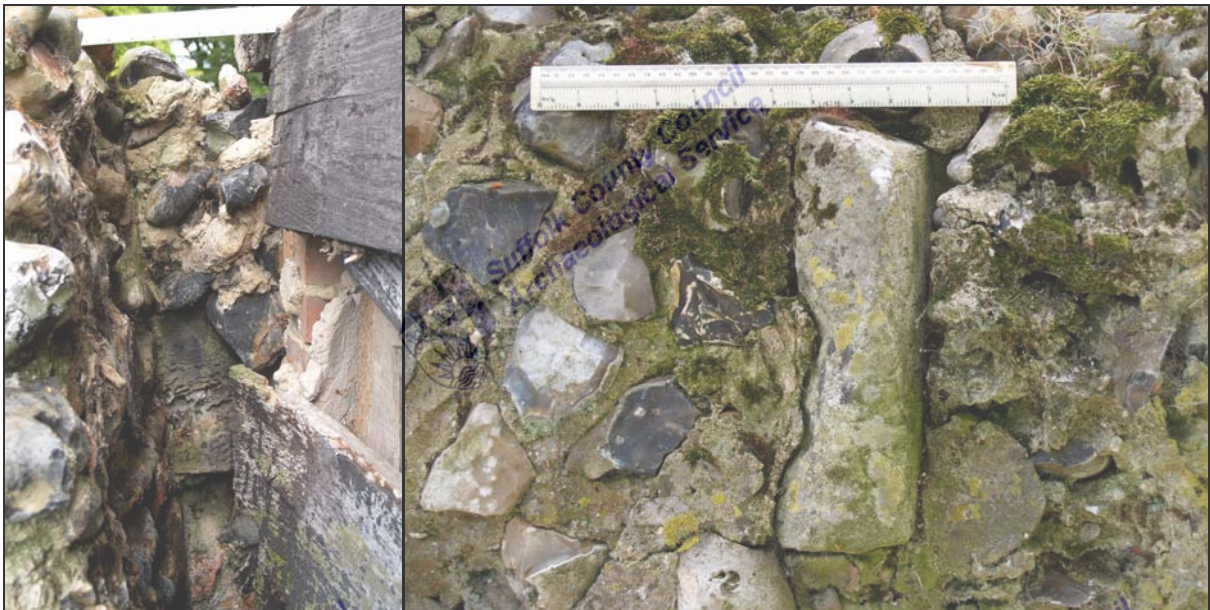
Plate 7: Detail of Quoins at Junction Between North and West Walls

The relationship between two limestone quoins seen internally at the junction between wall fabrics {A} and {J} was difficult to assess as access was limited (Plate 7a). While clearly overlain by fabric {J}, the fact that one of the quoins could be seen externally on the north wall with its tooled face on the western side (Plate 7b) it seems likely that it is actually incorporated within Fabric {J}.

7a (internal junction)

7b (north wall, external)
