ARCHAEOLOGICAL EVALUATION REPORT

Home Farm, Woolverstone

WLV 047

A REPORT ON THE ARCHAEOLOGICAL EVALUATION, 2007

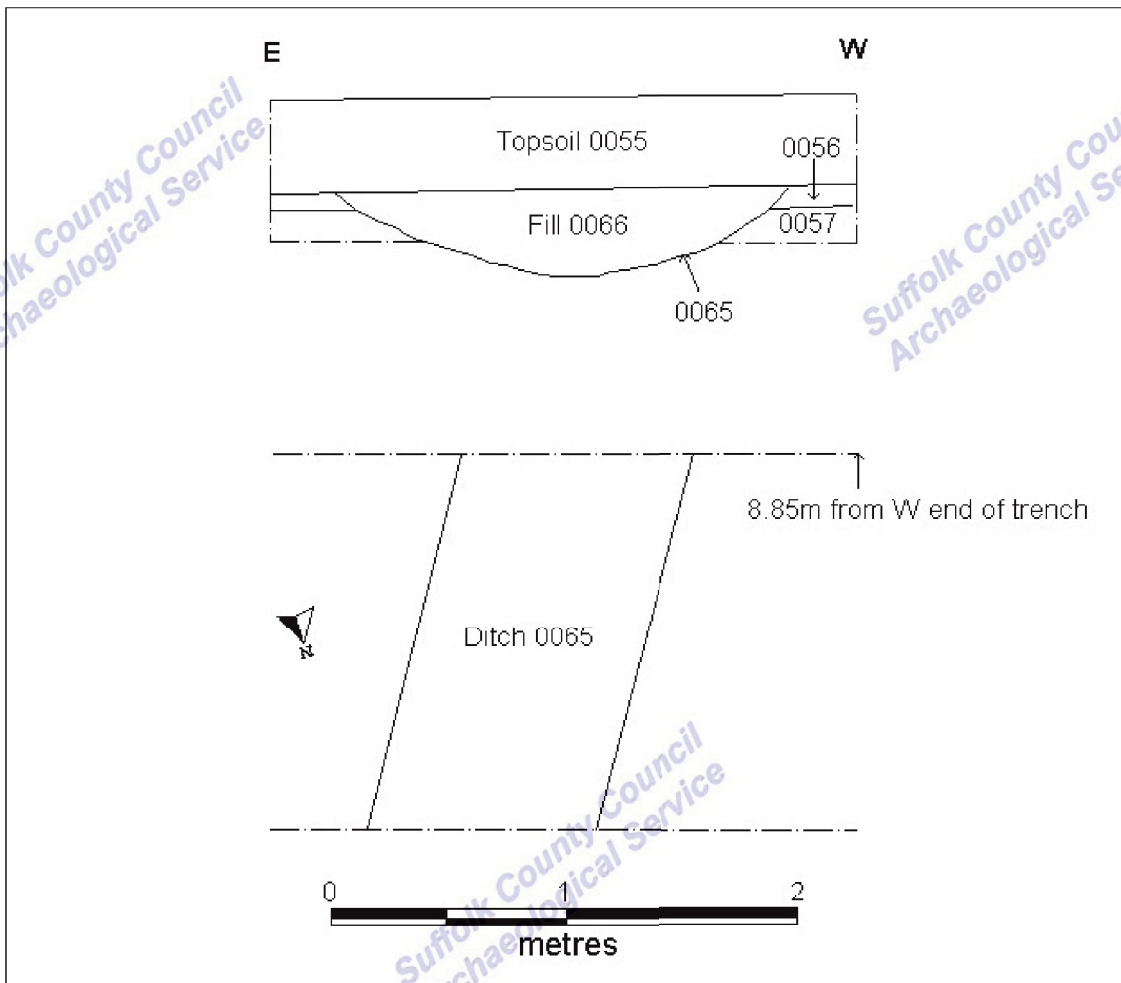
Figure 4. Plan and section of ditch 0065 in Trench 1

Ditch 0065 is oriented approximately NS. It is 1.90m wide and 0.38m deep, with a flattened, U-shaped profile. Fill 0066, is soft, light reddish brown silt containing occasional pebbles and flecks of charcoal, a small fragment of medieval (or later) roof tile and a struck flint of later prehistoric date.

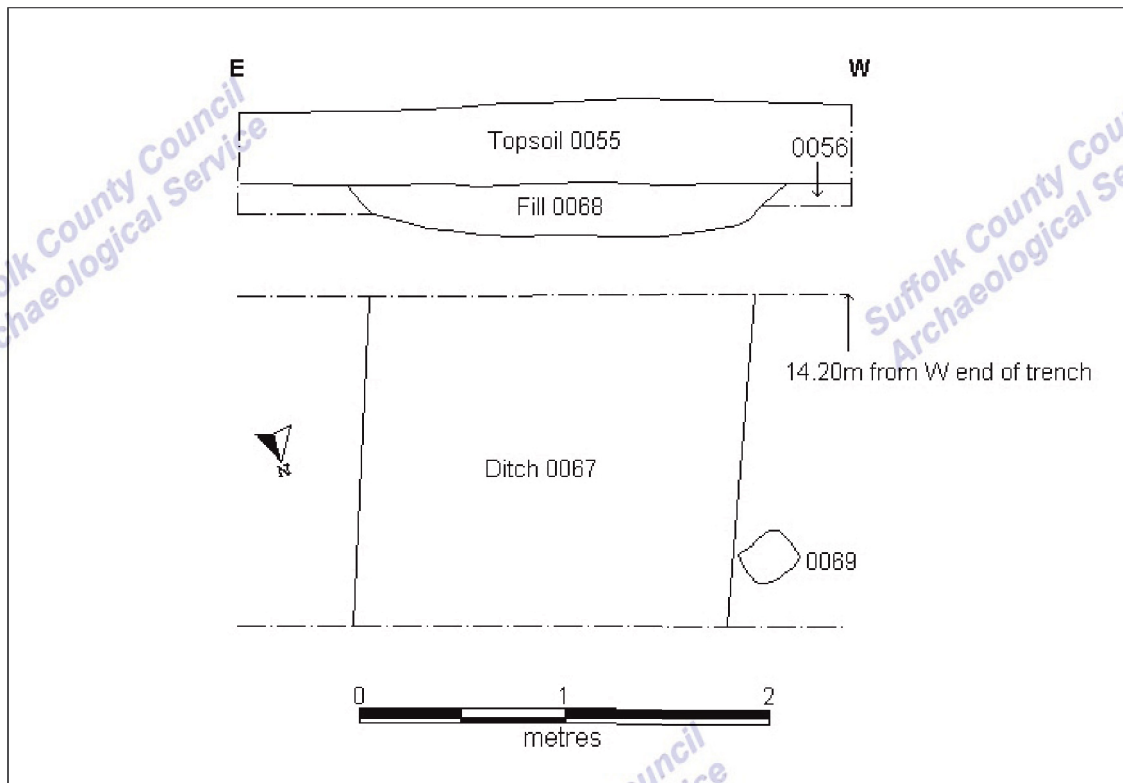
Figure 5. Plan and section of ditch 0067 and plan of posthole 0069 in Trench 1

Ditch 0067 is oriented approximately NS. It is 2.16m wide and 0.26m deep, with a flattened, U-shaped profile. Fill 0068, is soft, light-mid brown silty sand containing occasional pebbles and flecks of charcoal and a struck flint of later prehistoric date.

Posthole(?) 0069 is sub-rectangular in plan, measuring 0.25 x 0.20m and is 0.20m deep. Its sides are steep and irregular, tapering to a blunt point. Fill 0070 is soft, mottled light brown and yellow sandy silt, devoid of inclusions. It is located close to the western edge of ditch 0067.

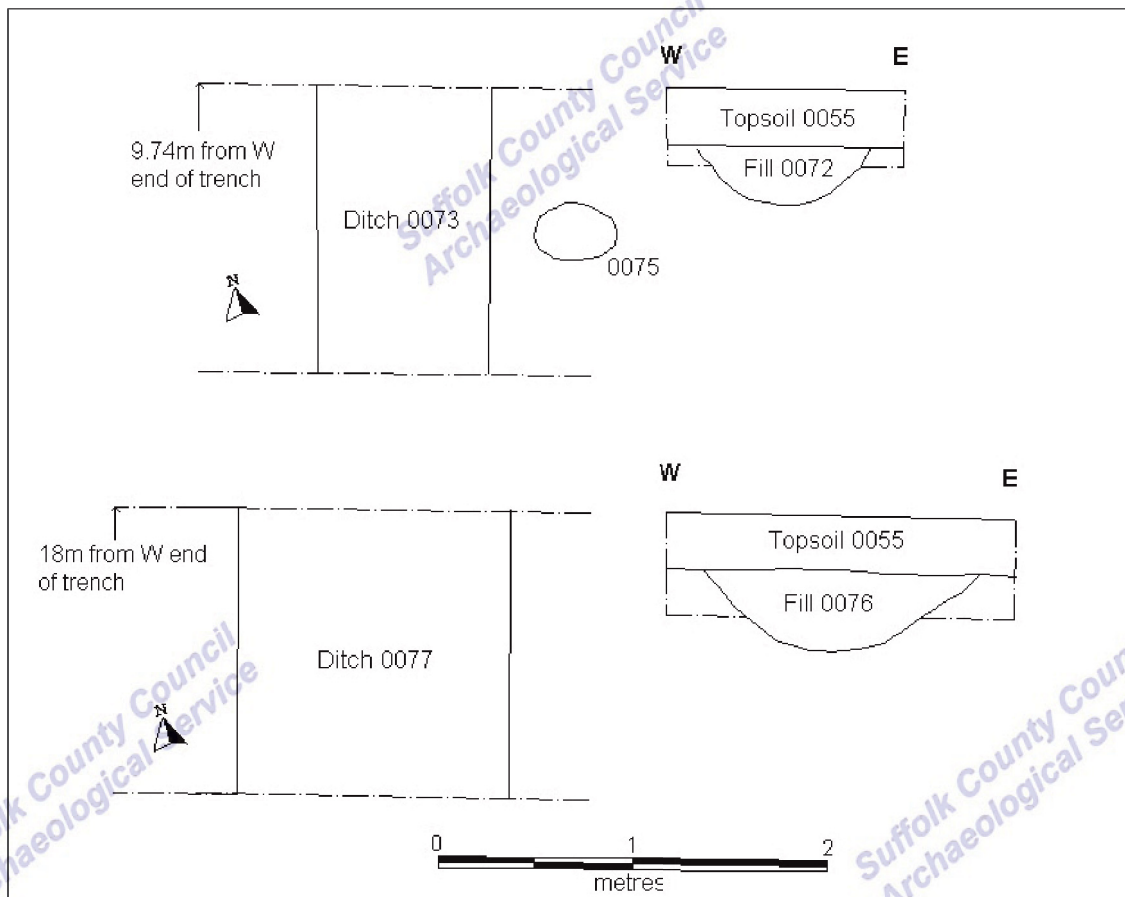
Figure 6. Plans and sections of ditches 0073 and 0077, and plan of posthole 0075, in Trench 3

Ditch 0073 is oriented approximately NS. It is 0.90m wide and 0.30m deep with a flattened, U-shaped profile. Fill 0072 is soft, mid brownish grey sandy silt with occasional pebbles and flecks of charcoal but no cultural material.

Ditch 0077 is oriented approximately NS. It is 1.40m wide and 0.42m deep with a flattened, U-shaped profile. Fill 0076 is soft, mid brownish grey sandy silt with occasional pebbles, flecks of charcoal and two small pottery sherds of possible Iron Age date.

Posthole(?) 0075 is located close to the eastern edge of ditch 0073. It is oval, measuring 0.40m x 0.30m and 0.12m deep. It has an asymmetric profile and a rounded base. Fill 0074 is soft, mid brownish grey sandy silt with occasional pebbles and flecks of charcoal.

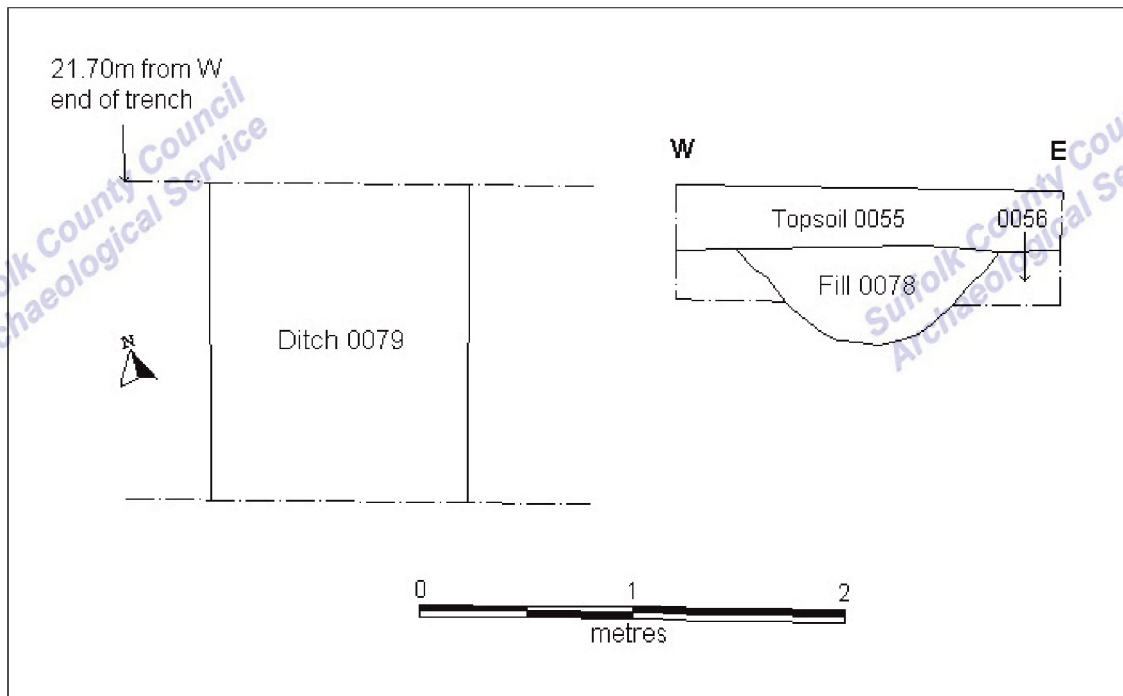
Figure 7. Plan and section of ditch 0079 in Trench 3

Ditch 0079 is oriented approximately NS. It is 1.20m wide and 0.46m deep with a flattened, U-shaped profile. Fill 0078 is soft, mid brownish grey sandy silt with occasional pebbles and flecks of charcoal and a small fragment of wheel-thrown pottery of Roman or medieval date.

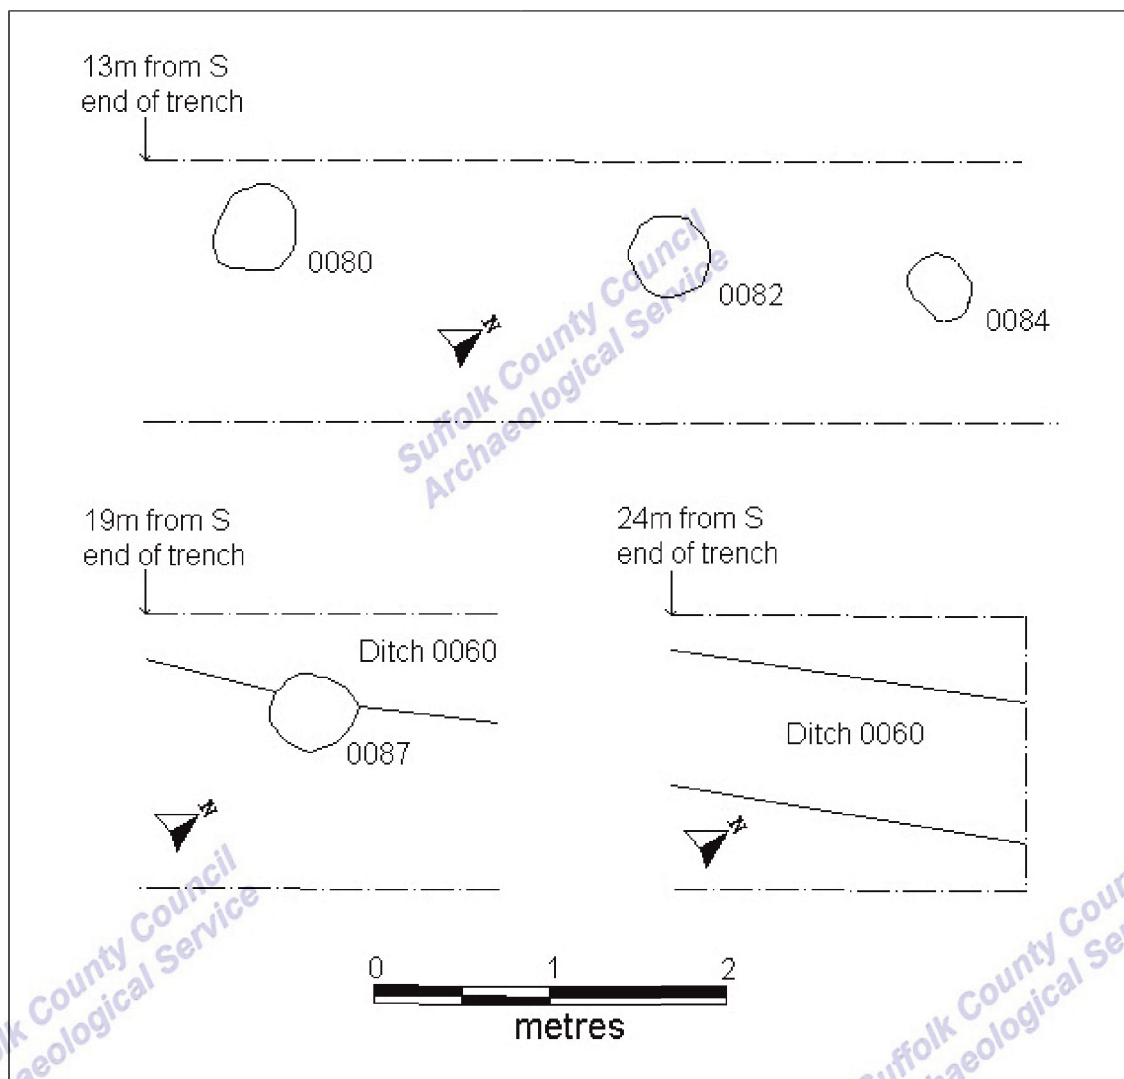
Figure 8. Plans of features in Trench 4

Pit or posthole 0080 is oval, measuring 0.50m x 0.43m x 0.12m deep with a bowl-shaped profile. Fill 0081 is soft, dark grey-black charcoal-rich silt with small patches of light brown silt. It contains moderate flecks and small fragments of probable burnt bone; for this reason it was sampled for analysis (Sample 1) to determine if the bone is human. The function of this feature is uncertain, although clearly it might be a cremation burial.

Posthole 0082 is sub-circular with a diameter of 0.48m and depth of 0.24m. It has steep sides breaking gradually into a flat base. Fill 0083 is soft, mid brownish grey sandy silt with patches of light brownish yellow silt. It contains moderate flecks-medium fragments of charcoal and occasional pebbles and small fragments of hand-made pottery of possible Iron Age date.

Posthole 0084 is sub-oval, measuring 0.40m x 0.30m x 0.35m deep. It has vertical sides breaking gradually into a flat base.

Posthole 0087 is circular, with a diameter of 0.45m and depth of 0.35m. Its sides are steep or vertical, tapering to a blunt point. Fill 0086 is soft, mid brownish grey sandy silt with patches of light brownish yellow silt. It contains occasional pebbles and frequent flecks—medium fragments of charcoal, but no cultural material.

Note that posthole 0087 cuts the southern edge of ditch 0060.

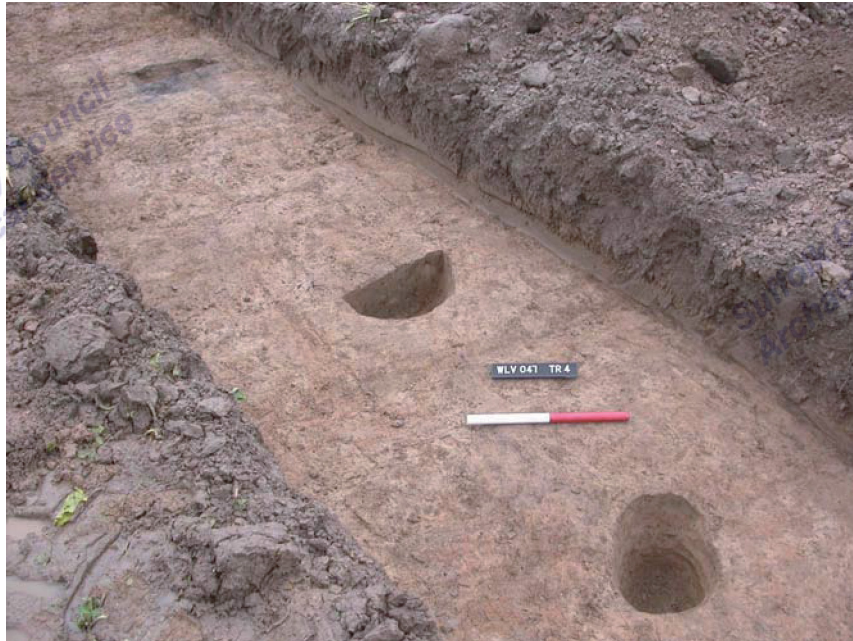
Figure 9. View of postholes 0080, 0082 & 0084 in Trench 4, looking SW (0.5m scale)

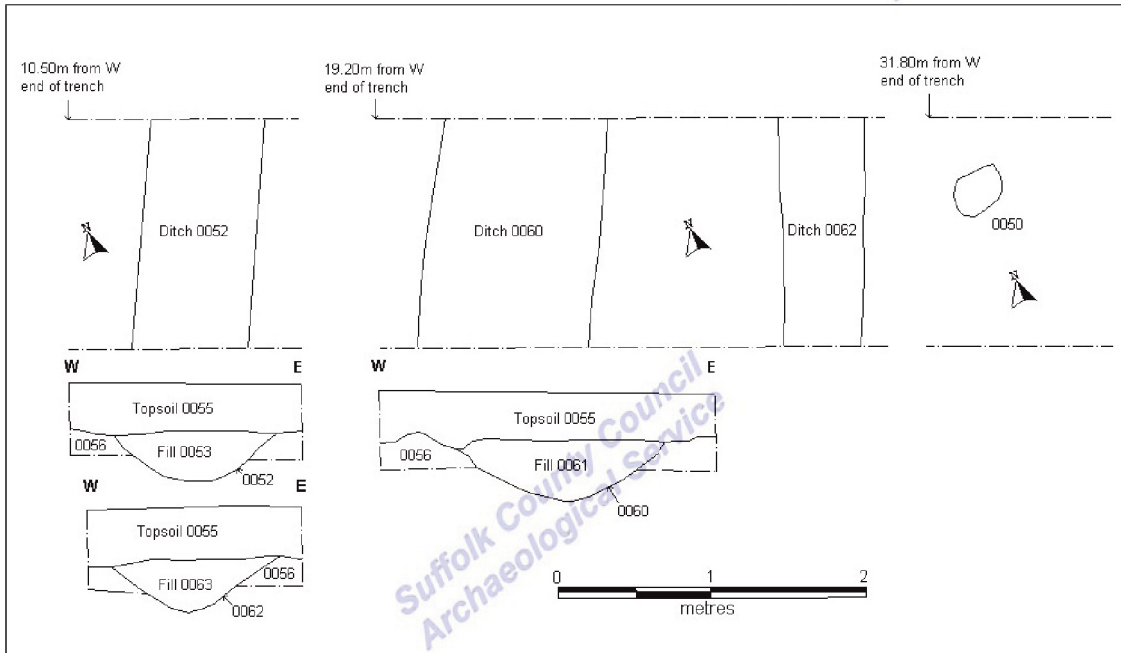
Figure 10. Plans and sections of features in Trench 5

Ditch 0052 is oriented approximately NS. It is 1.04m wide and 0.33m deep with a flattened, U-shaped profile. Fill 0053 is soft, light orange-brown sandy silt with occasional pebbles and flecks of charcoal, a fragment of fire-cracked flint and a small sherd of pottery of possible Iron Age date.

Ditch 0060 is oriented approximately NS. It is 1.55m wide and 0.42m deep with a flattened, U-shaped profile. Fill 0061 is soft, light orange brown sandy silt with occasional pebbles and flecks of charcoal, and five small fragments of pottery. Three of the pottery sherds are possibly of Iron Age date, one sherd is possibly medieval and another is definitely of medieval form.

Ditch 0062 is oriented approximately NS. It is 1.08m wide and 0.34m deep with an almost V-shaped profile. Fill 0063 is soft, light orange brown sandy silt with occasional pebbles and flecks of charcoal, and four small fragments of pottery.

Posthole(?) 0050 is oval, measuring 0.30m x 0.24m x 0.16m deep. It has steep or vertical sides breaking sharply into a flat base. Fill 0051 is soft, light orange brown clayey silt containing charcoal flecks and twelve small fragments of pottery. 11 of the pottery sherds are from the same hand-made vessel, of Iron Age date. The remaining sherd is too small to date accurately and might be medieval, although this seems unlikely given the date of the bulk of the pottery.

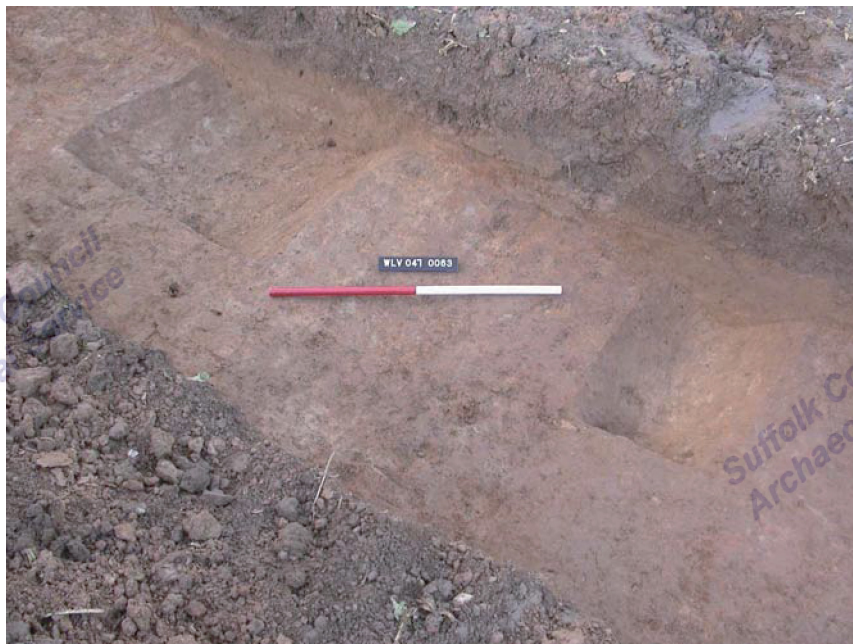
Figure 11. View of ditches 0060 and 0062 in Trench 5, looking N (scale 1.0m)

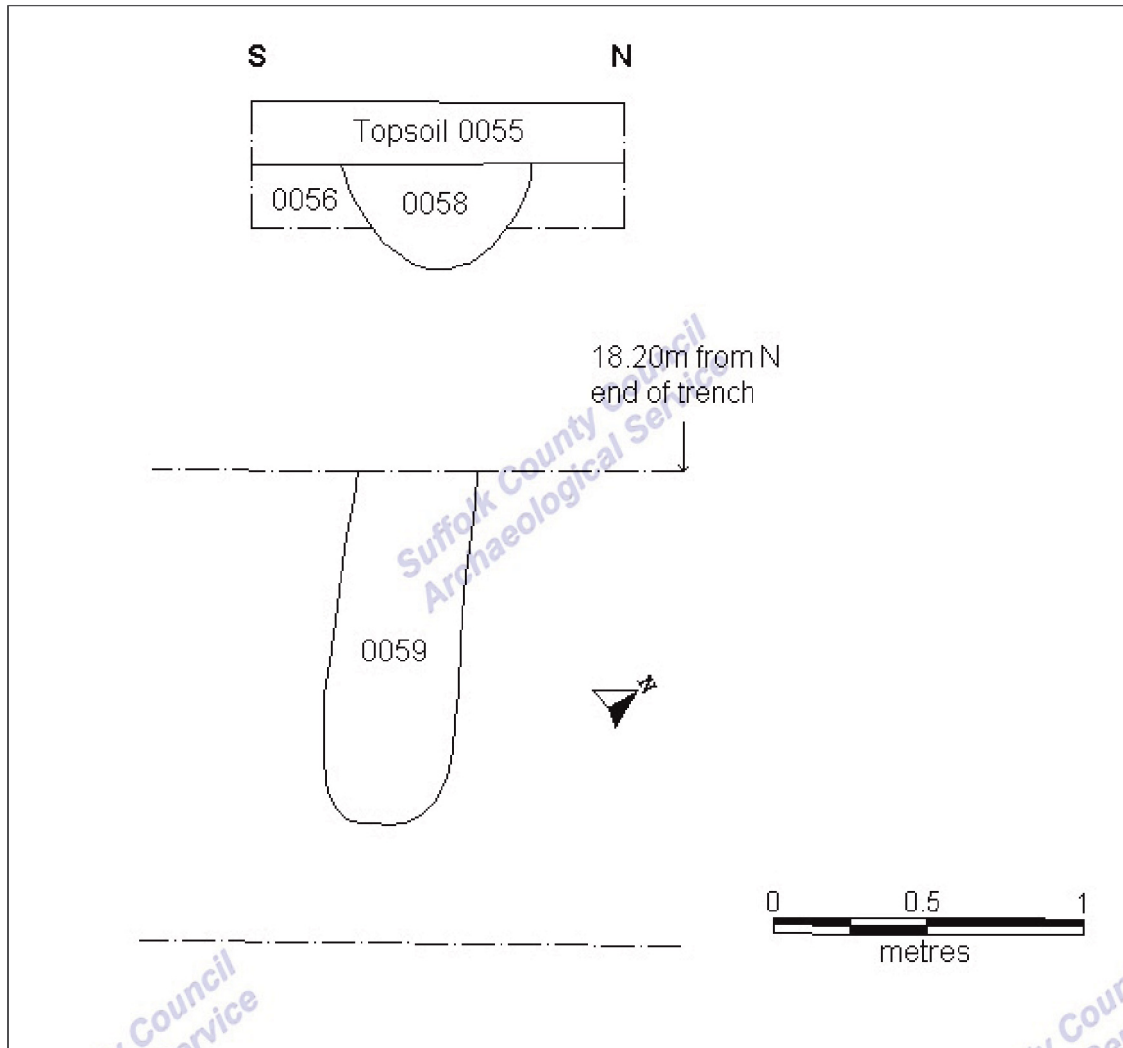
Figure 12. Plan and section of linear cut 0059 in Trench 8

Cut 0059 is oriented approximately EW. It is at least 1.20m long x 0.40m wide x 0.34m deep, having steep sides and a U-shaped profile. It extends beyond the edge of the trench to the W, and has a rounded terminus to the E. Fill 0058 is soft, light brownish grey sandy silt containing occasional pebbles and flecks of charcoal but no cultural material.

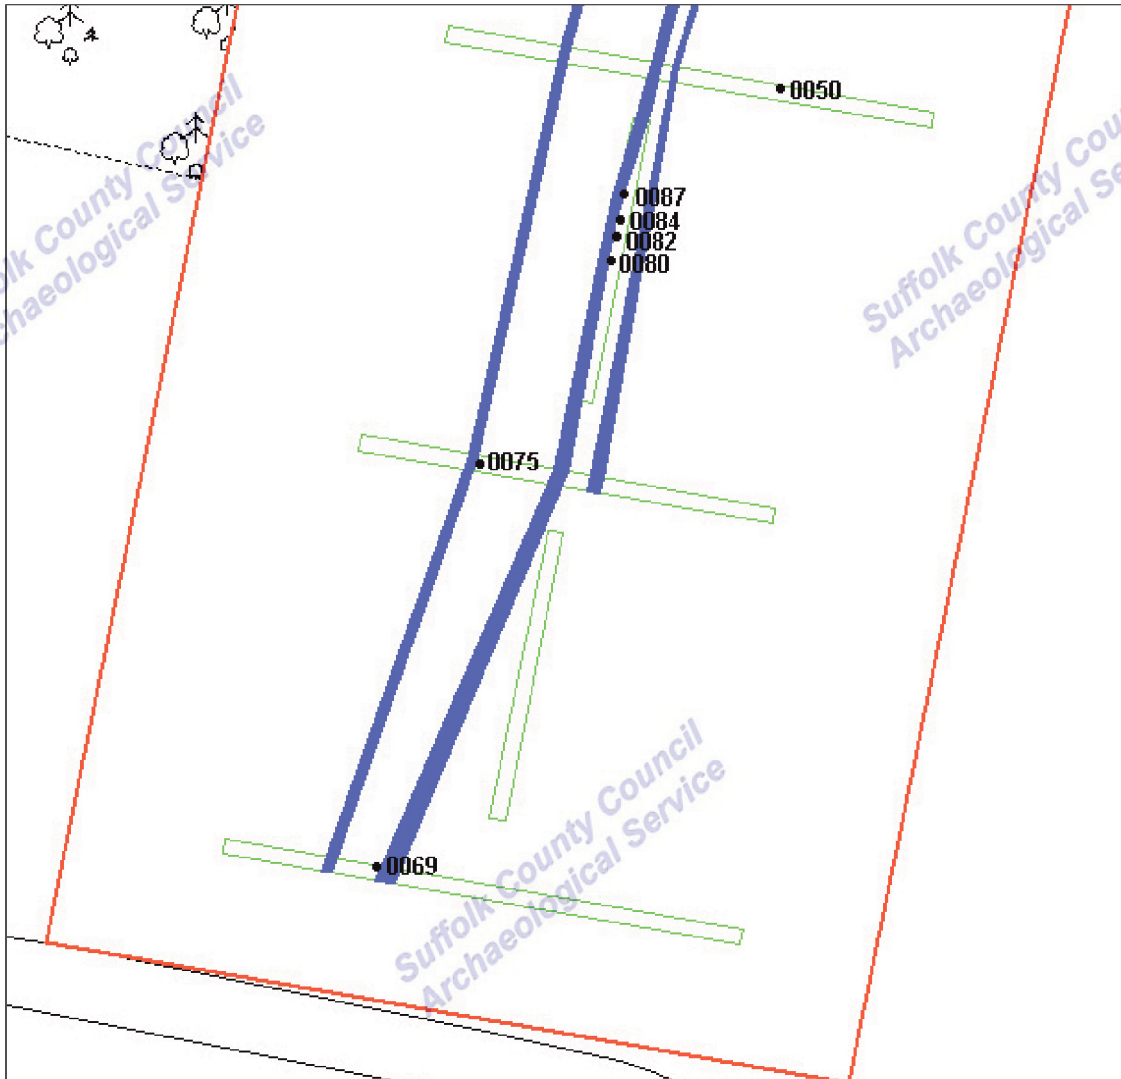
Figure 15. Approximate locations of the posthole-sized features (black). Also showing extrapolated plans of the ditches (blue), evaluation trenches (green) and area of proposed reservoir (red)

Single postholes (or posthole-sized features) were recorded in Trenches 1, 3 and 5 (Fig 15). Those in Trenches 1 and 3 (0069 and 0075) are undated. Posthole 0050 in Trench 5 contained 11 sherds from an Iron Age vessel, apparently broken prior to deposition.

Trench 4 contained a group of four probable postholes (Fig 15) one of which (cut 0082, fill 0083) produced three sherds of possible Iron Age pottery. The fills of these features all contain moderate fragments of charcoal, with 0081 (cut 0080) being particularly charcoal-rich. There is also some possible burnt bone in 0081 (awaiting analysis) suggesting a cremation deposit. Three of the possible postholes (0080, 0082 and 0084) are in a line, roughly parallel with and close to the projected eastern edge of ditch 0060. Note that posthole 0087 cuts the eastern edge of ditch 0060; since the ditch fill (as excavated in adjacent Trench 5) produced medieval pottery it follows that posthole 0087 is of medieval or later date.

The posthole-sized features (Fig 15) are more difficult to interpret. One of them (0050 in Trench 5) is undoubtedly Iron Age in date, containing 11 sherds from the same vessel. At least one of the postholes in Trench 4 (0082) is probably of similar date. Assuming that these *were* structural features it seems likely that there was occupation of the site in the late prehistoric period, and this is supported by the presence of a reasonable amount of residual prehistoric pottery and some struck flints in the medieval ditch fills. Note however that at least one of the posthole-sized features in Trench 4 (0087) is thought to be medieval in date. Further excavation would elucidate the extent and nature of prehistoric occupation on the site.
