ARCHAEOLOGICAL WATCHING BRIEF REPORT

SEWER REPLACEMENT, CASTLE STREET, FRAMLINGHAM (SMR ref. FML 049)

A REPORT ON THE ARCHAEOLOGICAL WATCHING BRIEF, 2008

Suffolk County Council Archaeological Service Report No. 2008/130
(OASIS Ref. suffolkc1-40018)

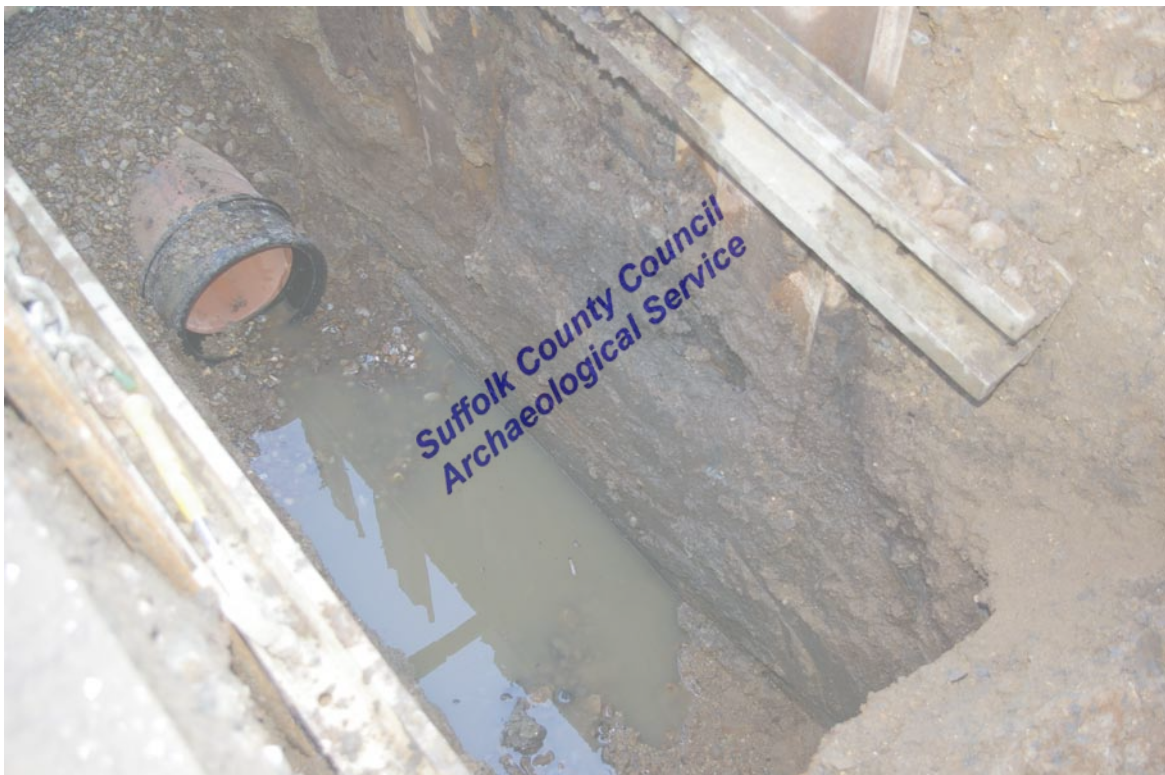
Figure 3. General view of the sewer trench, looking southeast

Depth below GL	Description
0 – 0.15m	Concrete road surface
0.15 – 0.85m	Gravel make-up for road surface
0.85 – 2.40m	Discrete deposits of light grey or yellowish brown (iron stained) clay/silt and mid reddish brown silty sand, with some thick lenses of dark brown 'peaty' soil. They contain moderate pebbles and small fragments of chalk, and occasional small-medium fragments of leather and animal bone.

It seems likely that the fine-grained sediments described above represent a sequence of alluvial deposits within the medieval ditch of Framlingham Castle. They do not suggest deliberate infilling of the ditch, although deposits of this nature might have existed at a higher level and been removed when the modern road was constructed. The 'peaty' deposits are probably layers of decayed vegetation.
