Leiston Old Abbey Chapel (LCS 002; SAM 21404); Building Recording & Excavation

SCCAS Report No. 2008/90; Oasis No. suffolkc1-41038

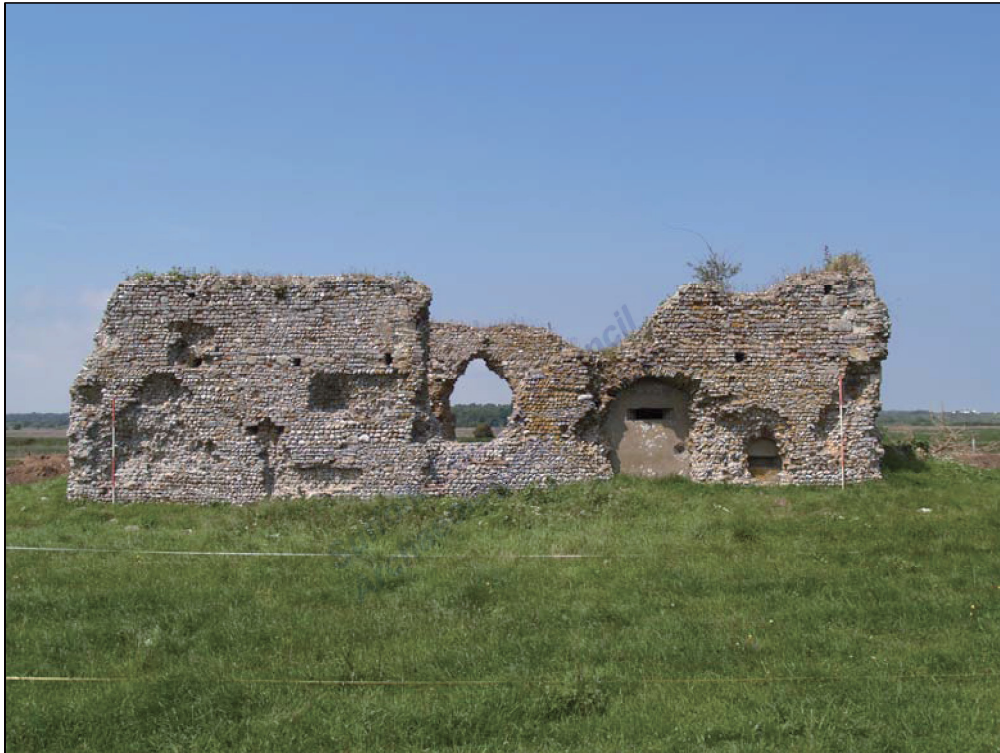
The south side of the surviving building

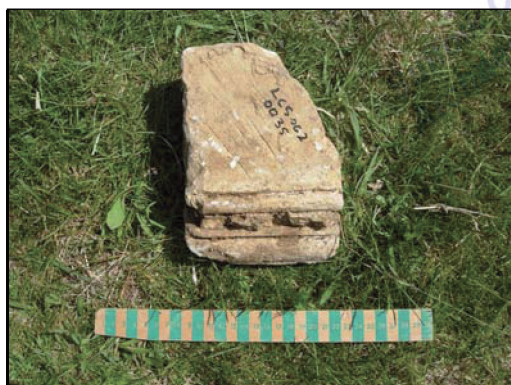
Plate 1 Caen-type limestone (LCS 002 0035)

Three stone types were represented; Caen-type limestone (61 pieces, red on Fig. 4; Plate 1), an unidentified grey silty limestone (10 pieces, green on Fig. 4; Plate 2) and one hard shelly fragment of a shaft, probably Barnack-type limestone (Blue on Fig. 4; Plate 3). The plot shows concentrations of material close to the north-west and north-east corners, a bias purely due to the fact that this coincides with the two main areas of excavation. The plot also shows the grey silty limestone only occurring on the north side of the building. However, this material was present as a component of the upper wall fabric on all four sides of the building, and the bias of the plot does not seem to signify any real difference in the structural composition of the walls. Also, given that the majority of the tooled masonry pieces in the standing structure appear to have been re-used from earlier buildings, mostly in the wall fabric rather than as dressings of architectural features, it seems unlikely that the distribution plot can provide worthwhile information regarding the architectural character of the building.

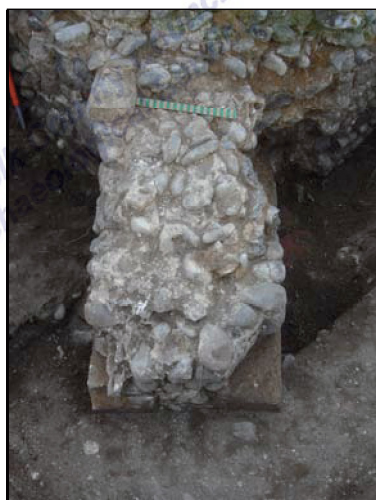
Plate 12 Buttress 0074

However, the situation at the north-west and north-east corners was considerably different. Part of the upper component of buttress 0074 on the north-east corner, essentially all Phase II fabric, had survived, but the lower Phase I component had not, leaving a cavity with a dangerous overhang above. The excavation at the wall base, prior to the required consolidation works at this juncture, was intended to reveal any surviving below ground masonry that could be recorded then used as a solid base for the repair.

The bottom of the buttress was exposed in the excavation with *in situ* Caen-type limestone quoins forming the corners at the base of the structure (Fig. 5; Plate 12). At its base the buttress was 0.56 metres wide, but then stepped in by c.0.06 metres at a point 0.66 metres above the base of the wall. Here, the vestiges of a plinth, comprising a single piece of tooled Caen-type limestone (0079), was recorded at the junction between the buttress and the west wall (Fig. 5; Plate 13). A second step must have occurred higher up the wall as the surviving Phase II component of the buttress was only 0.30 metres wide.

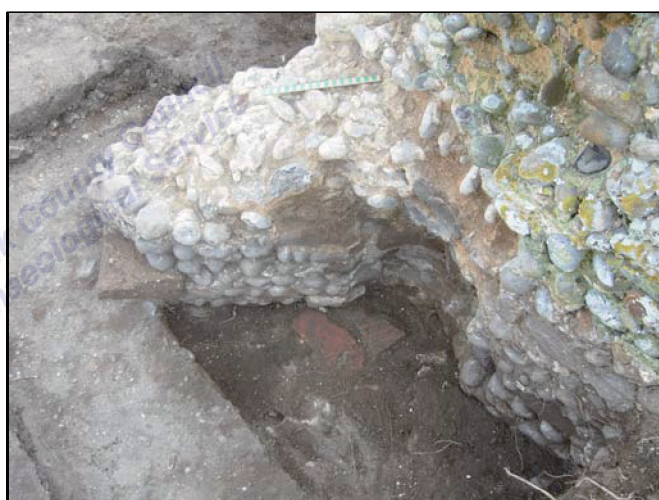
Plate 14 Detail of feature 0080

The evidence for the exact height that this occurred had been lost and could not be inferred from any of the other corners of the building. At the junction of the buttress base with the building's north wall a rounded cut in the fabric was recorded (0080) (Fig. 5; Plate 14) surviving up to the height of the plinth. This feature did not seem to represent the simple removal of a few facing clasts, but appeared to have been

genuinely chipped out to that shape. The only explanation that could be offered was that it represented a socket for a post-hole, although why it needed to be actually cut into the wall is unclear.

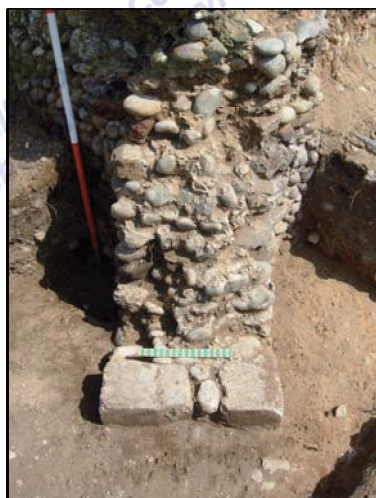
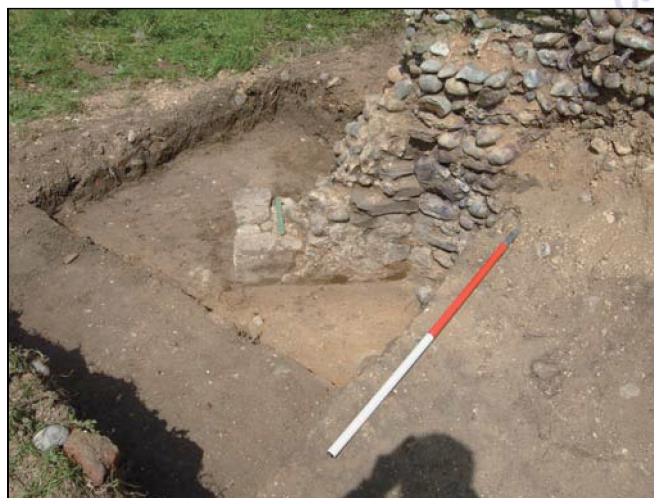
Plate 15 Buttness 0077

Plate 16 Buttness 0077

At the north-west corner (0077), none of the above ground component of the buttness had survived. Indeed most of the corner formed by the junction of the west and north walls had also collapsed, at least some during the period between the submission of the proposal for the consolidation project and its subsequent commissioning. Similarly to the north-east corner, the intact base of the buttness was revealed with its Caen-type limestone quins forming the basal corners at the front of the structure which was c.0.55 metres wide (Fig. 5; Plates 15 & 16). In addition, there was also the vestiges of a plinth

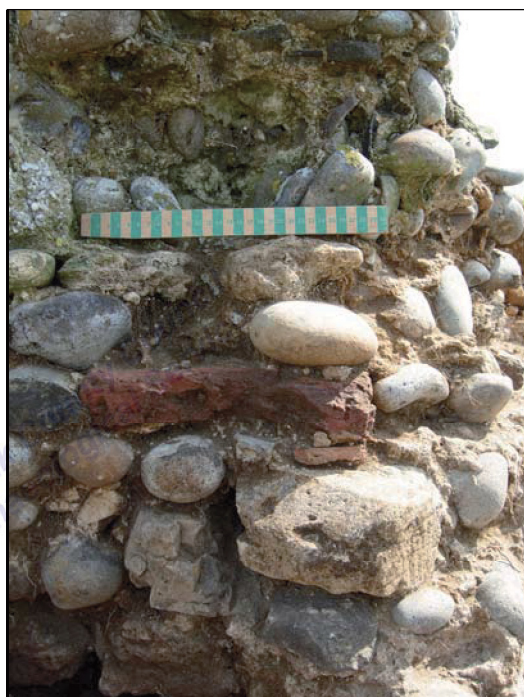
Plate 17 Detail of surviving plinth 0081

represented by another single piece of tooled Caen-type limestone (0081) recorded at the junction between the buttness and the north wall of the building at a point c.0.69 metres above their base (Fig. 5; Plate 17). The plinths were seen on the buttnesses only and clearly did not continue around the main body of the building.

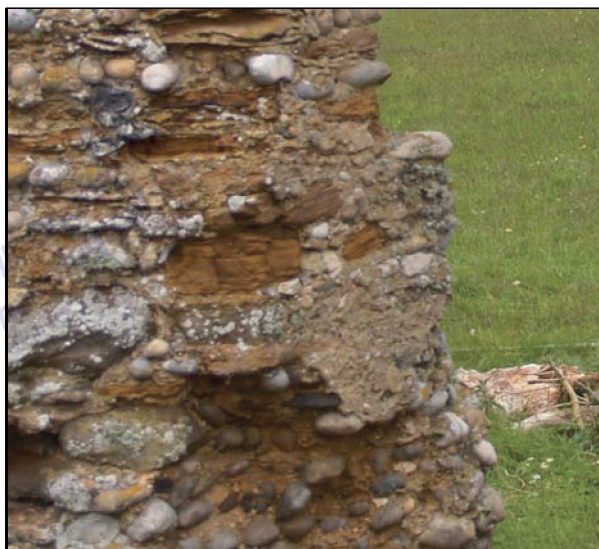
Plate 18 Detail surviving splay in window 0082

Approximately halfway along the north wall there was a large ragged opening (0082) (Figs. 5 – 7; Plates 4 & 5), which was badly in need of consolidation work as loose material was present throughout. Its identification as a Phase I window was based on three main observations; firstly, the surviving face of the angled splay on its west side did not include any of the characteristic brick

dressings of the Phase II openings (Plate 18), secondly, if the face of the splay was projected downwards it intersected with core fabric which would not have been possible if it had been a doorway and thirdly, there was no evidence for a door threshold when the wall at the base of the opening was cleaned back to intact corework. There was no evidence in the overlying Phase II fabric for the top of a window at this juncture and it seems likely that the Phase I window was truncated at that level and

blocked as part of Phase II in a similar manner to the more intact Phase I window (0083) on the south side of the building. Subsequently, this blocking must have been removed or fallen out. The excavated 1.00 metre square box adjacent to the opening inside the building revealed nothing more than the genuine base of the north wall with no evidence for internal floors or surfaces.

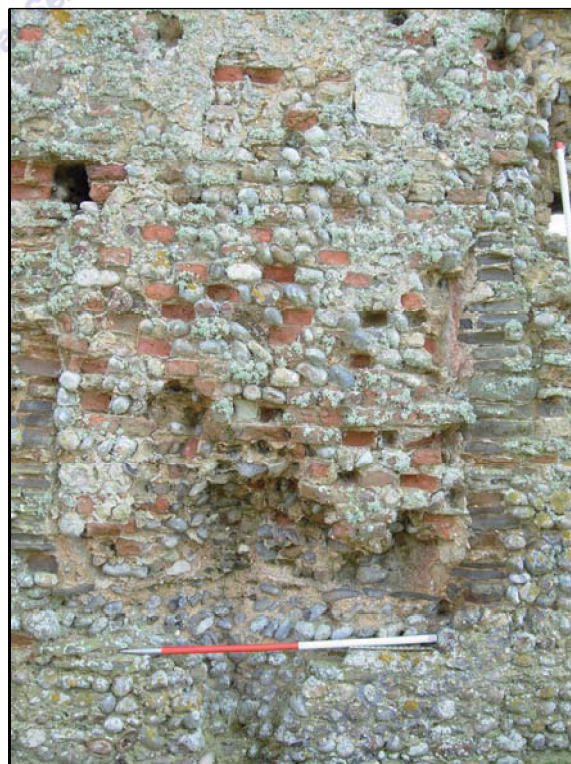
Plate 19 Blocked window 0083, external view

Plate 20 Blocked window 0083, internal view

A Phase I window (0083), subsequently blocked as part of Phase II, was also identified towards the western end of the south wall (Figs. 5, 8 & 9; Plates 6, 7, 19 & 20). The window would have been c.1.40 metres wide internally with an angled splay giving an external width of c.0.50 metres. The irregular

shape of the blocking in the external face of the wall suggests that there may have been dressings of some sort present in the Phase I window that were removed prior to the infilling. Internally the angles between the splay and the main wall face were constructed using flat slabs of hard ferruginous sandstone, a material also used to construct the internal corners of the building (Plate 21). The external base of the window was at +1.28 metres (measured above concrete floor of the pillbox) while the internal base was at +0.97 metres, a fall of 0.31 metres. A layer of pink coloured lime plaster was recorded lining the sides and base of the window where it was revealed at the edge of the Phase II blocking (Plate 22). While the complete profile through the window was not visible, the layer of plaster could be seen sloping down from the external wall face, but ran in horizontally from the internal wall face. If these continued until they intersected they would have formed a flat bench-like sill that, given its height from the ground, could have functioned comfortably as a window seat.

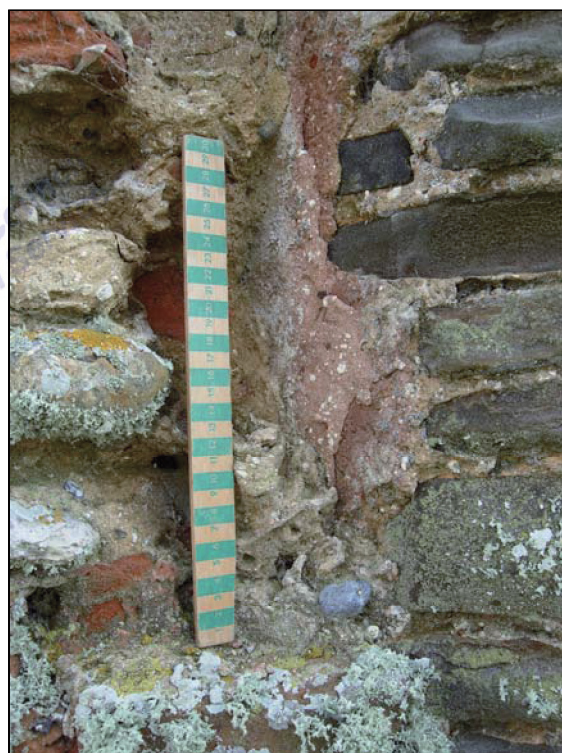
Plate 22 Detail of plaster layer in 0083 splay

The surviving evidence provides one other possible reason for the major refurbishment. The Phase I plaster in the recess of the blocked window on the south side was pink in colour, often an indication of intense heat causing an alteration of the surface. If this was evidence of burning, it is possible that the Phase II rebuilding was the result of damage caused by a fire in the Phase I structure. However, if this were the case, there was no other evidence to support this interpretation, either in the form of other heat altered surfaces or charcoal deposits that could be expected if there had been a major fire at the site.

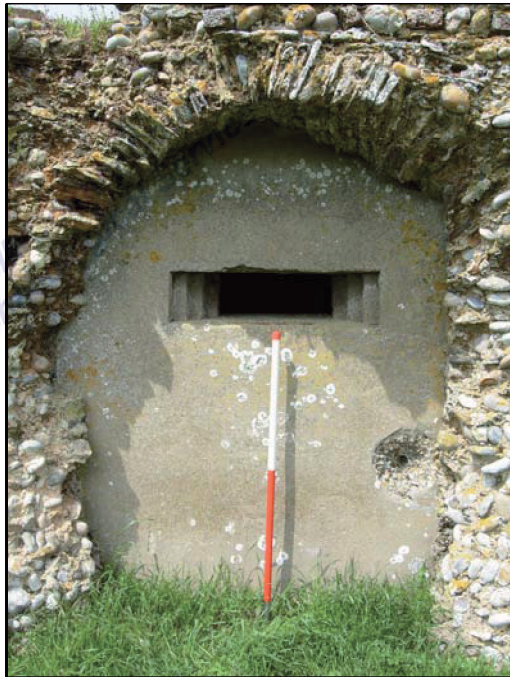
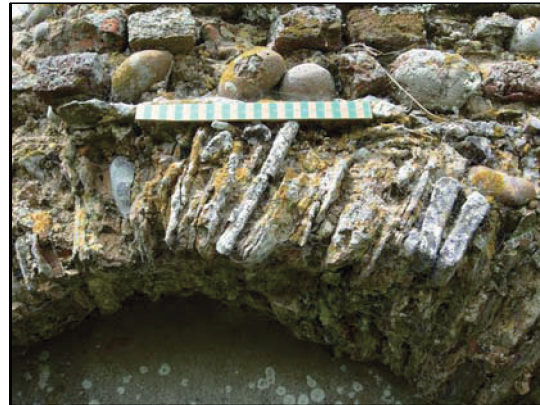
There was a Phase I doorway (0085), with a blocking associated with the Phase III pillbox, in the south wall towards its eastern end (Figs. 5 & 8; Plates 6 & 23). The opening was 1.65 metres high and 1.20 metres wide, the latter possibly not an absolutely true reflection of its original width as some fabric may have been lost, particularly on the western jamb. The relatively flat, almost depressed arch retains most of its dressings which comprise thin slabs

Plate 23 Detail of doorway 0085

Plate 24 Detail of doorway arch 0085 of hard ferruginous sandstone lain face to face radially around the top of the feature (Plate 24). This pattern may have once continued down the jambs, but all facing at this juncture had been compromised.

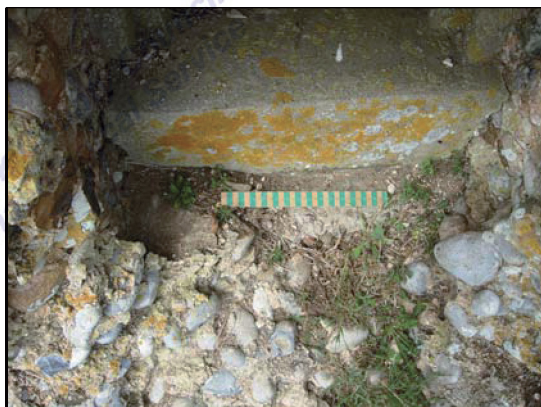
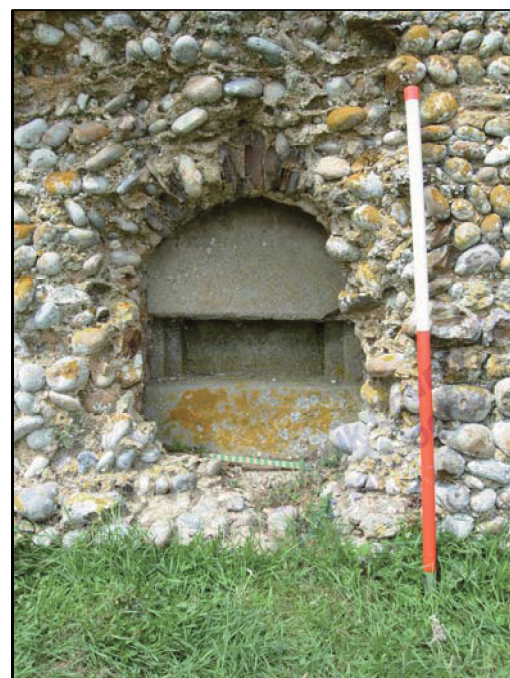
Immediately to the east of doorway 0085, there was another architectural feature (0086), a 0.75 metre high, 0.50 metre wide opening just above external ground surface (Figs. 5 & 8; Plates 6 & 25). Similarly to the doorway to the west, this feature had been reused as part of the Phase III structure. Initially thought to represent an opening right through the wall, on more detailed examination this was found not necessarily to be the case. Within the core fabric of the wall was a well defined squared edge which may represent the impression left when tooled masonry blocks forming the back of an internal architectural feature had been removed, or even the genuine back of the feature itself (Plate 26). The adjacent outer facing of the wall had then subsequently been removed to form the opening right through the wall, possibly as part of the Phase III pillbox insertion. The base of the squared socket was found to be +0.48 metres

Plate 26 Internal detail of low feature 0086

Plate 25 Low feature 0086

above the concrete floor of the pillbox and given that we do not know at what level the contemporary Phase I floor had been, its position towards the eastern end of the south wall is consistent with the type of feature that might be found at this location in a chapel or church.

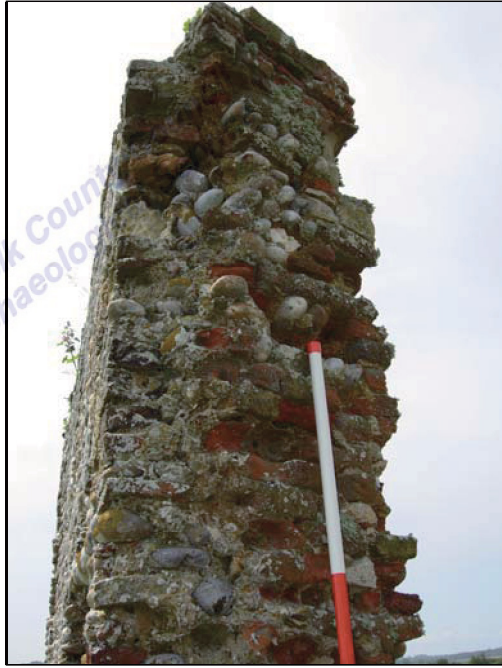
Plate 27 Brick dressings of window 0085

Window 0088 on the south side of the building survived only on its western side as an angled splay dressed with brick (Plate 27). Its eastern side, top and wall fabric below the window were no longer present and, as a

consequence, its overall dimensions were indeterminate. Assuming that this was not a replacement of an earlier window, then Phase I wall fabric must have been removed to accommodate it as the 0088 brick splay continued down for c.0.75 metres below the Phase I/Phase II interface.

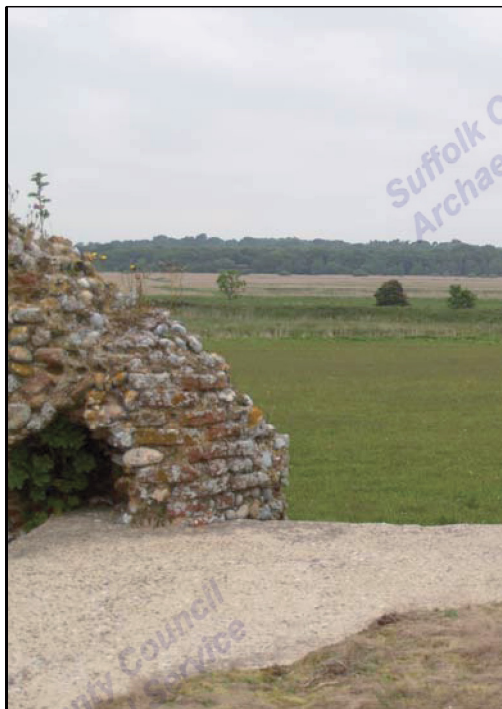
Plate 28 Brick dressings of window 0089

Plate 29 Brick dressings of window 0089

Similarly, window 0089 on the north side of the building had also lost its top, eastern side and material from below its base with its angled brick splay only surviving, in part, on its western side (Plates 28 & 29). In this instance, assuming again that this was not a replacement of an earlier window, the Phase I fabric had been removed down to 0.71 metres below the Phase I/Phase II interface to accommodate the Phase II window. Subsequently, this opening was modified again during Phase III.

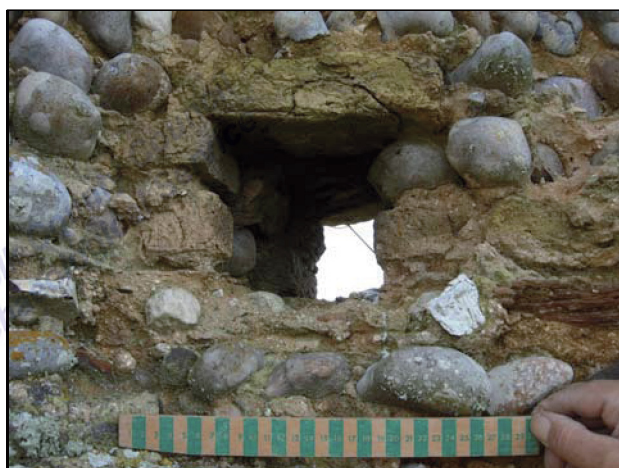
Plate 30 Detail of brick lining in putlock hole 0097

The only other structural features relating to Phase II were the eighteen putlock holes (0090 - 0107) that were recorded in all four walls. These were variously framed and lined slab-like stones and bricks (Plate 30) and continued right through the wall. Wooden poles would have been inserted through the wall to project both sides to take the horizontal scaffold boards. This system could have worked without the use of supporting uprights

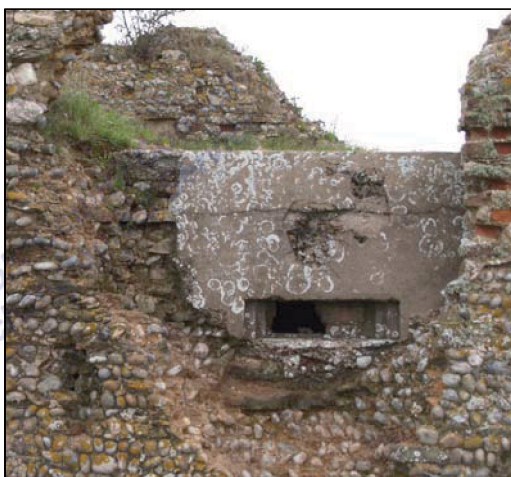
Plate 31 Phase III opening 0119

At the eastern end of the building a double opening (0116) had been constructed within the surviving vestiges of the Phase I window splay 0084 (Figs. 5 & 10; Plates 8 & 31). Subsequently, the opening to the south had been blocked with brick. There was no evidence associated with the north opening to prove that it had been treated the same way.

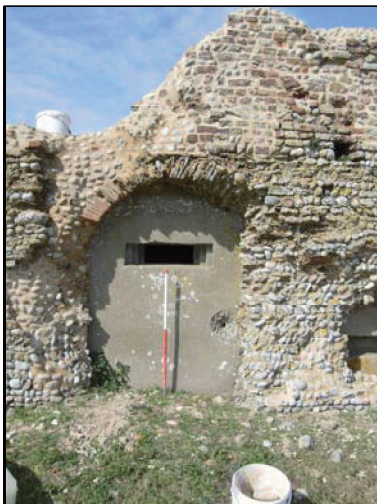
Plate 34 South doorway

As part of the works the turf and rubble material accumulated on the pillbox roof was removed and subsequently reinstated with an underlying membrane. Where water had been running from the roof and causing more serious localised damage (e.g. on the west side of the south doorway; Plate 34) more substantial consolidation was undertaken.

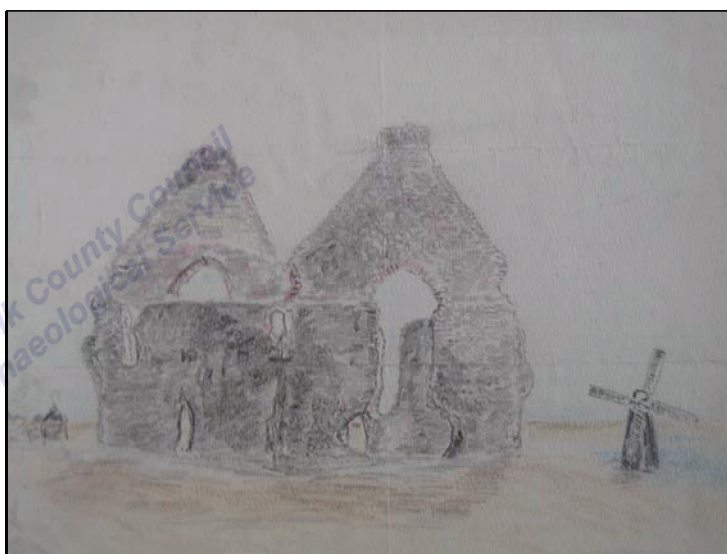
Fig. 14 "Sketch, Ruins of Chapel, Leiston Abbey"

Abbey". The coloured sketch shows the building from the northern west end of the chapel (Fig. 14).

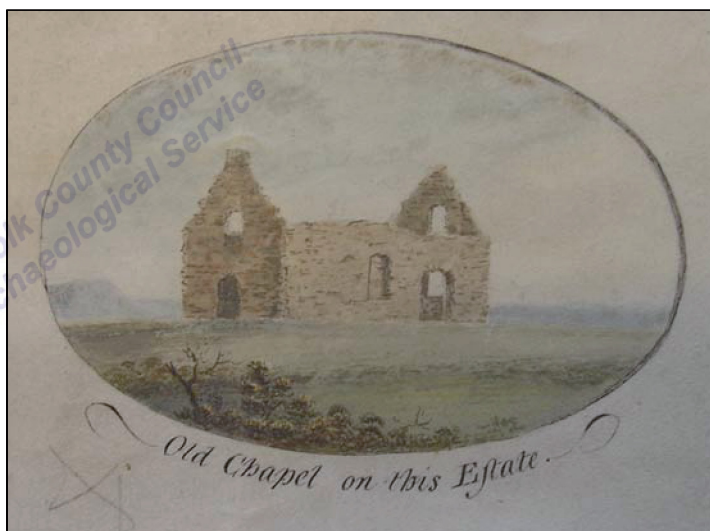
Fig. 15 Illustration on Estate Map of 1786

Amongst the estate maps there is a coloured illustration of chapel on a plan of an 'Estate lying in Leiston, Suffolk in the occupation of Geo Doughty gent and belonging to W. Tatnal esq' (ref. HD 306/1/1) (Fig. 15). The surveyor was Isaac Johnson of Woodbridge and according to an inscription at the bottom left hand corner of the plan he surveyed the estate in 1786. In the same collection is a rough drawing of the same estate plan without the illustration of the chapel.

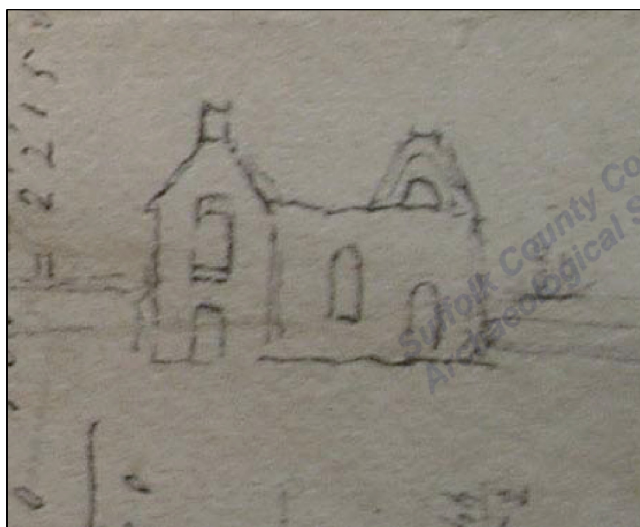
Fig. 16 Illustration in margin of Estate Map of 1814

There is another rough plan of 'The Old Abbey Estate W. Tatnal Esq' in the Isaac Johnson Collection (ref. HD11: 475/88) and dated 1814. On this rough plan there is an outline drawing of the chapel in the margin (Fig. 16). The acreages given in the legends of the two maps of 1786 and 1814 are different. The later map

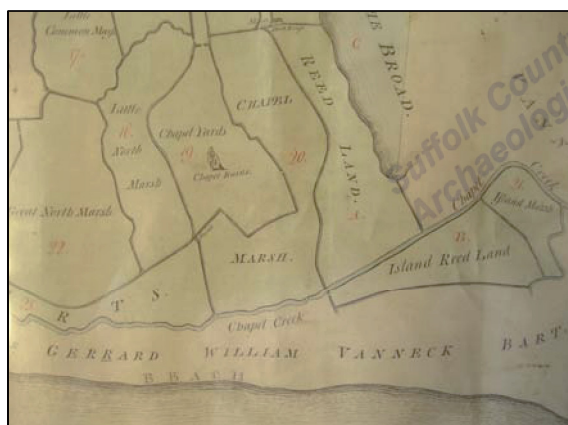
Fig. 17 Estate map of 1786

In 1786 the site of the chapel was within a field numbered in red as '19' and named as 'Chapel Yards' and measured at 15 acres 2 roods 38 perches (Fig. 17). In 1814 the same field is numbered in red as '11' and measured in the schedule as 17 acres 3 roods and 12 perches, though on

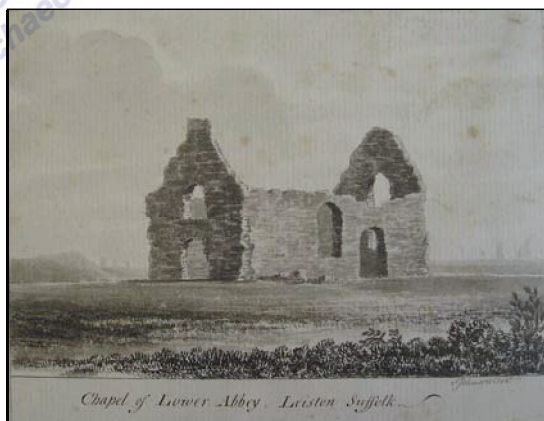
Fig. 19 Isaac Johnson drawing Ref. HD480/7 **Fig. 20** Isaac Johnson drawing Ref. HD 484/3

There are another two illustrations of this chapel both the work of Isaac Johnson. In William Fitch's 'Suffolk Illustrations' there is an undated drawing in pencil (ref. HD 480/7) entitled 'Chapel of Lower Abbey' (Fig. 19). The view is the same as the illustration on the map. The same view appears in Johnson's own 'Antiquities' dated 1820-21 (ref. HD 484/3) (Fig. 20). The setting and foreground in these various illustrations may not be accurate.

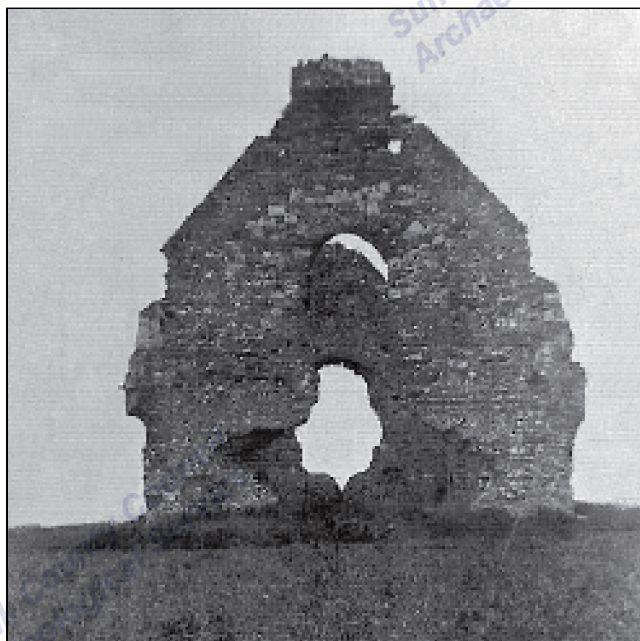
Plate 39 Photo from the East Anglian Daily Times

A photograph of the building taken from the west that appeared in the East Anglian Daily Times in 1914 was provided by Andy Needle of the RSPB (Plate 39).

Leiston Abbey chapel in 1914 – EADT
