ARCHAEOLOGICAL MONITORING REPORT

ALL SAINTS CHURCH, GREAT GLEMHAM (HER Ref. GLG 003)

A REPORT ON THE MONITORING OF GROUNDWORKS ASSOCIATED
WITH THE CONSTRUCTION OF A NEW TEA POINT, TOILET CUBICLE
& EXTERNAL SERVICE TRENCHES

Suffolk County Council Archaeological Service Report No. 2008/148
(OASIS ID. suffolkc1-42283)

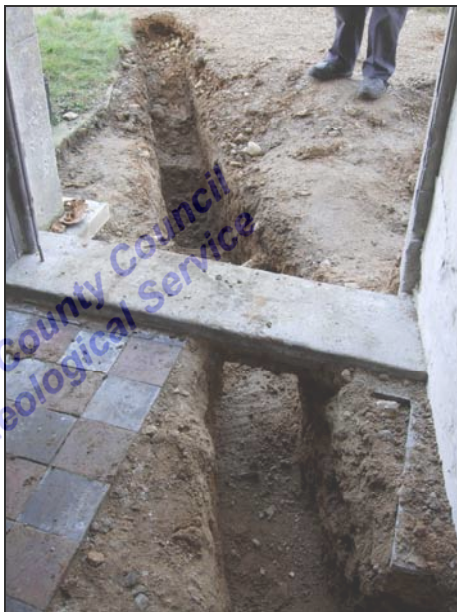
Plate 1 Trench under tower threshold

At the time of the initial visit, a trench had been excavated underneath the existing threshold of the tower's west doorway (Plate 1), revealing that the wall footing was not continuous for the west side of the tower. Below the tower threshold and continuing into the body of the building, the

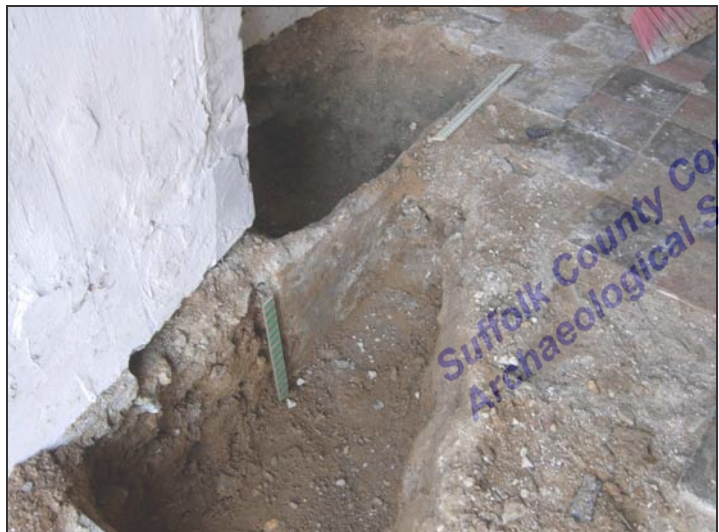
Plate 2 Vertical grave slab fragment

The excavation within the tower revealed a large fragment from a stone grave slab or paving slab set vertically in the ground in line with the north door splay of the tower's west doorway. To the north of the slab, against the tower north wall, the fill was unconsolidated and included fragments of coal. While the function of this feature was not positively ascertained it was thought to be relatively recent in date and in some way associated with the Victorian heating system.

removal of the existing tile floor and bedding had revealed a clayey/silty sand soil with occasional inclusions of human bone fragments. These were collected by the contractors for reburial. However, in the angle formed by the tower's north and west walls the underlying fill was considerably different, comprising unconsolidated grey/brown ashy sand with common inclusions of black cokey material and lime mortar. A vertically placed slab of stone, probably a re-used gravestone fragment, aligned with the north door splay and formed the boundary between the soft sand fill to the north and clay/sand to the south (Fig. 2 & Plate 2).

Other than the path gravels and grave cuts, no features of archaeological interest were recorded external to the church. It was impossible to tell within the confines of the trench whether the two skulls were *in-situ* or re-deposited from disturbed graves. The internal feature comprising the vertical stone slab with the unconsolidated fill to the north was considered to be late in date, probably relating to the Victorian re-orderings, probably associated with the insertion of the heating system which included an underground boiler.

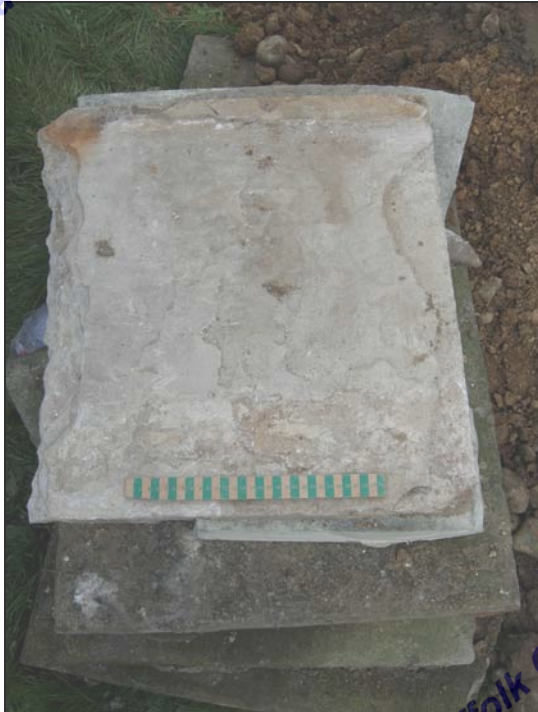
Plate 3 Stone slab after removal

Subsequently the stone was removed by the contractors and was found to measure approximately 0.60 x 0.50 by 0.06 metres (Plate 3). There was no evidence for an inscription on the stone. While this does not preclude the fact that it was part of a grave slab, it could also have been a reused stone paving slab.

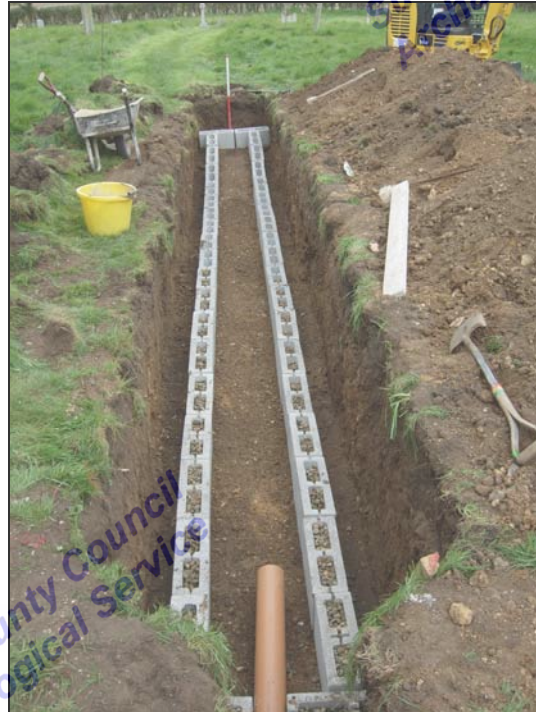
Plate 4 Trench Arch Drain

and were left in place, as they were almost on the base of the trench. The Trench Arch Drain (Plate 4) was excavated to a depth in excess of 1.0 metre, but no bodies were encountered, although a number of vertical grave cuts were visible in the side of the trench (Plate 5).

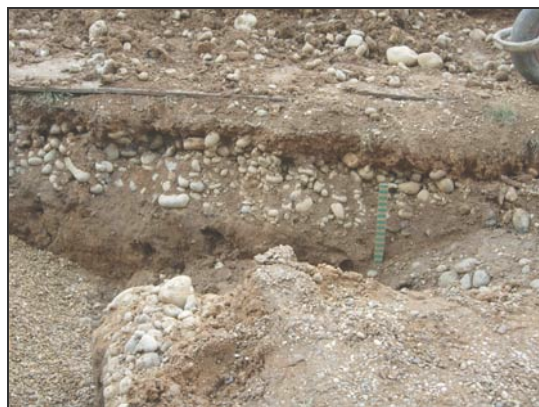
Plate 6 Accumulated layers of path

One other feature, the accumulated gravel and pebble layers making up the pathway around the church were seen opposite the tower doorway (Plate 6).
