St. Michaels Church, Oulton (OUL 004);
Building Recording & Monitoring Report

SCCAS Report No. 2008/154; Oasis No. suffolkc1-42917

Stuart Boulter
Field Team
Suffolk C.C. Archaeological Service

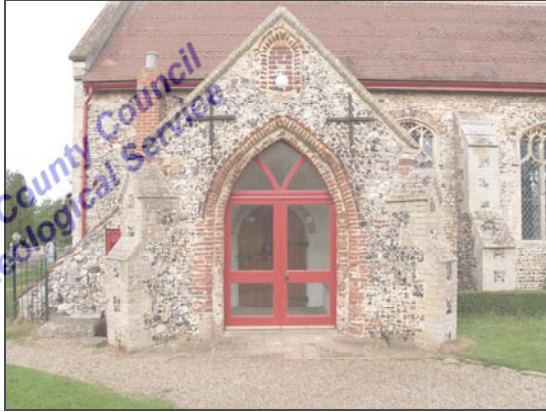
Plate 1 Detail of the south porch

The nave is c.18.00 metres long with a width of c.6.80 metres and there is a c.4.00 metres wide, c.3.55 metres deep porch providing access to the semicircular arched south door. The porch (Plate 1) was clearly heavily remodelled during the Victorian re-orderings, obscuring much of its original character, with its diagonal buttresses dressed in hard white bricks similar to those used in the vestry extension on the tower's north transept. Immediately to the west of the porch, occupying the angle between its western wall and that of the nave, there is a small chimneyed structure, presumably related to heating the church.

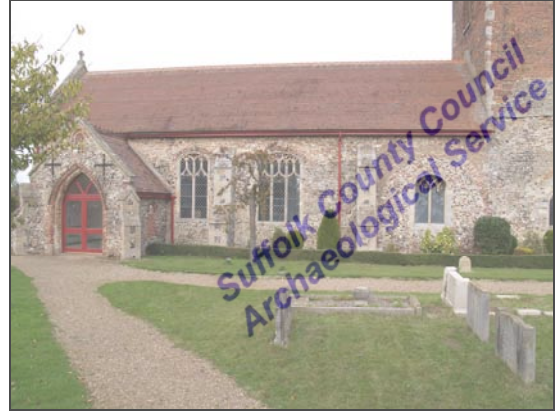
Plate 2 Nave south wall

To the east of the porch there are two perpendicular windows inserted into original coursed 12th century wall fabric and two buttresses, the latter dressed with hard white brick and thought to be Victorian in date (Plate 2). Radially lain bricks above the window arches are within a secondary fabric (see 0003 on the north side of the nave) which suggests that the wall was raised in height at the time of the window insertion. A further strip of wall fabric (see 0004 on the north side of the nave) above the secondary fabric is almost certainly contemporary with the cross braced pine roof that was thought to have dated to the 1850's (Mortlock 1992, p.143). At the eastern end of the south nave wall there is a third window, in late decorated or early perpendicular style, this time inserted through wall fabric forming the blocking to a large two-centred arch (Plate 3). This brick arch used to provide access to a side chapel, subsequently, that was dedicated to the Holy Trinity (Mortlock 1992, p.143). One of the buttresses obscures the western side of the blocked arch and, therefore, clearly post-dates the removal of the chapel.

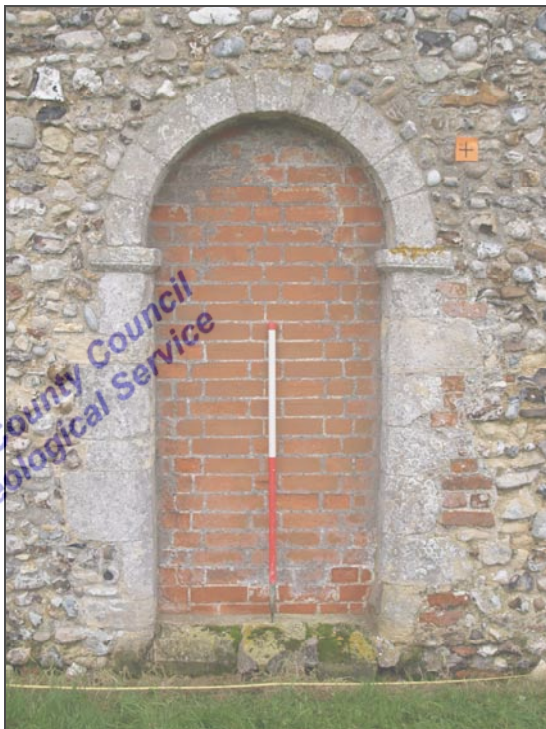
Plate 5 Detail of nave north doorway

The north doorway (0010), now blocked with red brick (0005), was the only architectural feature in the north wall that could be considered to be contemporary with fabric 0002 (Fig 2 & Plates 5 & 7). However, there were some inconsistencies which suggest that at the very least it had been reset. The doorway has a simple semicircular arch springing from square impost blocks, the latter with a single horizontal incised decoration and chamfered lower edge, with a simple chamfered edge to the door jambs. Stylistically, the door is completely in keeping with the

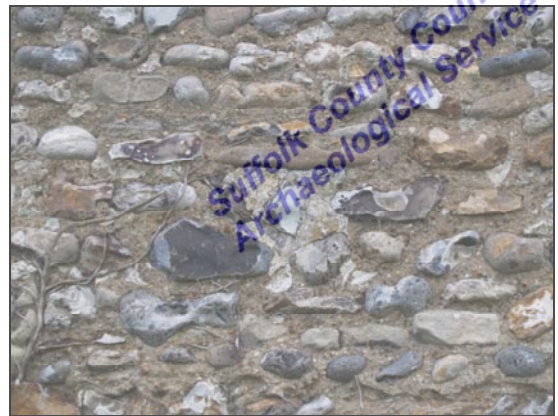
Plate 6 Detail of putlock hole 0018

The lime mortar associated with fabric 0002 was very coarse with common gravel-sized inclusions. Four contemporary, but now blocked, putlock holes (0015-0018), topped by flat stones, were recorded (Fig. 2 & Plate 6) in a line at c.2.50 metres above the present ground surface.

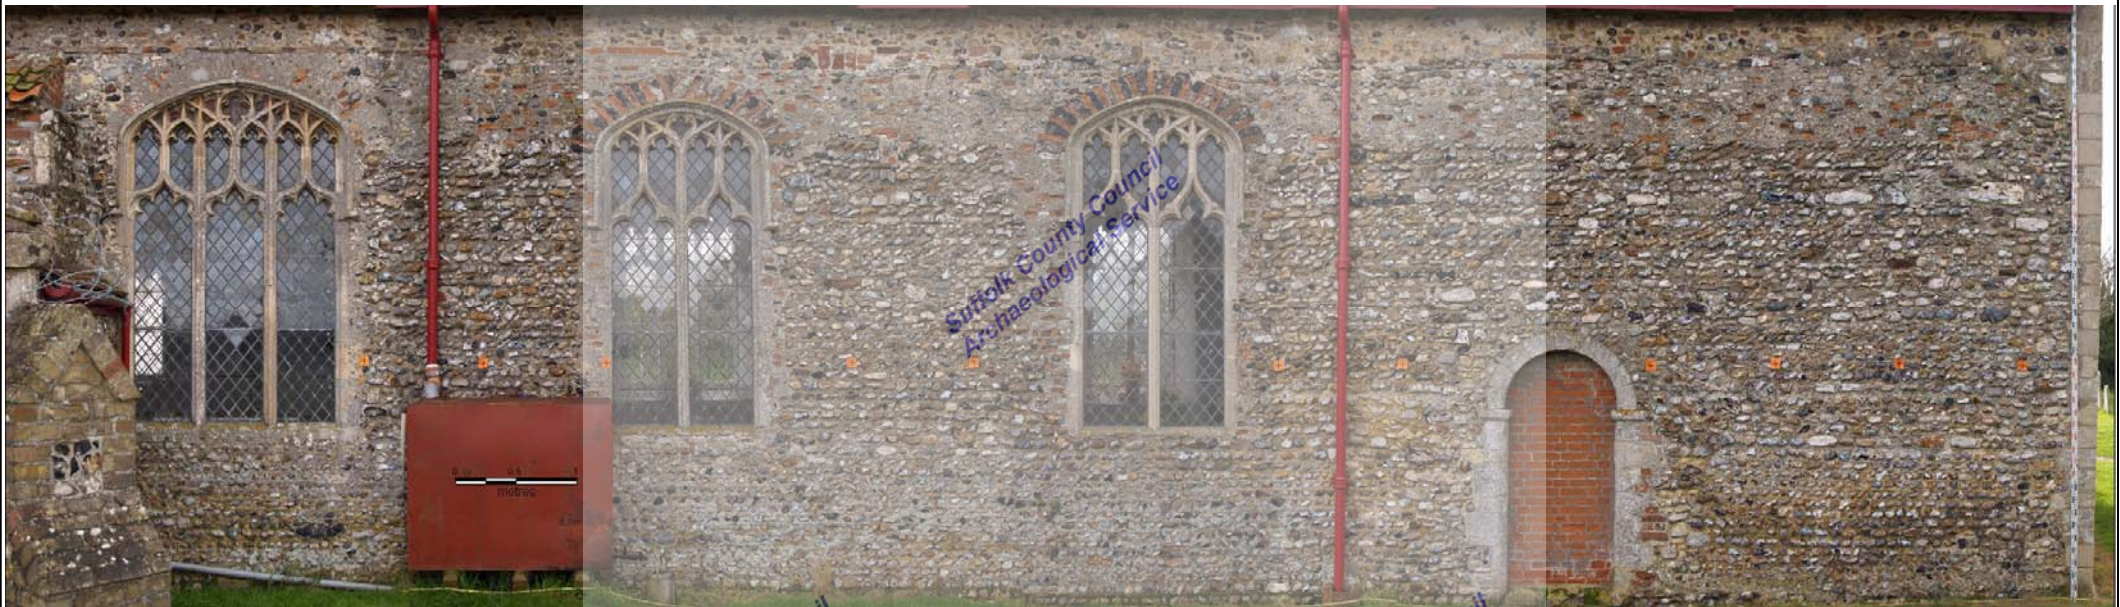
Plate 7 North nave wall elevation, composite photograph

The north wall of the nave was recorded in more detail as this was the area that would be compromised by the proposed extension. A composite photograph of the entire elevation appears as Plate 7 while a digitised elevation showing the architectural and constructional elements of the wall is presented as Figure 2.

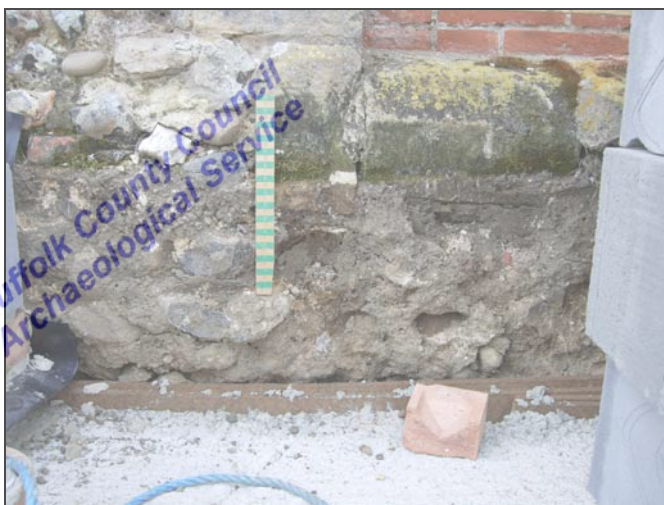
Plate 8 Nave north doorway, base of eastern jamb

proposed 12th century date for the wall, but there is a clear insertion line around the doorway. To the west of the doorway the insertion fabric (0008) includes formally lain red bricks. The lower blocks of the western jamb are also set slightly proud of the wall when compared to the eastern jamb, arch and upper western jamb which are essentially flush. In addition, the chamfered edge of the eastern jamb continues down beyond the external threshold to a stop in the bottom block at a point which is c.0.20 metres below the step out at the base of the wall.

The wall footing does not continue below the doorway and the basal masonry of the jambs could be seen sitting directly on earth, as is the clearly later step which is composed from re-used masonry pieces (Plate 8). At the very least, the door has been completely re-set at its original location, although it could also be argued that it is in fact a later insertion.

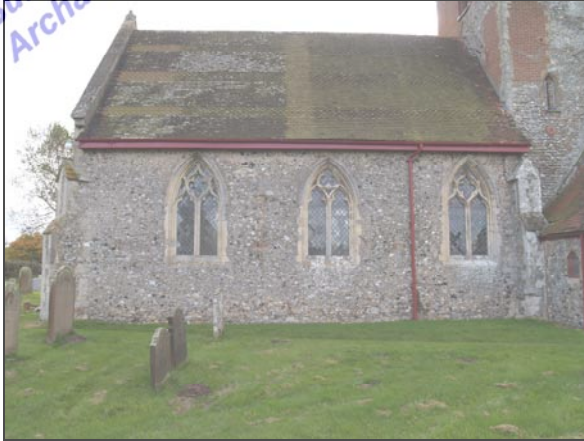
Plate 9 Chancel north wall

The chancel measures c.12.50 metres in length with a width of c.7.00 metres. The whole structure is essentially a rebuild of 14th century date with decorated reticulated tracery in its large east window and the three windows in each of its north and south sides (Plates 9-11). Relatively minor stylistic differences between the tracery of the central window and the flanking windows in the north wall (Plate 9) do not represent a conflict in date as both appear to be original features and, therefore, contemporary. There is also a priest's door with a head corbel above (cover photo & Plate 10) and diagonal buttresses at the north-east and south-east corners.

The wall fabric was randomly faced, predominantly with unknapped or naturally split flint cobbles/pebbles, although other stone types (ferruginous sandstone, quartzite pebbles etc) were represented, including limestone pieces, possibly re-used architectural fragments from the earlier structure.

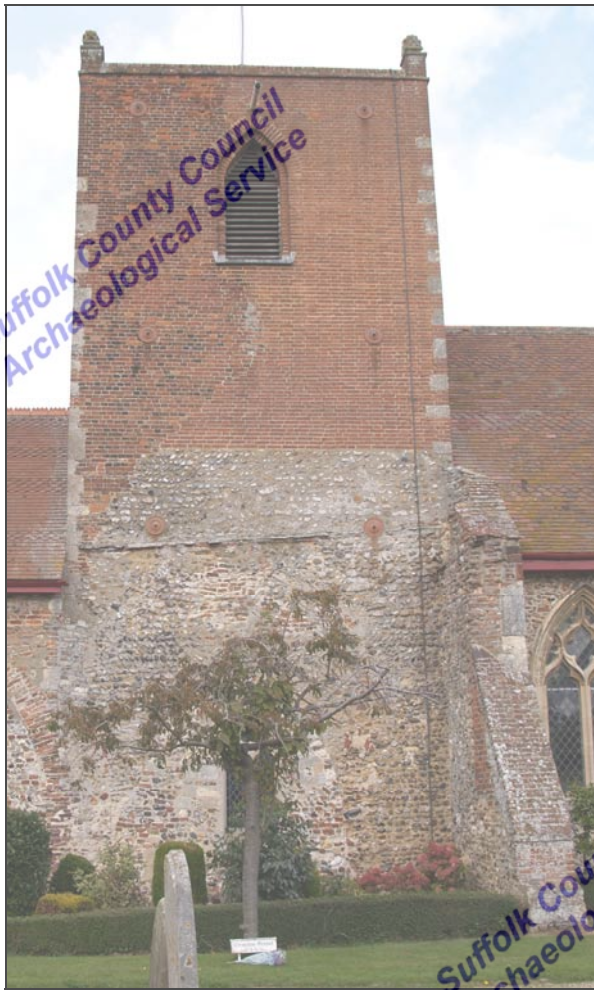
Plate 12 Tower south side

The squat central crossing tower and associated transepts were clearly part of the 12th century church. The characteristic coursed facing visible towards the tower base and in the north wall of, what was originally, the north transept and the architectural style of its internal arches (semicircular) confirm this early date. However, the upper portion of the tower above the level of the nave and chancel roof had at the very least been refaced, possibly totally rebuilt (Plates 12 & 13). The rebuilding has been attributed an 18th century date (Mortlock 1992, p.143).

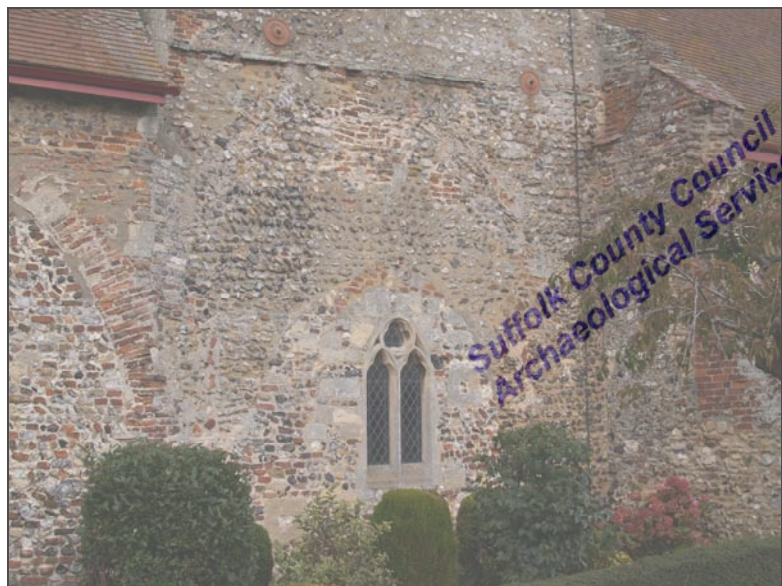
Plate 14 Scar of south transept arch

The south transept no longer exists, although an extant buttress projecting on the line of the east wall of the tower incorporates fabric from its east wall. The scar for the semicircular arch at the junction between the tower and south transept clearly

survives (Plate 14). At some time, the semicircular arch was partially blocked with a smaller, two-centred arch inserted which, itself, was subsequently completely blocked with a decorated style window central to the new fabric. While this window is in a style consistent with a date in the first half of the 14th century, it had the feel of being incomplete and may represent parts of a window moved from elsewhere and not reassembled in its entirety.

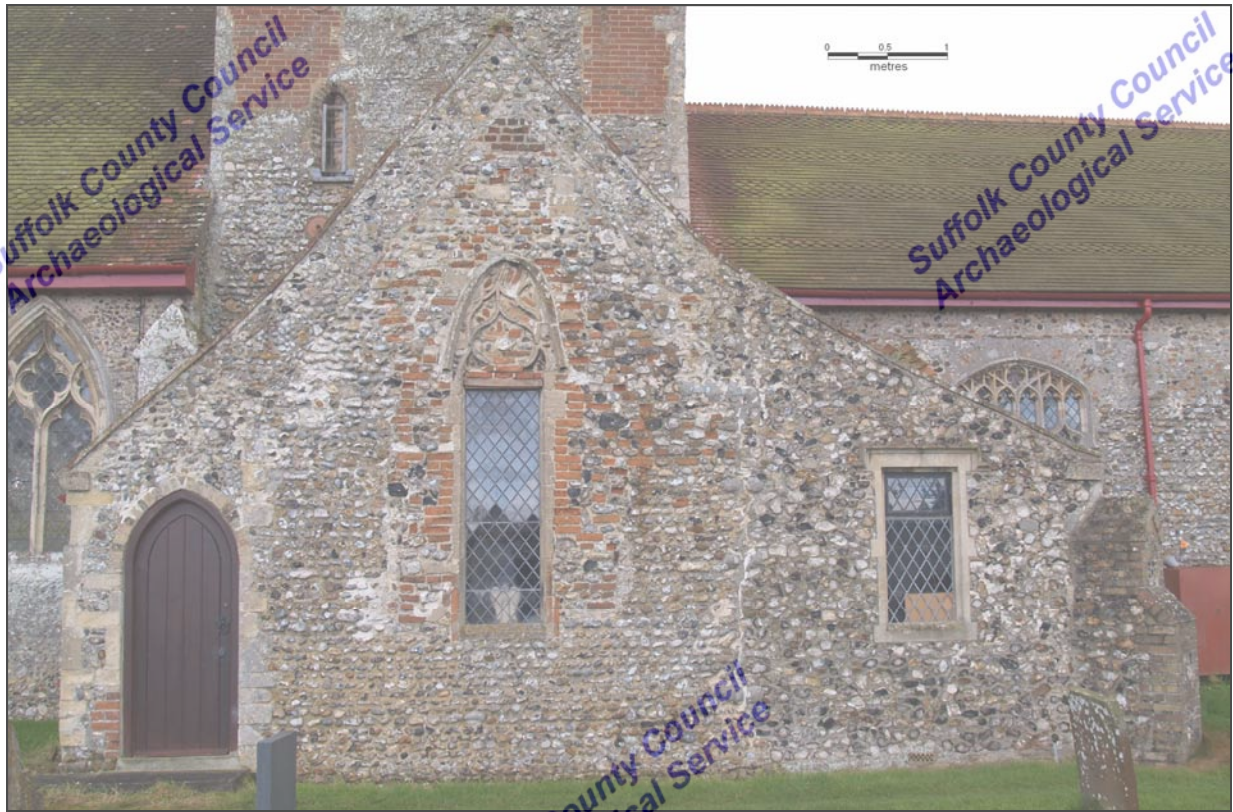
Plate 15 North transept, north wall

Considerably more of the wall fabric of the north transept had survived, but not without considerable alteration on a number of occasions. The north wall of the north transept was recorded photographically (Plate 15) in such a way that a digitised elevation could be constructed (Fig. 3). Original coursed 12th century fabric (0024) survived at the base of the wall for at least a height of c.1.30 metres for its entire

length, rising to c.2.8 metres at the west end and c.4.50 metres at its east end where four of the original quoins survived (0031).

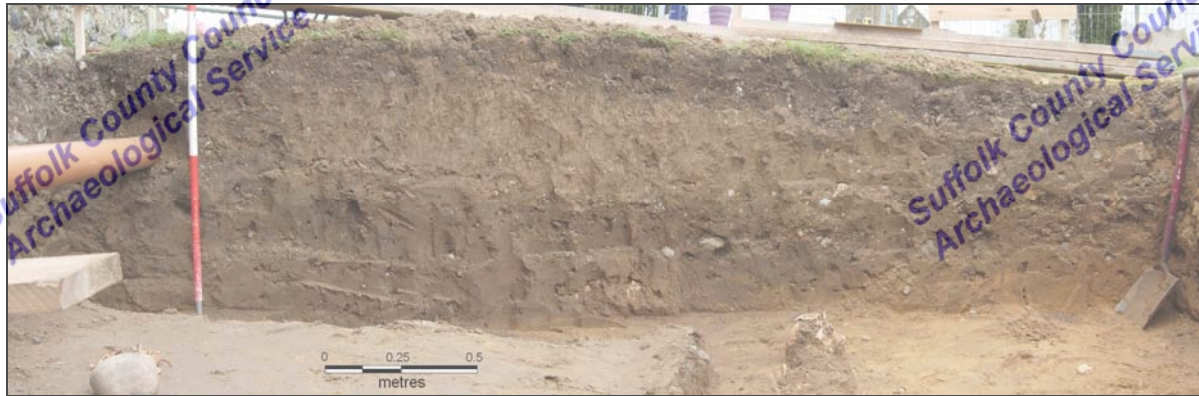
Plate 16 West side of excavated trench, photo

During the photographic recording undertaken in October 2007 it had been noted that there was a raised bank running parallel to the north nave wall. As the top of the stepped out base of the wall footing was exposed, it was presumed that the ridge was the result of removal of material along the base of the wall, possibly to alleviate damp, and dumping it immediately to the north. However, the excavation of the 4.00 metre by 3.75 metre footprint of the extension exposed a section through the bank which revealed its structure (Fig. 4 & Plate 16). Below the c.0.20 metres thick layer of turf and topsoil (0039), a c.0.40 metres thick layer of stiff grey green clay (0040) was encountered which sealed a layer of brown silty sand (0041), and in turn either overlay naturally occurring yellow/orange sand subsoil (0042), or continued on down as grave fill. Clay layer 0040 was continuous across the trench and clearly sealed all of the underlying graves and must represent imported material. Indeed, the section revealed that it was the clay which formed the ridge and that the upper surface of the underlying layer (0041) almost certainly represented the earlier ground surface. However, this does mean that the north wall of the nave was built with virtually no below ground footing.

All three layers were cut by the inserted drain trench (0036) with its fill of loam and gravel. The sectioned ceramic pipe had been removed in the excavation area and replaced by a section of plastic pipe (0038).
