## St. Lawrence Church, Ipswich (IAS 2501 & IPS 598); Evaluation, Building Recording & Monitoring Report

SCCAS Report No. 2008/163; Oasis No. suffolkc1-43261

Stuart Boulter & Richenda Goffin  
Field Team  
Suffolk C.C. Archaeological Service

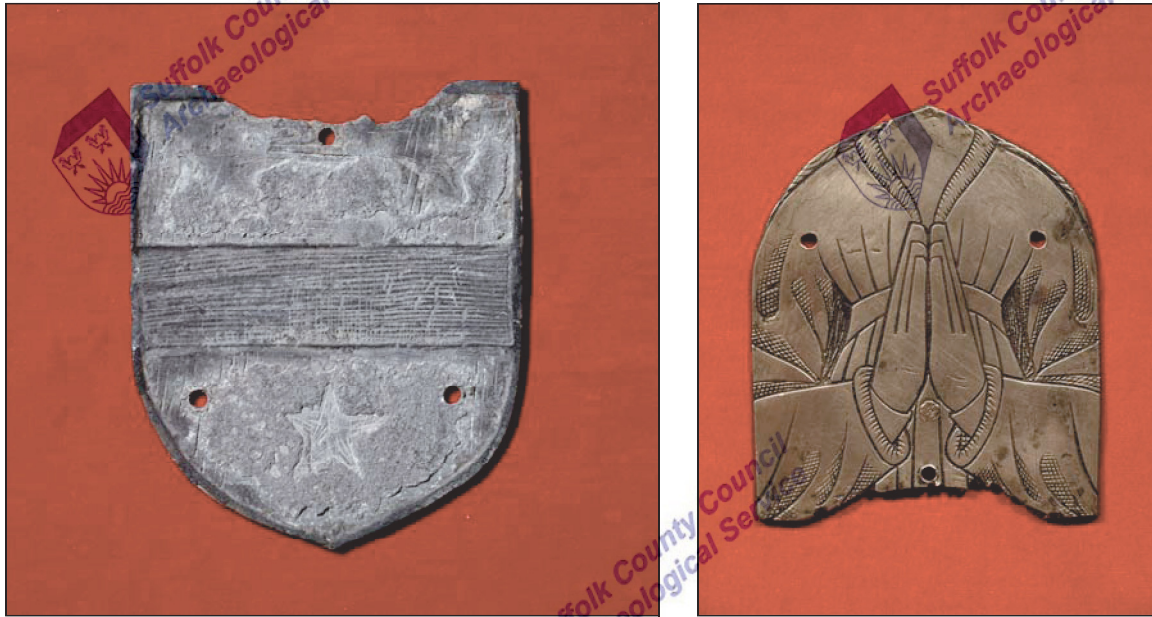
**Plates 3 & 4** The Moore Brass (obverse & reverse)

following description of the arms on the shield was extracted from 'The Dandy Pedigree' a paper written by Francis W. Steer for the Suffolk Institute of Archaeology (PSIA XXVII, 1958, pp. 133-154) (reference kindly supplied by Doctor John Blatchly).

{Dandy} Quarterly azure and or in the first quarter a mullet of the second impaling {Gilbert} Argent on a chevron sable between three leopards' faces azure, as many roses of the field seeded or barbed vert..

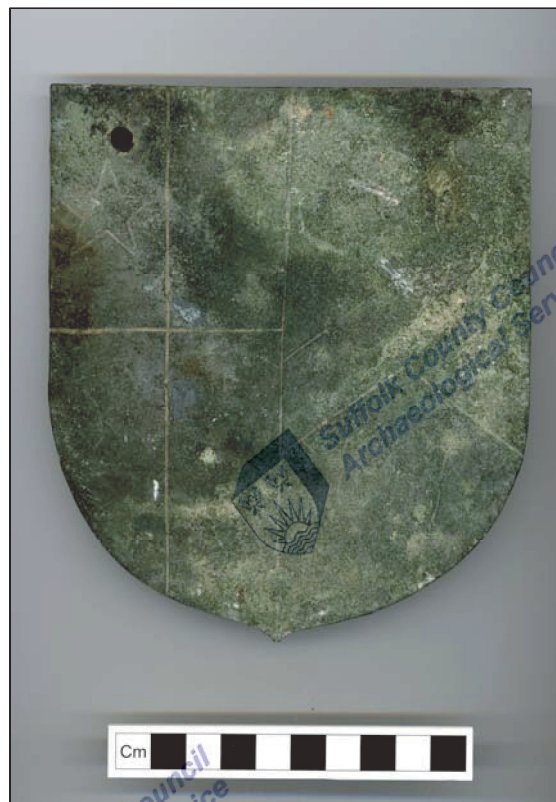
**Plate 5** Shield Brass (Dandy impaling Gilbert)

**No. 14:** A complete ledger stone measuring 1.84 metres from east to west and 0.84 metres from north to south, with no incised inscription, but indents for five brasses (Appendix II & Fig. 2). These indents comprise a central rectangle, almost certainly for an inscription, two diamond shapes, one each at the opposite south-west and north-east corners, and two shields at the opposite north-west and south-east corners. The arrangement of the indents in this strongly suggests that it is the one described by a number of the antiquarians as being that of Margaret Gilbert with the central inscription on the brass reading *'Here lyeth the body of Margery the daughter of William Gilberde, Esq., who was married to John Daundy Gent., by whome she had issue one daughter Alice the late wife of George Royle and after married to John Drury Esq. she died the ... day of March, Anno Domini 1618'* (Nunn 2004?, p.4). It was also recorded that one of the brasses carried a shield of arms showing Dandy impaling Gilbert and a brass shield fitting that description (Plate 5) was recovered from the loose earth under the pews immediately to the west of the stone (retained for conservation by Ipswich Historic Churches Trust). The shield, with its three fixing rivets, exactly fitted the north-west indent in the ledger stone. The

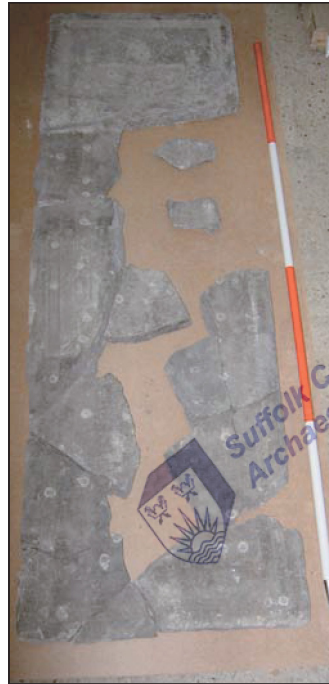
**Fig. 4 & Plate 6** The Edmund Daundy ledger stone

— EDMUND · DAUNDY ·  
— 1515 —  
— TOMB STONE —  
(1888)

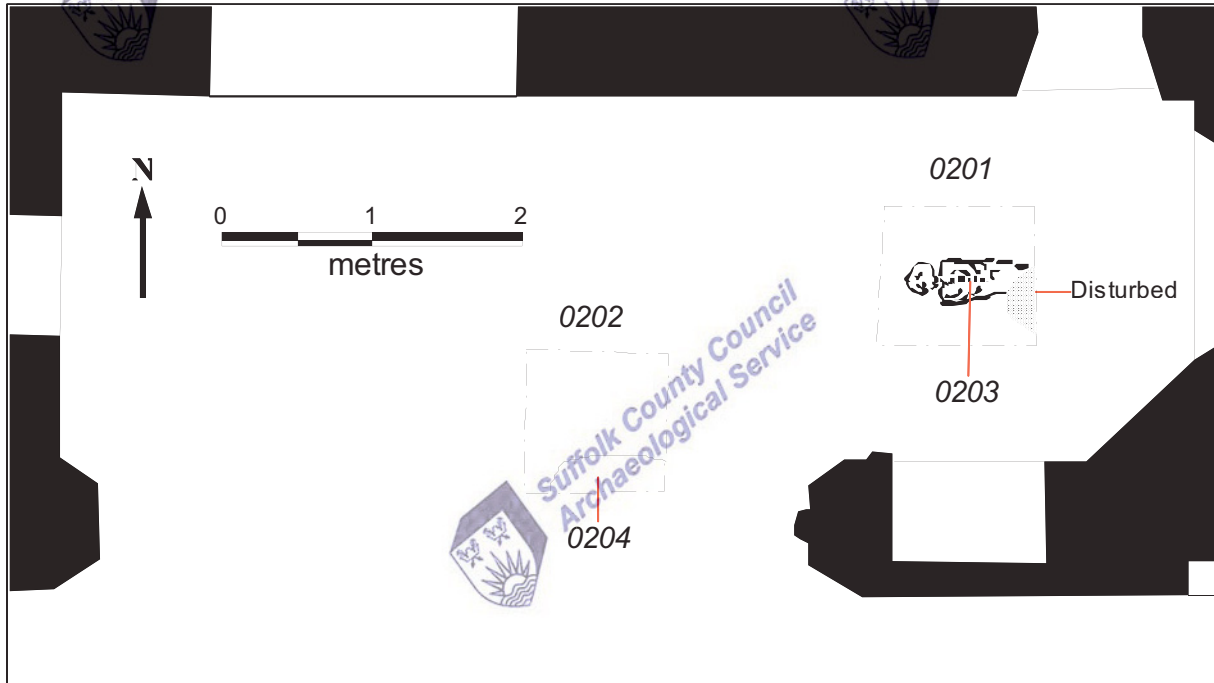
**Fig. 5** 1:50 scale plan, vestry inspection chamber excavations

Two inspection chambers (0201 & 0202) were excavated in the vestry area (Fig. 5) by the archaeologists, essentially as an evaluation exercise to provide evidence that would indicate whether other groundworks associated with project had any serious archaeological implications.

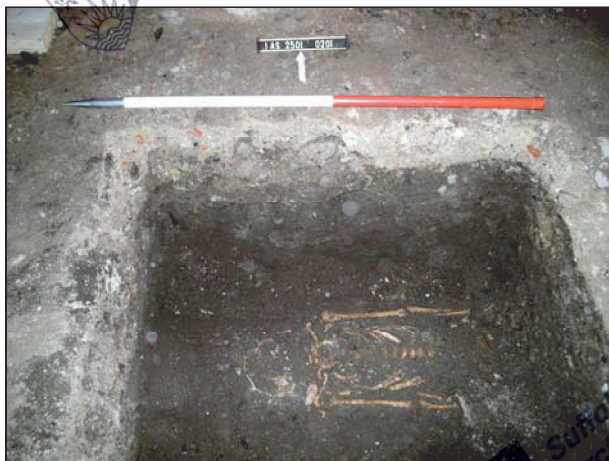
**Plate 7** Pit 0201, articulated skeleton 0203

Evaluation pit 0201 was located towards the eastern end of the vestry (Fig. 5). Following the removal of c.0.05 – 0.10 metres of mixed rubble and mortar (0205), a layer extending over the majority of the vestry and thought to represent the base for a tile floor, a uniform fill (0206) was encountered throughout the pit which continued down beyond its excavated base at a depth of 0.50 metres (Fig. 6). Fill 0206 comprised mixed dark brown loam and pale brown clay. Finds included bone (disarticulated human & animal), Ceramic Building Material, oyster shells and pottery. The CBM was discarded and the bone was reburied on site.

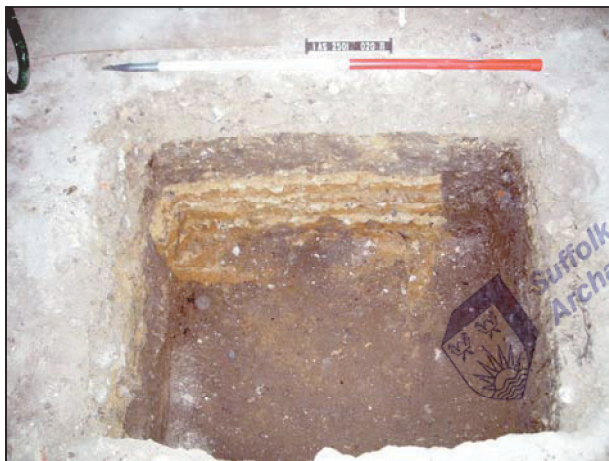
**Plate 8** Pit 0202, south side, footing 0204

Pit 0202 was located towards centre of the south side of the vestry (Fig. 5). At this juncture the mixed rubble and mortar layer (0205) was found to be a uniform 0.18 metres thick throughout the trench and overlay c.0.15 metres of pale brown sandy clay and rubble (Plate 8 & Fig. 7).

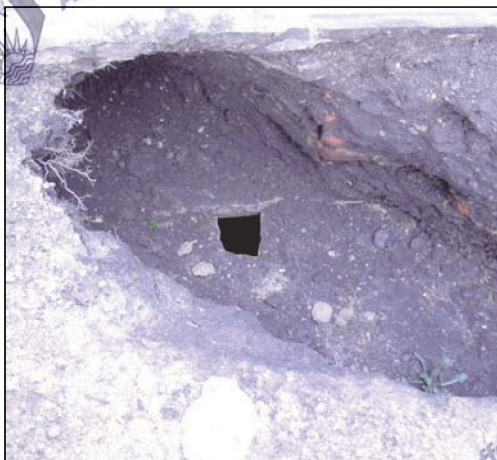
**Plate 9** York Stone tomb lid

- A tomb was encountered in a trench excavated to the north of the vestry to accommodate a drain pipe (Plates 9 & 10). The York Stone slabs covering the tomb (Plate 9) were uncovered at a depth of 1.06 metres below the existing ground surface under an overburden comprising 0.20 metres of paving and its associated underlying bedding layer and 0.86 metres of dark brown sandy loam churchyard soil. The tomb itself was constructed in red-brick and continued down for 0.94 metres, enough to accommodate two coffins stacked on top of one another. Degraded wood from a coffin lay on the base of the tomb (Plate. 10). Courses of brick at the top of the tomb were removed to allow the pipe to be inserted without disturbing the burials below.

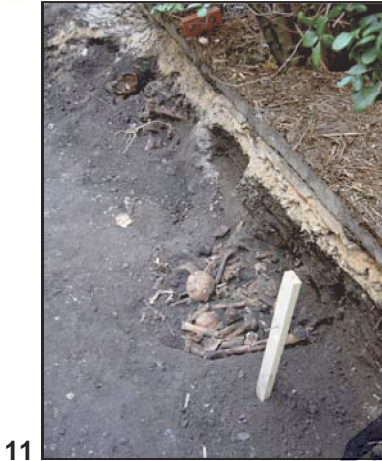
- While reducing the level of an 8.00 metre by 3.50 metre area to the north of the vestry by c.0.50 metres, two charnel pits were uncovered against the northern boundary of the churchyard. These were located on a ground plan and recorded photographically (Fig. 8 & Plates 11 - 13). The deposits were left *in situ* with the few bones that were above the formation level reburied in the immediate vicinity along with disarticulate material recovered from the removed overburden. The skeletons almost certainly represent burials disturbed during the excavation of later graves and tombs.

**Plate 11** Charnel pits from the south-east

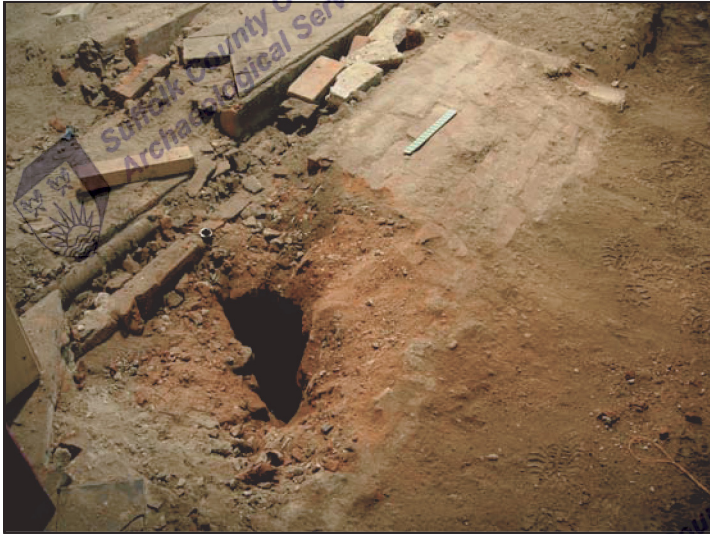
- The arched top of a 1.60 metres wide by 2.10 metres long brick built tomb was encountered in the north-east corner of the nave while reducing the floor level and removing the existing Victorian heating pipe conduit (Fig. 8 & Plates 14 - 16). Observations made through the small breach made in the arched roof suggested that the occupants had been removed, probably during the construction of the brick base to the pulpit, the latter recorded cutting the eastern end of the tomb and continuing on down to the top of a York Stone slab forming a ledge across the eastern end of the tomb. A single leg bone (femur) could be seen lying, along with some tin-plate coffin furniture, on the stone ledge. The ledge itself would probably once have continued for the full length of the tomb, forming a lower chamber and an upper chamber to accommodate multiple burials. A pile of rubble and earth lay at the western end of the tomb. As the tomb roof was intact it can only be assumed that this material was also a product of the disruption caused by the insertion of the pulpit base to the east.

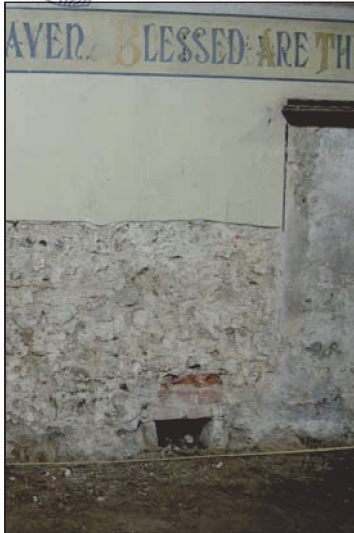
**Plate 17** Nave north wall,  
brick air vent at base of wall

The wall itself exhibited little of archaeological interest. Clearly there had been some minor patching of the plaster locally, and there was evidence of various phases of paint wash. A strip of plaster to the east of the north door had been removed completely exposing the coursed flint wall behind. Later insertions included brick built ventilation holes at the base of the wall (Plate 17) and the blocking fabric of two unidentified rectangular features, one each on the north and south walls (Plate 18).

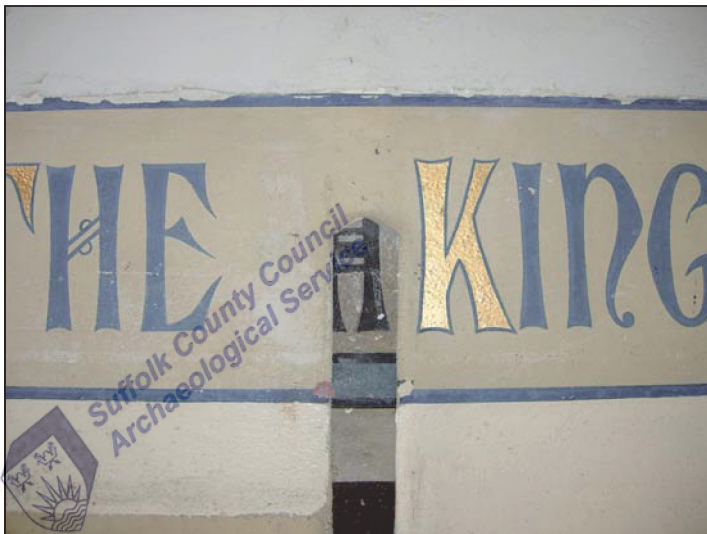
**Plate 19** Nave south wall, two  
phases of text

The Beatitudes text had replaced an earlier version of the same, a less colourful scheme which could be seen underlying the present text at locations where wooden fittings had been removed (Plate 19).

It has been suggested that the earlier text was that described by Davy in his visit of 1825 (Nunn 2004?, p.12) which was subsequently, in the later 19<sup>th</sup> or early 20<sup>th</sup> century, replaced with the text that survives to this day. However, his description is suggestive of more widespread texts over the walls rather than the localised strip that accommodates The Beatitudes.

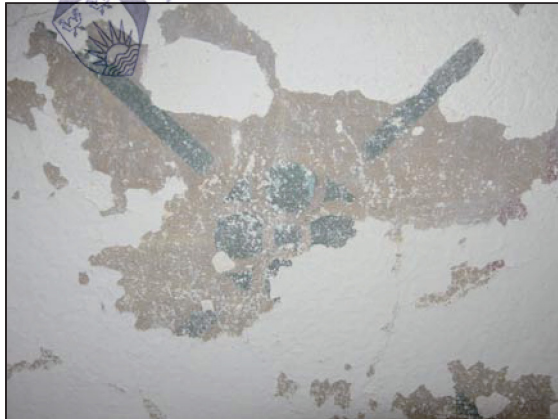
Plate 20 Wall painting, geometric design

During conservation work undertaken on text above the nave side of the chancel arch, reading *'Let thy priests be clothed with righteousness and let the saints sing with joyfulness'*, vestiges of earlier, wall paintings were found. Two phases of painting were recognised; a geometric design consistent with a Victorian date (Plate 20), which appeared to have covered the whole wall and an area of fabric painted in red and black, possibly a garment or hanging, adjacent to the arch itself (Plate 21).

While not easy to date, the fabric painting was clearly earlier than the geometric design and the plaster on which it had been applied could be seen to predate that further away from the arch and there was with a distinct junction between the two phases. A medieval date is possible for this painting and indeed, there is record (Nunn 2004?, p.2) that the internal walls of the nave and chancel were covered in allegorical pictures.

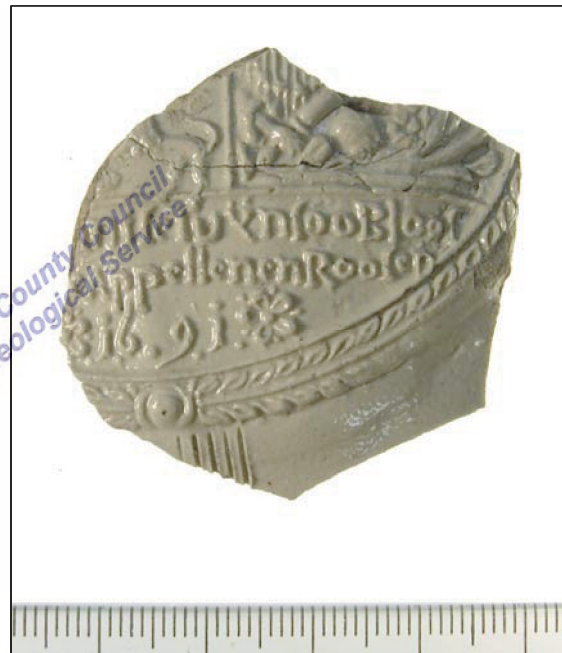
**Plate 22** Unstratified stoneware sherd

A single sherd of decorated Rhenish stoneware was present (0200) (Plate 22). It is made of a monochrome light grey salt-glazed stoneware (either Westerwald or Raeren), and has the remains of an applied medallion. Although fragmentary, sufficient details of the medallion survive to be able to identify the inscription and the lower part of the portrait. The sherd shows part of a double portrait of William III (1650-1702) and Mary Stuart (1662-95), co-regents of England. More complete examples show them both in their coronation robes (Gaimster, 1997, Catalogue 120, left, 264). The full inscription beneath the portraits could be translated 'In our Dutch garden blooms oranges and roses... 1691' (Gaimster 1997).

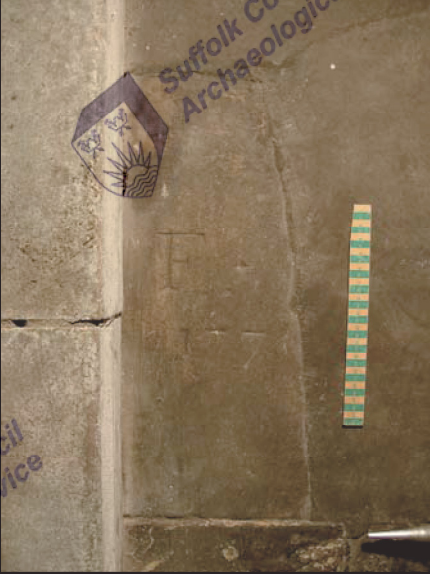
No.	Inscription	Notes	Photograph
Ledger stones in chancel, upper pavement			
1.	<p>F + .... 177....</p>	<p>Ledger fragment, partial inscription. c.0.25 x 0.6 metres North towards bottom of photo.</p>

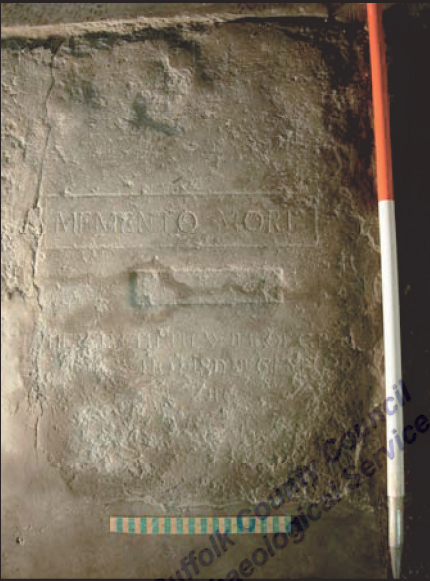
2.	<p>[MEMENTO MORI]</p> <p>[ ]</p> <p>HERE LYETH THE WIFE OF G... WHO DIED DECEMB... 1610</p> <p>Previously incorrectly transcribed by Grimsey as</p> <p>HERE LYETH THE BODY OF GEORGE DOWNING WHO DIED DECR. 1610</p>	<p>Incomplete ledger stone, includes small rectangular indent for a brass. 0.9 x 0.6 metres North towards right of photo.</p>

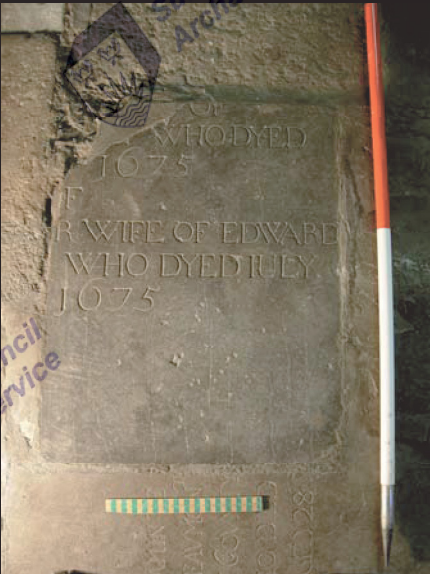
3.	<p>...OF ...WHO DYED ...1675 ...F ...R WIFE OF EDMUND ...WHO DYED JULY ...1675</p>	<p>Incomplete ledger stone. 0.6 x 0.75 metres North towards top of photo.</p>

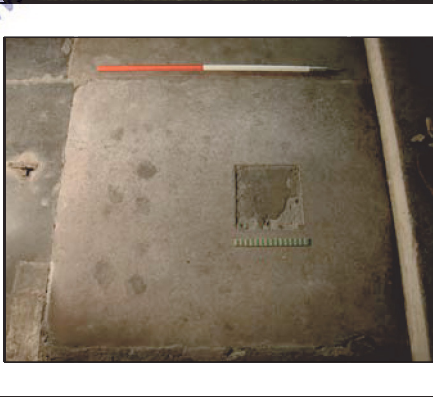
5.	None	<p>Complete ledger stone with small square (0.28 x 0.28 metres) indent for brass (Copping, see text). No inscription. Continues under steps of the sanctuary to the east.  1.2 x 1.4+ metres.  North to the top of the photo</p>

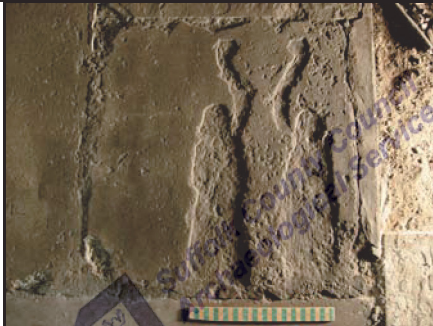
6.	None	<p>Incomplete ledger stone. Has indent for brasses, two figures and decoration above.  0.6 x 0.6 metres.  North to bottom of photo.</p>

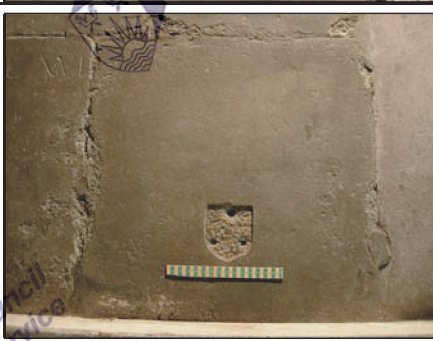
7.	None	<p>Complete? ledger stone continues under step of the sanctuary to the east. One indent for brass (John Moore, see text).  Davy 42?  0.8 x 0.75+ metres  North towards right of photo.</p>

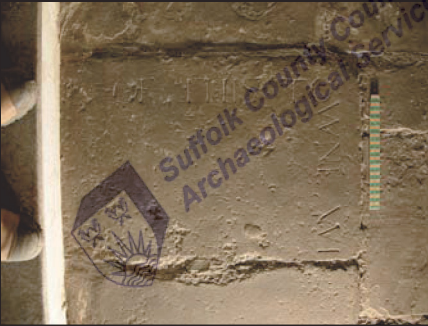
No.	Inscription	Notes	Photograph
8.	...OF THIS TOWNE WI...	<p>Incomplete? ledger stone. Continues under steps of sanctuary to east.</p> <p>0.75 x 0.55+ metres.</p> <p>North towards bottom of photo.</p>

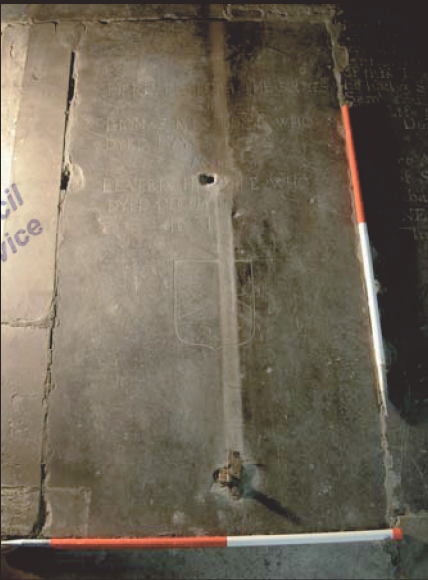
9.	<p>HERE RESTETH THE BODYES OF THOMAS IVES GENT WHO DYED MAY 5 1662 AND BEATRIX HIS WIFE WHO DYED DECEM 16 1631</p>	<p>Complete ledger stone. Holes inserted for rail.</p> <p>Heraldic shield below inscription includes a negro's head</p> <p>Davy No 13</p> <p>1.02 x 1.95 metres</p> <p>North towards right of photo.</p>

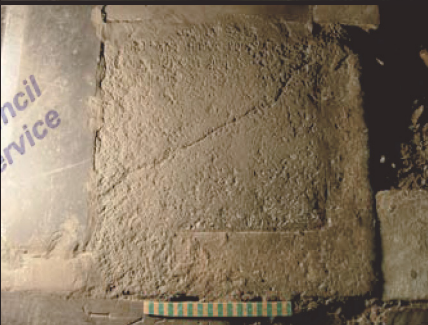
11.	Illegible	<p>Incomplete stone, rebated border with illegible script in internal panel.</p> <p>0.5 x 0.6 metres</p> <p>North towards right of photo.</p>

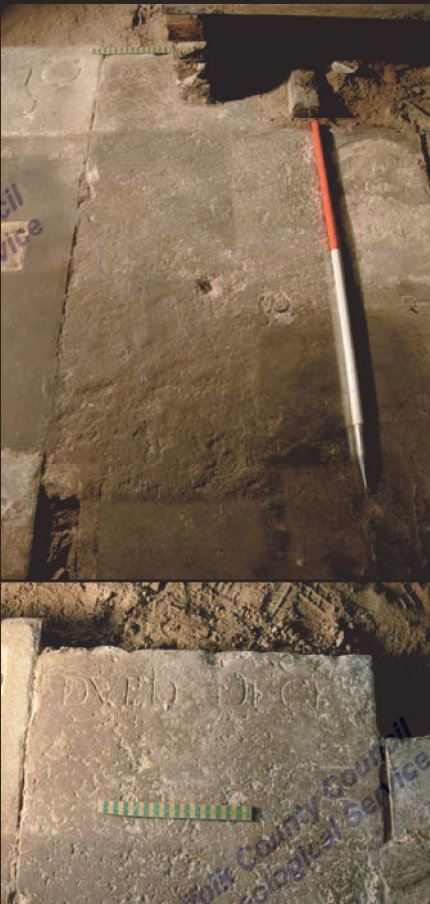
14.	None	<p>Complete ledger stone. Includes indent for five brasses. One almost certainly for the shield recovered during site works.</p> <p>Davy 17?</p> <p>1.82 x 0.84 metres</p> <p>North to right of photo</p>

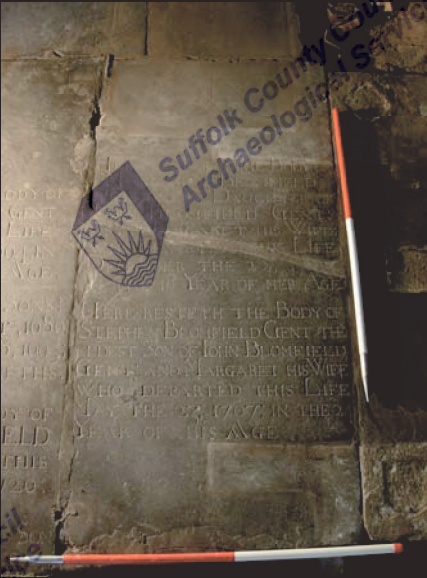
No.	Inscription	Notes	Photograph
15.	<p>HERE RESTETH THE BODY OF MARGARET BLOOMFIELD, THE ONLY DAUGHTER OF JOHN BLOOMFIELD GENT: AND MARGARET HIS WIFE: WHO DEPARTED THIS LIFE DECEMBER THE 22,... IN THE 18 YEAR OF HER AGE</p> <p>HERE RESTETH THE BODY OF STEPHEN BLOOMFIELD GENT: THE EDEST SON OF JOHN BLOOMFIELD GENT: AND MARGARET HIS WIFE: WHO DEPARTED THIS LIFE MAY 23, 1707; IN THE 24 YEAR OF HIS AGE</p>	<p>Complete ledger stone, but cracked. Heraldic square above inscription. Date lost in crack</p> <p>Davy No. 10</p> <p>1.88 x 0.92 metres</p> <p>North towards right of photo.</p>

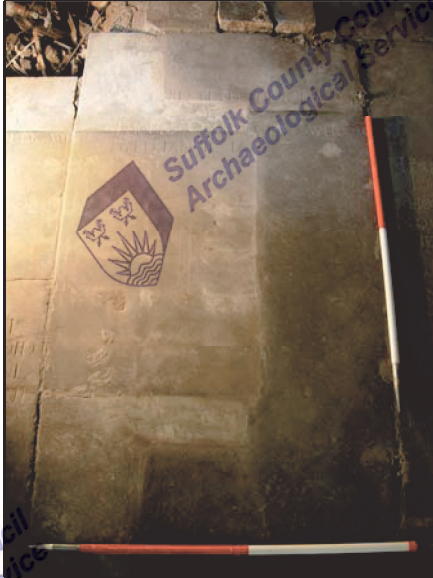
No.	Inscription	Notes	Photograph
17.	<p>HERE RESTETH THE BODY OF THOMAS CLARKE GENT WHO DYED JAN' 11 1667</p>	<p>Complete ledger apart from small fragment missing from north end of western side.</p> <p>2.03 x 1.15 metres</p> <p>North to right of photo.</p>

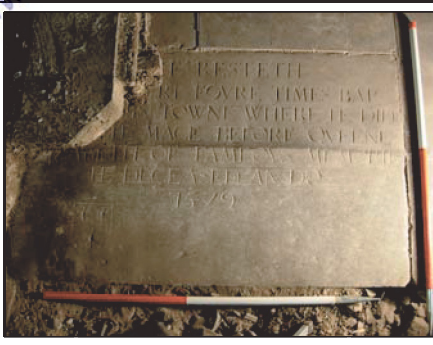
18.	<p>HERE RESTETH JEFFRY GILBERT FOVRE TIME BAI LIF OF THIS TOWNE WHERE HE DID BEARE THE MACE BEFORE QUEENE ELIZABETH OF FAMOUS MEMORIE HE DECEASED AN DO 1579</p>	<p>Complete ledger stone, continues under internal step of priest's door. Heraldic shield bottom left (three birds).</p> <p>Davy No. 20</p> <p>1.45 x 0.88 metres</p> <p>North to right of photo</p>

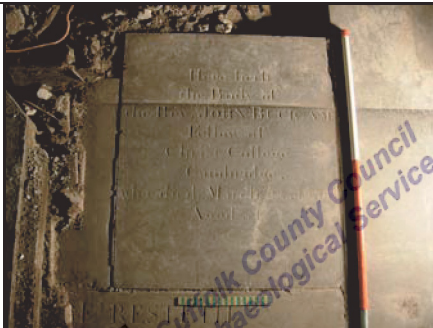
19.	<p>HERE LIETH THE BODY OF THE REV<sup>D</sup> JOHN BUCK. A M FELLOW OF CHRIST COLLEGE CAMBRIDGE WHO DIED MARCH 28<sup>TH</sup>. 1858 AGED 51</p>	<p>Complete ledger stone.</p> <p>0.78 x 0.90 metres</p> <p>North to right of photo.</p>

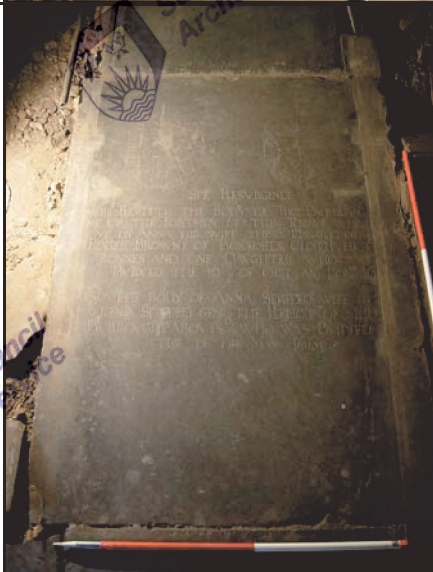
20.	<p>/ denotes end of line</p> <p>SPE RESVRGENDI HERE RESTETH THE BODY OF THO: BURROUGH/ ONE OF THE PORTMEN OF THIS TOWNE WHO LEFT/ ISSUE BY ANNA HIS WIFE THE 2<sup>D</sup> DAUGHTER OF/ ROGER BROWNE OF BOXFORDE CLOTHYER TWOE/ SONNES AND ONE DAUGHTER WHO WAS/ BURYED THE 16<sup>TH</sup> OF OCT: AN<sup>O</sup> DOM 1665</p> <p>ALSO THE BODY OF ANNA STISTED WIFE OF/ LAVRENG SISTED GEN<sup>T</sup> THE RELICT OF THO: / BURROUGH ABOVE<sup>D</sup> WHO WAS BURYED/ THE 12<sup>TH</sup> OF MAY 1668</p>	<p>Complete ledger stone. Two heraldic shields above (see detailed photos on next page).</p> <p>2.04 x 1.44 metres</p> <p>North to right of photo</p>

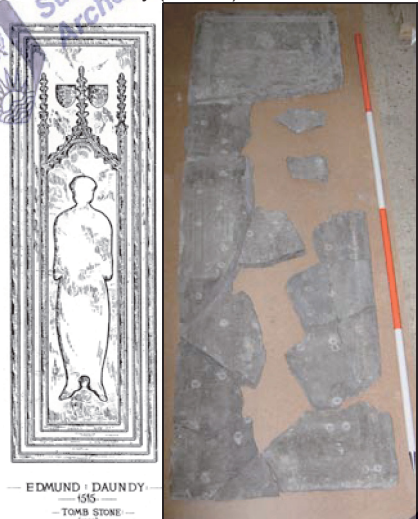
<p>The broken ledger stone of Edmund Dandy (Daundy). Canopy above head still in place. Other fragments then collected &amp; reconstructed.</p> <p>Davy No. 18</p> <p>Figure in brass with text border.</p> <p>North to right of photo</p>

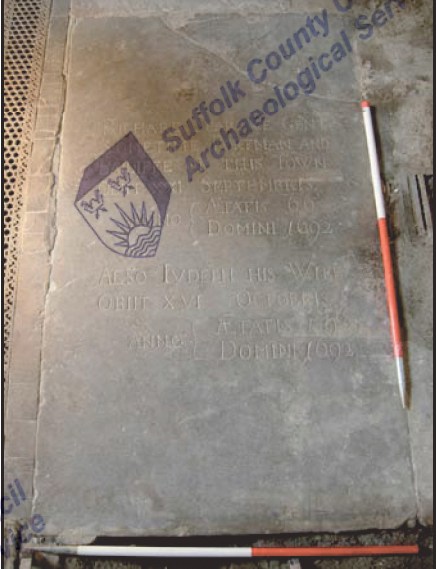
<p>RICHARD SPAROWE GENT SOMETIME PORTMAN AND BAILIFFE OF THIS TOWN OBIIT XXI SEPTEMBRIS</p> <p>ANNO {ÆTATIS 66 {DOMINI 1692</p> <p>ALSO JUDETH HIS WIFE OBIIT XVI OCTOBRUS</p> <p>ANNO {ÆTATIS 59 {DOMINI 1692</p>	<p>Complete, but cracked ledger stone.</p> <p>Davy No. 40</p> <p>1.14 x 1.98 metres</p> <p>North to right of photo</p>

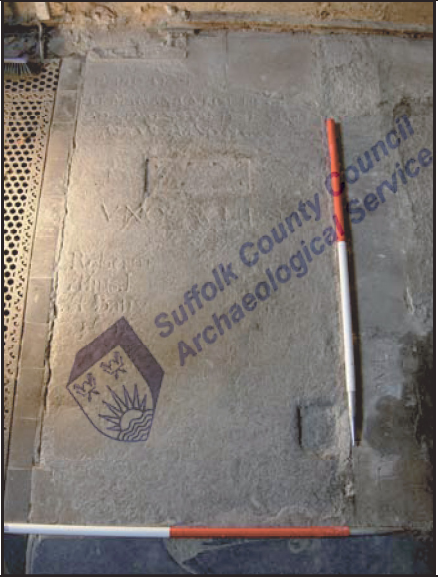
<p>Incomplete ledger stone. Indent for central rectangular brass and two heraldic shields below.</p> <p>1.5 x 0.8 metres</p> <p>North to right of photo.</p>

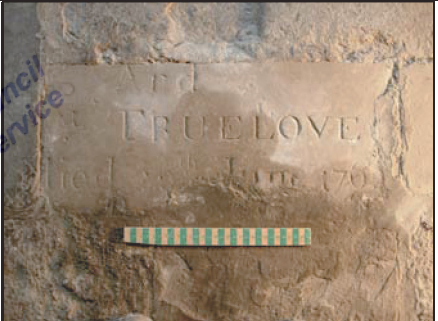
<p>Incomplete ledger.</p> <p>Part of Davy No. 41</p> <p>0.25 x 0.58 metres</p> <p>North to bottom of photo.</p>

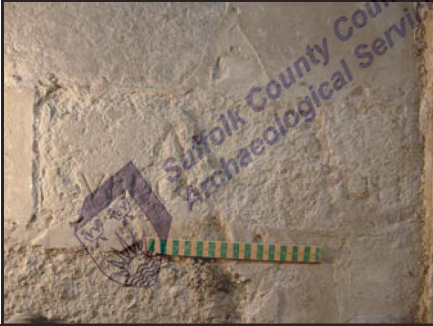
No.	Inscription	Notes	Photograph
27.	V...	Ledge fragment, illegible text.  0.23 x 0.65 metres  North to bottom of photo.

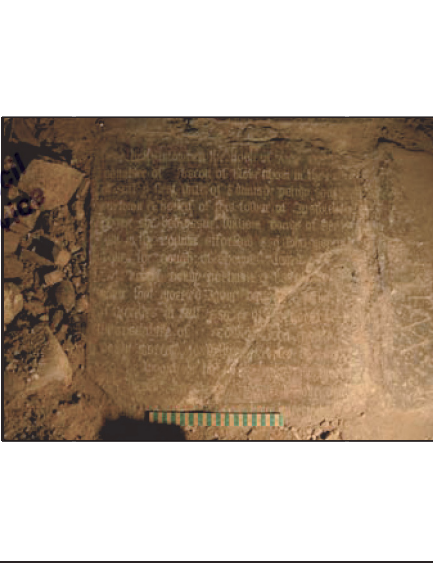
30.	<p>Transcribed with help from John Blatchly / denotes end of line. The last three lines are by no means certain.</p> <p>HERE LIETH INTOMBED THE BODY OF ANN D[ANDY]/ DAUGHTER OF BACON OF BLAKENHAM IN THE COUNTY/ OF SUFF: YE FIRST WIFE OF EDMUND DANDY SOMETIME/ PORTMAN &amp; BAILIEF OF THIS TOWNE OF IPSWICH BY/ WHOME HE HAD YSSUE WILLIAM DANDY OF CRETING-/HAM IN THE COUNTY AFFORSAID ESQ WHO MARRIED AGNES THE DAUGHTER OF THOMAS ALVARD OF IPSWICH/ ESQ. ROBERT DANDY PORTMAN &amp; BAILIEF [OF IPS] / WICHE THAT MARRIED JONE DAUGHTER OF [WILLIAM] / READE OF BECKLES IN SUFF:ESQ/ THE DAUGHTER OF SAID JOHN? DANDY.../ DANDY MARRIED IN.../...BY.../...KEEPER.../ ...GOD HAVE MERCY</p>	Incomplete ledger stone.  0.65 x 0.65 metres  North to right of photo.

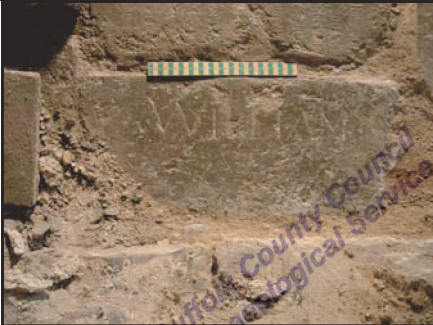
31.	WILLIAM	Incomplete ledger stone.  Poss. part of Davy No. 12 (circumscription)  0.32 x 0.65 metres  North to bottom of photo

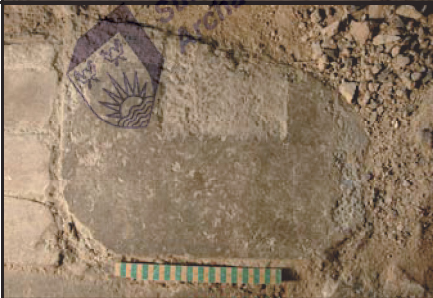
33.	None	Incomplete ledger stone. Indent for brasses, two figures.  0.6 x 0.36 metres  North to right of photo
