ARCHAEOLOGICAL MONITORING REPORT

St Mary's Bridge, Needham Market NDM 021

A REPORT ON THE ARCHAEOLOGICAL RECORDING, 2008

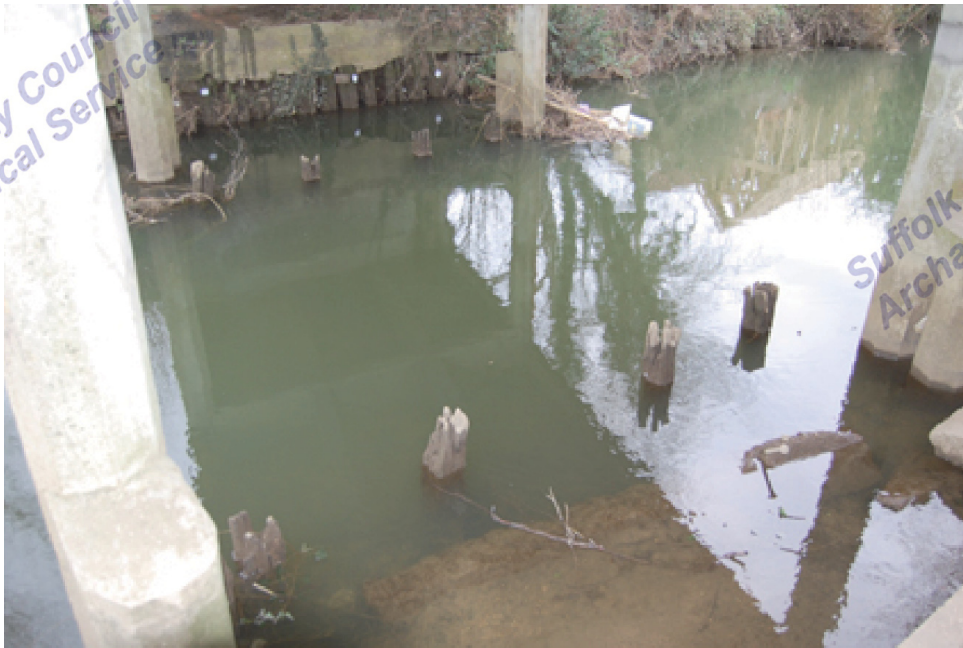
Figure 2. Timber piles of the 1790's bridge below the present concrete bridge (built 1922)

Part of the brickwork of the original 1790 bridge can be seen beneath the existing present structure. The dates of the timber that project out of the water and are partly encased in concrete are highly likely to be contemporary with the construction of the original bridge.

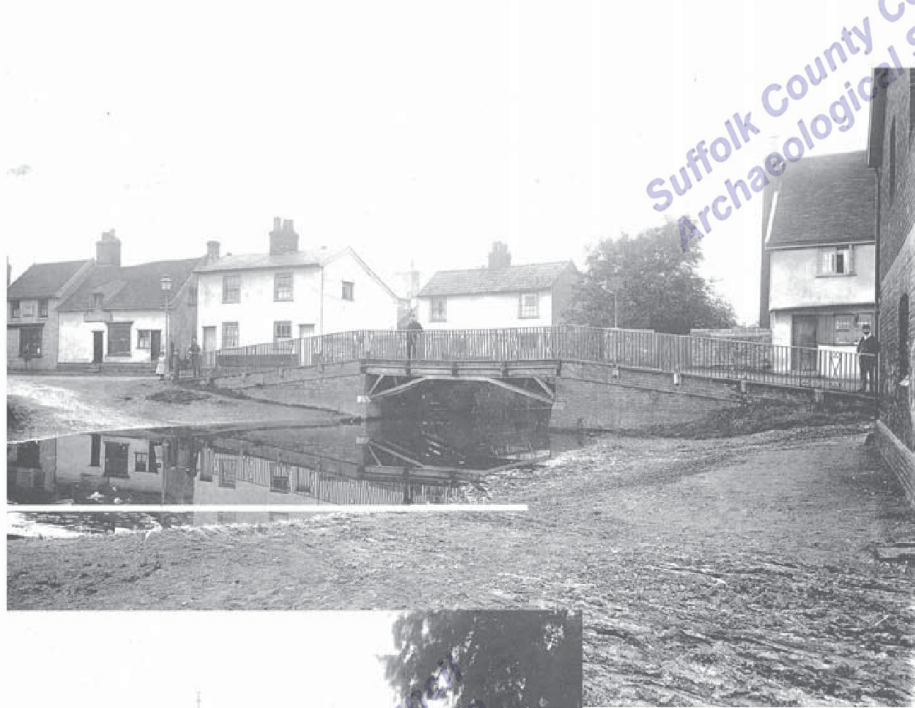
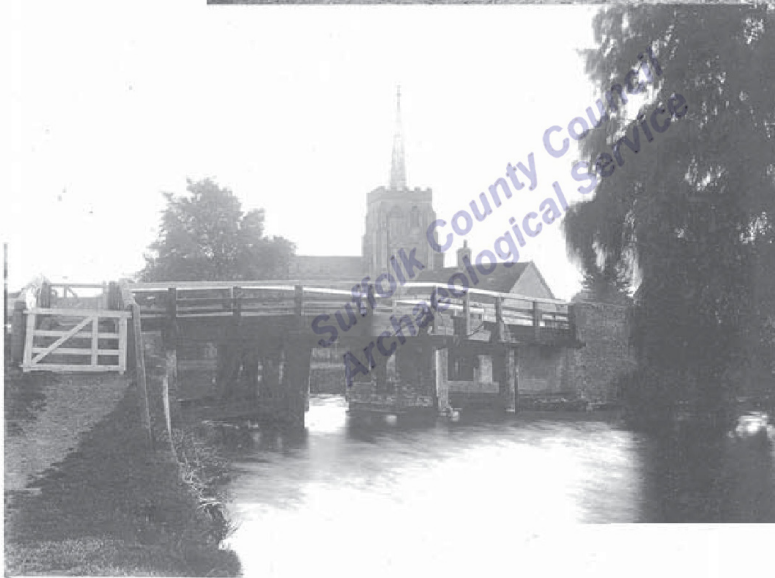
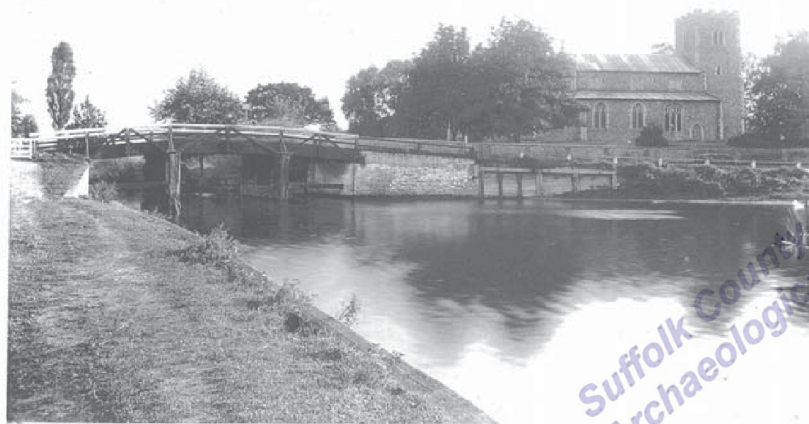
Figure 5. Bridges over the Gipping Navigation, taken as part of the legal dispute 1890-97
(From the top the bridges at Stowupland, Bramford and Sproughton)

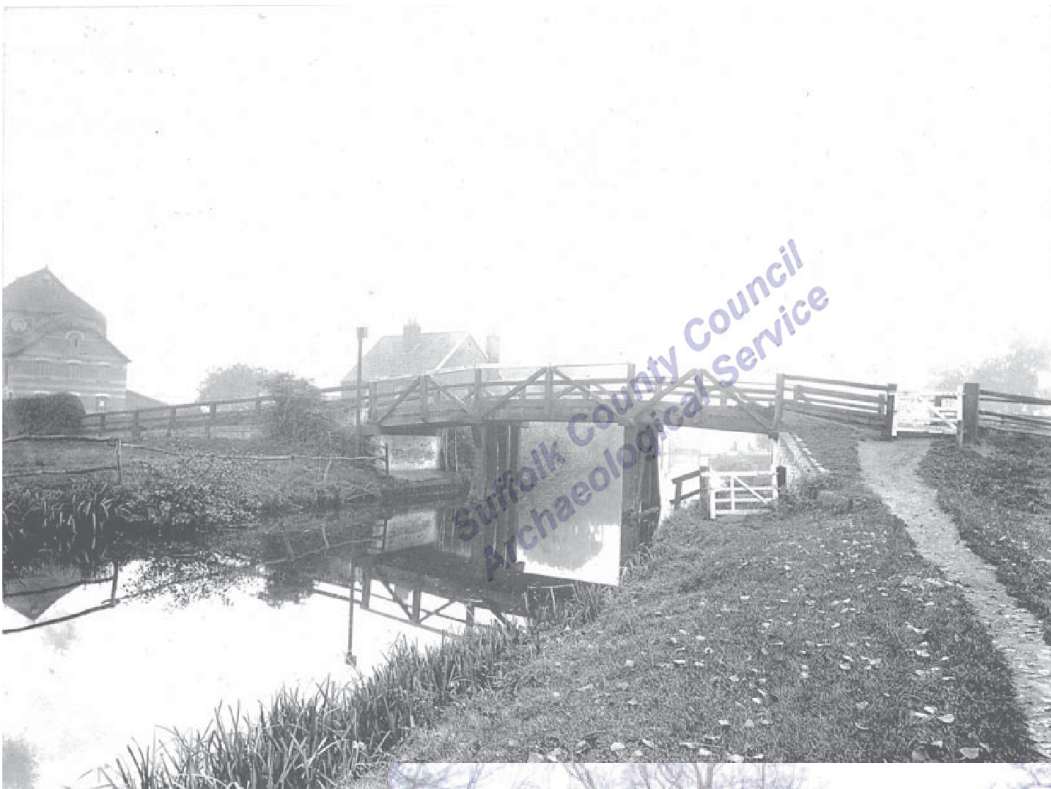
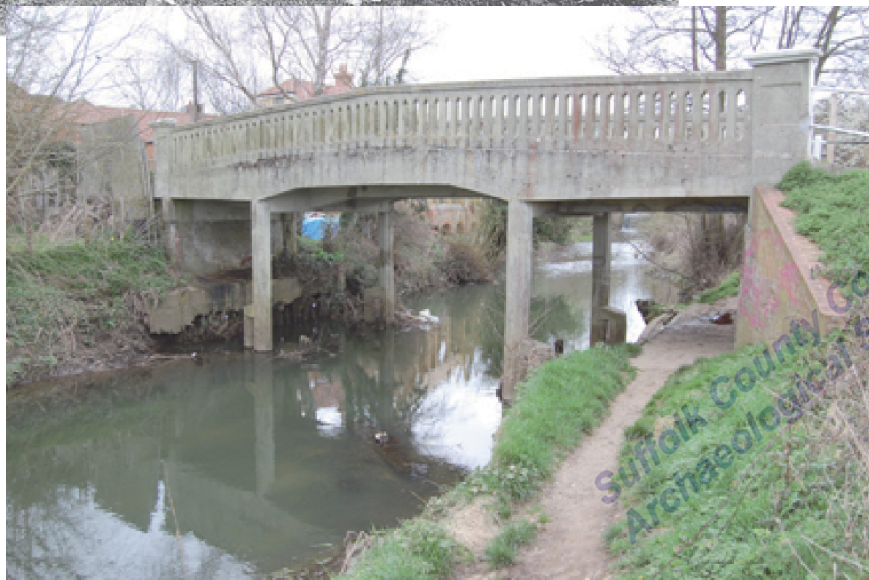
Figure 6. The C18th St Mary's Bridge (photographed for the legal dispute 1890-97) and the concrete bridge constructed 1922 (photographed prior to the start of work (2008)

There is a photograph of 'Needham Bridge' in a file of photographs (Fig. 6, ref. A808/5/1.28) prepared as part of a legal dispute between East Suffolk County Council and the Ipswich and Stowmarket Navigation 1890-97 (ref. A808/5/1). The file includes photographs of the Pickerel or Stowupland Bridge and Ford, Sproughton Bridge, Needham Market Bridge '*over the new cut*', Bosmere Bridge, and Bramford Bridge. Apart from the Pickerel Bridge each of the other bridges appears to have been constructed to a similar pattern.

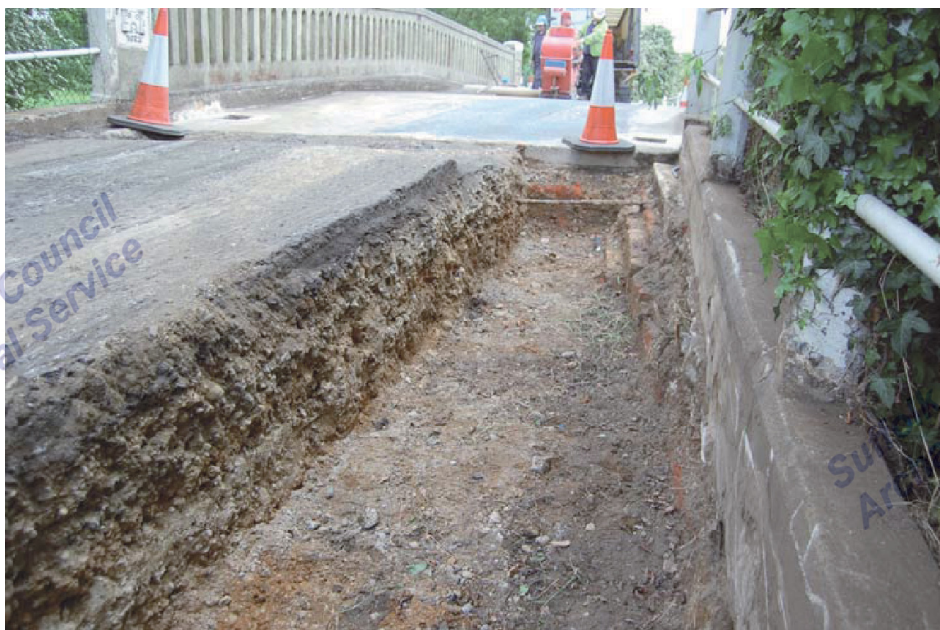
Figure 9. Trench showing road make-up and south wall of the west abutment

To support the construction of the bridge abutments, the riverbank below the bridge has been built up with layers of gravels, loose brick rubble, dumps of lime mortar and topsoil. These are held in place on the west bank behind a revetment of rectangular-section timbers driven vertically into the riverbed. This projects forward of the general line of the river bank across the width of the abutment and can be seen in the plan of the revetment timbers (Fig. 6). Above the water line the timbers have rotted so that they no longer effectively retain the soil, which has been eroded away creating a void, but below the water they still have their original dimensions and butt closely together. The revetment timbers were described as old railway sleepers in an engineer's report in 1837 suggesting that they are later than the original bridge. The top of the timbers have been capped with concrete which conceals the relationship between an apron of horizontally laid bricks and the top of the revetment timbers. Casting marks of the horizontal shuttering boards can be seen on the surface of the concrete. Projecting from the west bank are a row of three long, hand-wrought iron pins. These are square headed with washers and pass between the timbers and, at the south end, through the concrete. The pins are thought to be part of the temporary works associated with the manufacture of the concrete embankment and bridge in 1922.

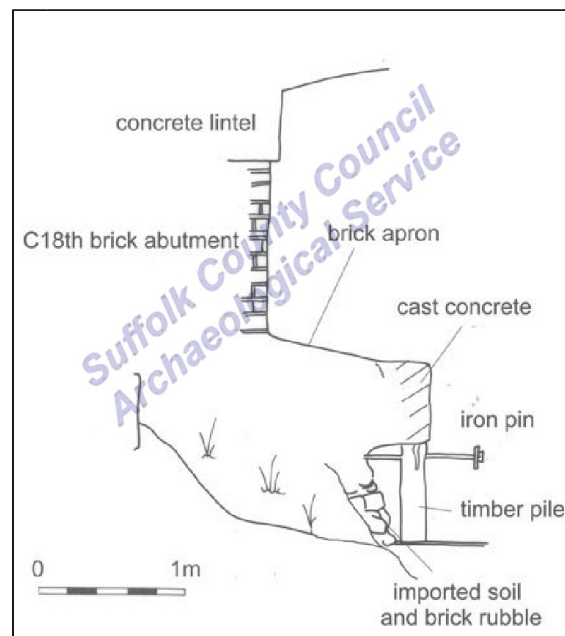
Figure 10. Profile of the west abutment and the revetment

Miller also observes 'the quaying on the right bank under the bridge is constituted of old railway sleepers' suggesting that the revetment recorded on the west bank was not part of the original 1790 structure. The identification of the source of the wood may be spurious; the railway company did take over the lease of the navigation and carried out repairs but this was not until 9 years after Miller's comments.

Examination of the bricks show that the brick abutments are a single build. They are probably original to the 1790's structure and are unchanged from the photograph of the bridge taken in 1890's. The bricks are *c.*1" longer and wider than might be expected for a house brick of the period but are similar in size to the bricks used in the construction of the brick arched bridge at Semer built in 1781 (Duffy 2004). The Navigation minute books beginning on 19 April 1790 (ref. EM 400/2) ordered that all the bricks used in the construction of locks and bridges should be '*made and burnt as near as may be possible to the places where wanted*'. This demonstrates that the bricks are custom made and suggests that 'outsized bricks' are being used in the construction of bridges.
