# ARCHAEOLOGICAL SERVICE

## St. James Leper Hospital, Dunwich (DUN 005, SAM Suffolk 40); Building Recording Report

SCCAS Report No. 2008/180; Oasis No. suffolkc1-45624

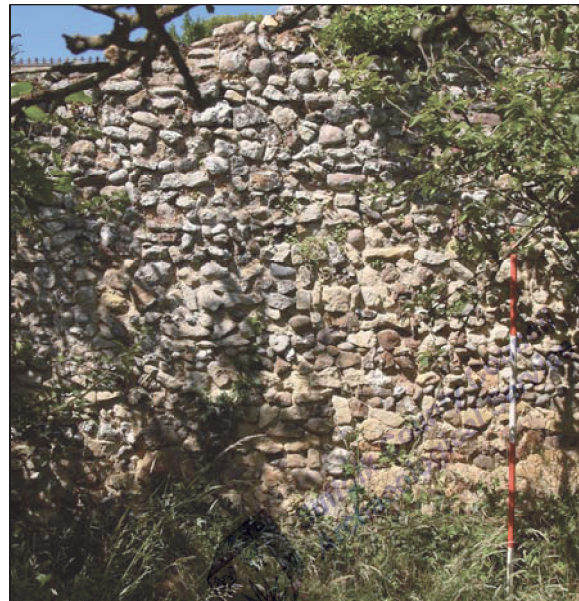
Plate 1 Representative area of chancel external wall fabric

Due to the presence of trees and other vegetation in the garden to the south of the chapel, it was impossible to take clear photographs of the wall which could be used to construct an elevation. However, all of the visible above ground fabric (0053) of the chancel and nave/hall at this juncture is a rebuild, the equivalent to internal fabric 0048 described above. A projecting ledge (0054) intermittently encountered at the base of the wall, but obscured by vegetation, may represent the stub of the original wall upon which 0053 was constructed.

The external facing fabric (0053) comprises c.45% Caen Limestone fragments, some architectural, c.45% rounded flint beach cobbles and c.10% exotics (Plate 1). The clasts are closely spaced and essentially randomly laid, although hints of horizontal coursing were locally present. This fabric has not been repointed. A photograph showing a representative sample of this fabric is presented as Plate 1.

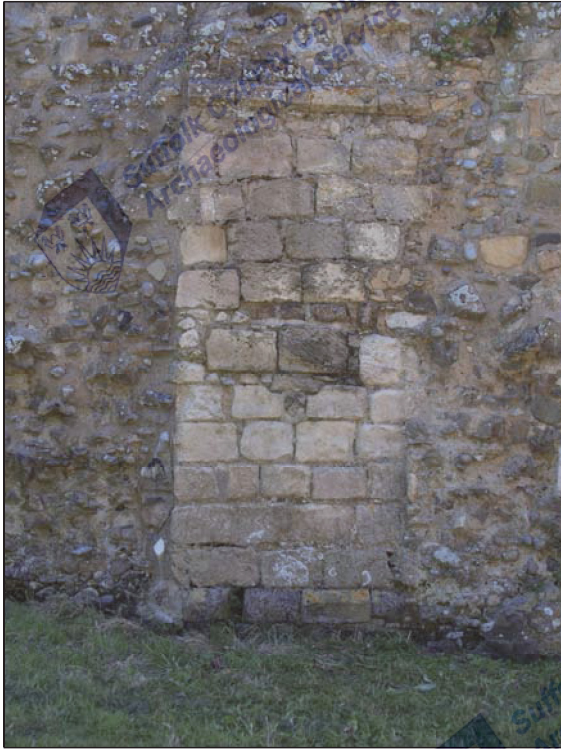
Plate 2 Apse ashlar fabric 0034 with putlock hole 0035

Ashlar facing survived in three areas at the base of the wall with a string course (0080) above. The first (0034), on the north side adjacent to its junction with the chancel was previously described with the north chancel wall (Plate 2). The straight vertical edge on the eastern side of 0034 coincides with the location of a pilaster on the Kirby drawing (Fig. 8) and the Wilkins groundplan published in *Archaeologia* (Fig. 10) and lies directly opposite surviving pilaster 0083 on the south wall. The second area (0079) of original ashlar facing was below the east window opening, extending round as far as the north window opening, while the third area (0086) was west of the northern window opening. The ashlar facing was well coursed with gaps between the blocks locally galletted with small pieces of limestone (Plate 3). While the repointing with 'Ancient Monuments' mortar had obscured the evidence in the original fabric for the location of lift-lines, their presence could be inferred from the increased galletting along certain joints. One putlock hole (0085) was recorded close to the ground at the eastern end (Plate 3) at a similar level to putlock hole 0035 in ashlar fabric 0034 on the north side of the apse.

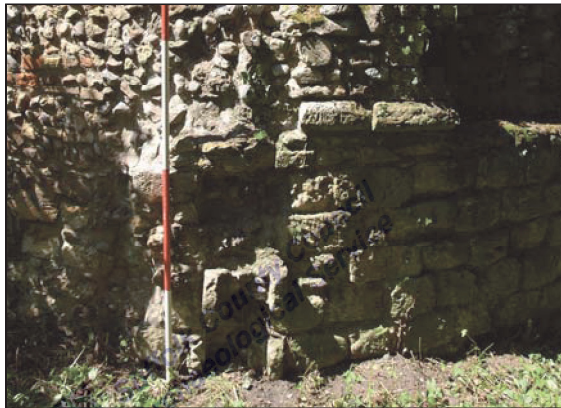
Plate 5 Pilaster 0082

Architectural features associated with the ashlar facing included the vestiges of three pilasters, one (0081) immediately south of the east window opening, another (0082) immediately east of the south window opening and the third (0083) immediately to the west of the southern window opening (Fig. 2 & Plates 4 – 6 respectively). Projecting ashlar blocks (0087) to the west of pilaster 0083, just visible in the top left hand corner of Plate 6, mark the junction of chancel, to the west, with the apse, to the east.

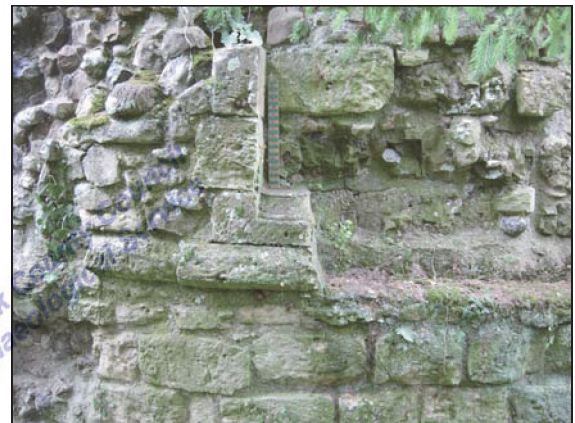
Plate 7 Blind window/niche 0084

In addition, the base for a shaft and part of the side of a blind window/niche (0084) (Plate 7) survived above the string course between the east and south window openings. Kirby's drawing of 1748 (Fig. 8) clearly shows a similar feature between the north and east windows.

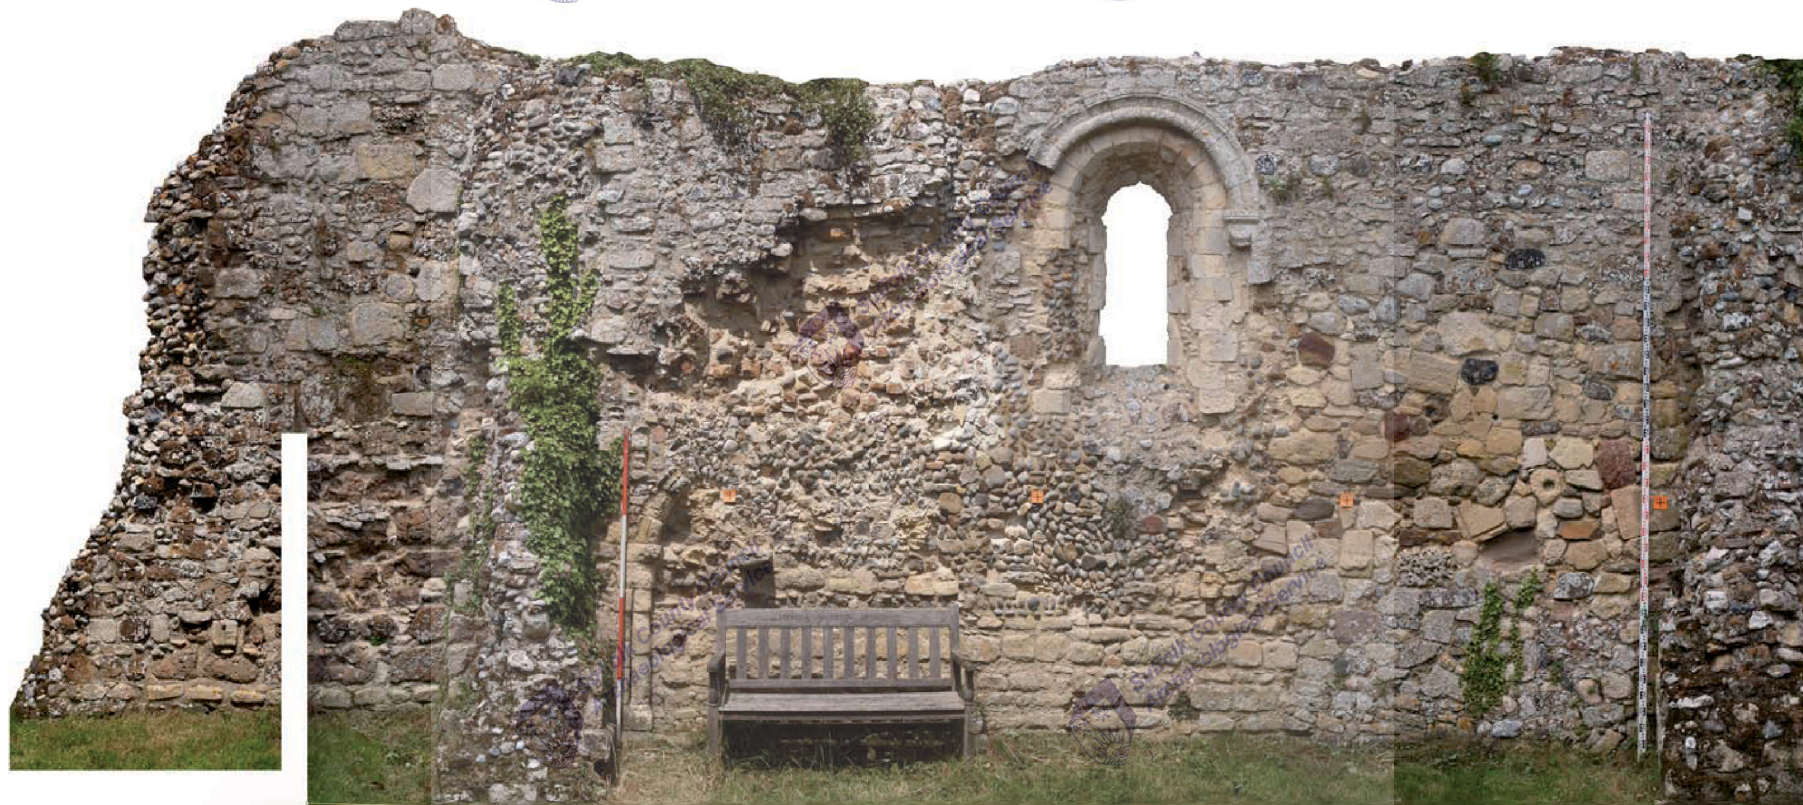
**Plate 8** North wall of Nave/Hall & Chancel (Internal); composite photograph (scale c.1:50)

The north wall survives to a maximum height of c.4.50 metres. Its c.11.50 metre length comprises c.3.00 metres of the eastern end of the nave/hall north wall, c.6.00 metres representing the entire length of the chancel and the vestiges of the two c.1.00 metres thick cross walls (0003 & 0010) that once would have accommodated the arches that dividing the nave/hall from the chancel and the chancel from the apse.

The surviving section of the north wall of the nave/hall to the west of the scar and the base of dividing wall 0003 included an area of original facing (0002) in a strip along its base and continuing up to a height of 2.00 metres in the area adjacent to dividing wall 0003. While predominantly constructed from squared septaria blocks lain in clearly defined horizontal courses, there was a course of smaller, roughly squared, pieces of limestone towards the base. Smaller fragments of a similar limestone had been used as galletting in order to level up successive courses and fill in gaps between individual septaria blocks. The wall face had been repointed with the hard gritty cementitious mortar described as possibly being that generally referred to as 'Ancient Monuments' mortar (Swann 2008, P.2) that was widely used in consolidation

of historic monuments during the middle and later of the 20<sup>th</sup> century. While obscuring any partings within the original wall mortar that would be indicative of structural lift-lines, their presence could be inferred by the differences in the thickness of the mortar bed between the courses. The facing of the wall (0001) above 0002 was entirely different in character with only rudimentary, localised, coursing with the included clasts varying from small beach pebbles through to large pieces of reused limestone masonry. These characteristics suggested that the wall facing at this juncture had been applied as part of later consolidation works. Similarly to 0002, 0001 had been repointed with 'Ancient Monuments' mortar which obscured the junction between the two phases. The exposed corework (0015) on the western end of the wall had also been repointed using the same mortar mix and consolidated with rounded beach pebbles.

Some original fabric and architectural features survive in the internal face of the north chancel wall. These include most of the semicircular arch and eastern jamb of a window (0014) and the basal plinth and a single shaft, capitol, impost block and the first three voussoirs of an arch that once formed the western end of a blind arcade that, from earlier drawings, is known to have extended along the full length of the wall and exhibited an interlaced design incorporating semicircular arches. All of these architectural features were constructed using Caen Limestone. The Caen Limestone block ashlar face (0008), forming the basal courses of the wall towards its western end, is set back from the face higher up the wall and would have formed the rear panel of the blind arcade. While predominantly constructed from Caen Limestone blocks, 0008 also incorporated a single course of septaria. Evidence for lift-lines within the original mortar was obscured by the 'Ancient Monuments' mortar. However, the location of lift-lines was inferred from the size of the joints and the presence of limestone fragments inserted as galletting to level up between lifts. Associated with 0008, there is a projecting impost block (0016) that would have supported the western side of the second arch of the interlaced blind arcade and a blocked socket (0013) that would have accommodated a protrusion on the back of a limestone block forming part of one of the shafts within the blind arcade and helping to hold it in place. Original facing (0004), albeit repointed with 'Ancient Monuments' mortar, also survives as a strip along the top of the wall. Similarly to the external wall, the upper wall face is not constructed in ashlar, but from a mix of smaller pieces of limestone, septaria, flints and occasional exotics. However, coursing is still apparent and despite the obvious incongruity with the ashlar work below, it appears contemporary with the window masonry and is consistent with the surviving upper wall of the apse. It is on this basis that it has been considered to represent original wall fabric.

To the west of window 0014, an area of original corework (0005), comprising angular fragments of septaria, with a hint of coursing, is exposed where the facing has fallen away. Where a small area of core mortar is still visible through the applied 'Ancient Monuments' mortar, which at this juncture had not been given a brushed finish, but left in a rough condition, a distinct lift-line was recorded. Immediately below this is an area of extremely rough patching (0006) comprising beach pebbles set in hard light-coloured lime mortar. To the east of 0006, is another area of patching (0007), which continues up the western jamb of window 0014, and while also comprising beach cobbles, is set in 'Ancient Monuments' mortar that in contrast to that over 0005 had been subjected to a brushed finish.

At the bottom of the eastern end of the wall, a large area of fabric (0009) is clearly not original and as it coincides with a similar area (0030) on the external face of the chancel, almost certainly represents the total rebuild of a section of wall rather than just superficial patching. This randomly laid facing comprises c.80% fragments of reused Caen limestone blocks, up to c.0.30 metres in size, with the remaining c.20% comprising exotics. The good condition of the mortar in the joints of the patched area had resulted in it not being repointed with the otherwise ubiquitous 'Ancient Monuments' mortar. An early print (H. Davy of 1824; front cover & Fig. 12) shows a hole through the wall at this juncture that matches the patched area exactly.

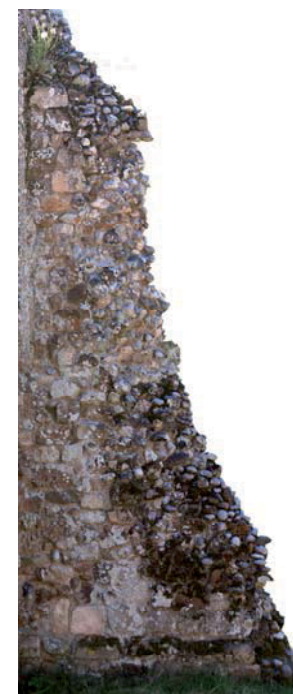
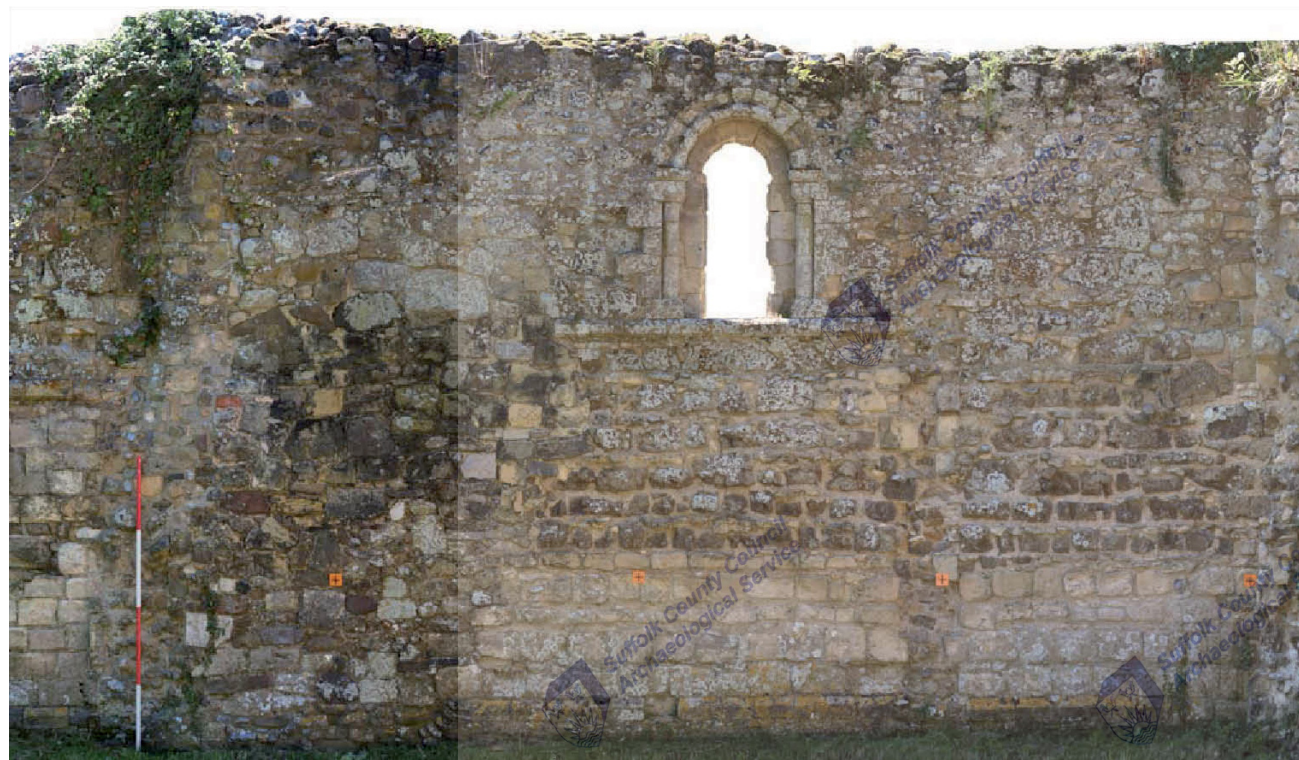
**Plate 9** North wall of Nave/Hall & Chancel (external); composite photograph (scale c.1:50)

Of the surviving c.4.50 metres of the nave/hall north wall, approximately 1.85 metres was obscured by a concrete buttress (0041) constructed to support its north-east corner. To the west of the buttress, two phases of facing (0017 & 0018) were recognised. At the base of the wall a small area of original wall facing (0019) comprised roughly squared limestone blocks lain in distinct horizontal courses with a basal plinth. To the east and above 0018, a second phase of wall facing (0017), probably representing refacing similar to 0001 internally, comprised more randomly lain, less regularly sized clasts of limestone (45%, some reused architectural fragments), pieces of septaria (45%) and 10% flint cobbles. Both 0017 & 0018 had been repointed with 'Ancient Monuments' mortar which had obscured the junction between the two phases. In addition, the core of the wall (0018) was exposed at the eastern end and similarly to 0015, on the internal elevation, was consolidated with rounded beach pebbles and repointed with 'Ancient Monuments' mortar. Immediately to the east of buttress 0041, the vestiges of the north-east corner of the nave/hall (0028) was recorded with its basal plinth joining the chancel wall above the level of the chancel plinth (0027). While very little facing remains and the exposed corework has been repointed with 'Ancient Monuments' mortar, the character of the wall suggest that it was contemporary with the chancel wall to the east.

Immediately to the east of its junction with the nave/hall, a large area of original walling survives (0040), albeit with some degradation and entirely repointed with 'Ancient Monuments' mortar. Architectural features, all constructed using Caen Limestone, include a window (0026, representing the external elements of that recorded as 0014 internally), an associated string-course (0029), a basal plinth (0027) a scar marking the site of a vertical pilaster strip (0039), to the west of the window, and six putlock holes (0020 - 0025).

The external masonry of window 0026, comprising the jambs, with their two flanking shafts, and arch, are relatively well preserved compared with the internal elements (0014). The sill of the window continues on as a string course (0029) for c.0.75 metres to the east, where it is truncated by later fabric 0030, and c.0.50 metres to the west, as far as pilaster scar 0039. There was no evidence to suggest that the string course had ever continued on beyond the pilaster, an observation that was confirmed in the Joshua Kirby print of 1748 (Fig. 8). The scar for the pilaster strip was c.0.40 metres wide and extended from the existing ground level up to within c.0.20 metres of the top of the wall, an observation that helped confirm that the upper portion of the wall was original and had not been refaced.

Original fabric 0040 included a basal limestone block plinth (0027) broken only by pilaster scar 0039. Above the plinth the wall comprised squared limestone ashlar blocks for c.1.00 metre, then squared septaria blocks for a further c.1.50 metres, up

to the string course, before changing to a more mixed facing of flint pebbles, septaria and limestone fragments. All three variations in fabric exhibited coursing, but these were more prominent towards the base where the clasts were larger. Galletting was common in the lower two fabrics, usually in the form of chips of Caen limestone. As the original mortar joints were obscured by a repointing of 'Ancient Monuments' mortar, lift-lines could only be inferred from the character of the coursing.

The western end of the apse also occurred on this elevation, with an area of squared Caen Limestone block ashlar facing (0034) surviving to a height of c.2.50 metres, with a basal plinth and a string course above. Above this, the apse wall (0038) had lost its facing, comprising fragments of septaria with heavy repointing in 'Ancient Monuments' mortar.

Seven putlock holes were recorded, six (0020 - 0025) in two horizontal lines in chancel fabric 0040, and one (0035) in apse fabric 0034 at a similar level to the lower line in the chancel.

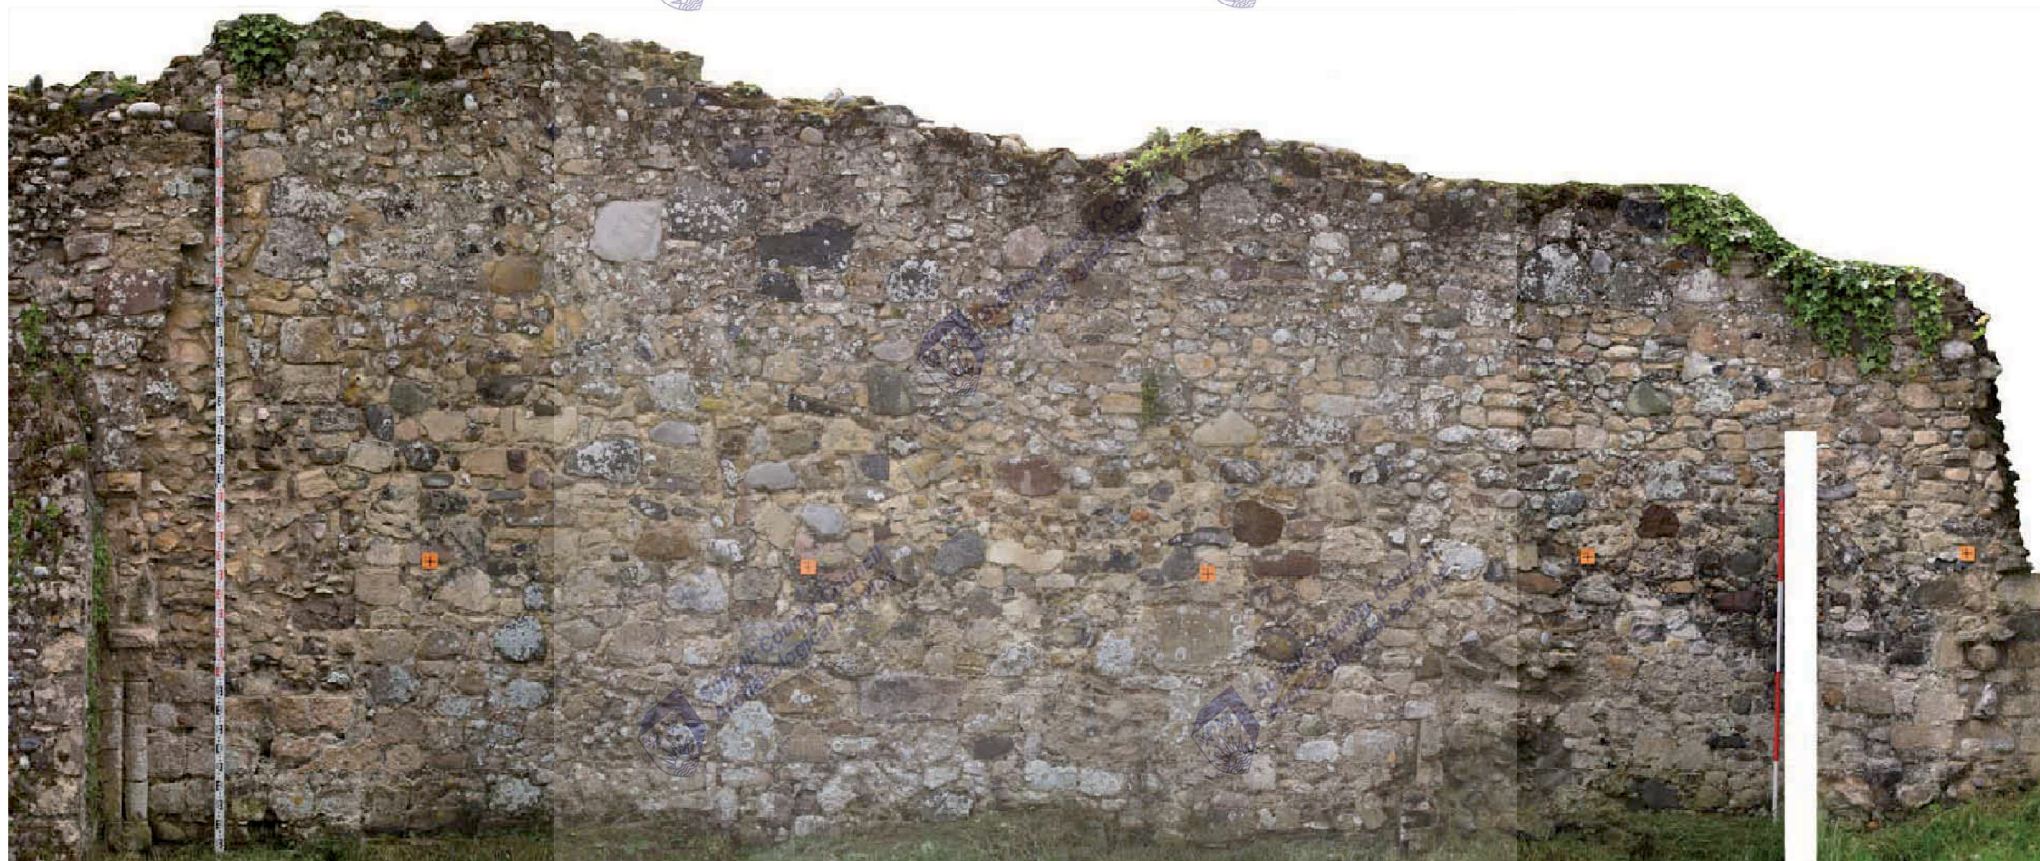
**Plate 10** South wall of Nave/Hall & Chancel (internal); composite photograph (scale c.1:50)

The south wall of the chancel & nave/Hall stands to a maximum height of 4.50 metres internally which, due to the building being terraced into the slope, is only 3.50 metres externally. Examination of the wall fabric suggests that very little of the south wall represents original build, an observation that is confirmed by the early drawings (Figs. 8 - 12).

At the eastern end of the chancel, original wall fabric (0042 & 0045) survives along with the a shaft, capitol & impost block (0044), the first in what is likely to have been a blind arcade matching that to the north, and one Caen Limestone block of a string course that was entirely absent on the north side of the chancel.

Wall fabric 0042, comprising coursed squared blocks of limestone ashlar, represents the rear face of the blind arcade panels, the equivalent to 0008 in the chancel internal south wall elevation. One possible socket (0049) survives which would have held in place one of the shafts of the blind arcade. Fabric 0045 is all that remains of the upper face of the original wall, the equivalent to 0004 in the chancel internal south wall elevation. While little can be said regarding such a limited area of wall, similarly to the south wall, the facing materials included septaria, limestone, flints and occasional exotics, with smaller clasts used more frequently towards the top. Fabric 0045 had been repointed with 'Ancient Monuments' mortar.

Immediately to the east of the surviving original walling was the wall stub (0046) representing the southern side of the dividing wall between the apse and the chancel. Considerably less survives than on the north side of the chancel, and what is there has been heavily consolidated up to the level of string course 0052, forming what is effectively a buttress. Above the buttressed area the wall face (0047) is essentially corework, possibly consolidated with rounded flint beach pebbles, and then repointed with 'Ancient Monuments' mortar.

One other original area of fabric was recorded (0043), the truncated stub of the north-south wall that would have divided the chancel from the nave/hall to the west which only survived to a height of c.1.40 metres.

The vast majority of the south chancel and south nave/hall wall (0048) represents a rebuild with its internal face maintaining the line of original fabric 0042, i.e. set back from 0045 consistent with what would have been the rear of the blind arcade. The fabric comprises an eclectic mix of materials, essentially uncoursed, with the clasts closely spaced and randomly laid. Approximately 50% of the facing is limestone, including many reused masonry pieces, c.30% flints and c.20% exotics, with sizes varying between pebbles and c.0.50 metre blocks. Most of the larger pieces were lower down the wall, but not exclusively. This fabric has not been repointed.

To the west, a series of limestone quoins (0050) provide a formal end to the internal face of the wall, with projecting corework immediately to the east (0049) possibly indicative of another north south wall. The same formal construction of quoins is not evident on the south side of the wall and it seems likely that they are a cosmetic feature only, not representing part of a formal architectural feature, with 0049 and 0050 being contemporary with 0048.

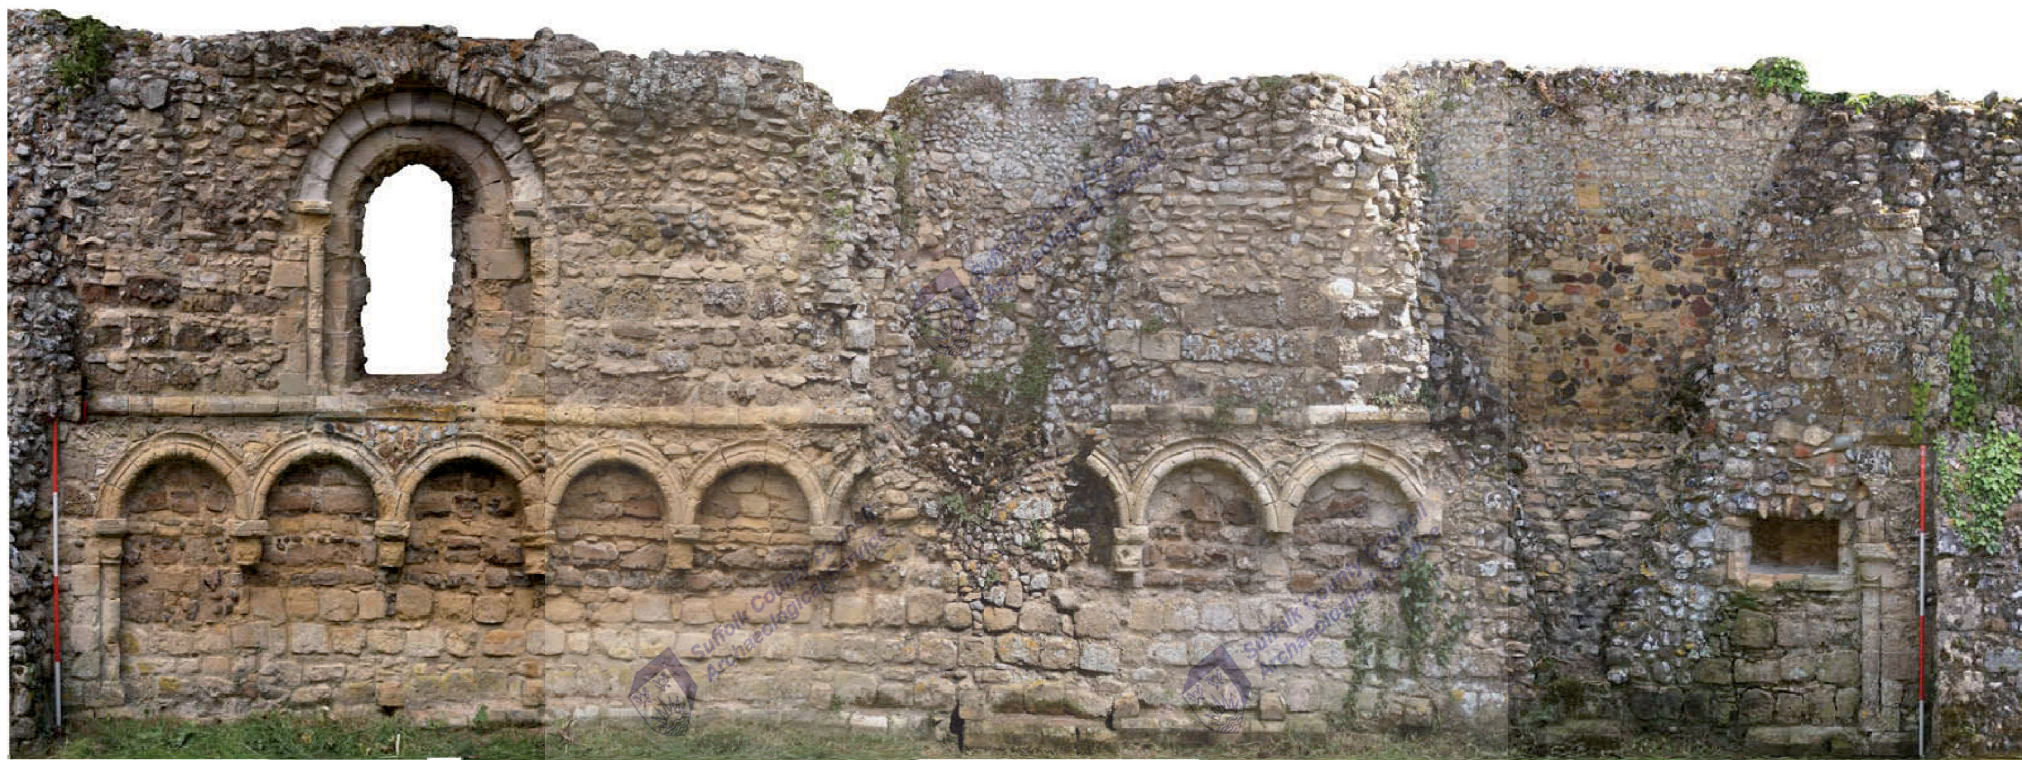
Plate 11 Apse wall (internal); composite photograph (scale c.1:50)

The internal wall of the apse represents the best area of preserved original fabric and associated architectural features within the whole monument. For the purposes of the elevations (Fig. 6 & Plate 5) the curved internal wall face has been flattened out onto the two dimensional page.

The lower 2.00 metres of the wall has a twelve bay blind arcade (0057), although only ten have survived, none completely intact. The basal plinth (0067) of the arcade survives for approximately 60% of its length along with eight square bases that would have supported the shafts of the arches. The only surviving shafts were those at the very ends of the arcade. A line of filled sockets (0059 – 0066) represent anchoring points for the now lost shafts. Eight capitols and associated impost blocks survive

out of what would have been a total of thirteen. Immediately above the arcade was a string course (0058). The intervening wall facing (0056) between the string course and the arcade arches, had been locally patched with flint pebbles and repointed with 'Ancient Monuments' mortar. The wall face forming the rear of the arcade (0055) comprised coursed Caen Limestone ashlar blocks at its base (three courses), followed by squared septaria blocks (two or three courses), with mixed septaria and limestone fragments in the arches themselves. All had been repointed with 'Ancient Monuments' mortar which had obscured any evidence within the original mortar joints for lift-lines, but again, these could be inferred from the courses themselves. The joints had locally been galleted with fragments of limestone and occasionally patched with flint pebbles.

In the area that would have been the first arch at the end of the arcade on its southern side, a rectangular niche (0070) had been inserted into the wall fabric. The original full size and shape is unclear, as the extant top of the niche is a later patching (0071) of flints, brick and limestone fragments, with steel reinforcing used to maintain its integrity.

There would originally have been three windows in the apse, only one of which (0068) has survived, although having lost one of its shafts. Unusually, the first order of its arch was constructed using chalk (Palmer 2008) rather than the otherwise ubiquitous Caen Limestone.

Original wall facing and core fabric (0069) was evident on the upper north and east sides of the apse, albeit heavily repointed with 'Ancient Monuments' mortar. Immediately above string course 0058, the wall facing comprised well coursed septaria blocks with galleting of limestone fragments, the latter helping to define the lift-lines. From the level above the springing point of the window arch, the wall fabric was relatively rough, comprising small pieces of limestone and septaria with less well defined courses that represented corework rather than facing. However, the surface of the wall in the vicinity of the window curved inwards, projecting out beyond the genuine facing below. This was considered to represent the vestiges of the domed roof of the apse clearly shown on early drawings/engravings (Figs. 8, 9, 11 & 12).

Apart from two dressing blocks on the north side of the east window, the east and south windows of the apse had been completely destroyed, with the exposed corework of the wall consolidated, predominantly with flint pebbles (0047), and the intervening gap built up to the full height of the wall, with facings set back from original wall face (0075 – 0078). With the eastern wall, the damaged section included the window, the wall fabric above, and extended down into two arches of the blind arcade. The filling fabric (0078) comprised randomly lain flints with occasional brick, septaria and limestone fragments all repointed or possibly even set in 'Ancient Monuments' mortar. The filling within the area of the south window was more complex. At this juncture the damaged area extends down even further in a V-shape, almost to the level of plinth 0067. The wall face adjacent to the damaged area (0072 & 0074) was clearly not original as it comprised a mixture of randomly lain flint cobbles/pebbles, brick, limestone and exotics all repointed with, or even set in 'Ancient Monuments' mortar. In addition, there was an area of consolidated corework (0047) at the top of the wall. Three distinct fabrics were identified within the filled area of the window (0075 - 0077). The lower c.1.50 metres of filling fabric (0075) comprised roughly coursed limestone fragments with occasional flints set in cream coloured lime mortar.

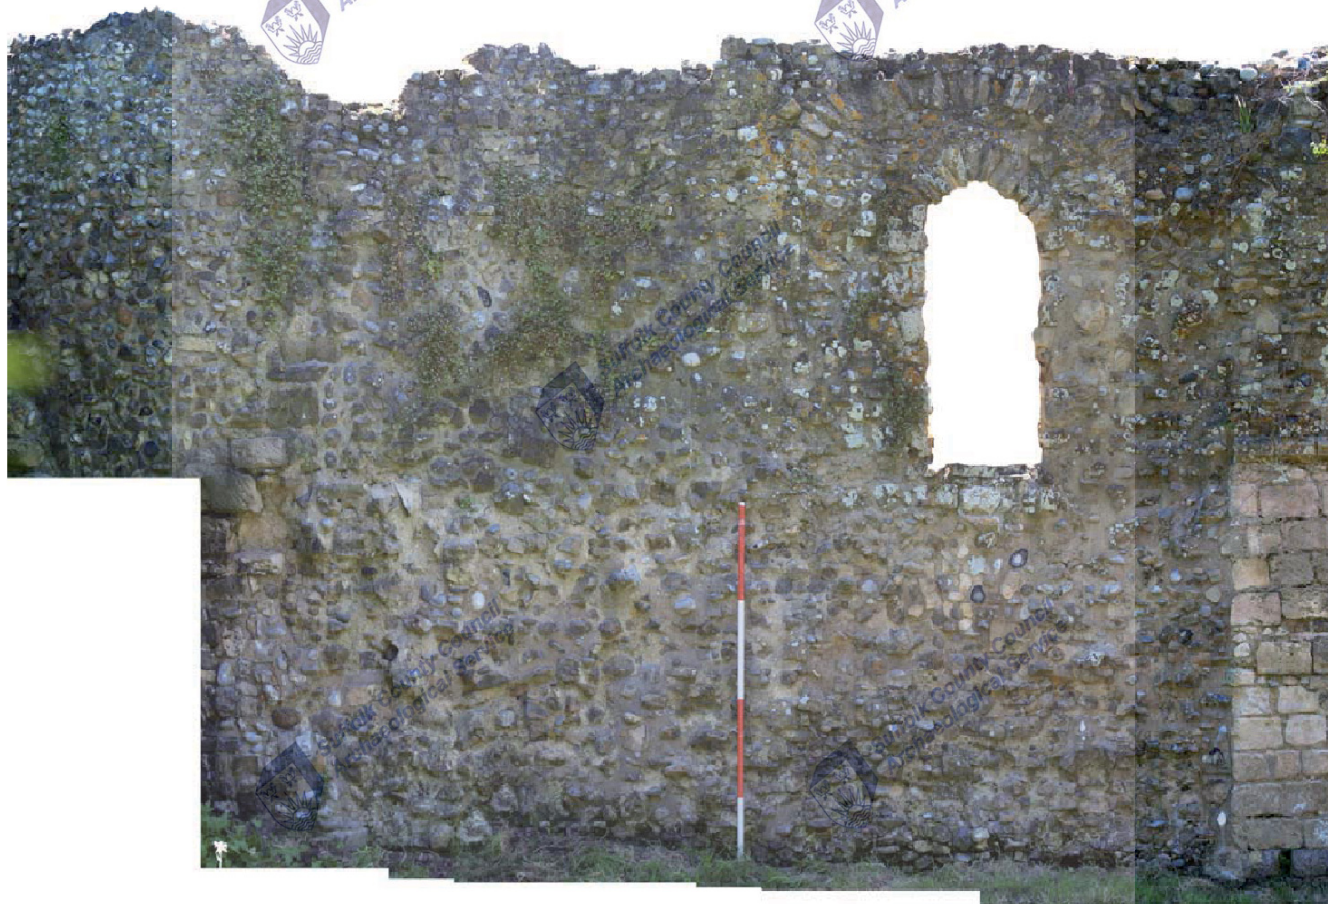
**Plate 12** Apse wall (North side external); composite photograph (scale c.1:50)

Only the northern side of the external wall of the apse could be presented as a composite elevation due to the difficulties caused by various obstructions to the south and east. The south side is described in the text and illustrated with detailed photographs (Plates 3 – 7).

Large areas of the wall had lost their facing (0038) with exposed corework consolidated and heavily repointed with 'Ancient Monuments' mortar. In addition, the south window opening (0068) had lost all of its formal masonry revealing a roughly lain arc of limestone fragments that represent a structural component of the window, possibly a relieving arch, that would not originally have been visible. The set back facings of the blocking fabrics 0074 - 0077, in the south window area, and 0078 in the east window area were similar to those described internally, although here they had been repointed with 'Ancient Monuments' mortar.

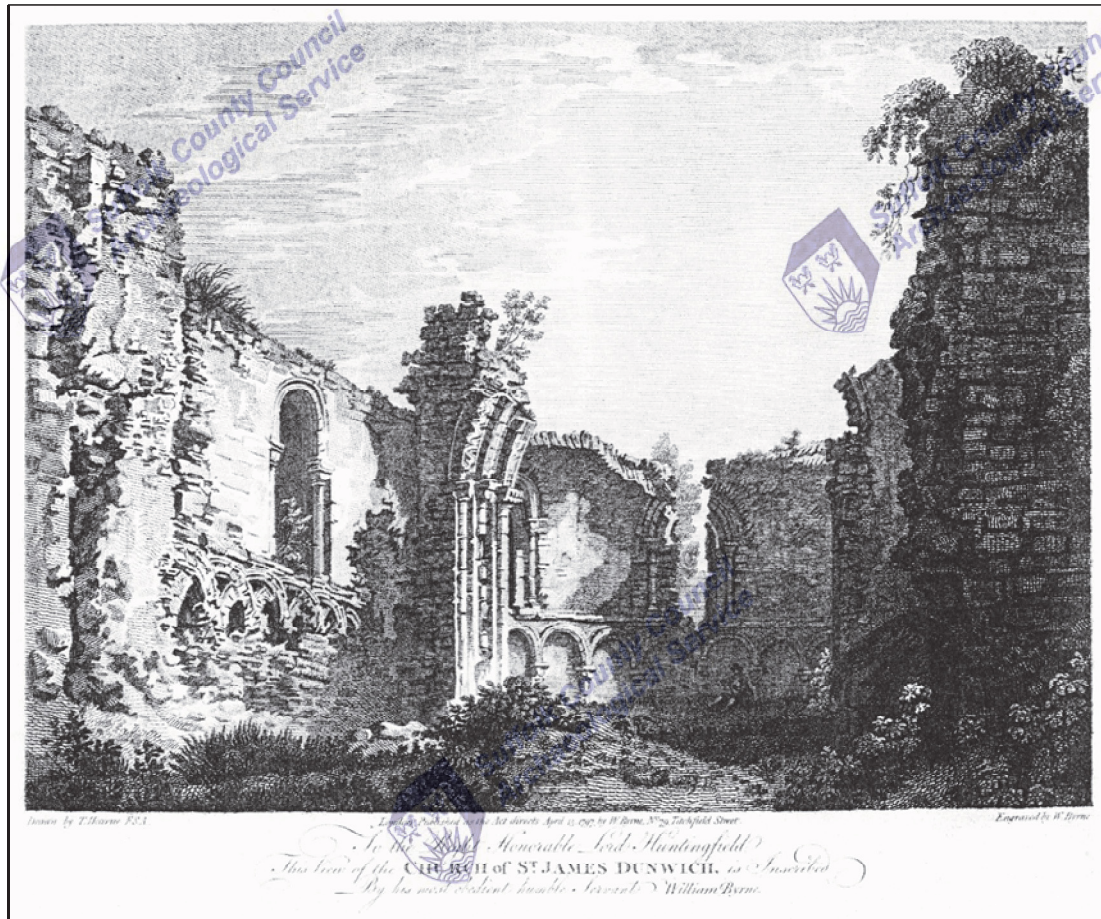
Fig. 11 Drawing by T. Hearne engraved by W. Byrne, c.1797

We then have Hearne's drawing of 1797 (Fig. 11) and Davy's of 1824 (Fig. 12), both offering broadly similar views of the inside of the chancel and apse from the west-south-west and south-west respectively. There had clearly been some loss of building fabric during the intervening years between the Kirby drawings and that of Hearne, and more major deterioration between that and Davy's. By 1797 the domed roof of the apse had suffered major collapse, with only the outer edges surviving and the middle section of the arch of the apse east window and its sill had been compromised, although its flanking shafts, capitals and first few voussoirs of the arch were intact. Much of the underlying blind arcade is in shadow and the southern end does not appear in the drawing. However all of the arches shown are intact, although the presence or absence of their shafts at that time is not easy to assess.

In the chancel the shafts of the interlace arcade all appear to be missing, while the arches themselves are increasingly damaged towards the east. The window is intact, but there is an area of facing loss at the eastern end, extending both above and

below the level of the string course that ran the entire length of the chancel above the arcade.

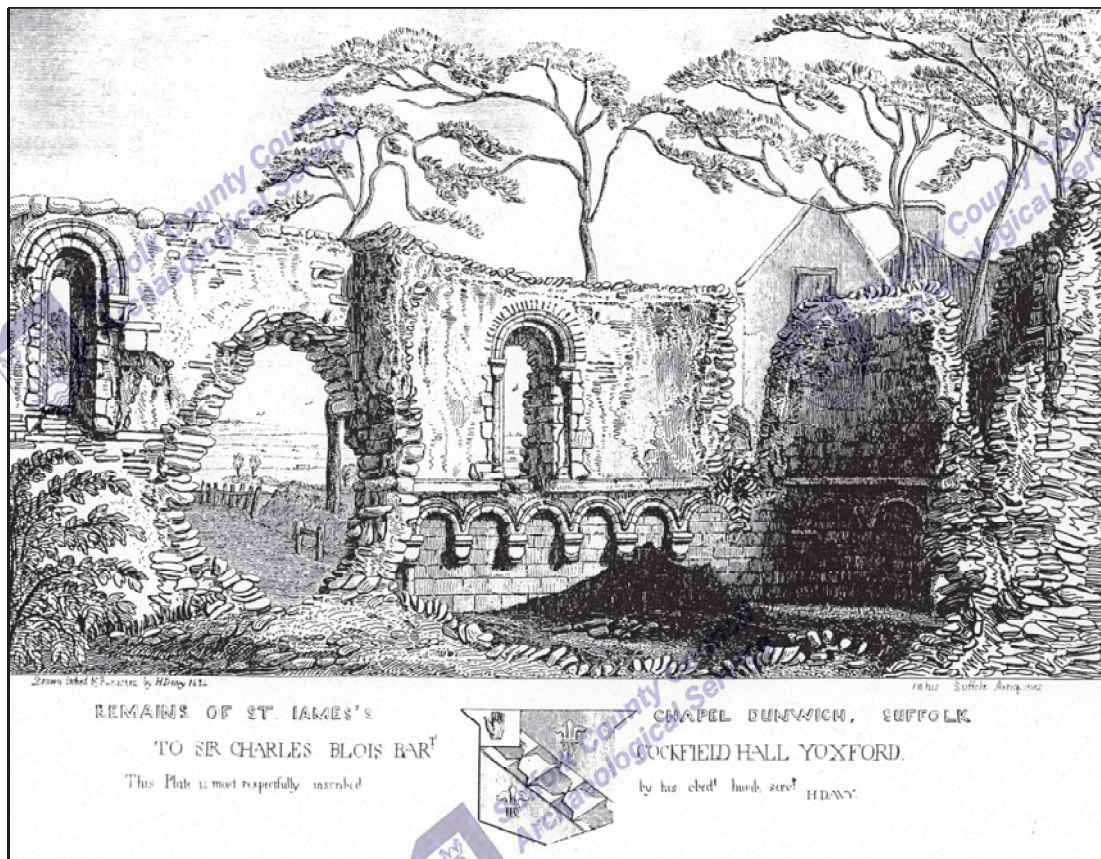
Fig. 12 Drawing by Henry Davy, c.1824

Davy's drawing of 1824 (Fig. 12) shows a much more sorry state. In the intervening period of twenty seven years, almost all vestiges of the domed roof in the apse have collapsed in. The north apse window is still essentially intact, but those to the east and south have lost all of their mouldings. There has been some deterioration of the blind arcade, and the only shaft now surviving is that at the western end of the north side. The responds for the arched opening into the chancel have lost all of their tooled masonry and are no more than stubs of walling.

The Davy drawing represents the most recent of the historic depictions of the chapel used in this report and shows the building only two years before the initial construction of the adjacent church, later remodelled in 1881. Since that time there have been further changes to the historic fabric, including localised rebuilding and consolidation as well as further deterioration. The examination of the standing building has identified two major phases of work to the structure, with many minor alterations that may be related to the two main phases, or were undertaken independently, as and when necessary. The original wall fabric was easily recognisable as it was very consistent in its composition. Original wall facings were almost entirely composed from Caen Limestone ashlar and the locally derived septaria mudstone. Flint pebbles were occasionally used, particularly higher up the wall, and there was a limited use of chalk as dressings in the arch of the south apse window.

The first of the two main phases of alteration and repairs included the blocking fabric in the large hole in the north chancel wall, the rebuilding of the south chancel wall and rebuilding of the east end of the nave/hall wall. It is also possible that the east and south windows of the apse were blocked at this time, although this may be rather simplistic as the fabrics here are not entirely the same. There is no direct dating for this phase, although there was some indirect evidence and some assumptions can be made. The blocking and rebuilding fabrics included an eclectic mix of material (see Palmer 2008) which does not look dissimilar to that used in the facing of the adjacent church, the result of the Barne family alterations and construction of the chancel in 1881. Given that the chapel once held the tomb of the Barne family, it seems reasonable to suggest that the work on the leper chapel was undertaken at the same time as the major work on the church and, possibly, the insertion of the Barne family tomb itself, which does not appear in Davy's drawing of 1824.
