# ARCHAEOLOGICAL MONITORING REPORT

## ST. MICHAELS CHURCH, WOOLVERSTONE (HER Ref. WLV 023)

A REPORT ON THE MONITORING OF GROUNDWORKS ASSOCIATED  
WITH THE CONSTRUCTION OF A NEW TOILET FACILITY AND  
EXTERNAL SERVICE TRENCHES

Suffolk County Council Archaeological Service Report No. 2008/238  
(OASIS ID. suffolkc1-47173)

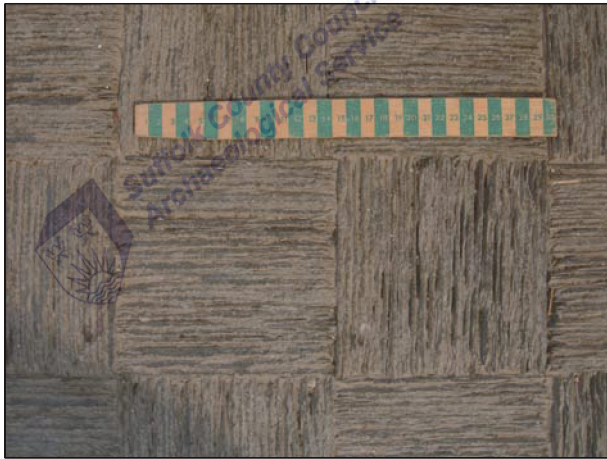
**Plate 1** Representative area of extant tower floor

The extant floor of the tower comprised a checkerboard pattern of *c.*0.15 metres (6 inch) squares of thin cut pieces of roofing slate laid on edge with each successive square at right angles to the last (Plate 1), forming an alternating pattern. A similar floor surface was present in the porch. The floor was found to be 0.07 metres (3 inches) thick and was bedded on approximately 1 centimetre of mortar. The slate was found to be very hard and not easily to break out and, as a consequence, it was decided to allow the contractors to remove the entire slate floor in the tower with regular monitoring visits from the archaeologist.

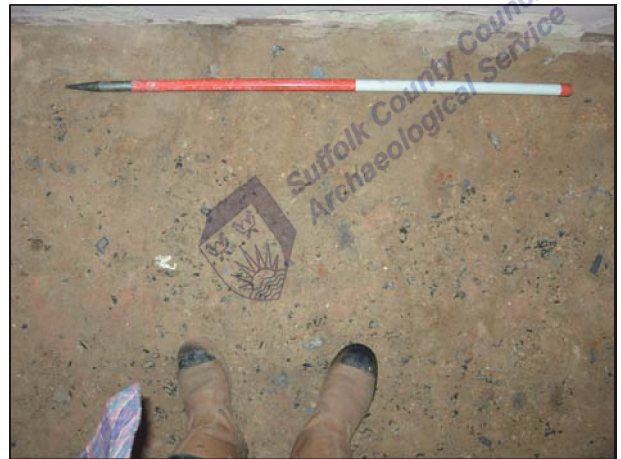
**Plate 2** Junction between stepped tower wall footing (top) & secondary floor level (bottom)

The removal of the slate floor revealed a second surface comprising a mixture of brick fragments and flint pebbles in lime mortar which appeared to change in character close to the base of the walls (Plate 2). Subsequently, the material close to the wall was found to be the stepped out footing of the tower wall itself. While relatively rough, this did seem to be a formal surface that could have functioned as a floor. In addition, the existing plaster facing on the wall continued down to the stepped footing, which is further evidence that this lower level had at one time represented a functioning floor surface.

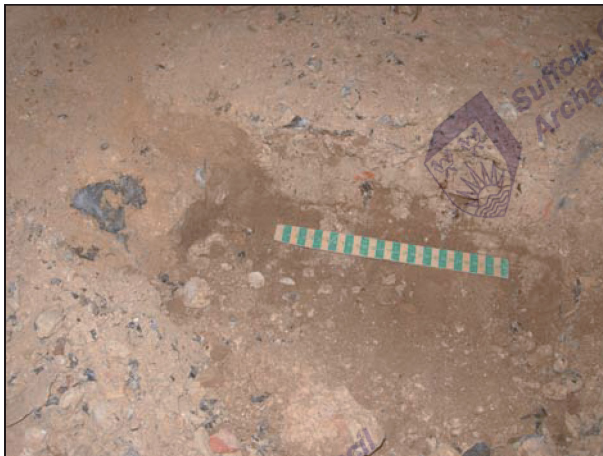
**Plate 3** Junction between tower footing (left) & secondary floor (right) level (right) & underlying cemetery soil

After photographic recording, the contractors removed the central material abutting the stepped footing, revealing its 15 centimetres thickness (Plate 3). Beneath this layer, brown silty sand was encountered with occasional disarticulated human skeletal material, probably from burials predating the construction of the tower in the 15<sup>th</sup> century.

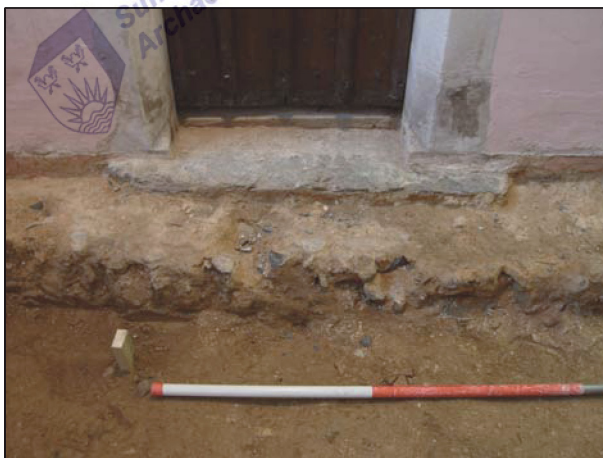
**Plate 5** Purbeck marble step

On the north side of the tower the threshold of the existing doorway was revealed comprising a single slab of crumbling Purbeck Marble (Plate 5).

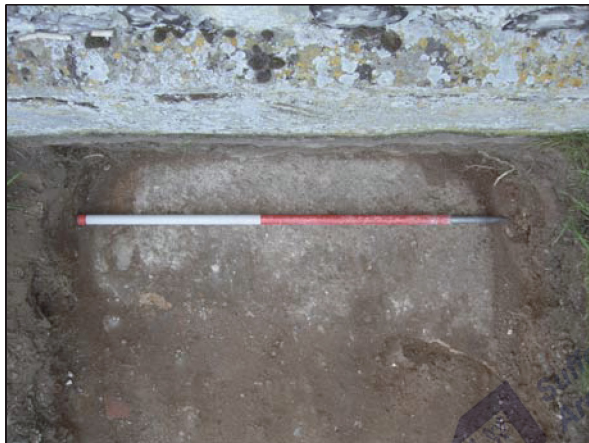
**Plate 6** Stepped out external footing

In one of the monitoring visits a 2.00 metres by 1.10 metres area had been excavated against the external west wall of the tower (Fig. 3; Plates 7 & 8). At a depth of 0.38 metres, the bonded flint and septaria footing of the tower wall was encountered, stepping out for 0.40 metres from the vertical face, at a point 0.45 metres below the tower plinth. The step increased to 0.50 metres wide as it approached the towers diagonal south west buttress. The removed overburden comprised c.0.20 metres of turf and topsoil overlying a further c.0.38 metres of mixed sandy soil with included building debris and mortar. Another visit was made after the contractors had excavated down to the west of and adjacent to the external tower footing. Disarticulated human skeletal material was recorded.

Both the internal and external stepped footing of the medieval tower was exposed, revealing that it was *c.*0.80 metres wider than the base of the wall at ground level. The purpose of this footing was almost certainly to spread the weight of the tower over a larger surface area. The internal tower excavations revealed two floor surfaces, both of which are post-medieval in date. An enigmatic feature comprising five half bricks surrounding a pad-like area of chalk and mortar was recorded almost central to the tower. The bricks themselves were in a white fabric, were clearly handmade and of a type often used for floors in the 18<sup>th</sup>/19<sup>th</sup> century. Given that the brick feature was sealed by the secondary floor level, then it follows that the floor must post-date the feature. The upper floor surface constructed from roofing slate was the same as that in the porch. Both floor levels must be considered to be associated with the extensive rebuilding and refurbishments undertaken during the 19<sup>th</sup> century.

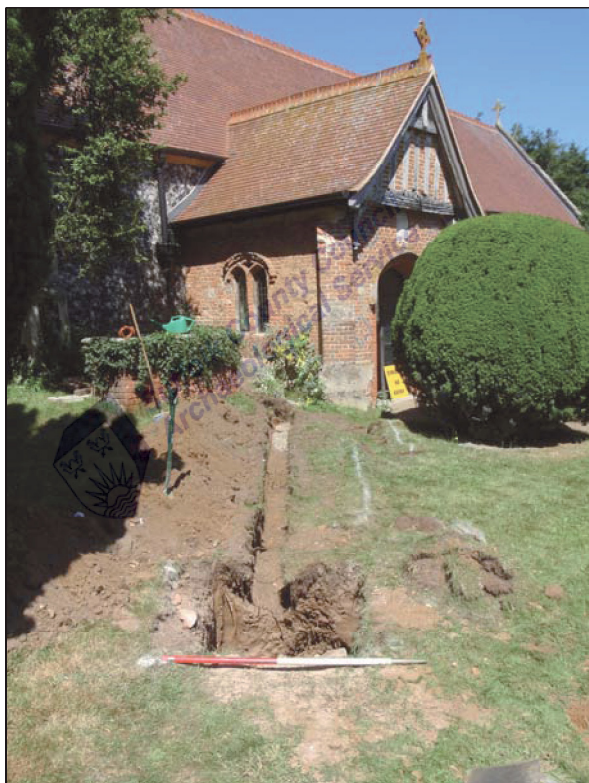
**Plate 8** Soakaway south of tower

A final site visit was made to monitor the excavation of a soakaway and associated drain run south of the tower (Fig. 3; Plate 8).

The dog-legged drain run was excavated to a depth of c.0.50 metres deep. Disarticulated leg-bone fragments were recovered from the upcast spoil. The c.0.80 metre square soakaway was excavated to a depth of 1.70 metres. Fragments of a skull were recorded at a depth of c.1.00 metre. No intact burials were encountered within the excavations. Subsequently, all of the disarticulated skeletal material was re-buried on the site.
