ARCHAEOLOGICAL MONITORING REPORT

10, CROSS GREEN, DEBENHAM (SMR ref. DBN 122)

A REPORT ON THE ARCHAEOLOGICAL MONITORING OF GROUNDWORK ASSOCIATED WITH THE CONSTRUCTION OF AN EXTENSION

Suffolk County Council Archaeological Service Report No. 2004/162

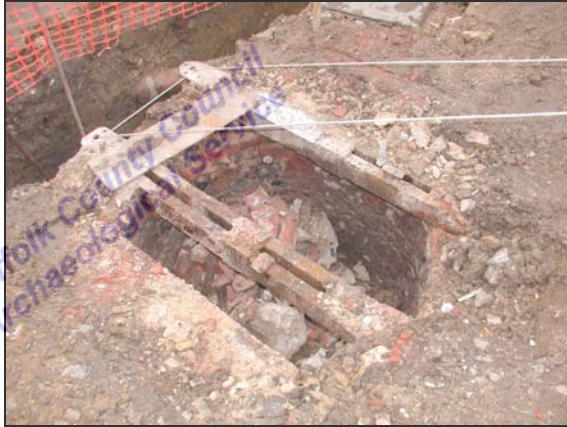
Plate I: The well

Within the area of the new extension the ground surface had been reduced by c.0.2m revealing a circular shaft interpreted as a well. Its internal diameter was 1.2m but it was not possible to ascertain its depth as it was filled with rubble to within c.1m of the top. The rubble appeared to comprise of 20th century bricks, mortar and concrete. The property owner reported that the area of the well had been covered in a thick layer of concrete.

Across the top of the well a series of three sets of girders had been placed (see Plates I and II). Each set comprised two 'U' shaped channels that were held together by square plates riveted across them. One end of the girders was exposed (the other ends were still buried in the topsoil) and these also had plates riveted across them although these were of differing shapes and contained circular holes.

It was initially thought the girders may have been part of a supporting structure for the pump and well cover but after further thought it is more likely that these had been used to support the thick layer of concrete that had been cast *in-situ* across the top of the well. The girders themselves had probably been reused and originally came from a steel framed structure, possibly a pylon, as the angles on the end plates of one girder suggest it had once been a diagonal brace.

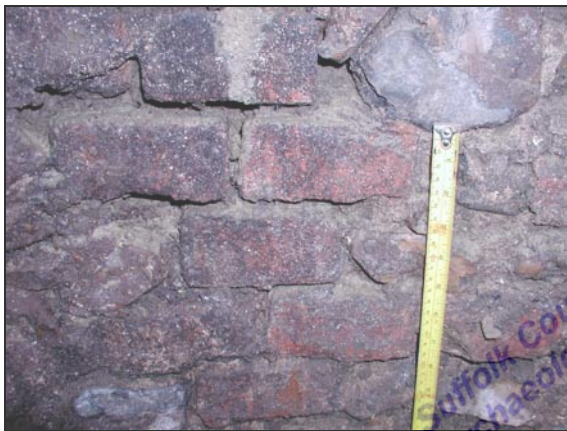
Plate III: brickwork within well

The well was lined with brickwork which also contained occasional small septaria blocks and flints. The bricks had dimensions of 55-60mm thick and 125-130mm wide (see Plate III). It was not possible to measure the length as only the ends were visible in the face of the well and it appeared that only half bricks had been used.

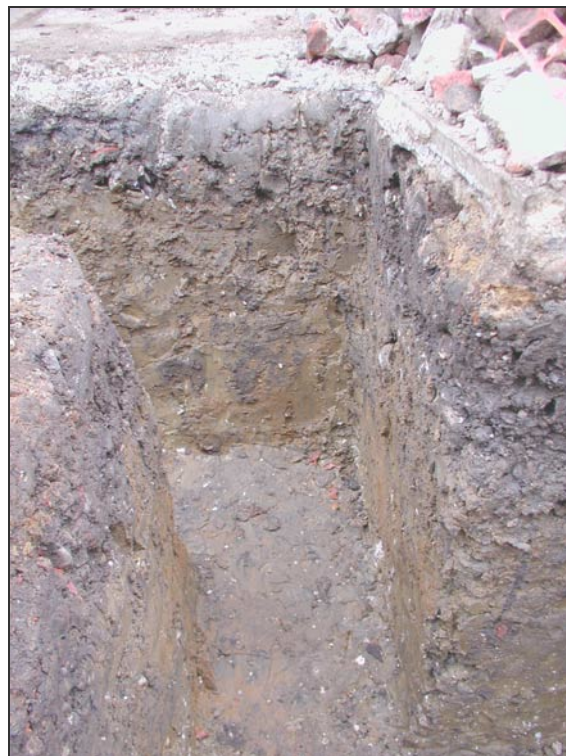
Plate V: The revealed soil profile

The site was visited on the 15th November 2004. All the footings for the new extension had been excavated by hand and were ready for concreting. The trench had been cut to a depth of c.1m revealing a 0.25m thick topsoil which immediately overlay a natural subsoil of stiff pale brown/yellow clay. The footing was thoroughly examined but no significant archaeological features or deposits were identified.
