# ARCHAEOLOGICAL EVALUATION REPORT

## FORNHAM HALL, FORNHAM ST GENEVIEVE FSG 021

A REPORT ON THE ARCHAEOLOGICAL MONITORING, 2009  
(Planning app. SE/04/2743)

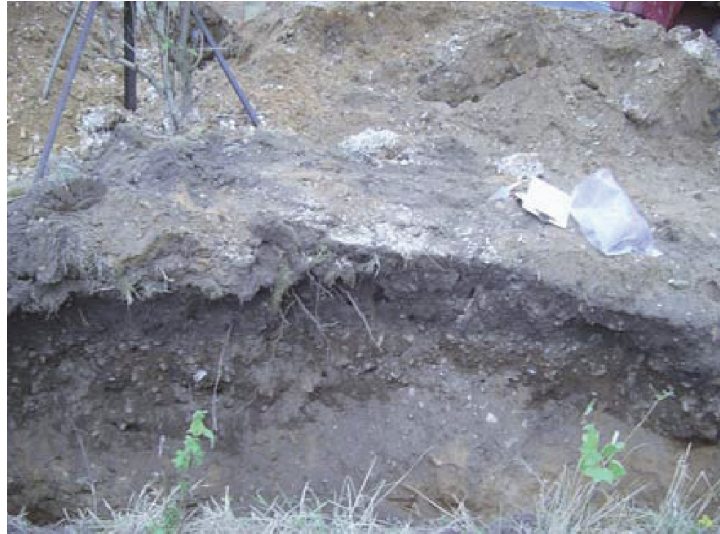
Figure 3. Disturbed length of section from where human remains were found.

the redundant cemetery and after the new pipe had been laid the bones were reburied close to where they were found. At the south end of the trench an existing pit was enlarged for the new settling tank (Figs 4-5).

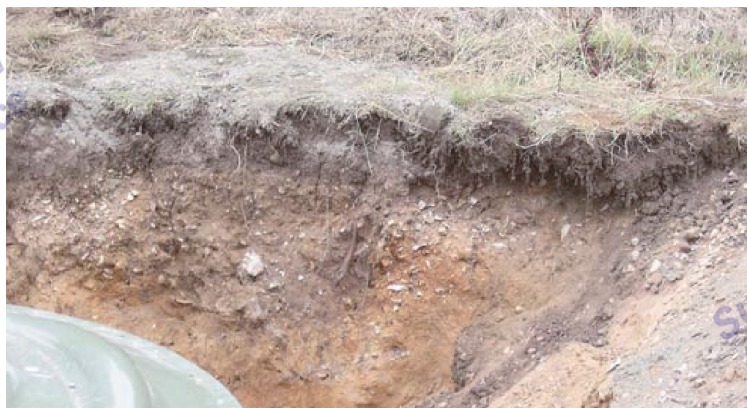
Figure 5. Feature 0034 exposed in the side of the cess tank pit.

A single section was recorded; it shows natural sand and gravel c.0.35m from the surface. It also reveals a brown sand filled feature, which was cut from below the topsoil, 0034. The general appearance of this feature tended to suggest it was quite old and might have been a grave. No bones were visible in the section and to avoid unnecessary disturbance, it was not cleaned.

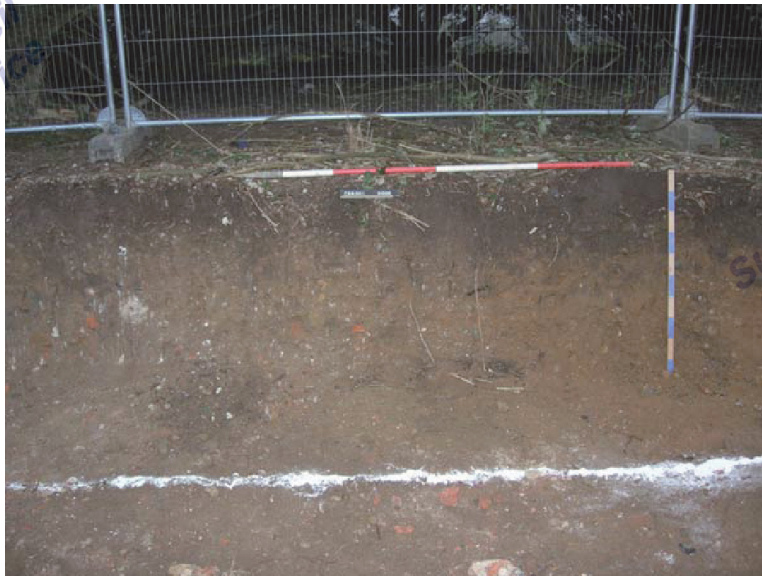
Figure 9. Profile of the topsoil and surface debris strip over the site of the Hall

The evidence from the monitoring has shown that the outline of the hall is probably preserved as footings. Almost a metre of topsoil and rubble was cleared from over the north end of the Hall; wall lines, including some that must have been internal, were preserved below. This suggests that demolition involved simply levelling the site.

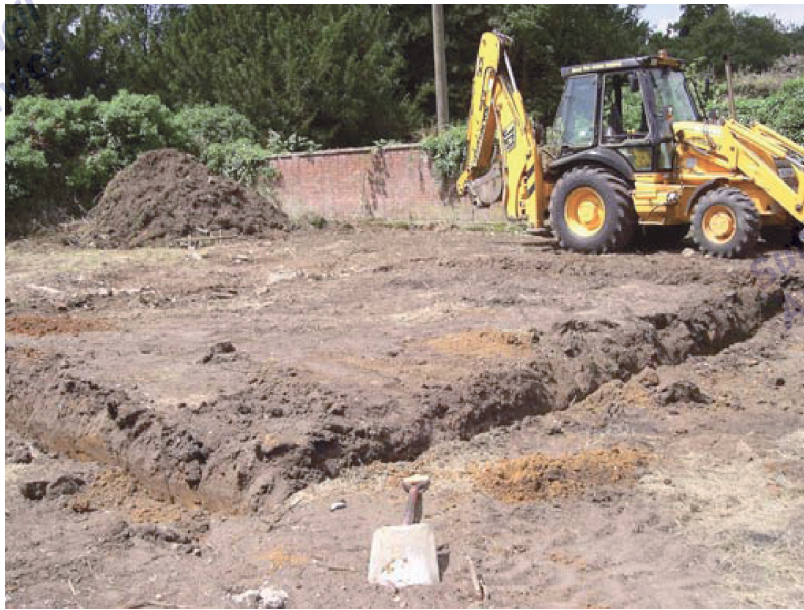
Figure 13. Garage 3 during excavation

Garage 2 was monitored while the footings were excavated. The topsoil was disturbed with brick and charcoal. A ditch was exposed, 0031, which appeared in both the footings for the north and south walls (Fig. 6 Section 0029). The fill was of brown sandy loam and no finds were recovered. The lack of recent finds, the consolidated state of the fill and the alignment of the trenches that was at odds with the surviving outbuildings of the Hall lends to the interpretation that this feature was earlier. Garage 3 was monitored during the excavation of footings. The trench was excavated to a depth of 1.3m. Crossing the footings from northeast-southwest were brick and flint foundations that were identified as the remains of glass houses associated with the garden. A vertical sided pit 0037 was exposed but not bottomed. The fill contained fragments of flint with mortar and was almost certainly associated with the Hall complex (this section has not been illustrated). Natural comprised yellow silt and sand. Garage 4 was monitored after the footings had been excavated to a depth of c1.3m and no features were identified. A service pipe was monitored through the walled garden (Figure 6, section 0033). It was c.0.6m deep; natural subsoil of sand with some gravel was beginning to appear in the base of the trench.
