ARCHAEOLOGICAL DESK-BASED ASSESSMENT

FELIXSTOWE, SOUTH SEAFRONT & MARTELLO TOWER 'P' (HER Ref. FEX 278)

**INCLUDING THE GEOPHYSICAL SURVEY REPORT OF
THE MILITARY ZONE AROUND MARTELLO TOWER 'P'
BY GSB PROSPECTION LIMITED**

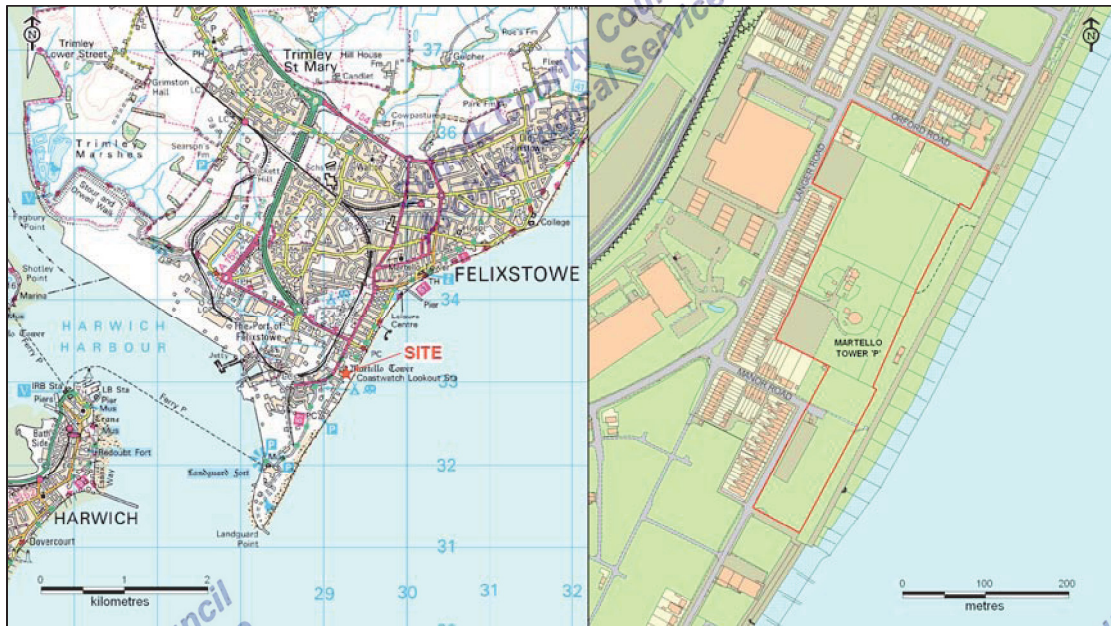
Figure 1: Location Plan

The site covers an area of approximately 55900 square metres and is bounded by Orford Road to the north, Langer Road to the west, Manor Road to the south and a concrete sea defence to the southeast. The site is relatively level and lies at a height of c. 3.5m OD. The National Grid Reference for the approximate centre of the site is TM 2929 3308.

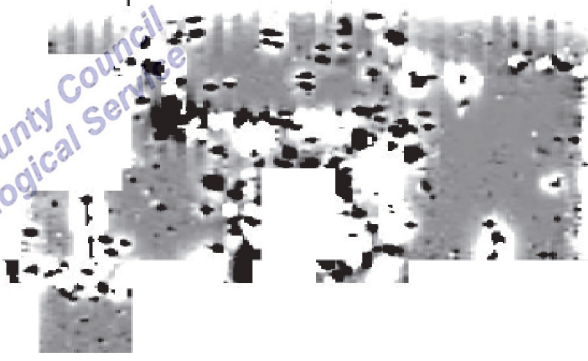
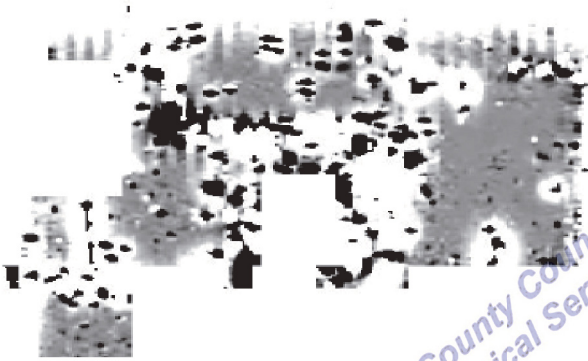
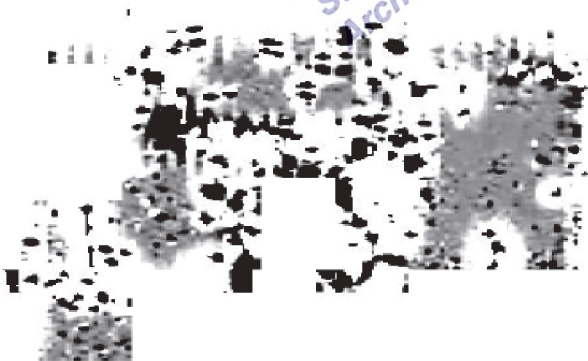
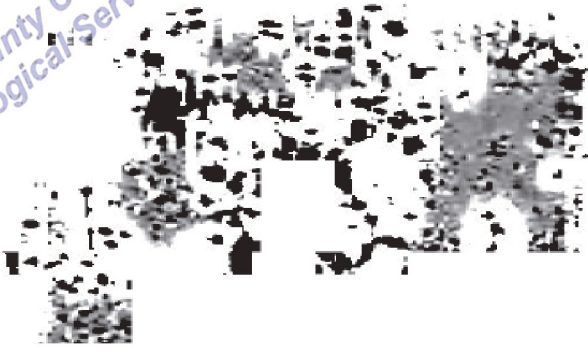
GSB Prospection Ltd.
2008/43 Martello Pt, Felixstowe
Magnetic Data
Figure 4

- 1.5 For comparison, a series of greyscales at different plotting level is provided in Figure 4. None of these indicate obvious features of potential interest.
