ARCHAEOLOGICAL SERVICE

**Part Garden to Rear of The Old Nursery, The Street, Easton;
Record of an Archaeological Evaluation ETN 013**

SCCAS Report No. 2008/51; Oasis No. suffolkc1-51904

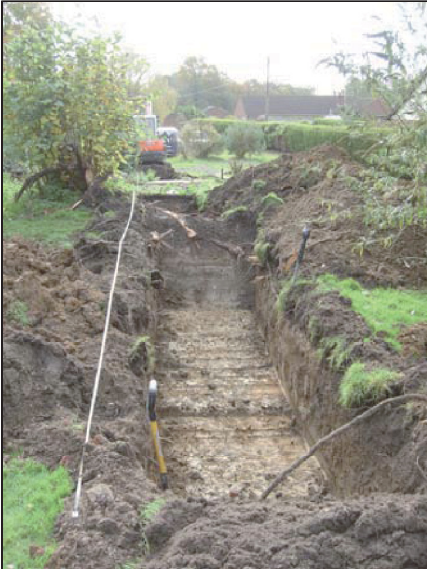
Plate 1 Trench 1 from the north

Trench 1: while totalling 15 metres in length, was broken in two places due to the presence of a substantial tree-root, the base of an old shed and another feature described as a 'water tower' on the architects plan (Fig. 2 & Plate 1). The section of trench reproduced in detail as part of Figure 3 is the middle section of the three shown on Figure 2.

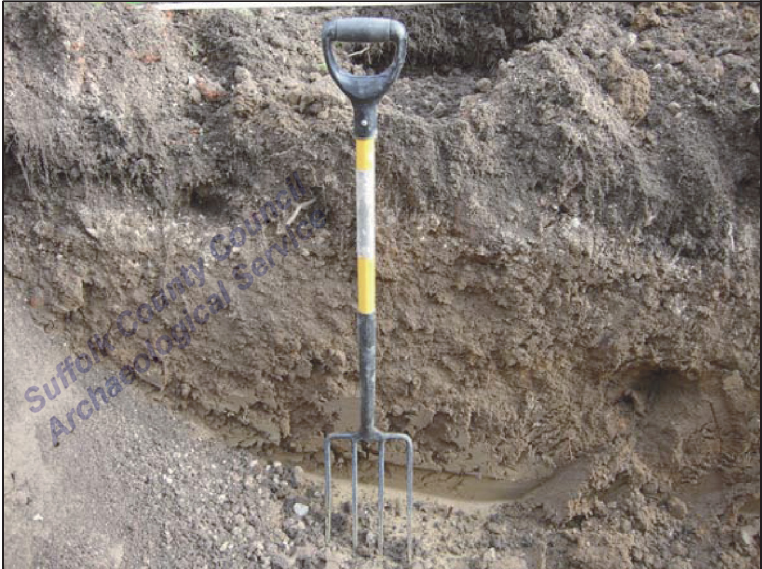
Plate 2 Soil profile, north end of Trench 1

The northern section of Trench 1 measured 1.5 metres by 6 metres. A uniform thickness (c.0.2 metres) of topsoil was encountered throughout, overlying a layer of mortar and rubble (0005) which increased from only 0.1 metre thick at the northern end of the trench section to 0.3 metres at the southern end. Below the rubble layer a 0.6 metres thick deposit of homogenous brown silty/sandy clay with charcoal flecks was recorded throughout and lay directly on the naturally occurring clay subsoil. A photograph of the soil profile at the northern end of the trench appears as Plate 2.

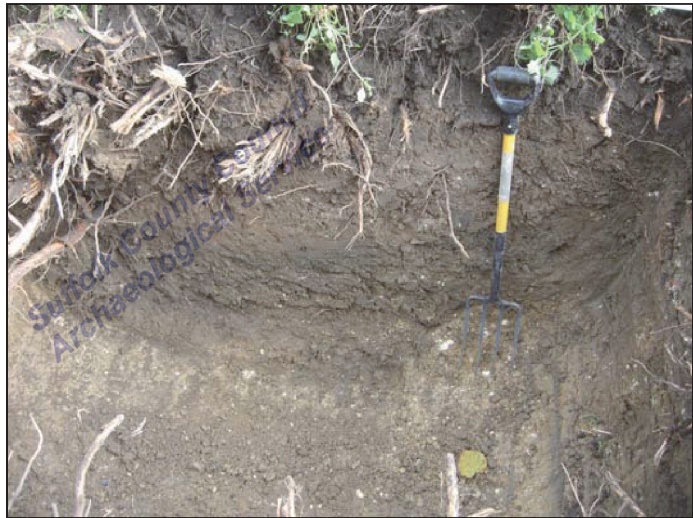
Plate 3 Ditch 0002/0003. section in side of trench

After a break of c.1 metre due to the presence of a large tree root, which could not be removed by the mechanical excavator, Trench 1 was continued for a further 3 metres. This section of the trench was found to coincide almost exactly with an east to west orientated ditch feature (0002) (Figs. 2 & 3 & Plate 3). The ditch cut through layer 0004 to the base of the topsoil with

rubble/mortar layer 0005 not in evident at this juncture. The fill (0003) comprised relatively homogenous dark grey/brown clay/loam with a hint of stratification. There was heavy disturbance by tree roots towards the top of the section. A single piece of rooftile was recovered from this fill (see Finds Report p. 5).

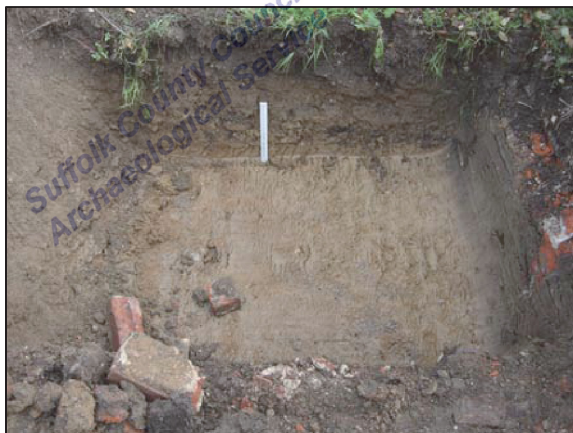
Plate 4 Trench 2 from the west

Trench 2: due to the presence of an existing hard standing and services, it was not possible to position a trench within the footprint of the proposed garage. As a result, a short (1.5 metres by 2 metres) length of trench was excavated

immediately to the west of the proposed garage (Fig. 2 & Plate 4). In addition, after hitting the cast iron heating pipe for a previous greenhouse, the trench was moved slightly further to the west.

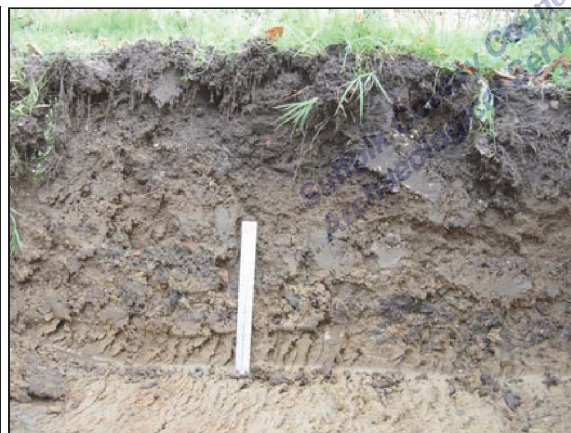
Plate 5 Soil profile, east side of Trench 2

Topsoil was found to be 0.3 metres in deep overlying a similar thickness of homogenous brown silty/sandy clay (0006), a layer thought to equate to 0004 in Trench 1, which gave way to the naturally occurring clay subsoil (Plate 5). No archaeological features were recorded and no finds recovered from the upcast spoil.
