**Proposed Leisure Facility, Stonehouse Road, Hadleigh;  
Record of an Archaeological Evaluation HAD 090**

**SCCAS Report No. 2008/58; Oasis No. suffolkc1-52092**

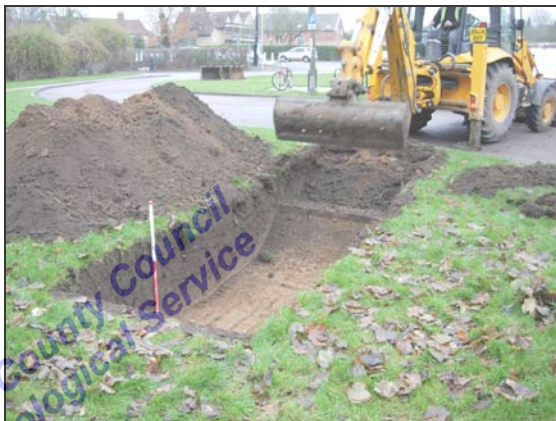
**Plate 1** Trench 1 from the south

**Trench 1:** Orientated from the south-west to north-east, Trench 1 measured 1.5 metres by 5 metres and was positioned in a small area of open grass immediately north of the standing building, its size constrained by the adjacent road and known services, and was entirely within the footprint of the proposed new building (Fig. 2 & Plate 1).

No archaeological features were identified and no finds recovered from this trench.

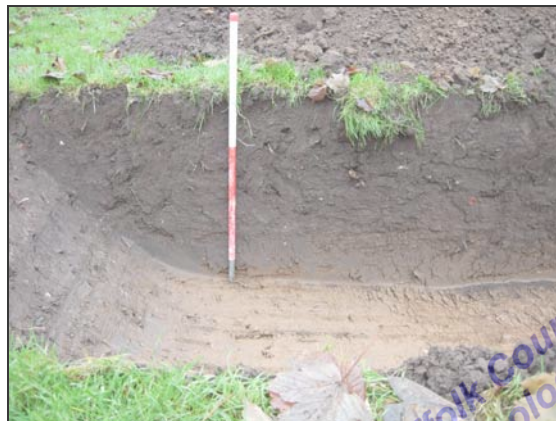
**Plate 2** Trench 1 soil profile

The overburden comprised c.0.65 metres of dark grey/brown loam over a further c.0.25 metres of homogenous, mid brown, very silty, sandy clay which, in turn, gave way to the naturally occurring buff coloured clay/sand subsoil (Plate 2).

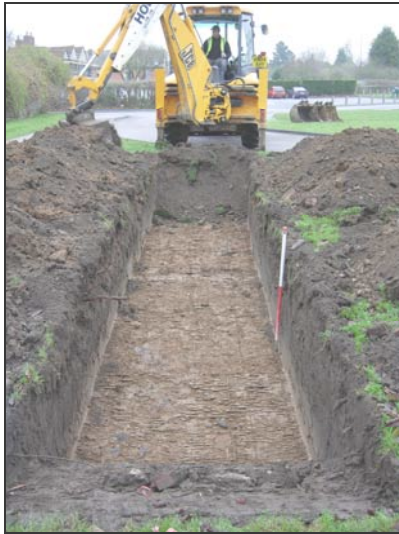
**Plate 3** Trench 2 from the south-west

**Trench 2:** On a similar south-west to north-east alignment to Trench 1, the 1.5 metres wide by 8.5 metres long Trench 2 was positioned along the northern edge of the same grassed area close to the northern wall of the proposed building (Fig. 2 & Plate 3).

No archaeological features were identified and no finds recovered from this trench.

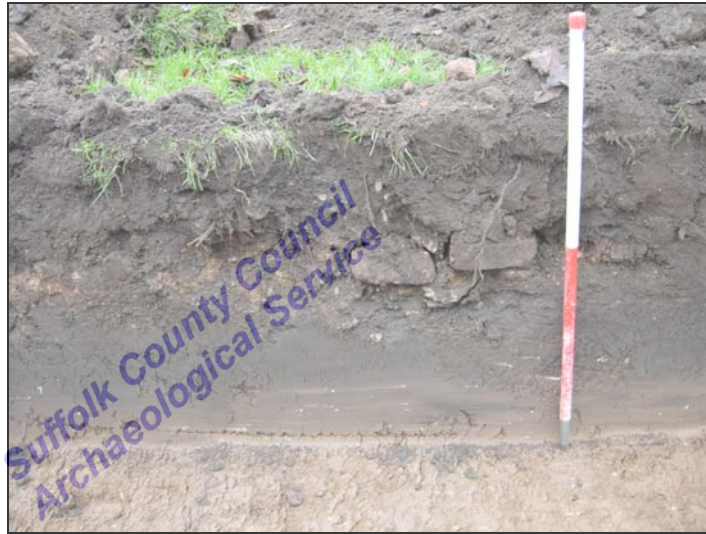
**Plate 4** Trench 2 soil profile

Here, 0.2 metres of heavy loam topsoil gave way to 0.2 metres of mixed loam and rubble which, in turn, gave way to 0.4 metres of dark grey/brown loam topsoil lying directly on the naturally occurring subsoil which, at this juncture, comprised brown silty clay with chalk flecks (Plate 4).

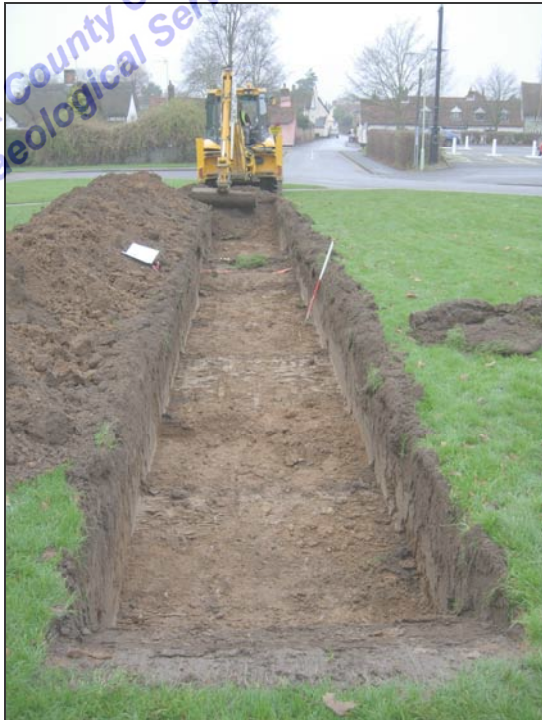
Plate 5 Trench 3 from the south-east

**Trench 3:** Measuring 1.5 metres by 18 metres, north-west to south-east orientated Trench 3 was located within a grassed area that would become parking in the proposed development (Fig. 2 & Plate 5).

One feature was recorded, an iron pipe running across the trench c.10 metres from its southern end. It was not clear if this pipe was live and it did not appear on the service plan.

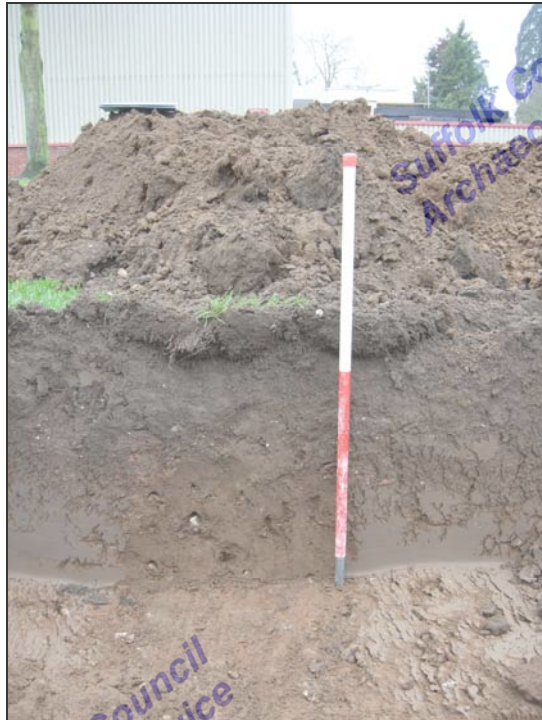
Plate 6 Trench 3 soil profile

The overburden comprised 0.4 metres of heavy loam topsoil overlying 0.3 metres of homogenous brown mixed silt/clay with occasional gravel to pebble-sized stones which, in turn, graded into the naturally occurring yellow/orange sandy clay subsoil with common inclusions of pebble to cobble-sized flints (Plate 6). A single sherd of highly abraded undiagnostic prehistoric pottery was recovered from the intervening layer between topsoil and subsoil.

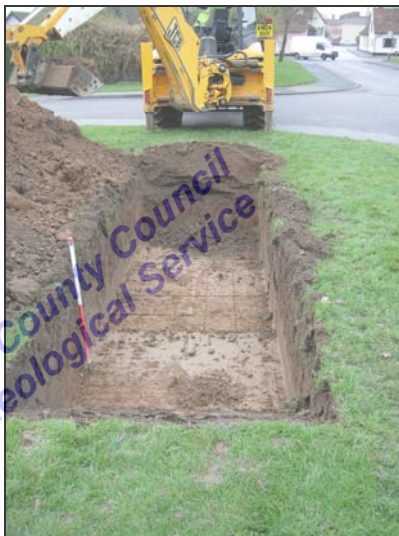
Plate 7 Trench 4 from the south-east

**Trench 4:** Measuring 1.5 metres by 6 metres, north-west to south-east orientated Trench 4 was, like Trench 3, located within a grassed area that would become parking in the proposed development (Fig. 2 & Plate 7).

No archaeological features were identified and no finds recovered from this trench.

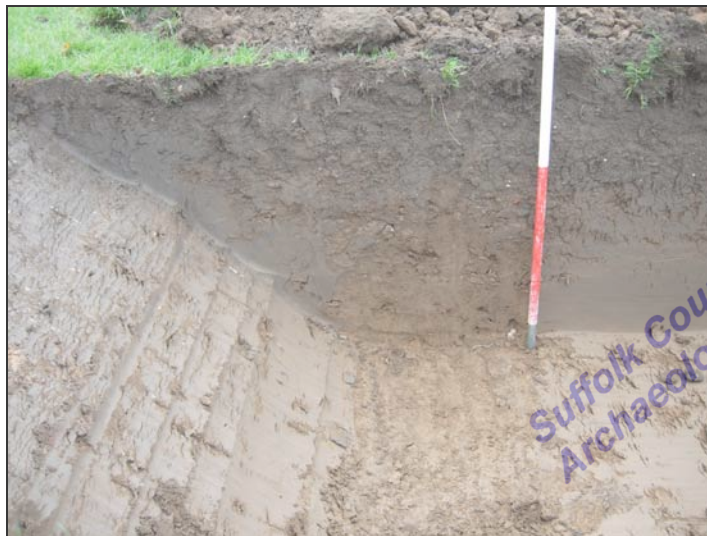
Plate 8 Trench 4 soil profile

At this juncture, the overburden comprised 0.4 metres of heavy loam topsoil overlying 0.5 metres of homogenous lighter brown, stiff, mixed silt/clay sand which directly overlay the naturally occurring subsoil here comprising very silty clay/sand with occasional pebbles (Plate 8).
