HISTORIC BUILDING RECORD

**‘BRICKFIELDS’
SAXMUNDHAM ROAD
ALDEBURGH
(HER Ref. ADB 021)**

SCCAS REPORT No. 2008/074
OASIS ref. Suffolkc1-52644

Summary: A basic photographic survey of a domestic residence known as 'Brickfields', Saxmundham Road, Aldeburgh, was undertaken in April 2008 prior to its demolition. The house was constructed between 1880 and 1900 and is believed to have been built for the manager/foreman of a nearby brickworks. The survey comprises general shots of all major external elevations, a small number of internal pictures and a plan of the interior layout based on a sketch. The site of the brickworks, including this house, is recorded in the County HER under the reference ADB 021. The survey was undertaken by the Suffolk County Council Archaeological Service Field Team who were commissioned and funded by MS Oakes Ltd, building contractors, acting on behalf of their client.

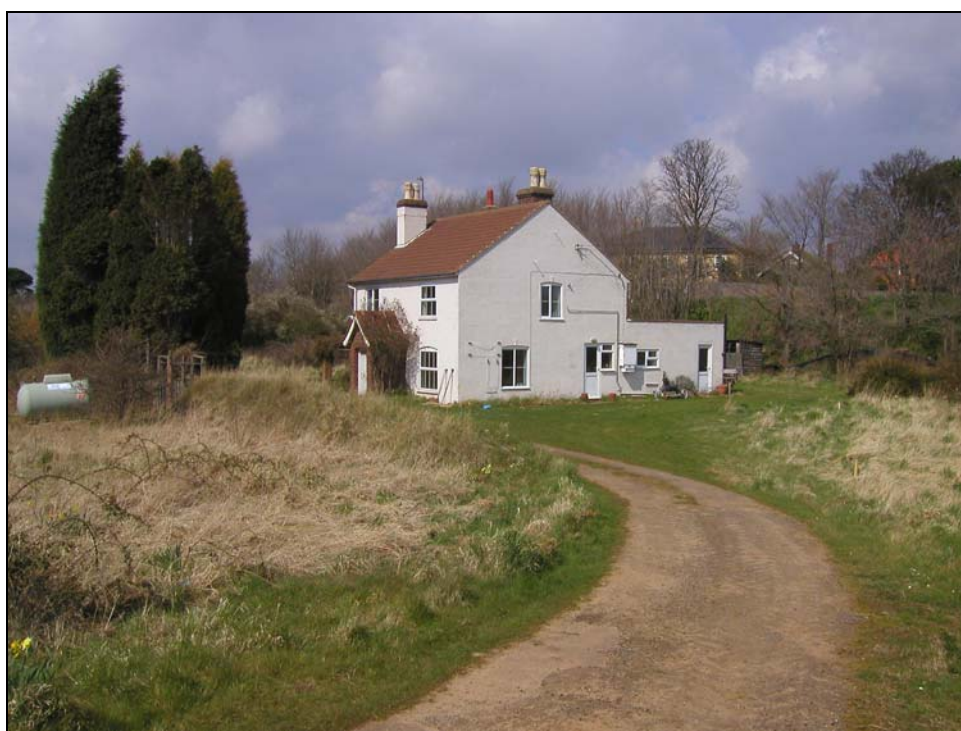
‘Brickfields’
(viewed from southeast)

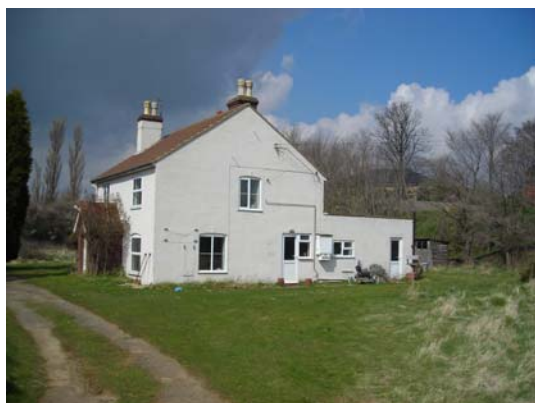
Film+ Frame	Description
FXU 33	'Brickfields', Aldeburgh: view looking west
FXU 34	'Brickfields', Aldeburgh: view looking northeast
FXU 35	'Brickfields', Aldeburgh: outside toilet view looking northwest
FXU 36	'Brickfields', Aldeburgh: outhouse with brick moulds, view looking northwest
FXU 37	'Brickfields', Aldeburgh: outhouses/sheds, view looking west
FXU 38	'Brickfields', Aldeburgh: view looking southwest
FXU 39	'Brickfields', Aldeburgh: view looking northwest
FXU 40	'Brickfields', Aldeburgh: view looking east
FXU 41	'Brickfields', Aldeburgh: view looking southwest
FXU 42	'Brickfields', Aldeburgh: view looking south
FXU 43	'Brickfields', Aldeburgh: view looking northwest
FXU 44	'Brickfields', Aldeburgh: view looking west
FXU 45	'Brickfields', Aldeburgh: view looking southwest
FXU 46	'Brickfields', Aldeburgh: interior view, ground floor view from room in SE corner looking northwest at doors to living rooms and kitchen

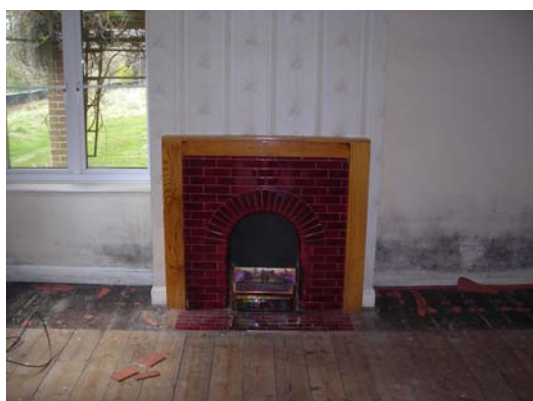
FXU 47	'Brickfields', Aldeburgh: interior view, ground floor room in SW corner – fireplace
FXU 48	'Brickfields', Aldeburgh: interior view, ground floor room in NW corner – fireplace
FXU 49	'Brickfields', Aldeburgh: interior view, 1st floor room in SE corner – fireplace
FXU 50	'Brickfields', Aldeburgh: interior view, 1st floor room in SW corner - fireplace

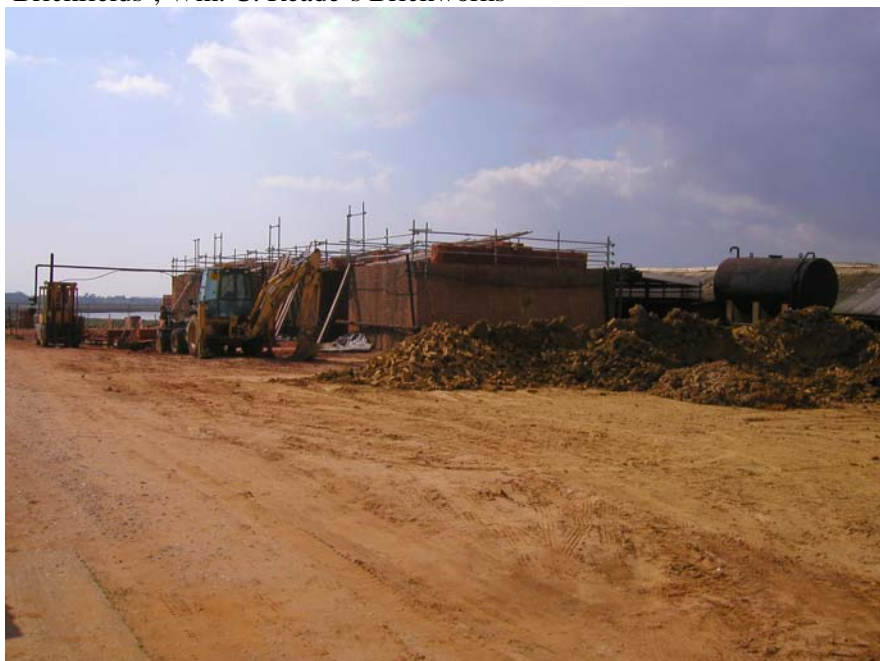
kilns (FXU 51)
