**United Reform Church,
(Former Congregational Chapel),
Old Street, Haughley,
Suffolk
(TM 027 629)**

An Archaeological Record

This report provides a written and photographic record at English Heritage (2006) Level 2 of a redundant chapel and associated hall. The report has been prepared to a brief written by the Archaeological Service of Suffolk County Council (Dr Jess Tipper, 23 October 2008, Ref. /FormerUnitedReformChurch_Haughley2008) and is intended to fulfil a condition of planning permission for residential conversion partial demolition (Mid Suffolk District Council application 2202/08).

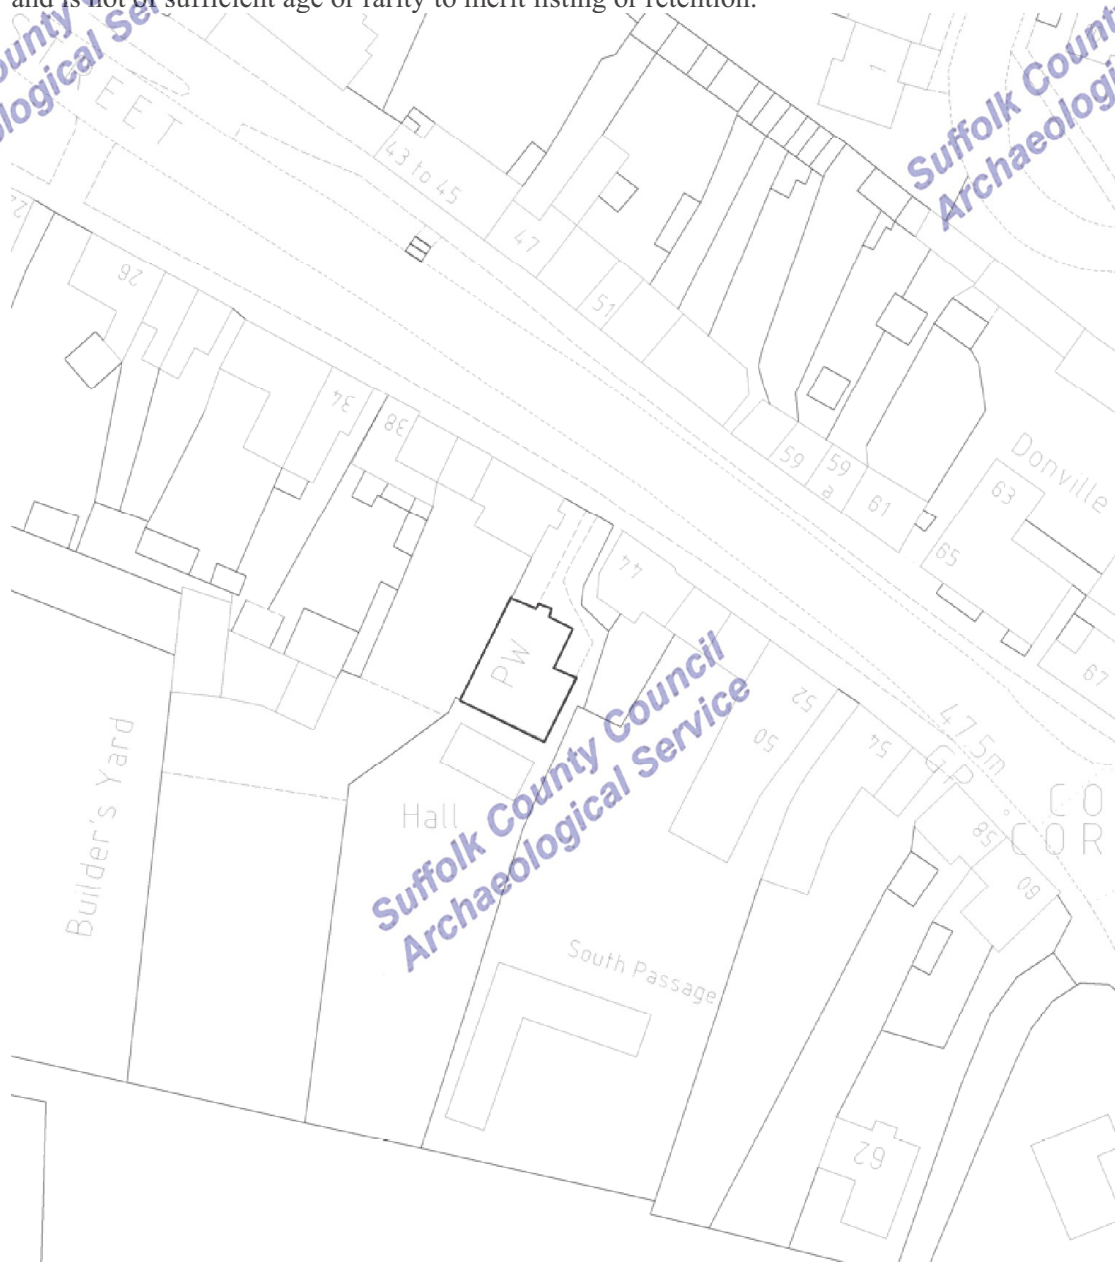
Figure 1
Existing Ordnance Survey Site Plan
Outlining the Chapel and attached vestry and showing Old Street to the north and the rectangular profile of Chapel Hall (1932) to the south

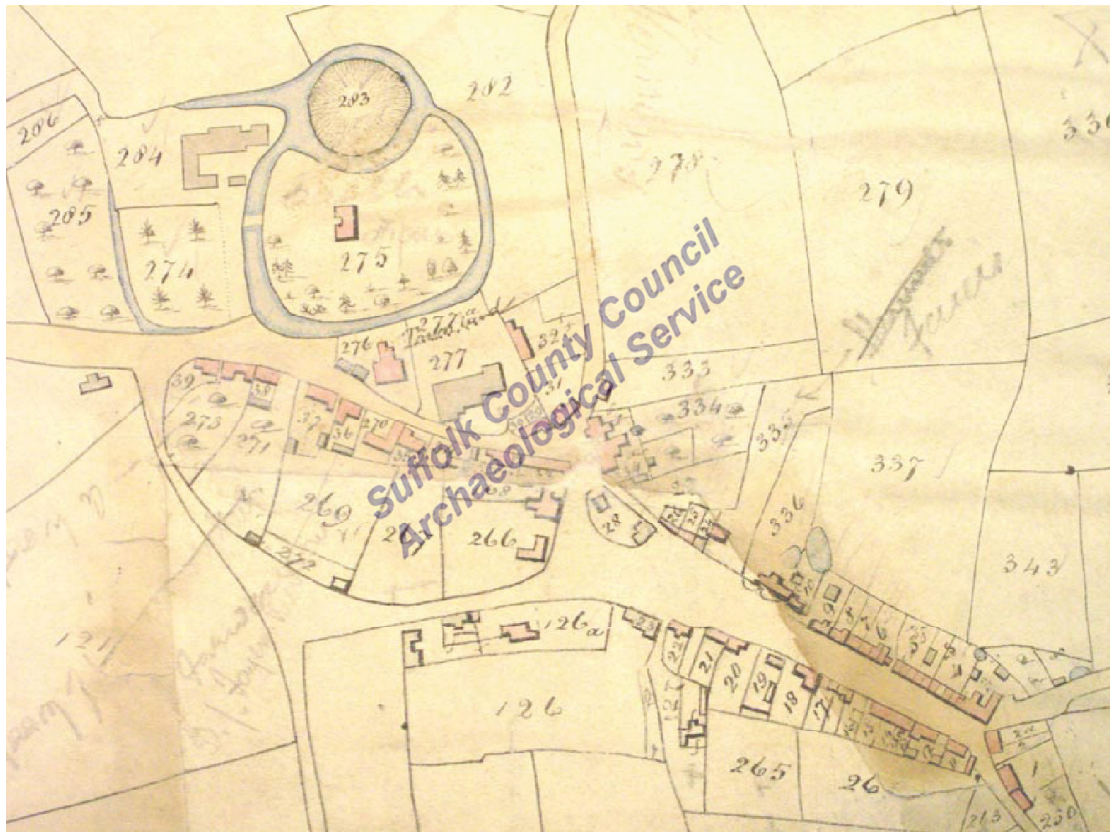
Figure 2

Haughley Tithe Map of 1844, showing the layout of the town to the south of the castle motte, with detail of the 'Chapel and Yard' (no.16) beneath. Ipswich SRO

The Haughley tithe map (figure 2) shows the square outline of the chapel (ostensibly without its porch), but dates from 1844 and does not contribute to the local debate over its year of construction. The accompanying apportionment describes the property (no. 16) as a 'Chapel and yard' owned by William Prentice along with the two adjoining cottages and gardens (nos. 15 and 17); the three properties were occupied by 'Charles Burrs and others'. No earlier detailed maps of Haughley village are known. The first and second edition Ordnance Surveys (figures 3 and 4) show a similar situation, but the porch is clearly defined and the smaller predecessor of the present vestry is shown attached to the southern end of the eastern elevation. The 'W' in the front yard refers to a well of which no trace is now apparent.

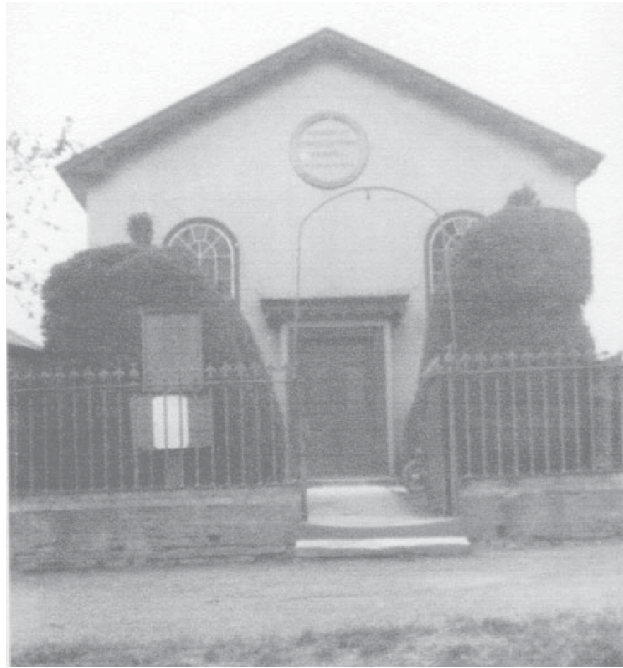
Figure 5
The northern gable in an old photograph
(from a copy in the possession of the present owners)

The photograph above probably shows the building in its original condition, with a rendered exterior, arched windows and a circular cartouche containing its (illegible) date of foundation. This elegant façade was provided with a skin of red brick during the 20th century and its windows replaced, leaving only the porch *in situ*. The wooden hall used for Sunday School and other ancillary functions and known as the ‘Chapel Hall’ was erected in 1932, according to the aforementioned note pinned to its notice board (entitled simply ‘Haughley Chapel 2000’). The same note dates the eastern brick extension to 1995, when it replaced an earlier Chapel vestry and included a kitchen, toilet and new vestry. The building became part of the United Reform Church when the ‘Presbyterian Church of England’ and the ‘Congregational Church of England and Wales’ amalgamated in 1972, but was recently sold for residential conversion. The Congregational church derived from the Protestant Nonconformist tradition, and was based on a theory of union published by the theologian Robert Browne in 1592.

wall fabric was clad in lath-and-plaster both inside and out. The original external plaster and arched windows shown in figure 5 were removed in the 1930s or 40s when the present rectangular window apertures were inserted and the existing four-inch skin of red brick applied. A small vestry was added between 1844 and 1886, as shown by figures 2 and 3, but this was replaced by the present eastern extension in 1995. The door to the earlier vestry at the southern end of the eastern elevation remains in use, and the shallow, flat-roofed northern porch with a decorative eaves board probably survives from the original building. The porch door is shown in figure 5 and is also probably original.

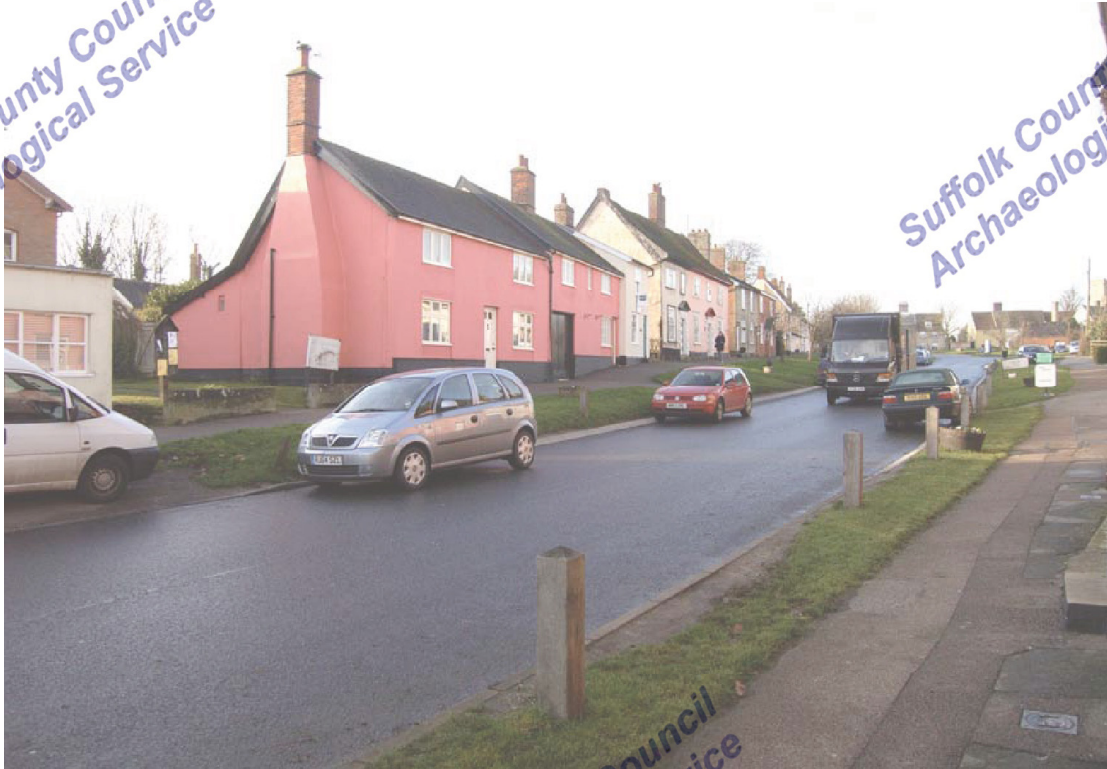
A2.1 General view of Old Street from east showing Chapel behind street frontage on left & St Mary's Church in distance to right

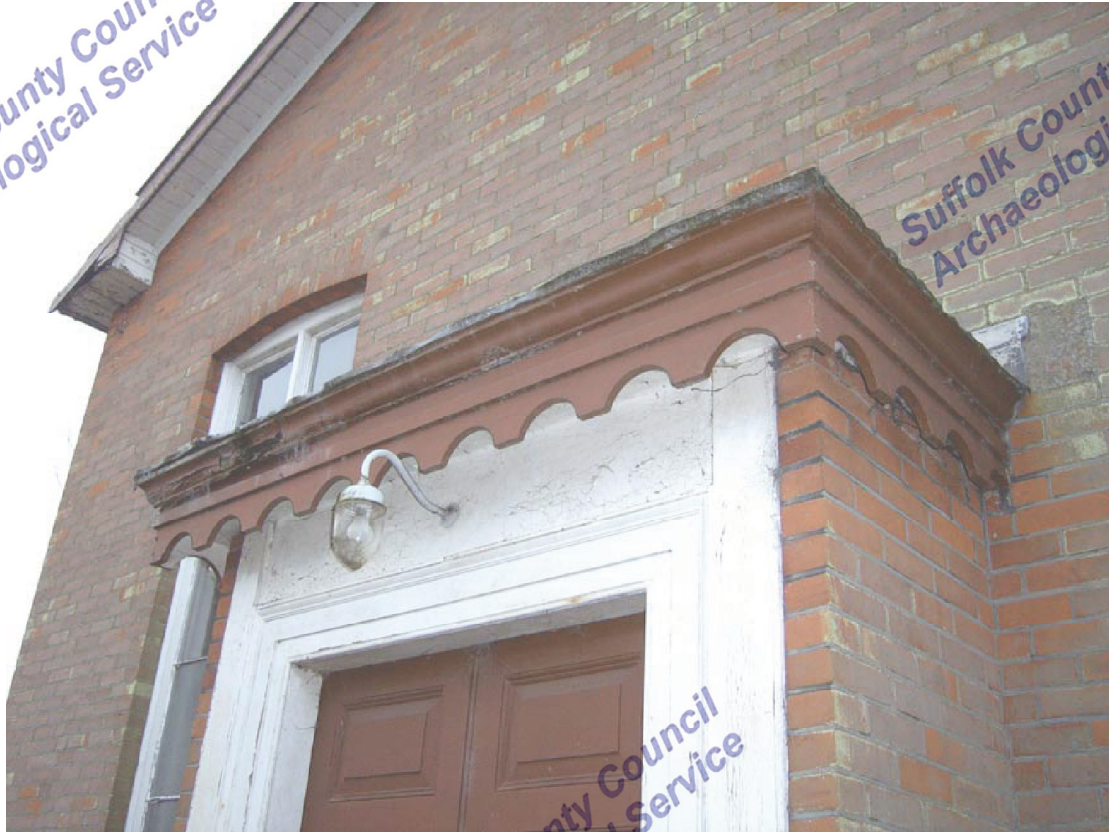
A2.3 Detail of original northern door and porch of 1843 showing decorated eaves board with early-20th century brick cladding

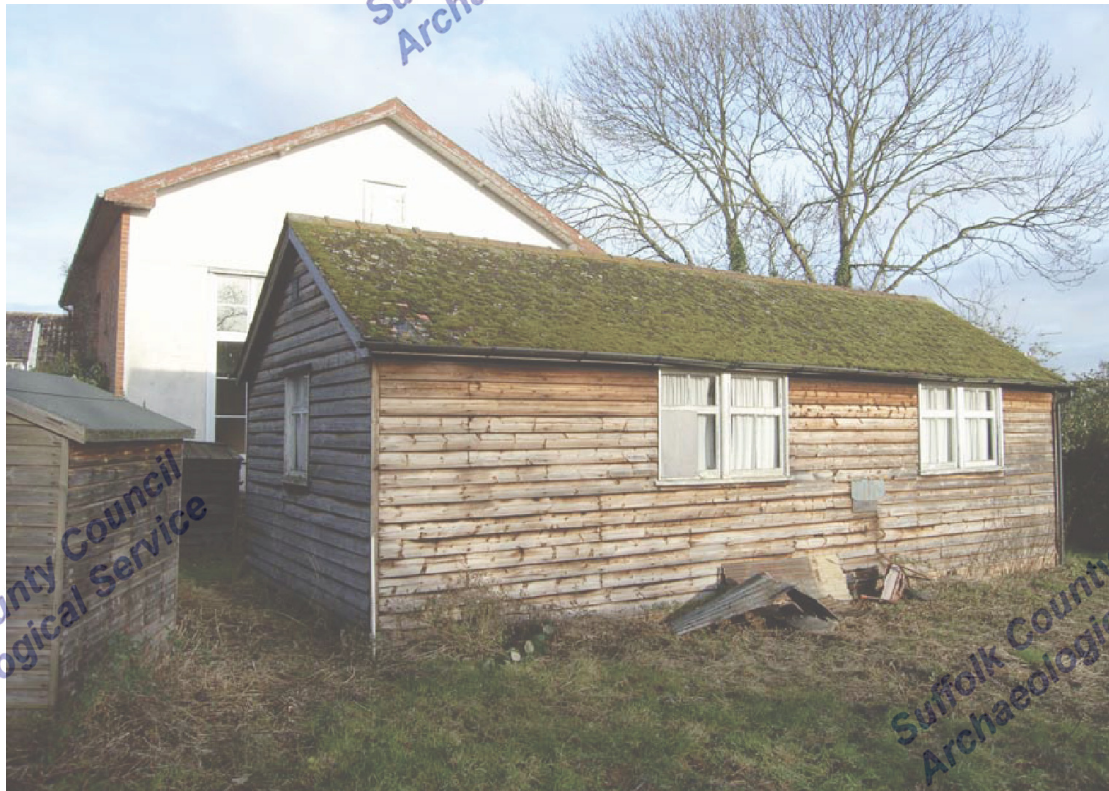
A2.4 Southern elevation of Chapel Hall from south-west showing rear gable of Chapel to left

A single-storied wooden shed with boarded interior and exterior is aligned on an approximately east-west axis at right-angles to the Chapel and 3.3 m (11 ft) from its rear gable. This structure, which extends to 10.4 m in length by 4.5 m in width (34 ft by 15), was built in 1932 according to the information sheet on its notice board. It contains an entrance door at both ends of its southern elevation, and an area 1.5 m in length at its western gable can be partitioned by a sliding screen to form a separate compartment. This hall was designed to accommodate Sunday schools and other ancillary activities, and is not of sufficient age or rarity to merit listing or retention.

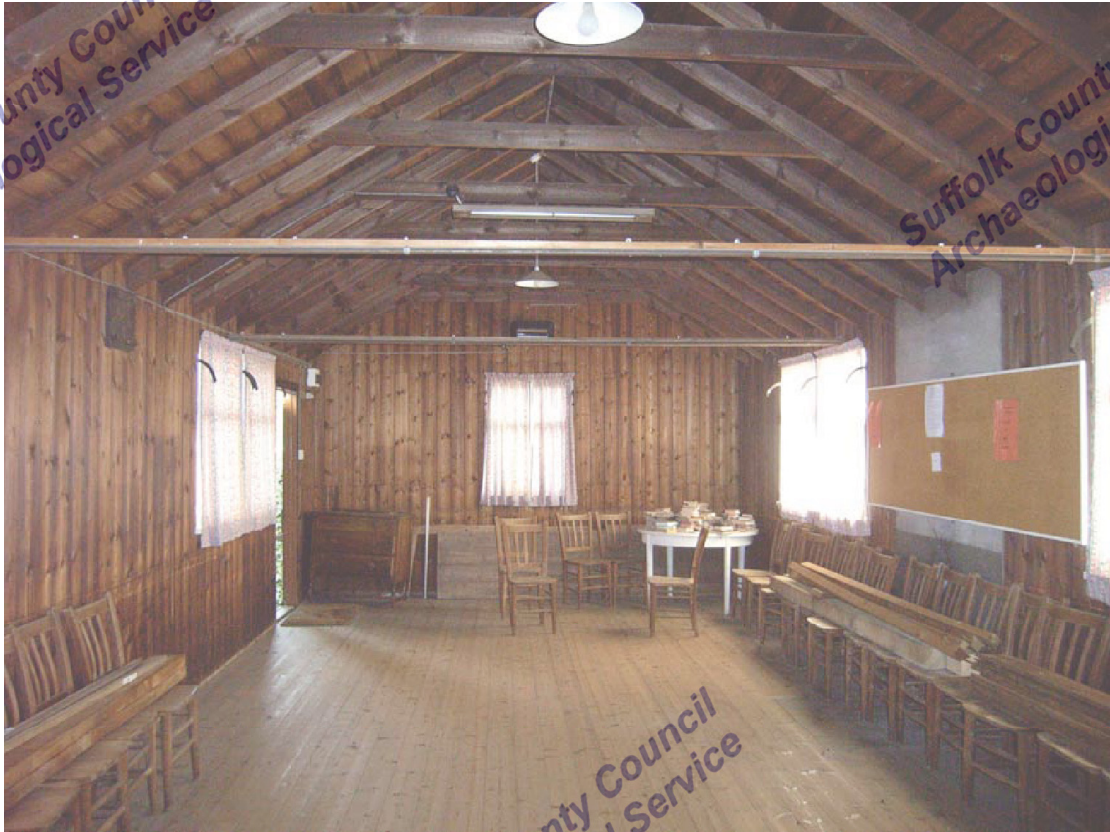
A2.5 Interior of Chapel Hall of 1932 from west

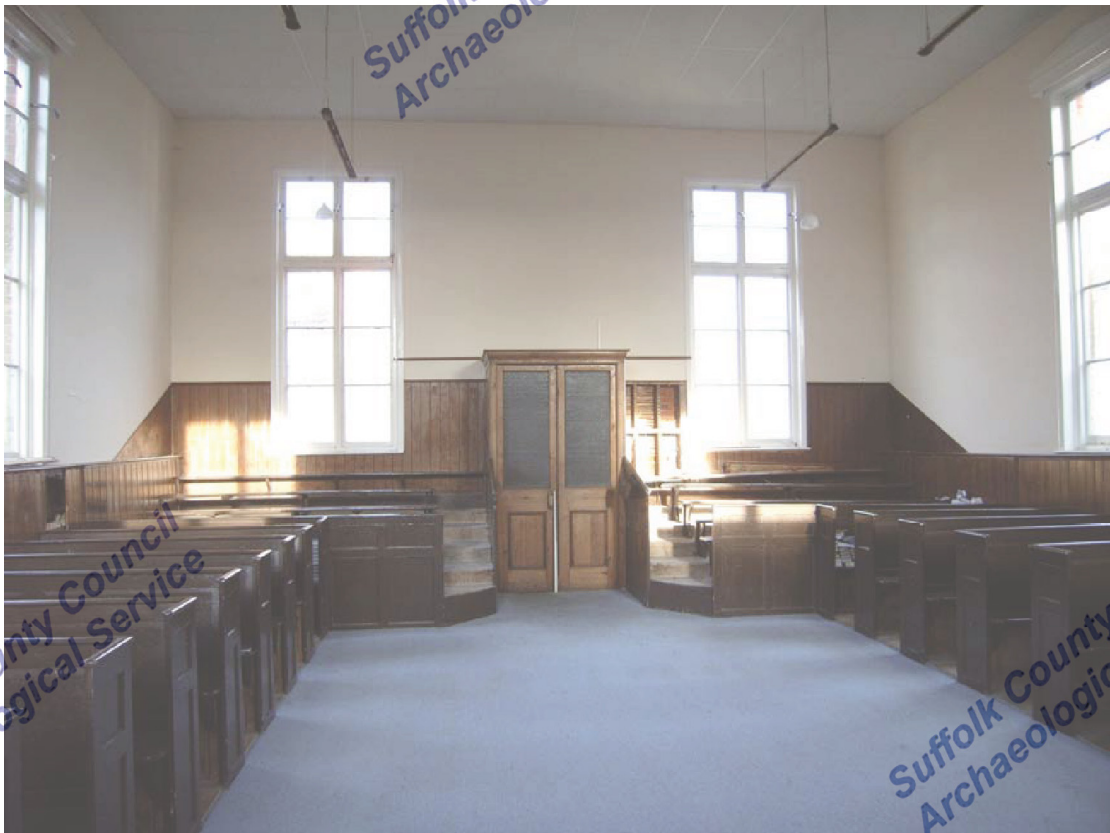
A2.6 General view of interior of Chapel from south showing original northern entrance with internal porch

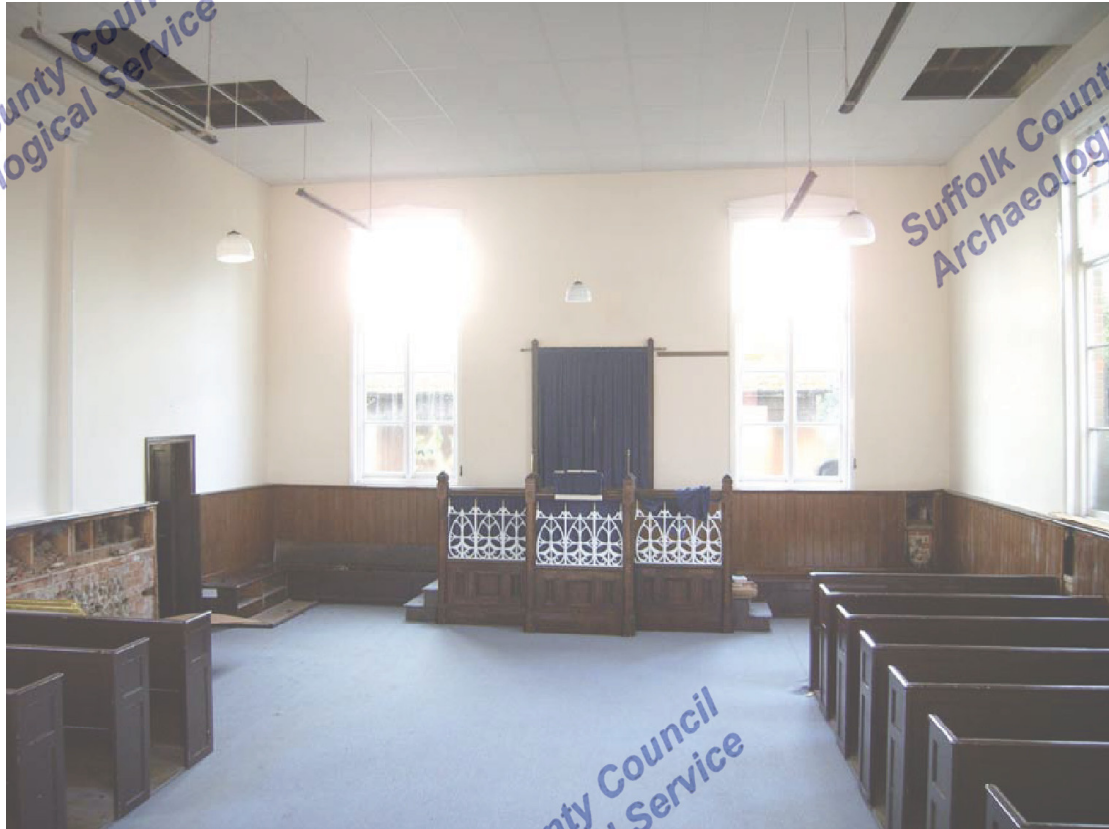
A2.7 General view of interior of Chapel from north showing reading desk opposite original entrance with blocked window and door to vestry of 1995 on left

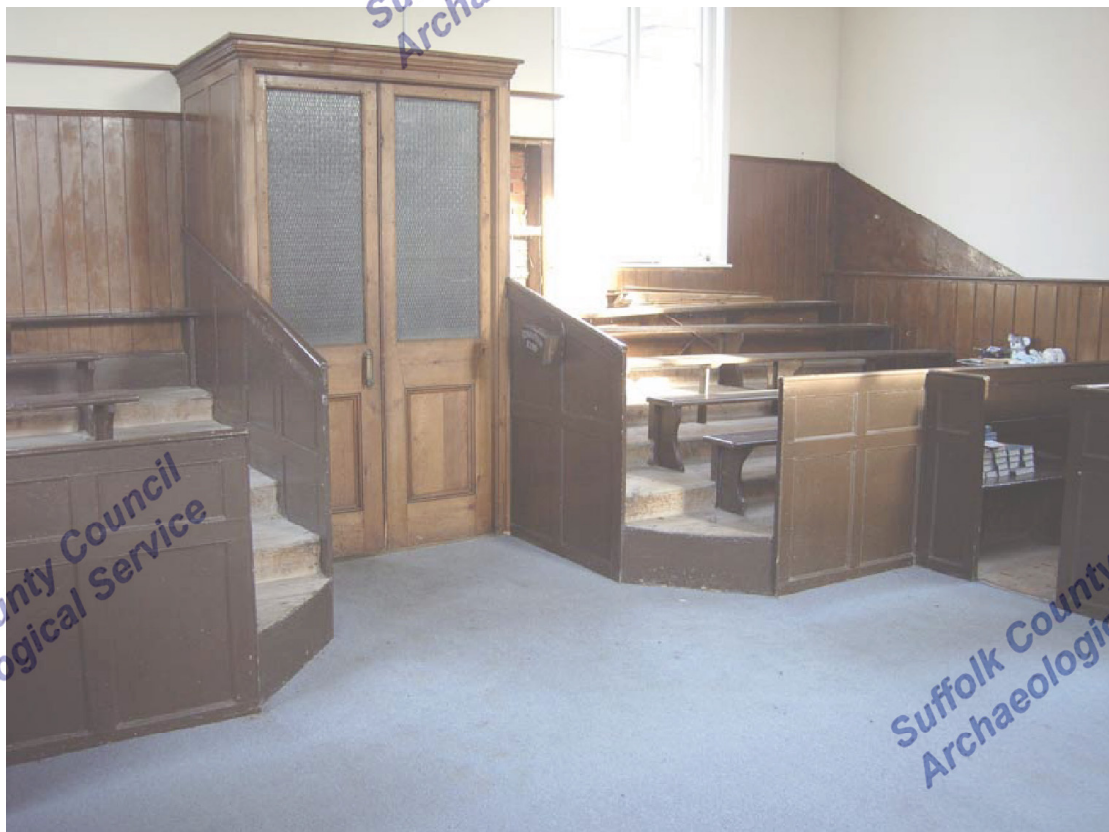
A2.8 Detail of internal porch and raised benches against northern elevation

Given its much-altered external appearance, the building does not merit listing but is of considerable historic interest due to the survival of its internal fittings. The painted benches with panelled and chamfered backs and square ends which adjoin the eastern and western elevation, (facing a 20th century reading desk or platform in the centre of the southern gable) are fine examples of their type. Tiers of benches without backs flank the internal entrance porch and seem to have been designed for children given their relatively low height. Each tier was provided with a small cross-bench to serve as a table (one of which contained toys at the time of inspection). The side walls are protected with pine wainscot to a height of 1.4 m (56 ins), but this may have been renewed.

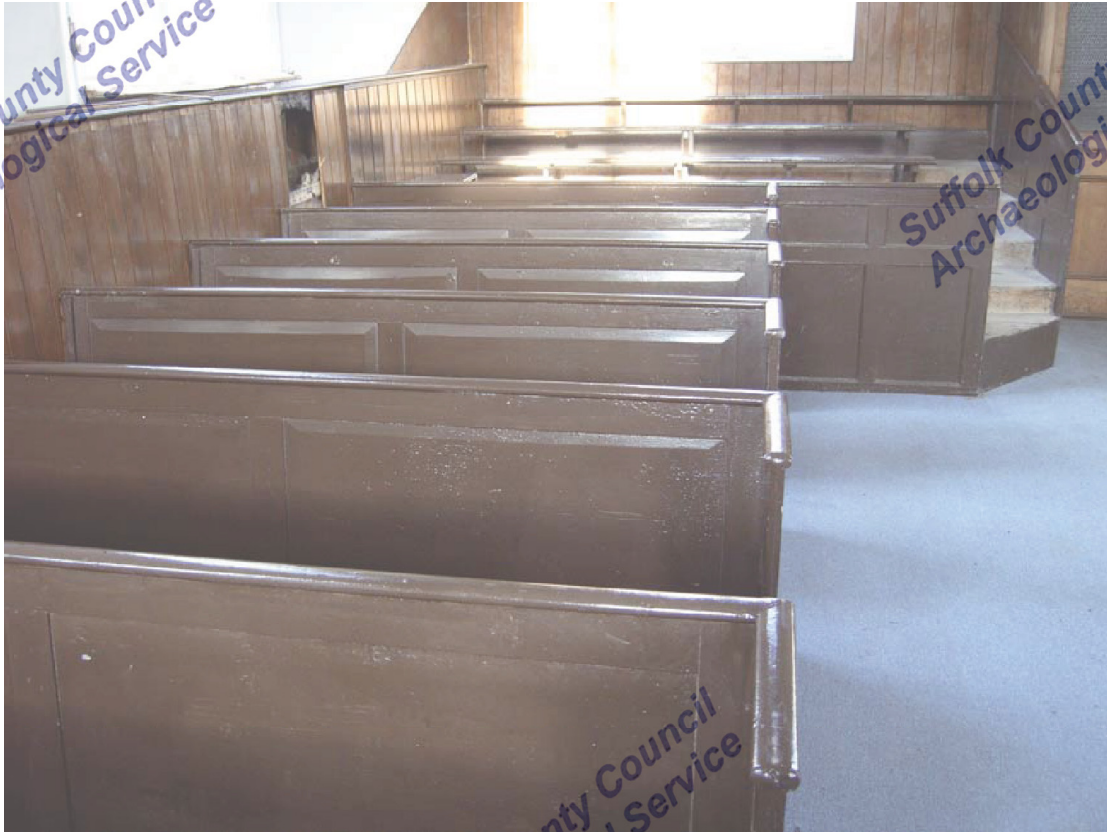
A2.9 Detail of chamfered boarded bench backs to western elevation (from south)

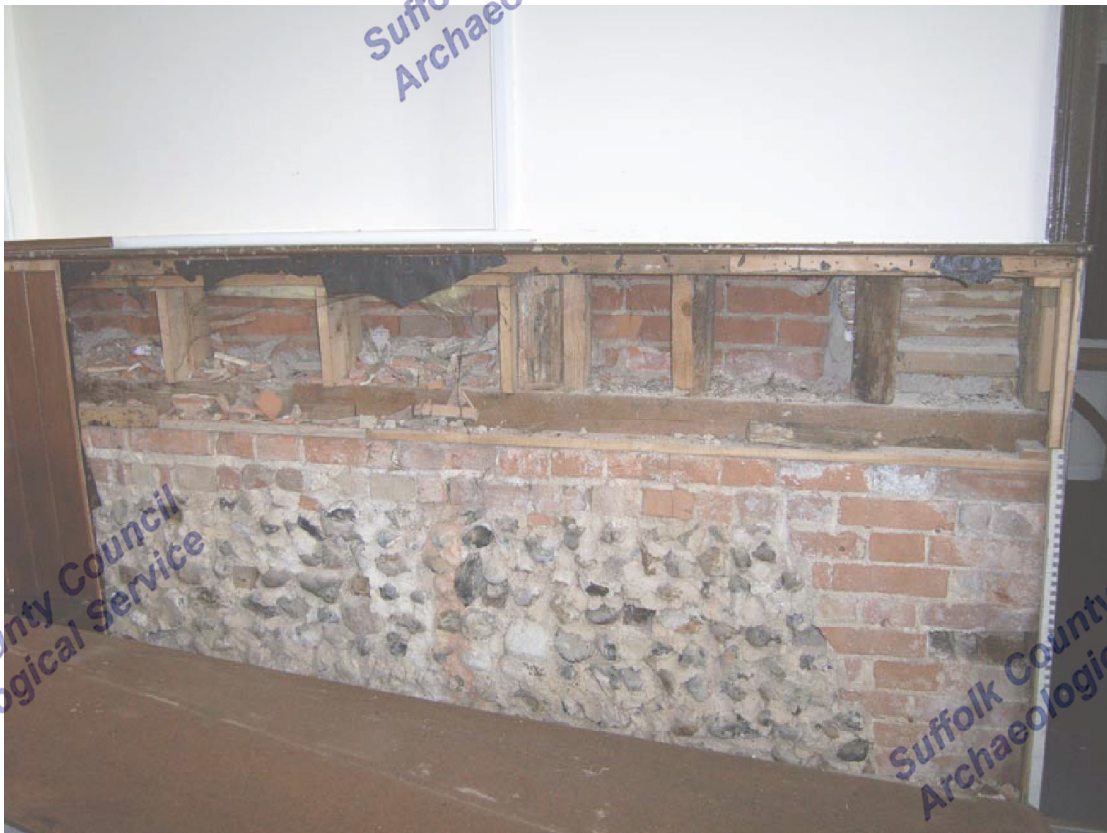
A2.10 Detail of flint plinth and studwork to interior of eastern elevation with vestry door to right

The original chapel of 1843 or 1835 formed a simple rectangular hall with a central entrance in its northern gable and extended internally to 11.75 m in depth by 6.25 m in width (38.5 ft by 26.5). Its walls rose to 5.1 m in height (17 ft) at the eaves and consisted of softwood studs on a tall plinth of flint rubble with dressings of red brick (1 m in height). A rendered horizontal ceiling of tall-sectioned softwood joists concealed the low-pitched rafters and the
