Trial Hole for new Pipeline at Wixoe WIX 017

Archaeological monitoring report.

Planning Application No: Pre MWH
Grid reference: TL 7096 4313
Date of fieldwork: 23rd November 2004
Project Officer: Jo Caruth
Oasis reference: suffolkc1-5315
Funding Body: Essex and Suffolk Water Company

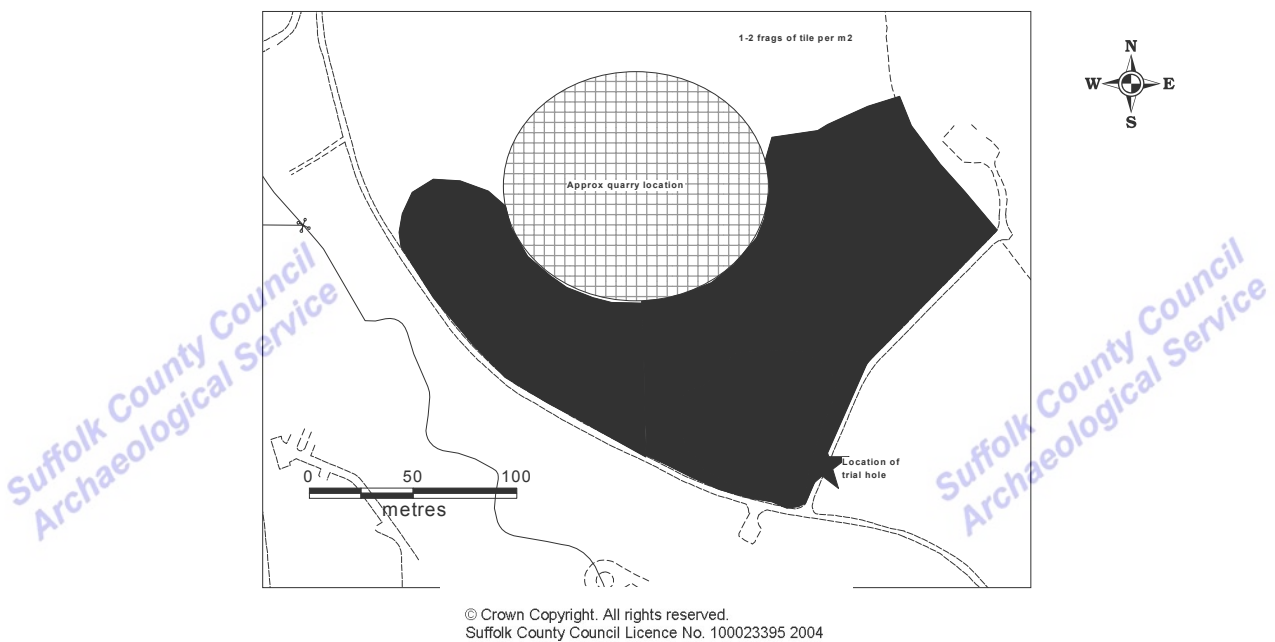
Figure 3 Sketch of tile distribution

Prior to the excavation a rapid survey of the field was carried out. This broadly identified differing densities of broken tile lying on the surface of the ploughsoil (Figure 3). Some pottery sherds were also seen and two interesting sherds collected and identified as part of a small whitewear mortarium, probably mid-late 2nd century and the base of a Roman flagon (C. Tester pers comm). The piece of mortarium was large and unabraded, demonstrating that archaeological deposits under the ploughsoil are still being newly disturbed (implying both the potential for deposits that remain undamaged and indicating that plough damage is increasing).

A systematic fieldwalking survey of this field would be worthwhile, it would closely locate the concentrations of finds giving clues as to the extent of the villa complex. The evidence from the trial hole appears to indicate that it lies within the property boundaries of the villa, but outside the building itself, however structural elements of the building may lie within the immediate vicinity.
