Decoy Farm, Melton, Suffolk

Archaeological Record

**Decoy Farm,
Old Church Road, Melton,
Suffolk**

An Archaeological Record

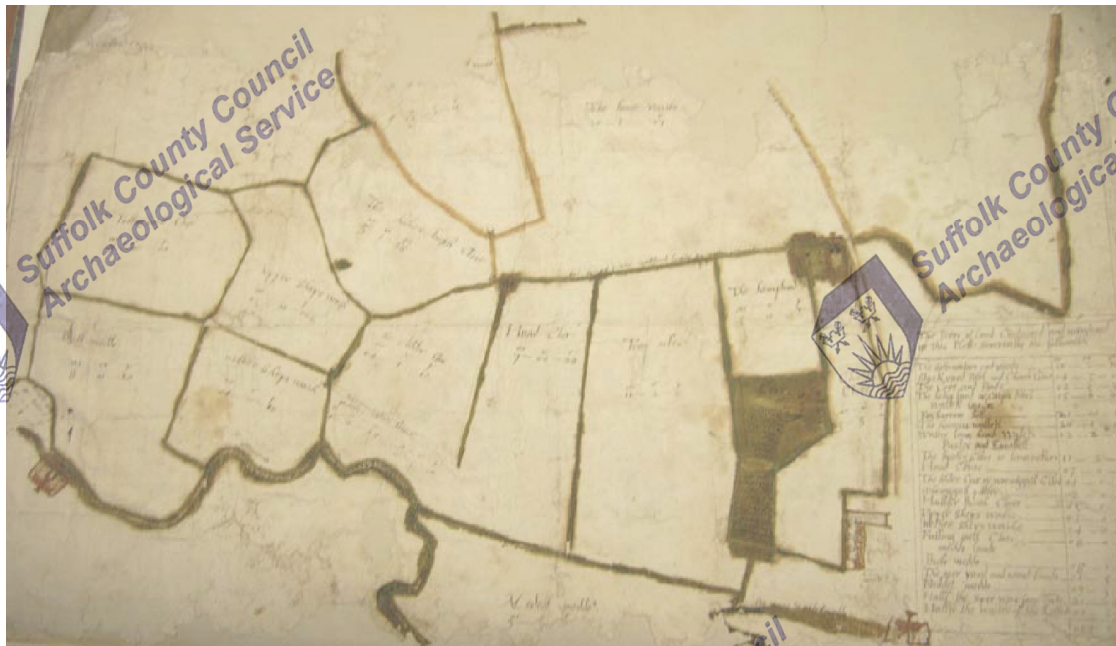
Figure 2
Manuscript map of early-17th century (Ipswich SRC HD80/1/1). North to right

A rare manuscript map of the farm in the Suffolk Record Office bears no date but is stylistically consistent with the early-17th century (figure 2). It shows a substantial holding of 140 acres along with the church and mill together with a second mill further downstream. The farmhouse is depicted with a central chimney and a fully enclosed eastern courtyard at the junction of the present road and a track marked 'the way from wellford bredg to melton Church' which is now a public footpath. Two barns form a farm yard adjoining the house to the south, and the pond is shown as three separate areas of water divided by narrow baulks with the westernmost labelled 'Coye' (i.e. decoy). The field to the south of the house is marked 'Stack yard pittell' (i.e. pightle), adjoining 'Church Close' to the east and 'The Hemplond' to the south. The list of field names refers to the ponds as 'The Coye and Ponds', suggesting that only the westernmost of the three (which tapers to a point) operated as a decoy. The map lacks its original title, but is inscribed 'A Mapp of The Decoy Farme in Melton' in an 18th century hand on the reverse.

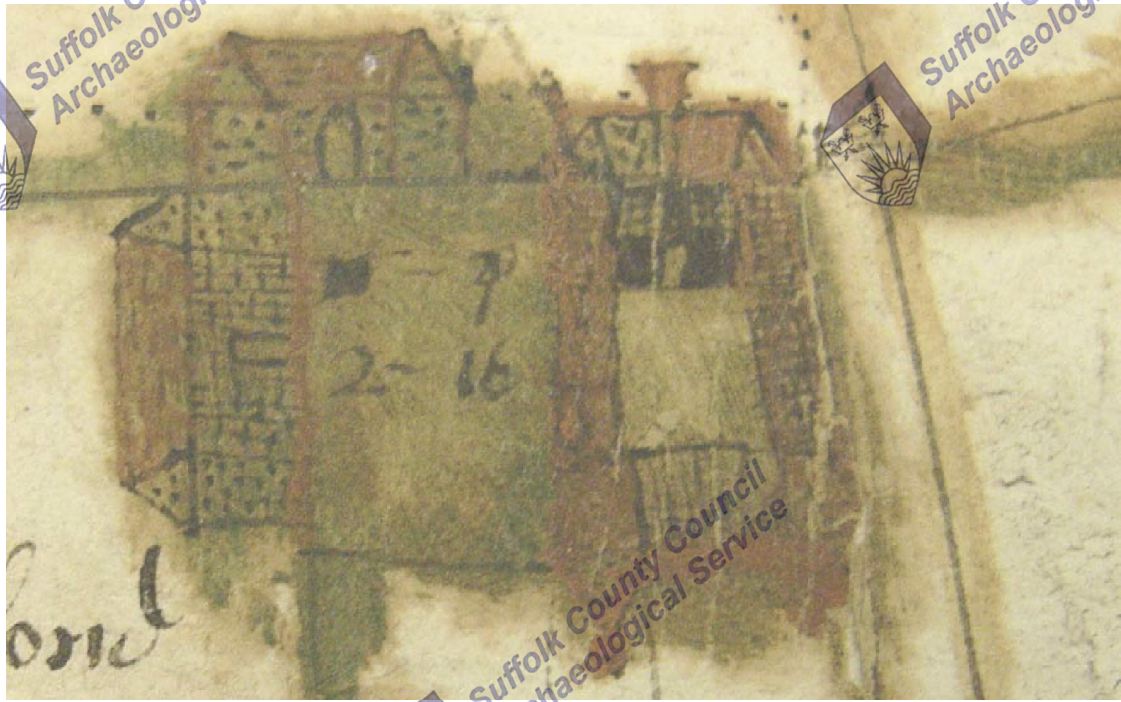
Figure 2a

Detail of figure 2 showing the house to the right and an adjoining farmyard formed by two barns on the south and west (the stylised buildings are shown with both gables flanking their elevations). The building at the eastern end of the farmhouse courtyard is depicted upside-down.

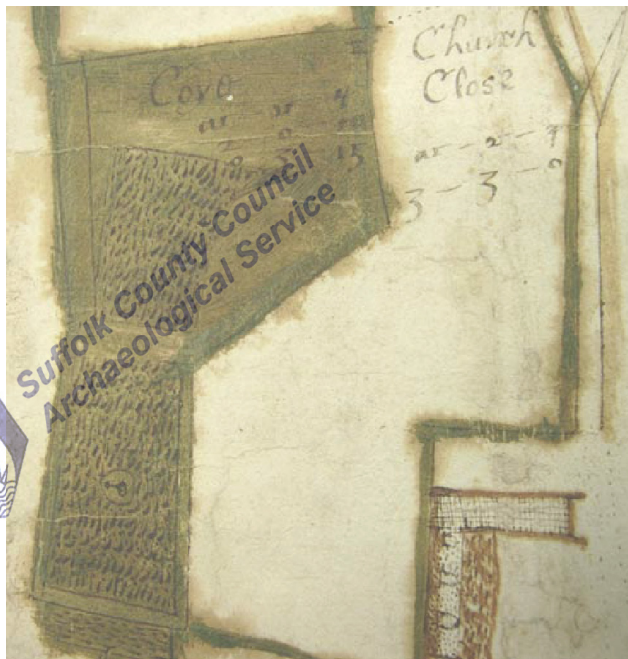
Figure 2b (left). Detail of the three ponds, with the westernmost labelled 'Coye'. An obelisk is shown on a circular island or platform in the centre of the central pond.

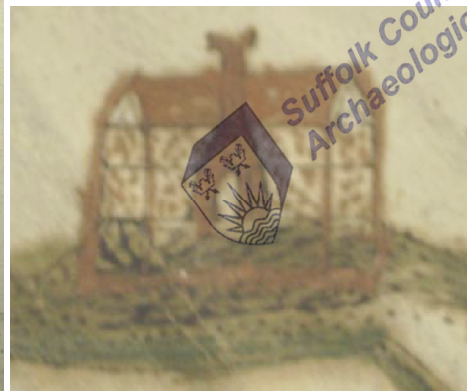
Figure 2c (right). Detail of the downstream mill, east of 'Fulling mell close', curiously depicted with an external chimney and a small wheel against its left-hand gable. Melton mill is shown in the same distinctive manner.

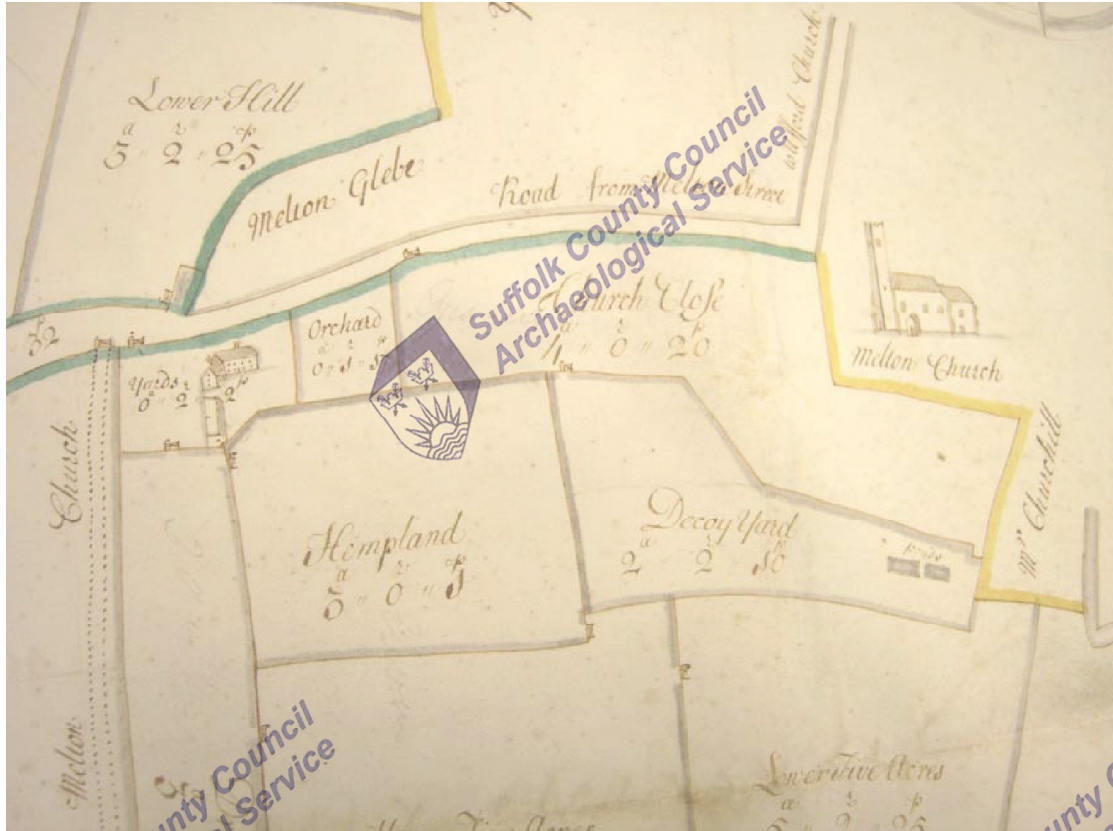
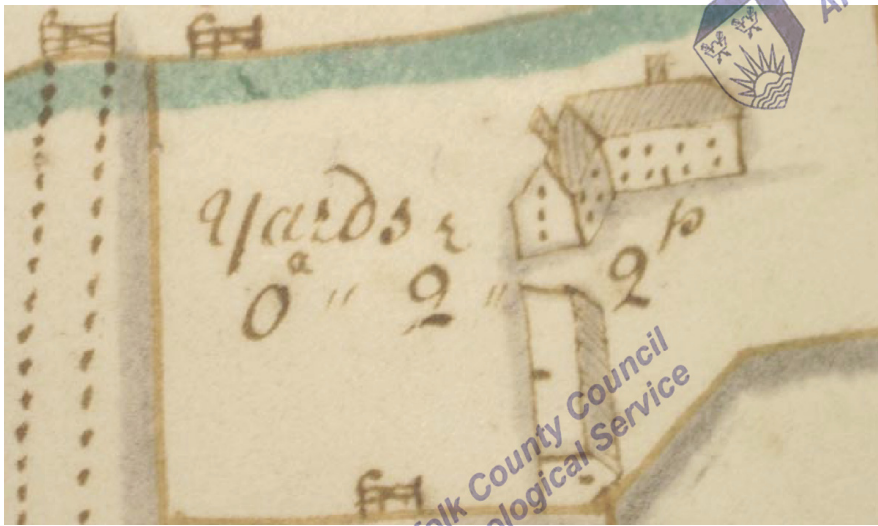
A second manuscript map of 1725 is entitled 'A Plan of an Estate lying in Melton belonging to Daniel Vickers Gentleman', with a later inscription: 'now of John Jeaffreson Gentleman' (SRO HD80/1/1). The farm contained 154 acres, and included two rectangular 'ponds' in a 'Decoy Yard'. Only the western barn of the earlier map had survived, and the farmhouse had lost its eastern courtyard and is shown with the L-shaped profile it still possesses. A later note to the reverse reads: 'Plan of Mr John Jeaffreson's Estate taken by Kirby in 1725, now much alter'd from lands sold to ye Corporation of Loes & Wilford Hundreds by the late Rev. C. Jeaffreson with other changes.' The workhouse for the parishes of Loes and Wilford Hundreds was built in Melton in 1765 and converted into the Suffolk Lunatic Asylum in 1827 (according to Whites Trade Directory of Suffolk for 1844).

Figure 3
Kirby's map of 1725, with detail of house and barn below

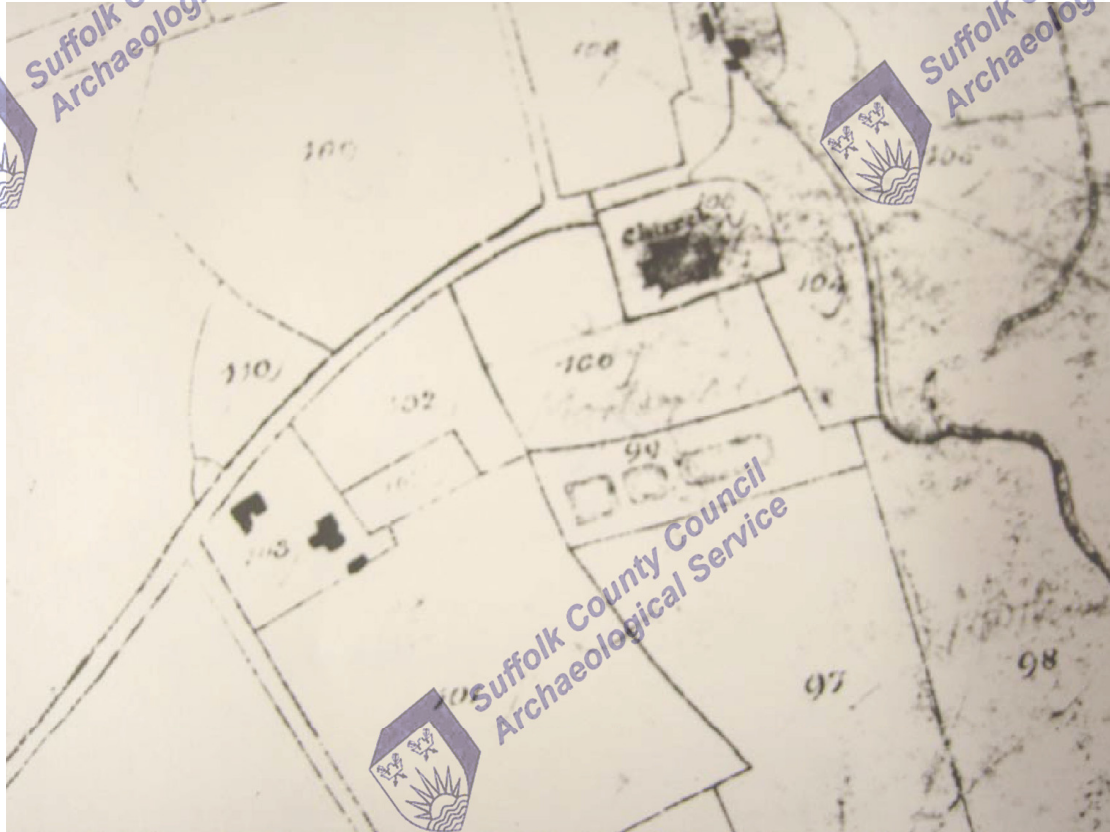
Figure 4
Melton Tithe Map of 1838 (SRO P461/171)

The difference between the Melton tithe map of 1838 and the First Edition Ordnance Survey of 1881 is striking. The former shows what appears to be a single barn with a west-facing central porch to the south-east of the farmhouse, while the latter shows the existing complex of brick buildings on approximately the same site. Agricultural redevelopment of this kind occurred on many Suffolk farms in the 1840s and 1850s as intensive cereal production was replaced by mixed animal husbandry in response to the collapse in grain prices and the arrival of the railways (which opened-up new urban beef and dairy markets). The existing barn (building 3 in figure 1) appears to be identical in construction to the rest of the yard, and it is not clear whether the barn of 1838 was the same as that depicted in 1725; the barns are shown much closer to the farmhouse on the two earlier maps, but manuscript surveys of this type were not always fully accurate.

The tithe apportionment records the size of the farm at 140 acres in the ownership of John Jeaffreson and the tenancy of John Hunt, but Jeaffreson owned another 37 acres to the south in separate occupation (including 'Soap House marsh'). The area of the ponds (99) was described simply as 'Decoy ponds' and the house and farm buildings (103) as 'Homestead, yards and gardens, stackyard, etc.'. The field to the east of the house (102) was Granary meadow and that to the south (101) barn field, while 'Church piece' lay between the ponds and church (100).

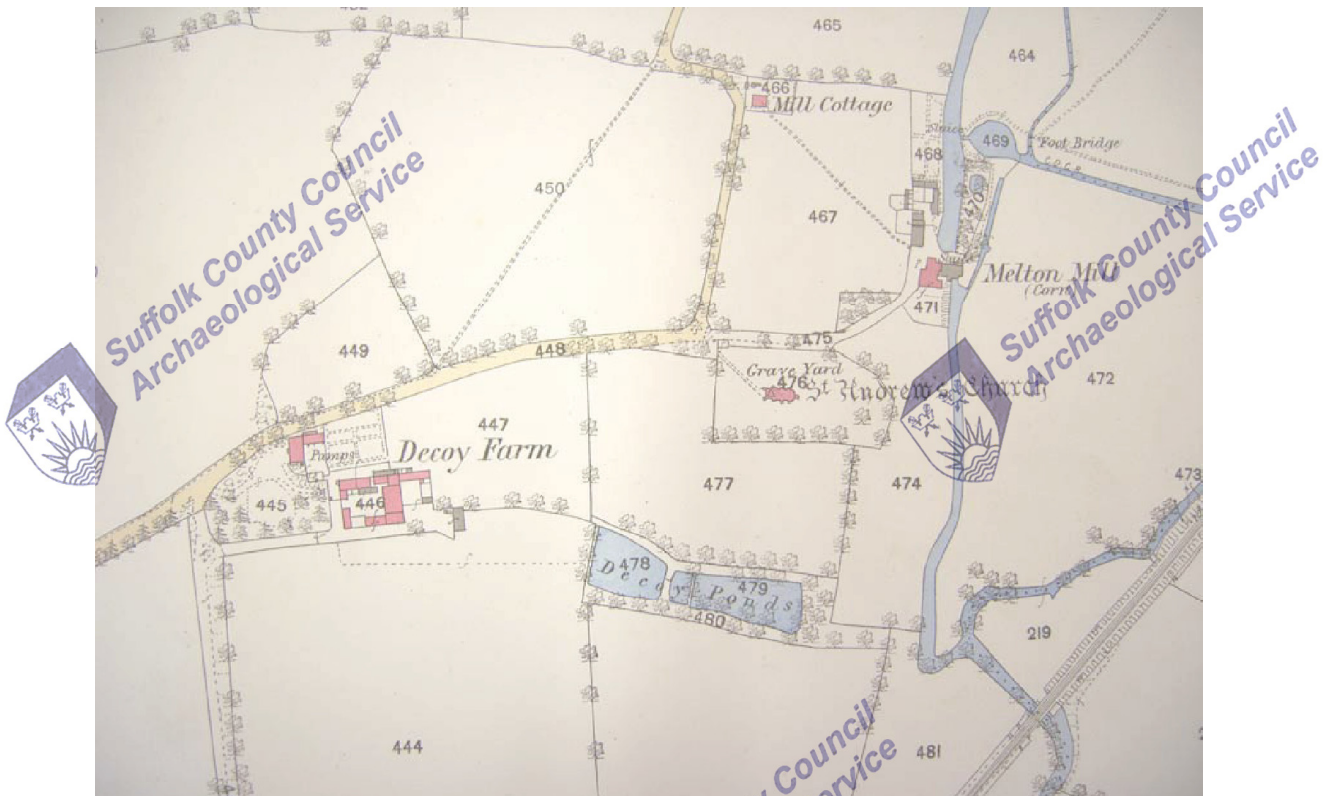
Figure 5
First Edition Ordnance Survey of 1881

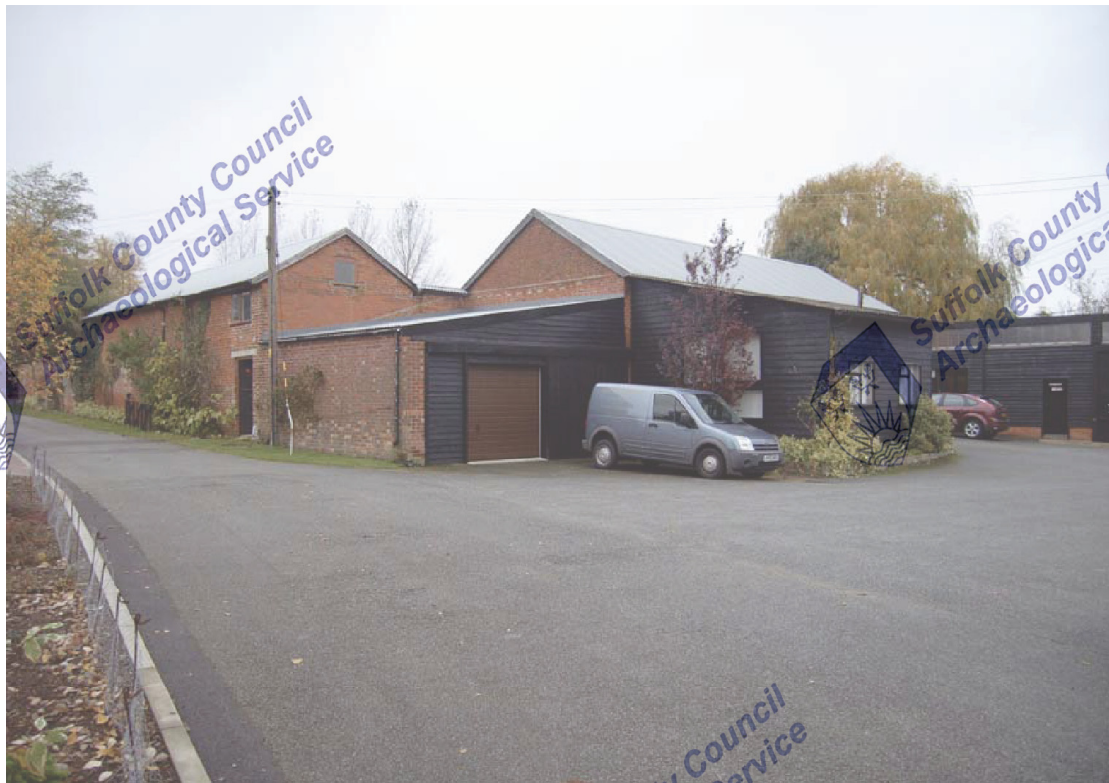
A2.4 Mid-19th century farm buildings from south-east showing converted barn (3) to right and stable (1) to left

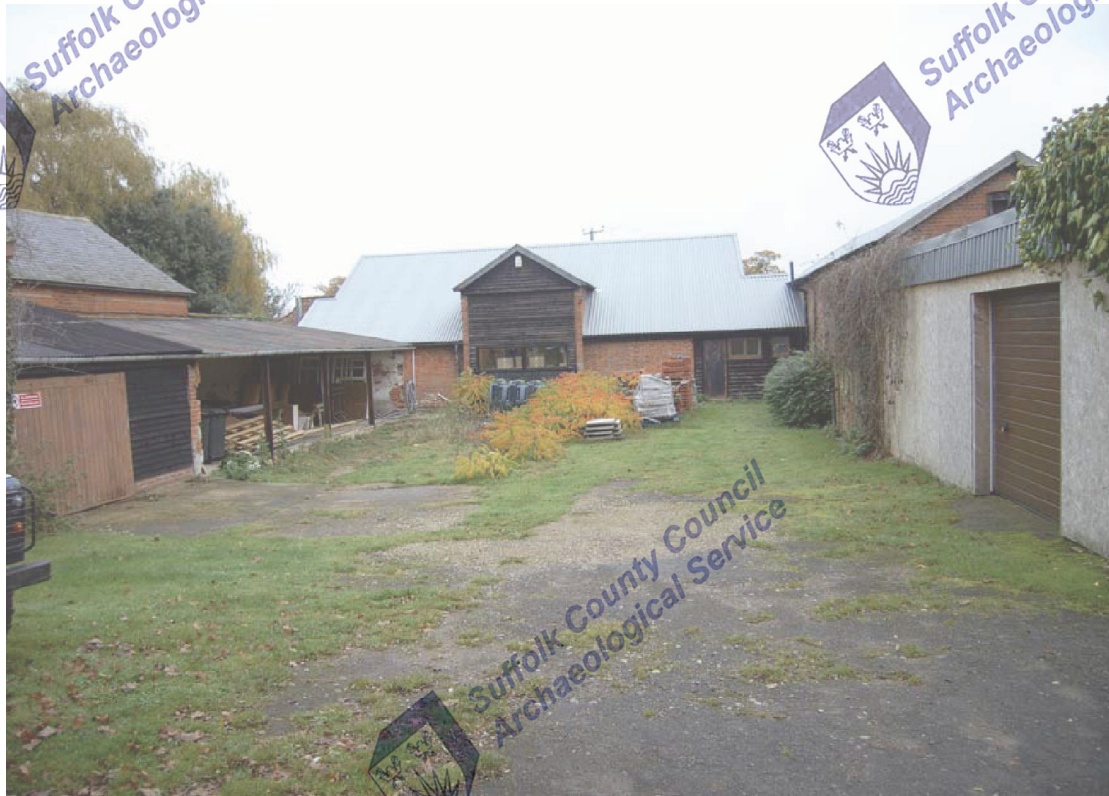
A2.5 Stable yard from west showing converted barn (3) in centre with stable (1) to right and open-sided shelter shed (2) to left

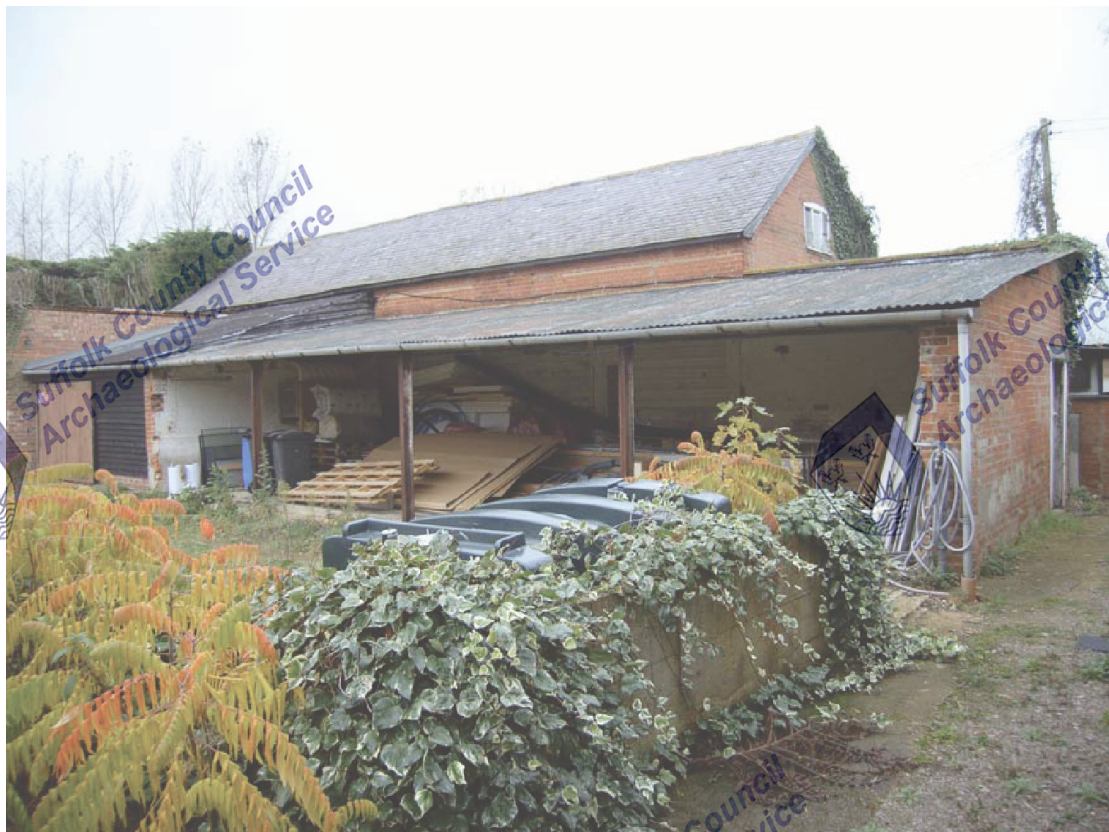
A2.6 Shelter shed (2) from south-east showing brick shed (4) in rear

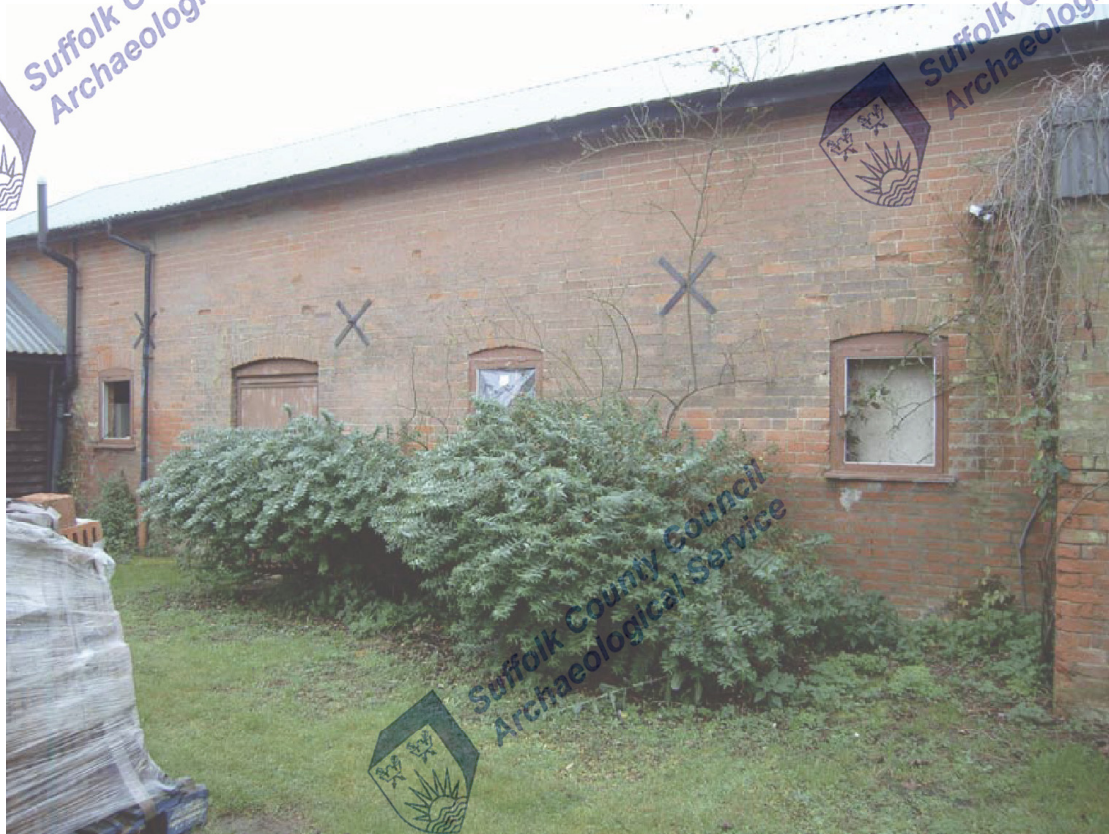
A2.7 Northern facade of stable (1) showing entrance door to left & tack room window right

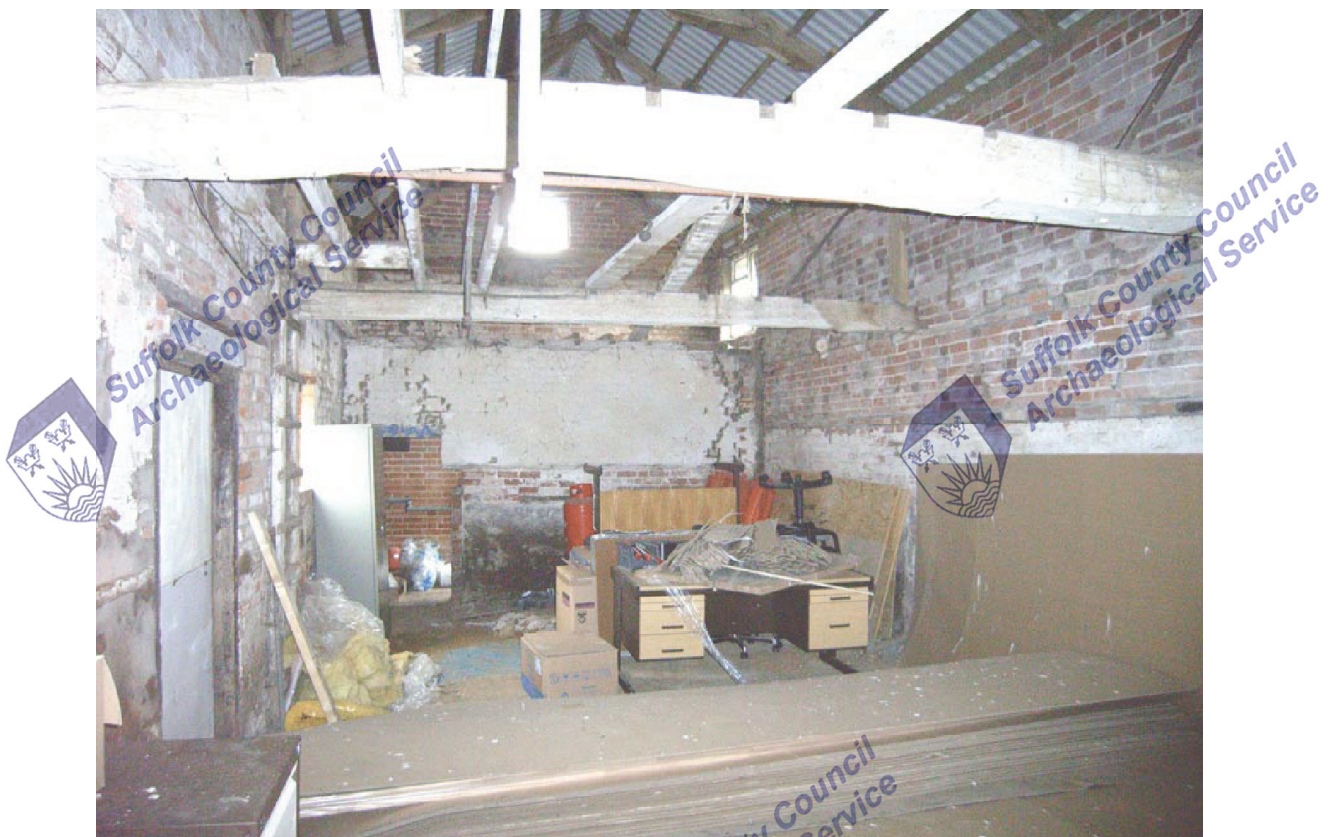
The building contained a ceiling of tall-sectioned common joists notched over a pair of lateral binding joists, but this has been removed to leave only the binding joists and a small number of common joists in place. The binding joists contain irrelevant pegged mortises in their lower surfaces and were re-used from a 16th or 17th century structure. The loft was entered by a loading door in the western gable and lit by a window in the opposite, eastern gable. Additional access was provided by an internal ladder of nailed rungs against the northern elevation. The ceiling lay 2.6 m (8.5 ft) above the present brick floor and there is evidence of a hay rack against the rear, southern elevation which lay 1.8 m (6 ft) above the same floor. This evidence takes the form of diagonal scars in the old whitewash of the brickwork and binding joists. The rack was open to the hay loft as the principal joists lack common joist notches at their northern ends. The height of the hay rack indicates the building was designed as a stable for working horses rather than a cow shed, and this is confirmed by the presence of a hay loft and tack rooms at both ends of the building. The western tack room is wider than its unusually narrow counterpart to the east (at 2.4 m as opposed to 1.5). The stable was entered from the yard to the north by a central door flanked by two windows, with a third window lighting the western tack room. The windows retain their original vertically hinged casements but the door has been renewed. A secondary door and first-floor window have been inserted into the southern elevation of the eastern tack room, and the surrounding brickwork rebuilt.

A2.8 Interior of stable (1). General view from west, showing remaining joists of removed hay loft with entrance to left and evidence of hay rack against southern wall to right

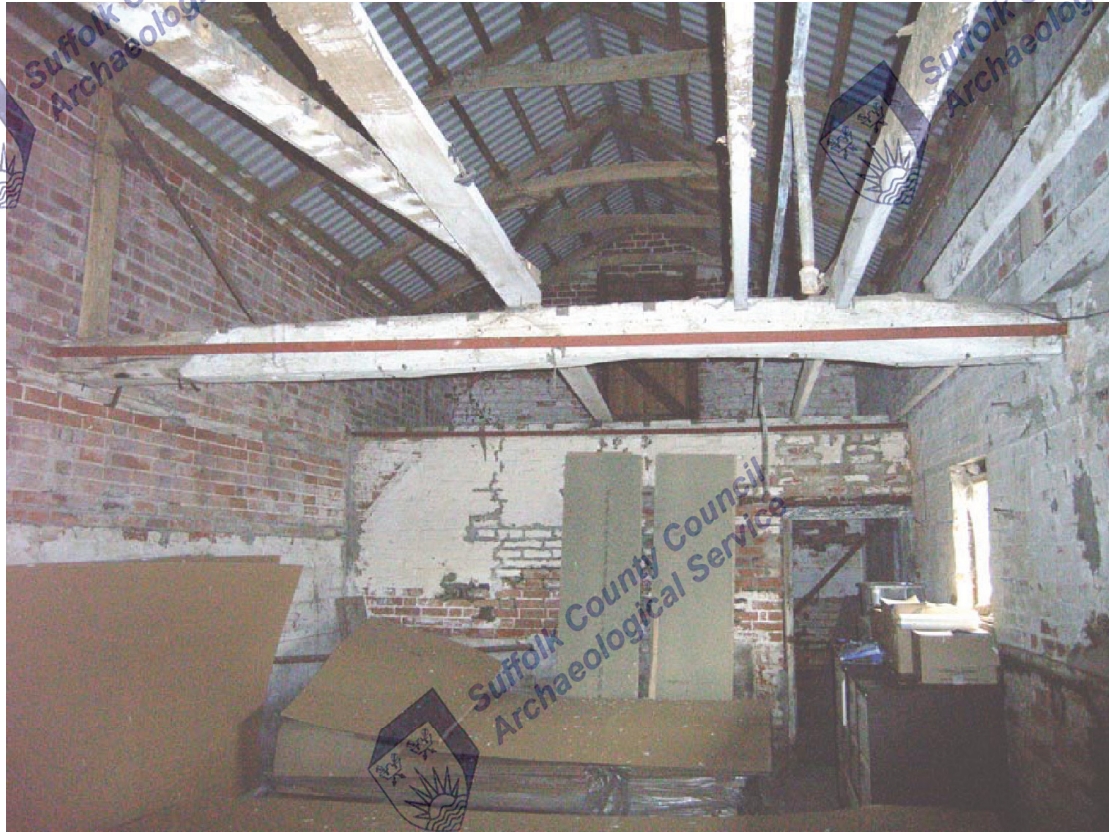
A2.9 Interior of stable (1). General view from east showing entrance to tack room against western gable to left and scar of former hay rack to left

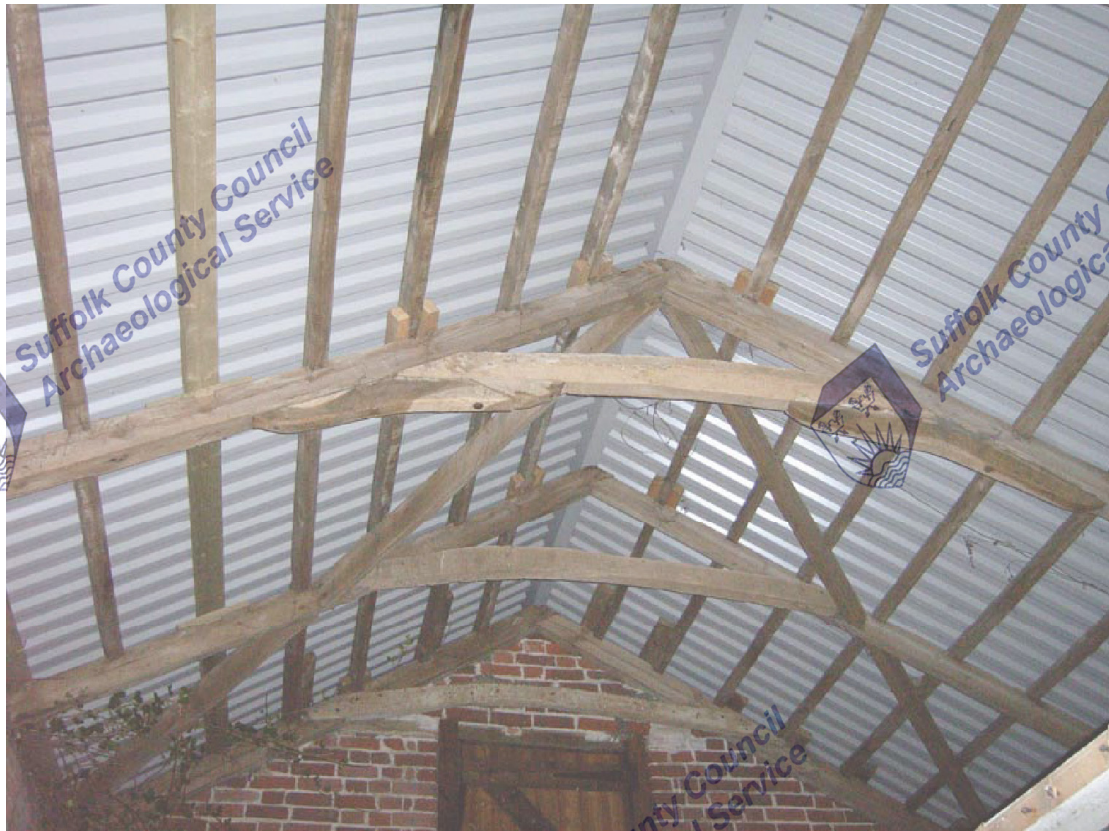
metal laid on new horizontal rails, but the original principal trusses remain *in situ* with bolted knee-braces to alternate collars. These trusses are typical of the mid-19th century, as is the brickwork, and the building was probably constructed in the 1850s or 1860s as part of a unified yard complex. Only the northern shed (building 4) retains its original covering of Welsh slate.

A2.10 Stable (1). Detail of roof structure showing loading door in western gable
