**‘The Old Thatches’, Rookwood Lane,
Preston St Mary
PSM 031**

Archaeological Excavation Report

SCCAS Report No. 2012/030

Site Name: 'The Old Thatches', Rookwood Lane, Preston St Mary

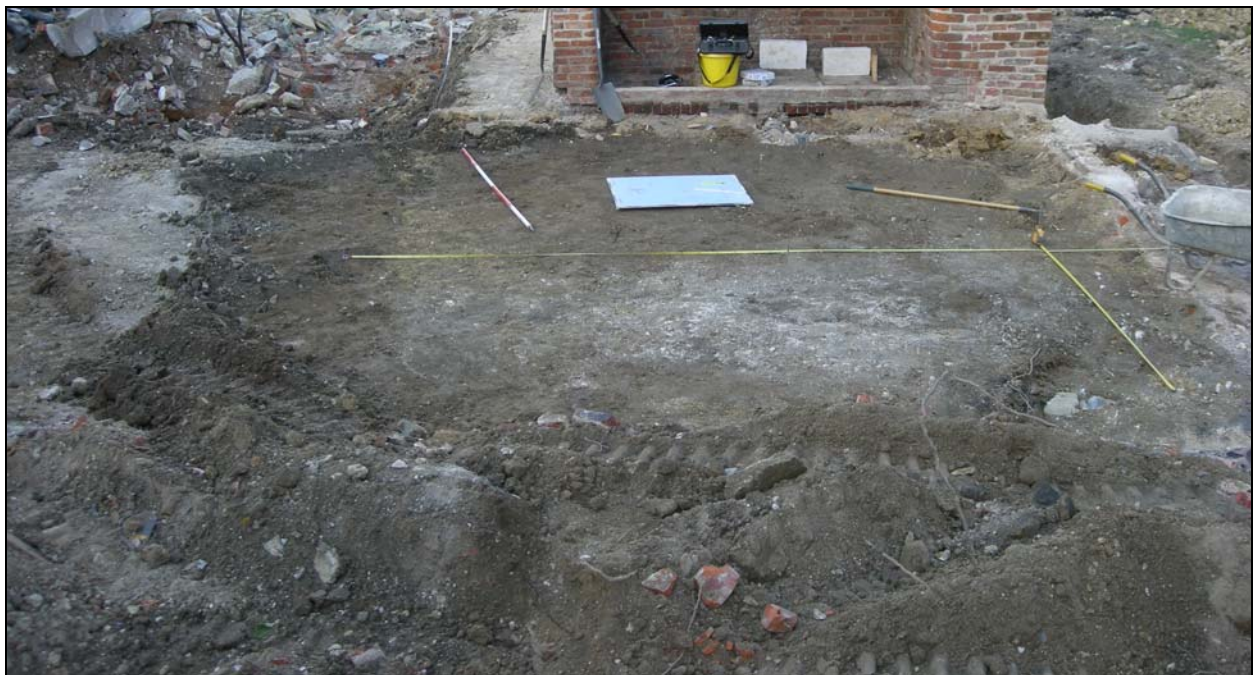
Plate 1. West end of possible building 0043 facing north. End of the building identified by the spread of yellow clay to the left of the scale. Chalky area in the foreground is the residue of lime, potentially material prepared for the building of Old Thatches in the 17th century. (2m scale)

All of the features associated with the suggested building cut overlay a buried medieval topsoil layer. Within the supposed area of the early building this was numbered 0026 and outside it, variously as 0010, 0031, 0032 and 0034. It is interesting to note that no finds were collected from this deposit within the footprint of the building but were plentiful outside it and no pitting occurred within the suggested building footprint.

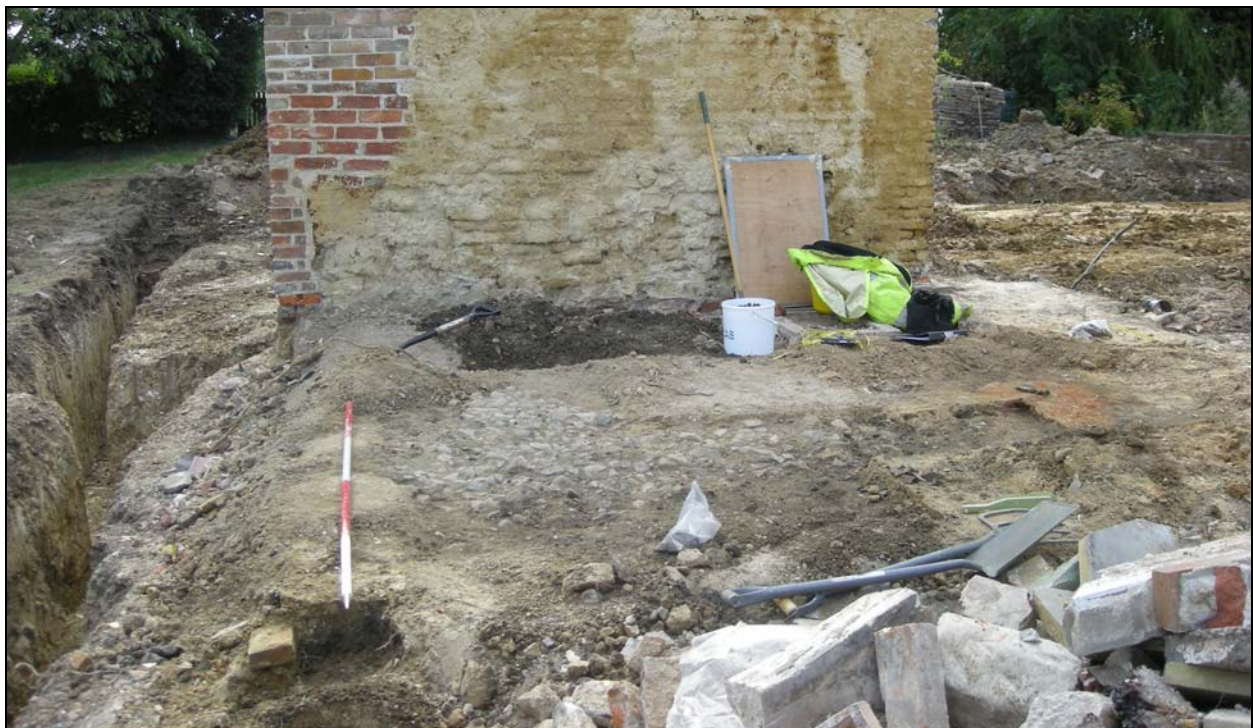
Plate 2. Flint yard surface 0030 and burnt clay patch 0033, to the north of Old Thatches' fireplace. Photographed facing south (2m scale)

The hearth floor (0033) was 0.9m long by 0.5m wide and 0.02m thick. There was an apparent even distribution of heat across the area with a thin spread of ash around the south and west edges. Heating in this area had also affected the surrounding soil, suggesting continued usage rather than a single firing event. No finds were found within the oven itself but pottery dating to 13th-14th century was found sealed beneath the hearth floor in the buried topsoil layer (context 0032)

Flint layer 0030 covered an irregular area of approximately 3m sq. and was sited in the north-east corner of the excavation area. It was made up of closely-packed medium to

large-sized cobbles laid a single stone deep; the recorded area of the flints was thought to be close to its full extent and the planned south and east sides, true edges. The extent of the north side of the spread mirrored the edge of ditch 0035; the ditch was not visible when the flints were planned as it was masked within the buried soil, but the flints may have been cut by or respected the ditch. Late finds (15th-16th century) were

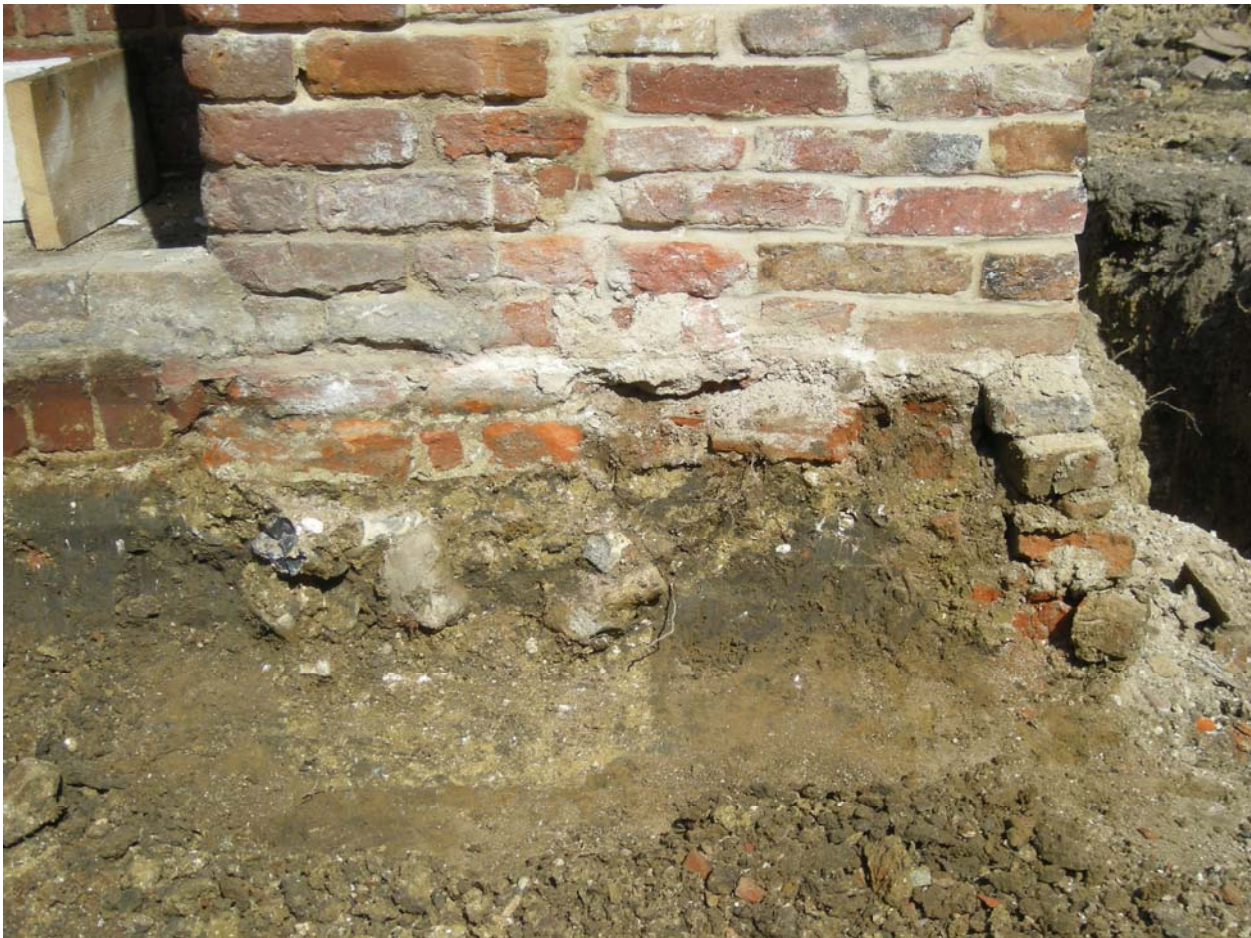
Plate 3. Part of the footing beneath the brick piers of the 17th century fireplace. The footing comprised a trench packed with yellow clay and large flints and would have been the only substantial piece below ground evidence that an early post-medieval building ever stood here at all.

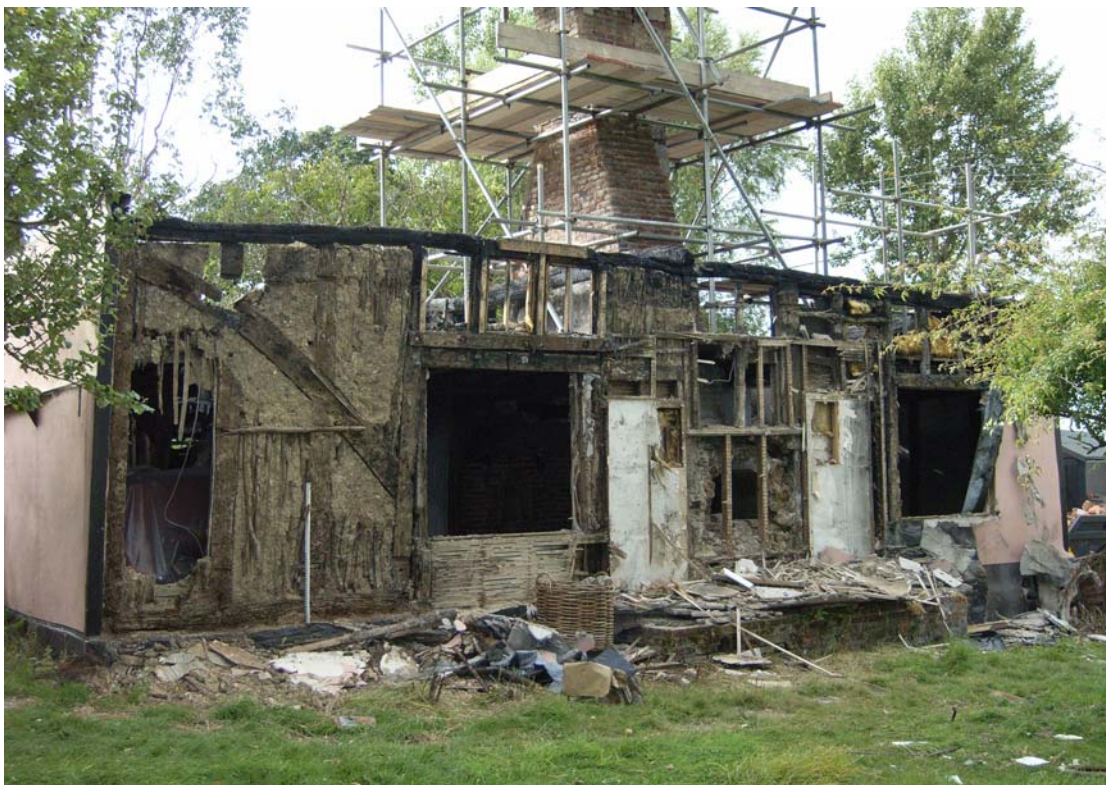
A2.2 External elevation H-N from south-east after commencement of demolition, showing original brace to left and infill of wattle-and-daub attached to externally trenched laths. A secondary bread oven against the eastern side of the chimney formerly projected beyond the plane of the wall.

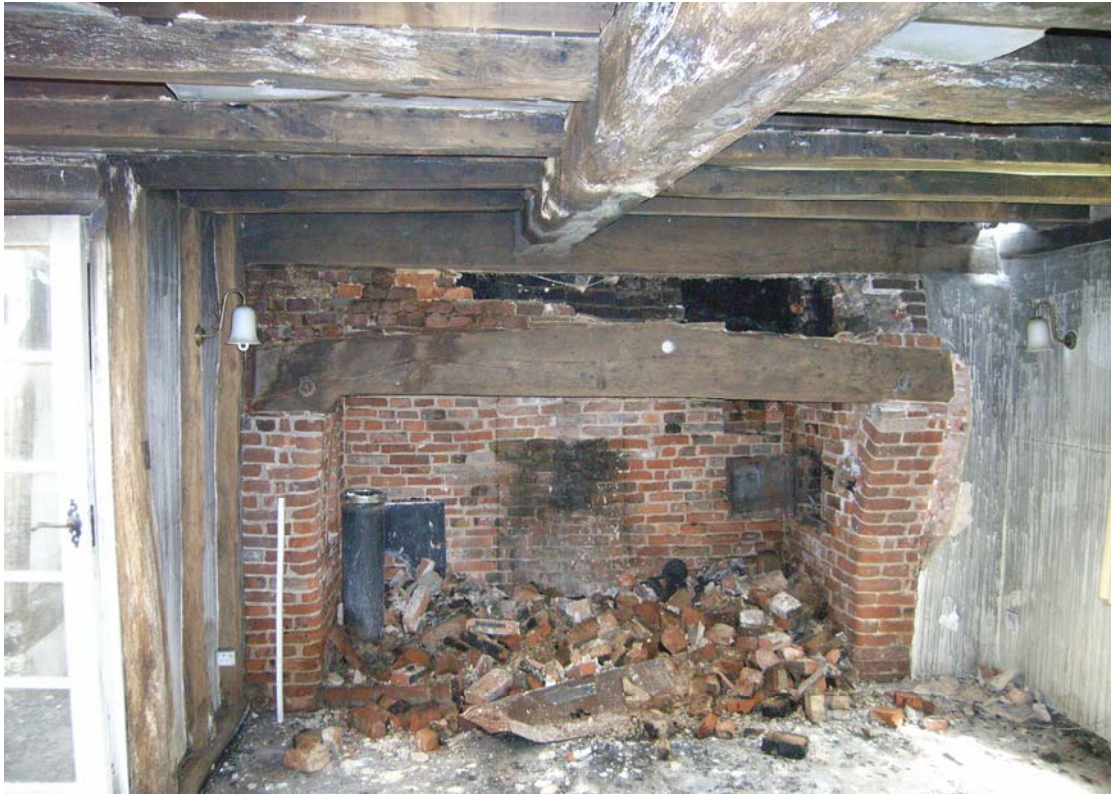
A2.3 Internal view of truss J-I from south, showing partly collapsed fireplace and largely original 17th century ceiling in room G-J-H-I.

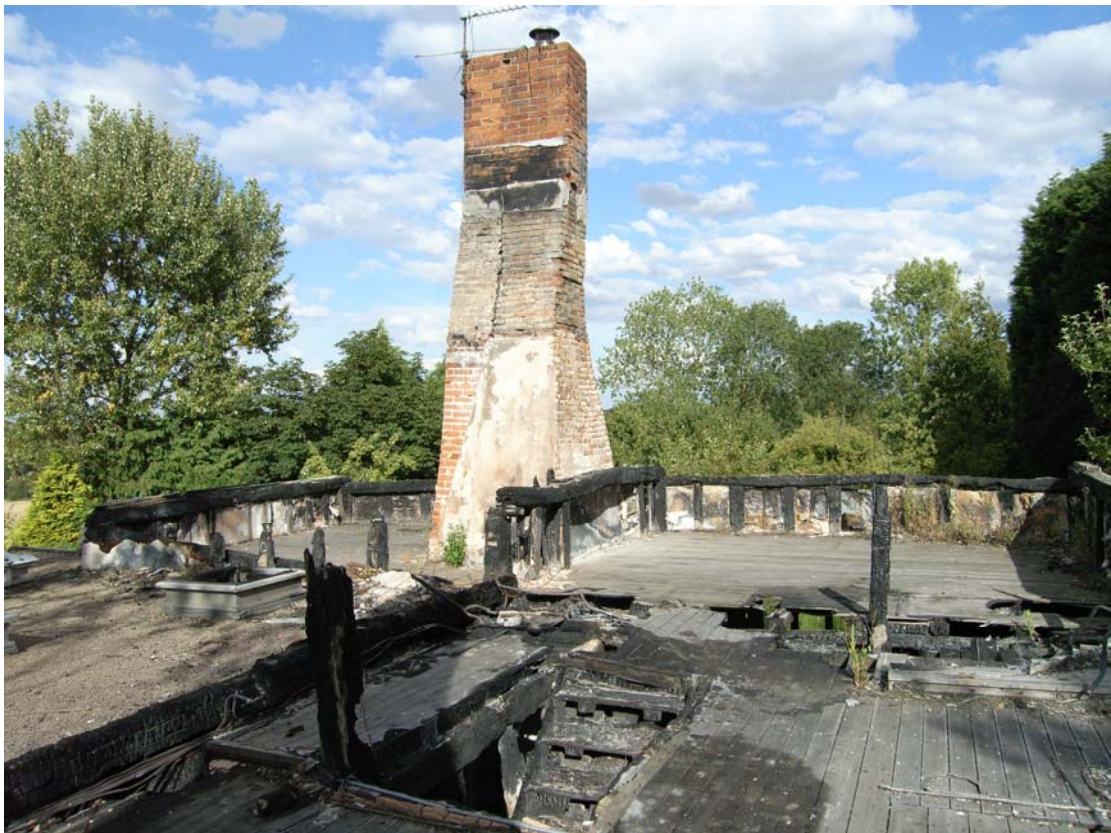
A2.4 Upper storey of structure G-H-M-N from west showing 17th century chimney to right with secondary chimney to left.

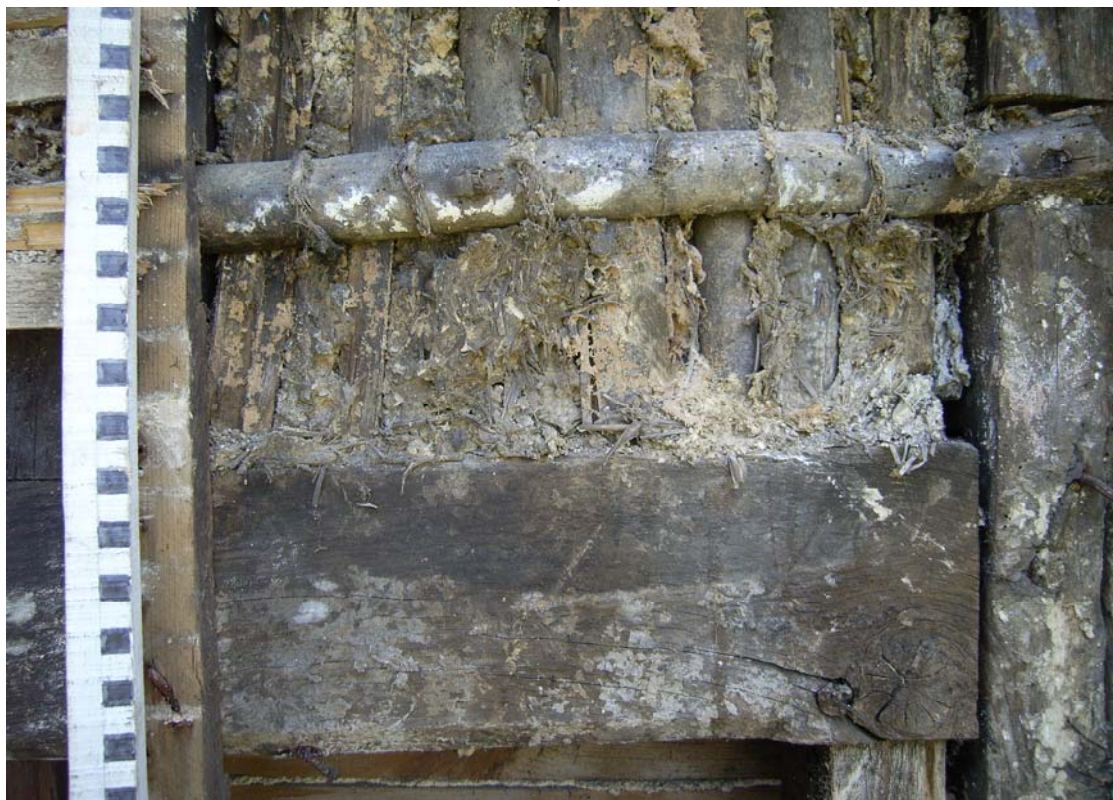
A2.6 Detail of external elevation H-I from east showing entrance door lintel (right-hand jamb lacking) and infill construction: Withy ties secure horizontal half-poles that are trenced and nailed against the exterior to vertical poles and half-poles between the studs.

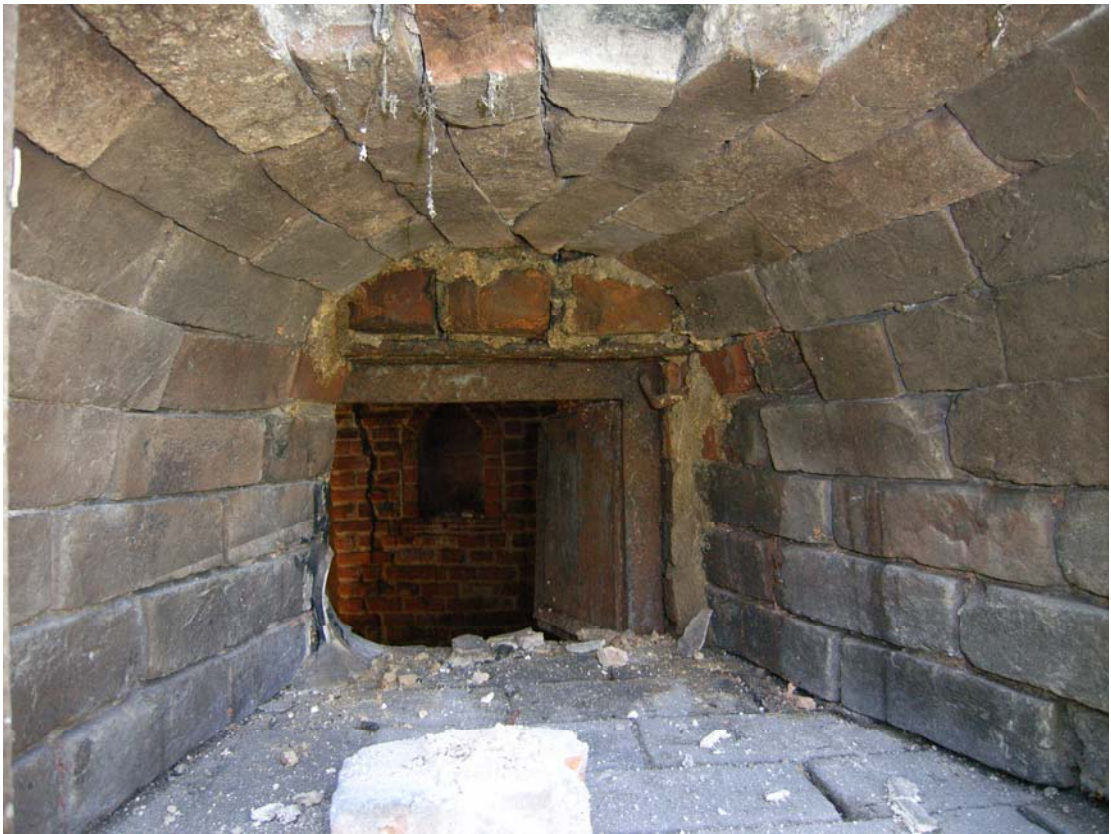
A2.8 Interior of brick oven between posts I and J

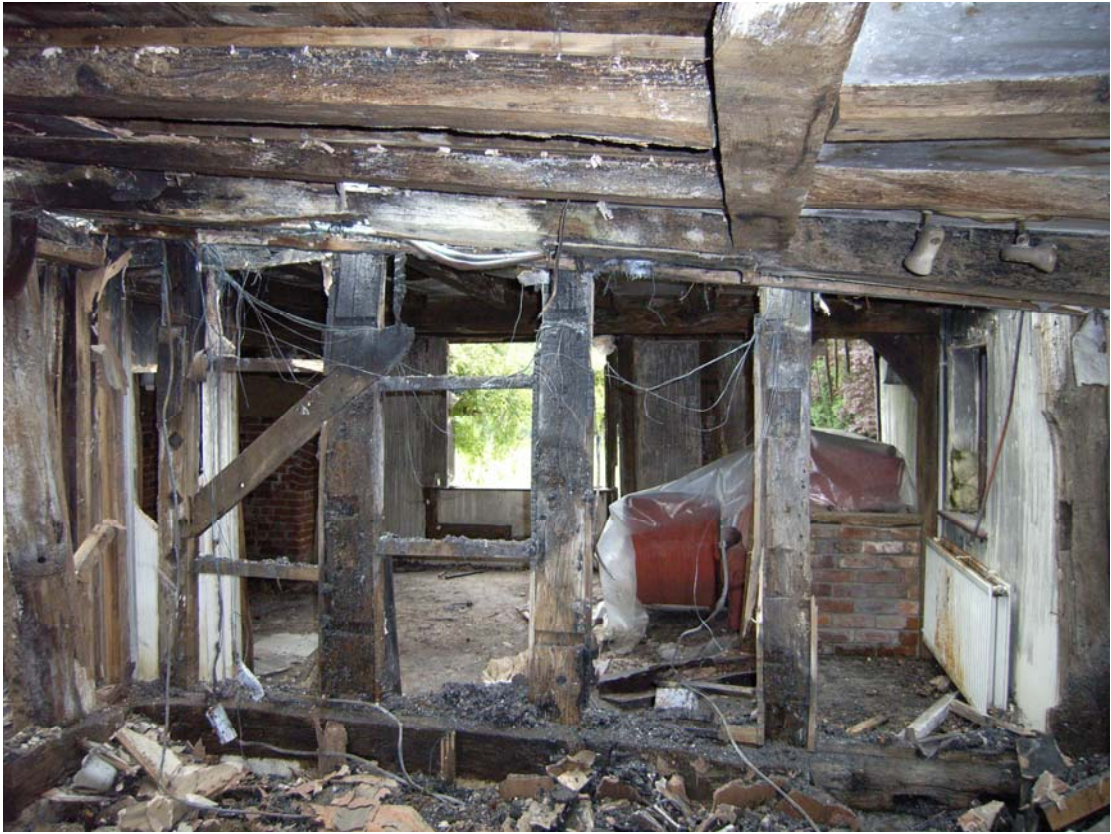
A2.9 Elevation J-G from west showing infill trenches and a window sill or lintel re-used as a stud to left (with original brace attached). Former door and stair trap to right.

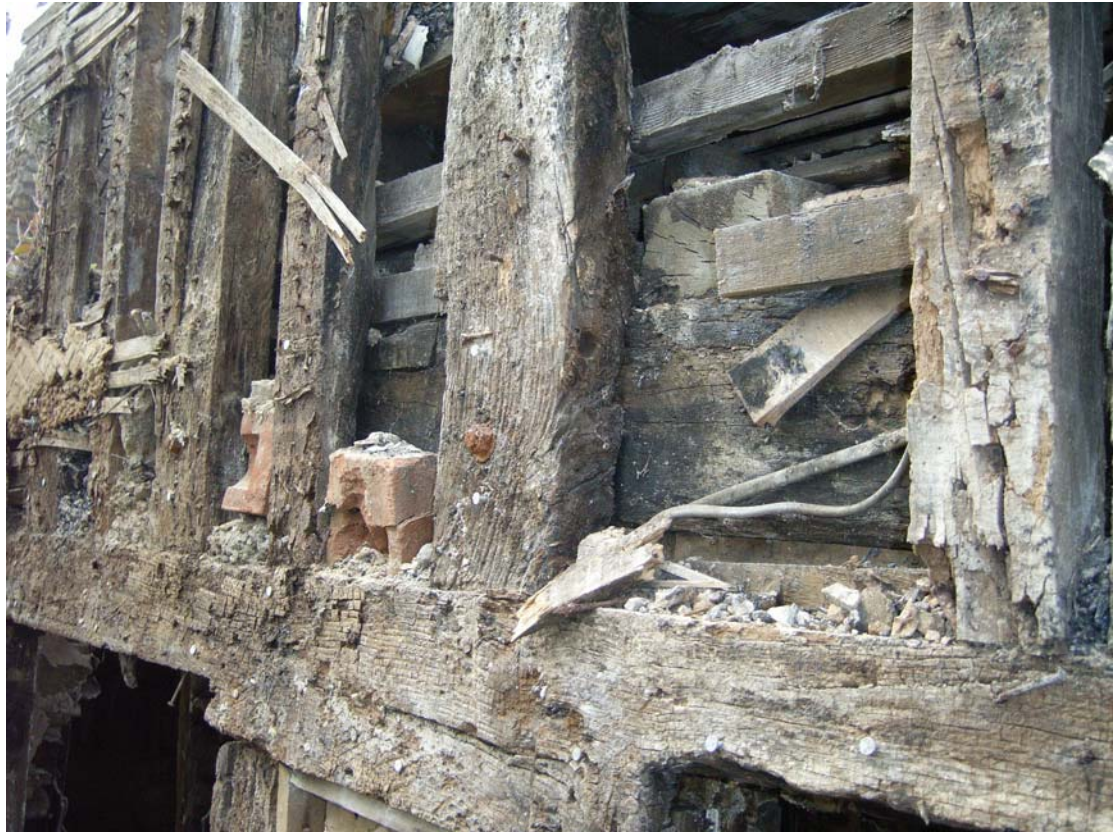
A2.11 Detail of external elevation A-E from south-east showing externally weathered studs with notches for infill staves (in contrast to infill of structure G-M-H-N).
