Archaeological Record

February 2009

The Granary, Hoo Hall, Hoo, Suffolk

An Archaeological Record

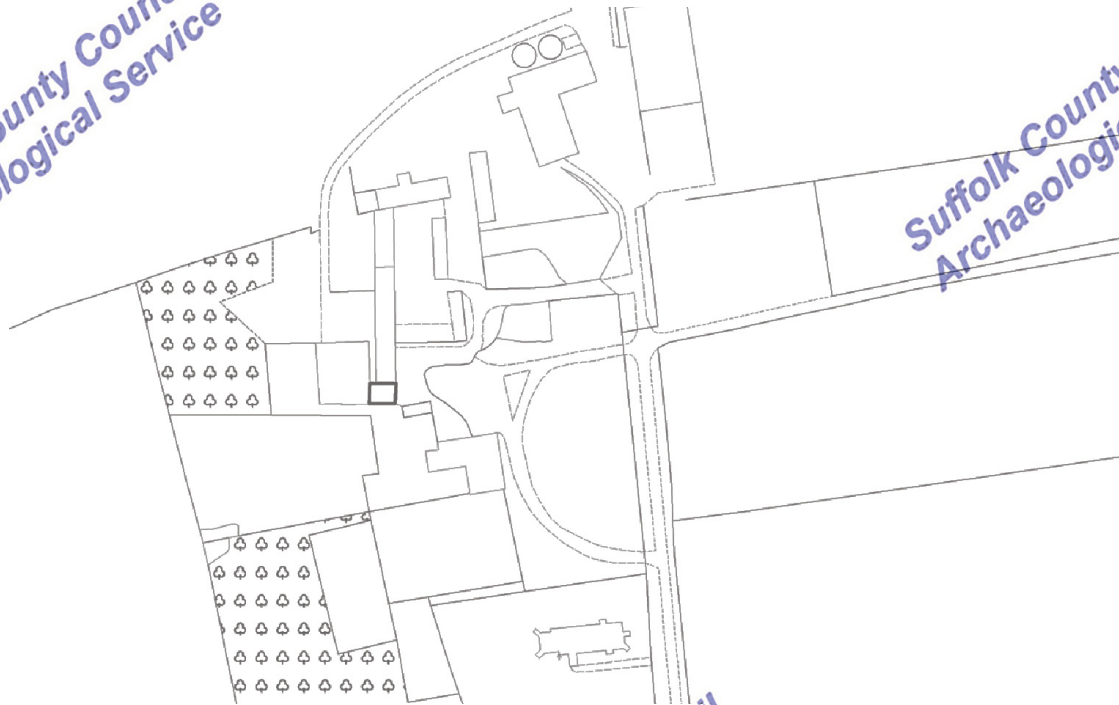
Figure 1
Existing Ordnance Survey Site Plan
Outlining the granary in the centre of the site, and showing the L-shaped house to its south-east with the parish church to the south

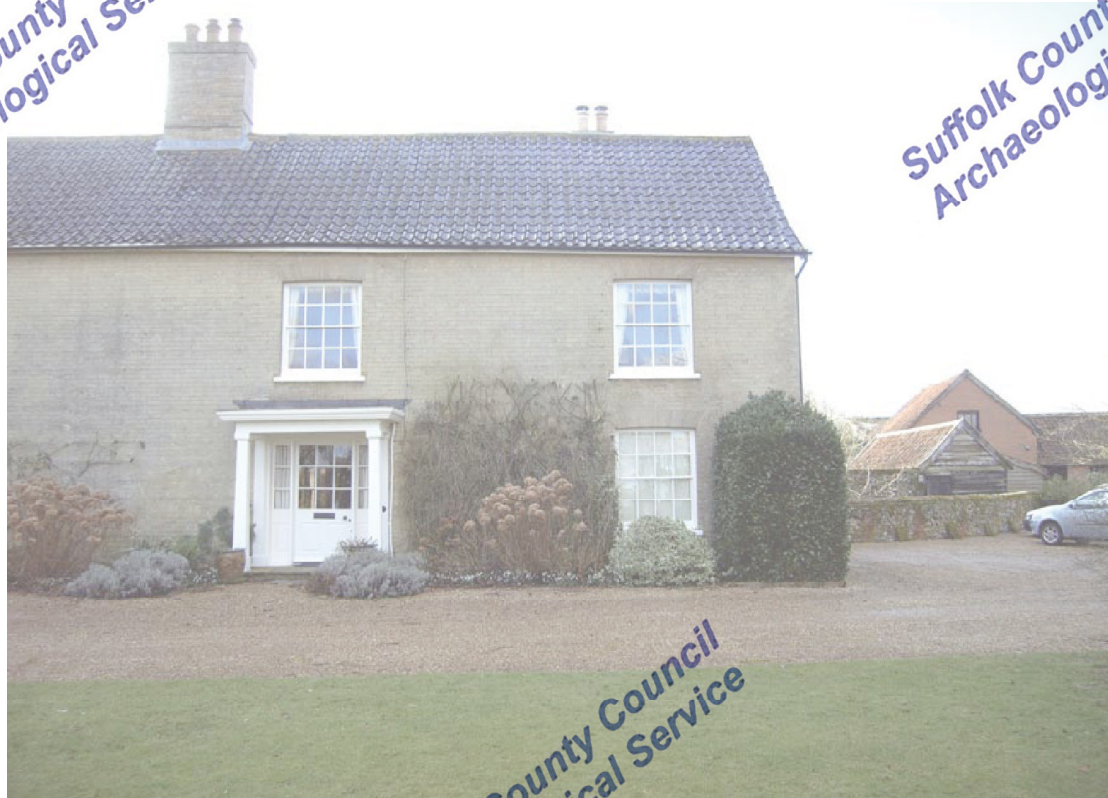
A2.1 View of site from east showing the proximity of the granary (in rear to right) to the principal eastern façade of Hoo Hall to left

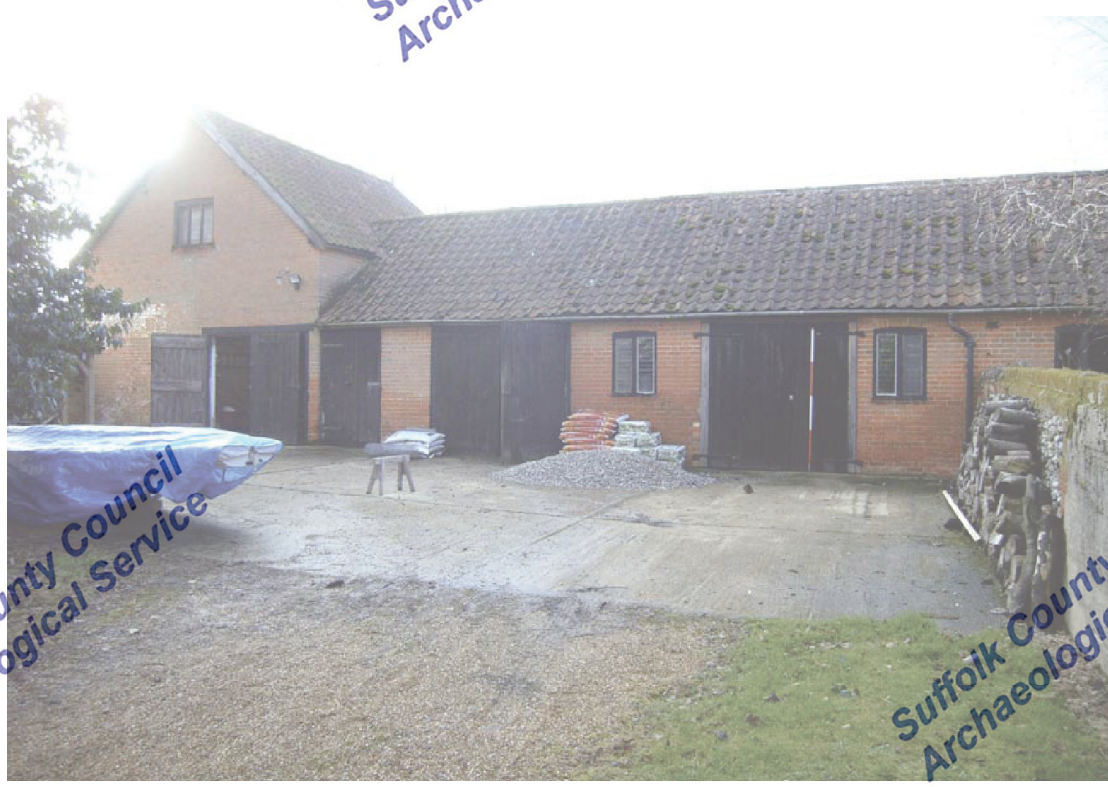
A2.2 Southern end of yard range from east showing the granary to left and the modern property boundary wall which separates the rest of the farm buildings to the right

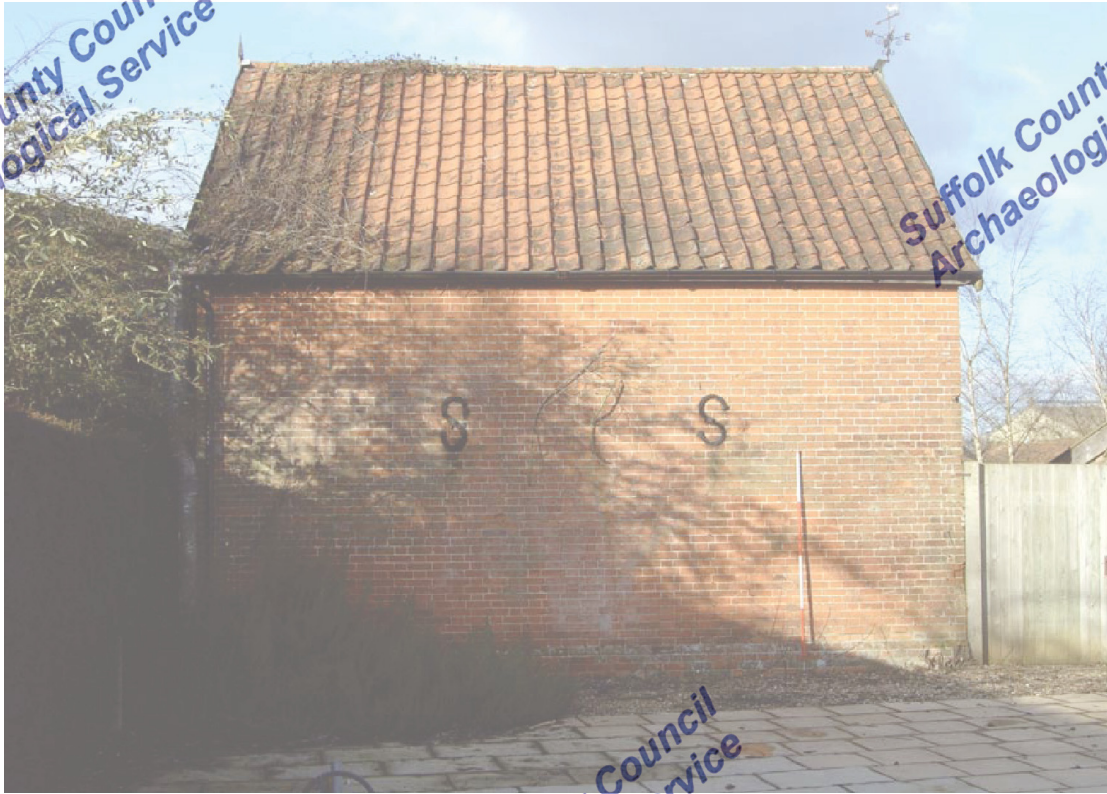
A2.3 Southern external elevation of granary showing 20th century farm shed obscuring western gable to left

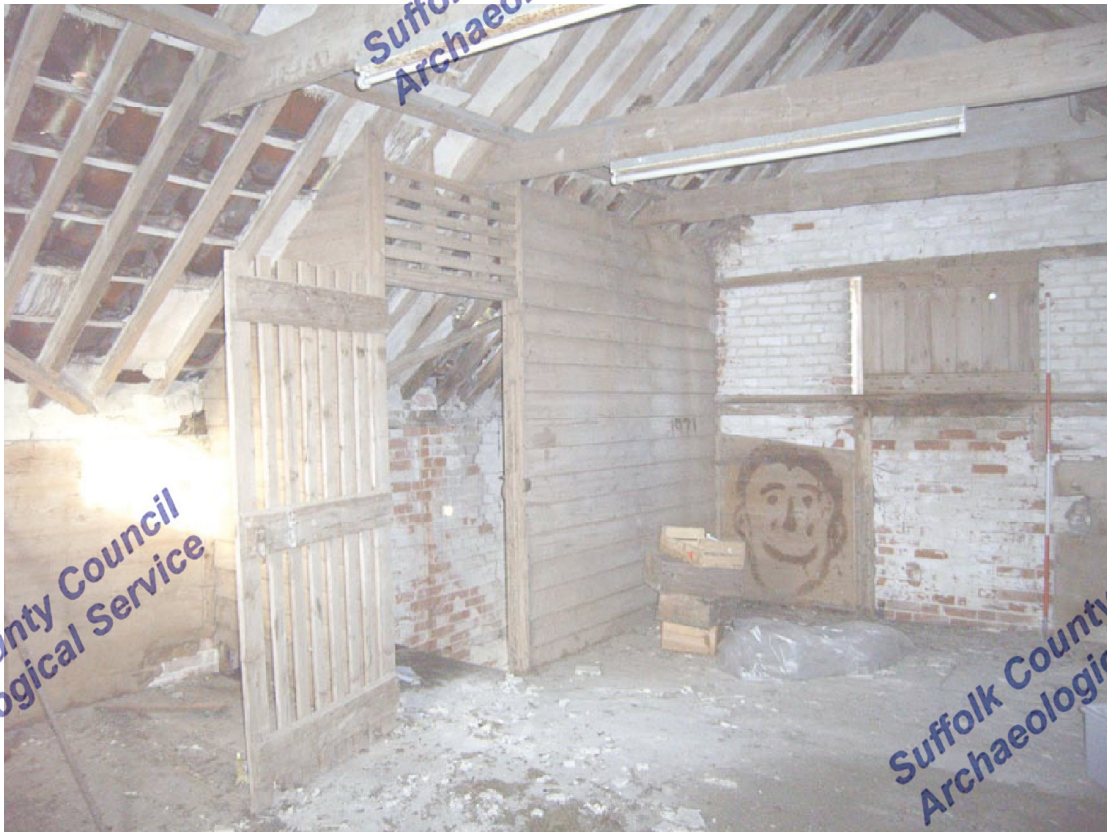
A2.4 Upper granary storey from south-west showing enclosed stair with slatted door and evidence of grain bins with axial passage against eastern gable to right

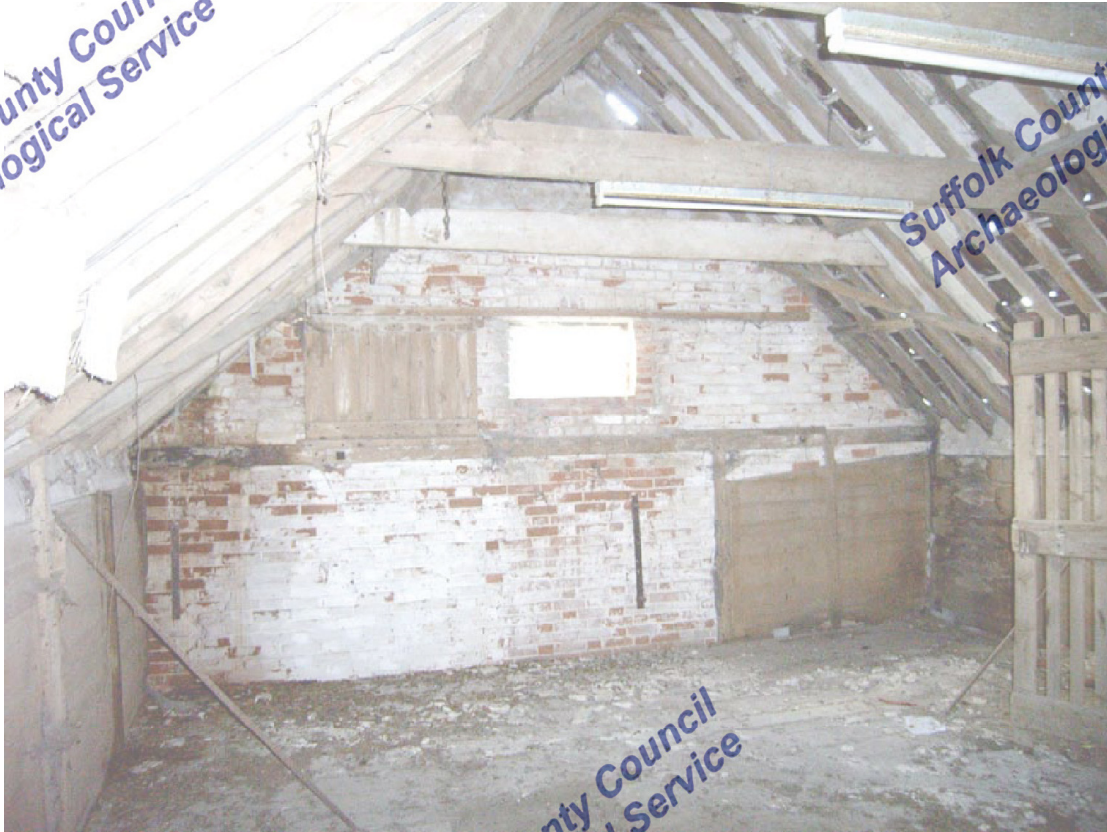
A2.5 Upper storey from east showing interior of western gable with evidence of grain bins to right & left

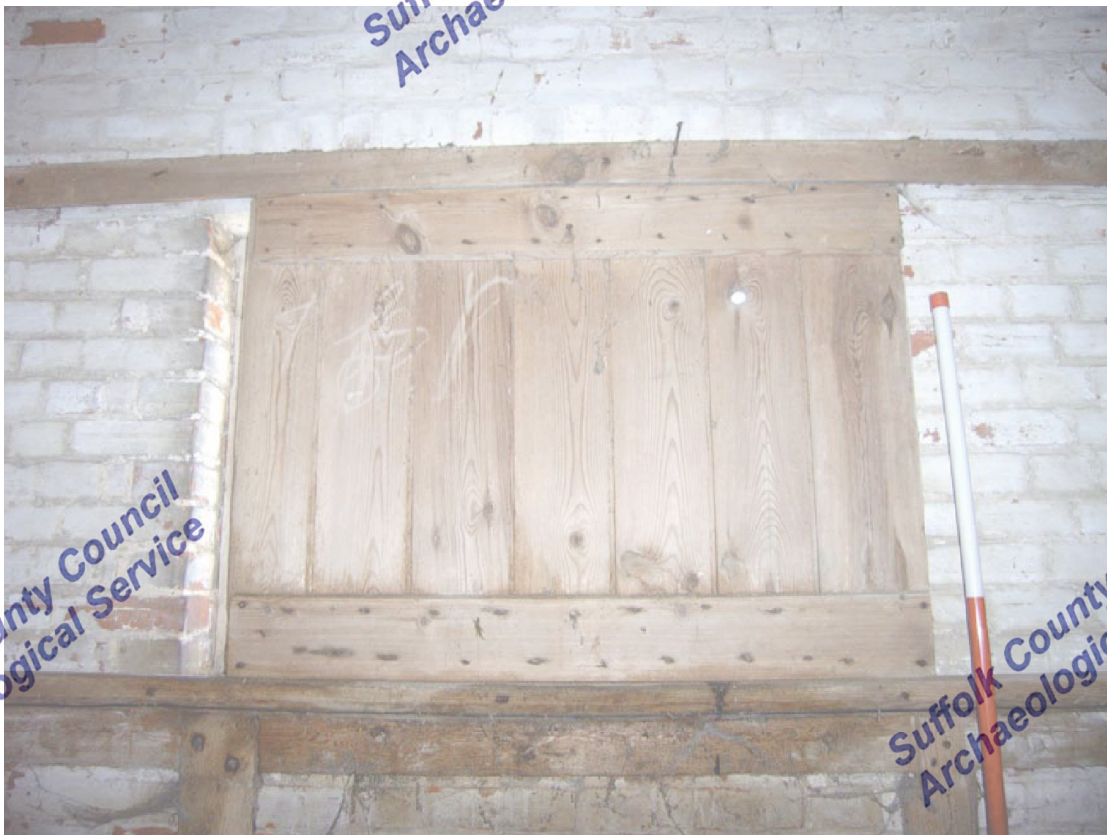
A2.6 Detail of deal sliding window shutter to internal eastern gable of upper storey

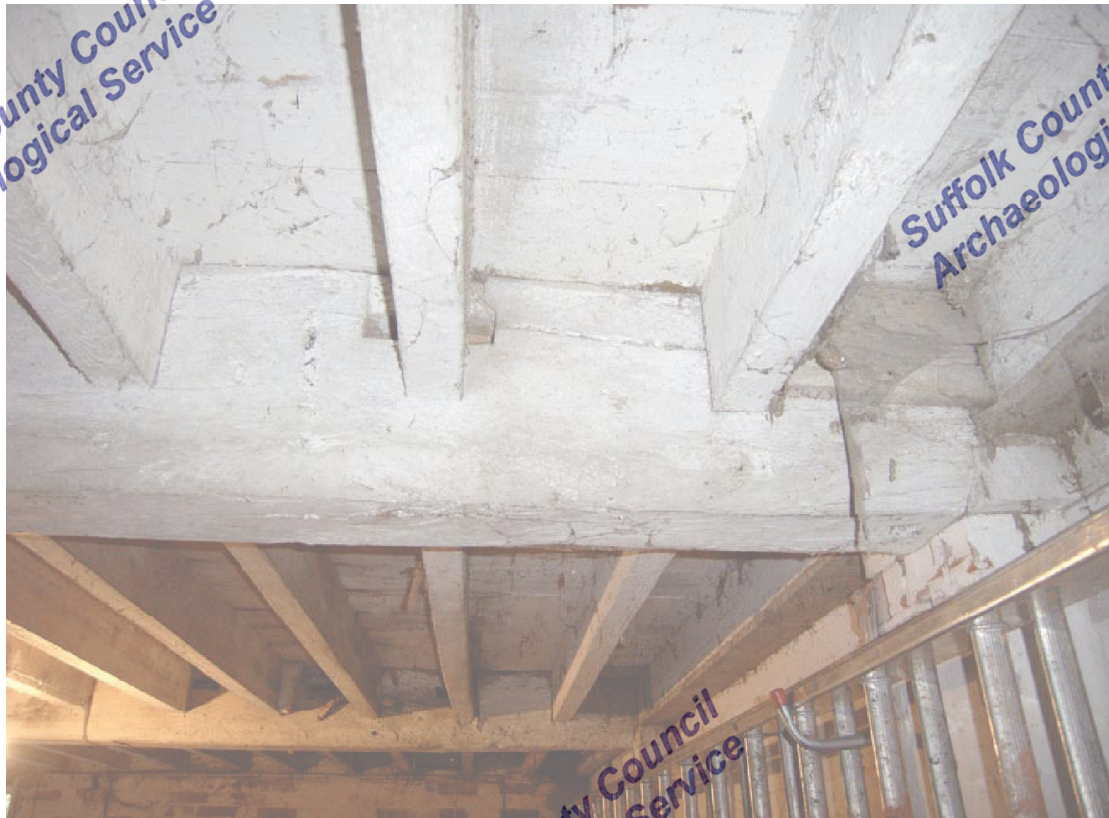
The lower storey now forms a storage shed with a ceiling of tall-sectioned joists laid on a pair of re-used 17th century binding joists (containing empty mortises with diminished shoulders for flat-sectioned joists, as seen in A2.7). This ceiling supports the granary floor, 2.3 metres above an original brick floor with an axial drain extending from the southern jamb of its northern entrance door (alongside the stair door). The interior is now unlit, but there is evidence of a blocked window in the rear western elevation. A boarded partition separates the principal space from a narrow shed behind the stair, which shed is lit by a window at the western end of its northern elevation. The presence of the floor drain suggests the ground storey was designed as a stable (probably for driving rather than farm animals) and notches in the brickwork of its southern internal elevation may have held a manger and rack. The boarded shed would have operated as a tack room, but no fittings remain and this is not certain. The whitewashed boarding includes re-used material with both red and grey/black pigment, indicating the external appearance of local weatherboarding before the advent of tar in the late-19th century. A small horse shoe has been nailed to the same internal boarding immediately adjacent to the eastern entrance door.

A2.7 Detail of ground-floor ceiling from west showing empty mortises in re-used 17th century binding joists

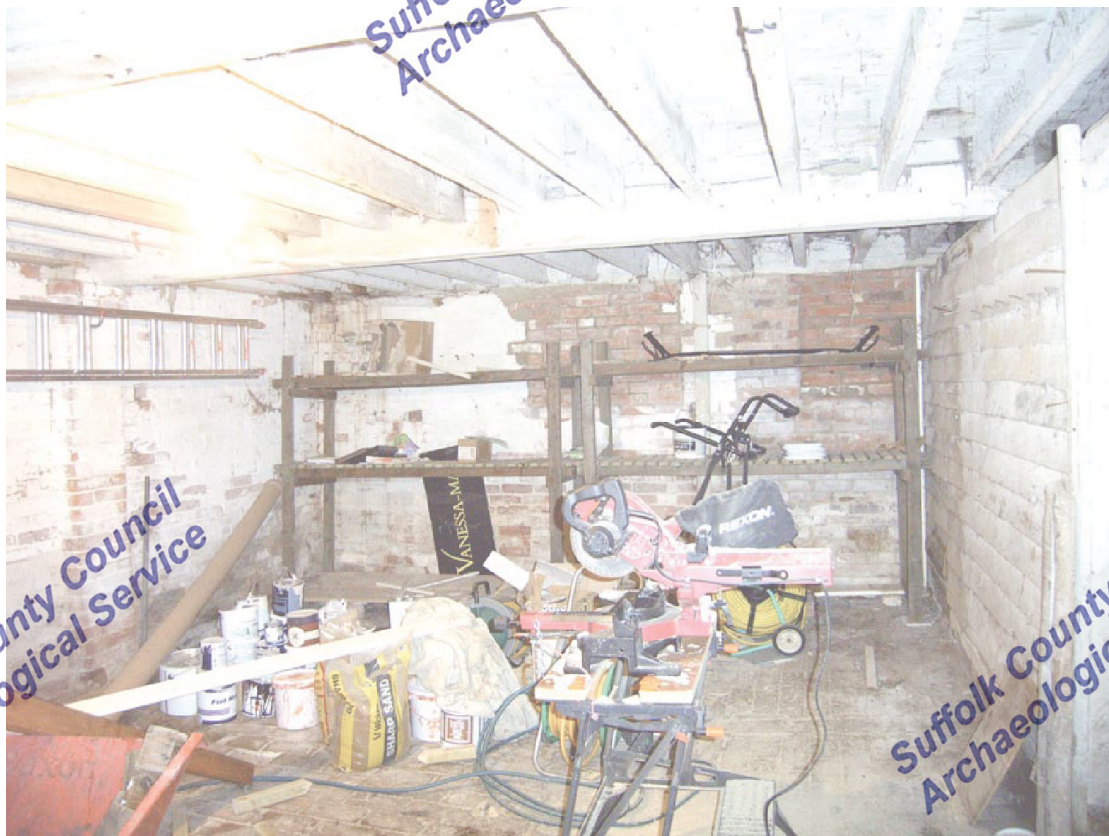
A2.8 Interior of lower storey from eastern entrance showing blocked window in western elevation and boarded partition to stair and shed to right
