ARCHAEOLOGICAL MONITORING REPORT

SCCAS REPORT No. 2009/012

**Church House, Church Road, Bardwell
BAR 074**

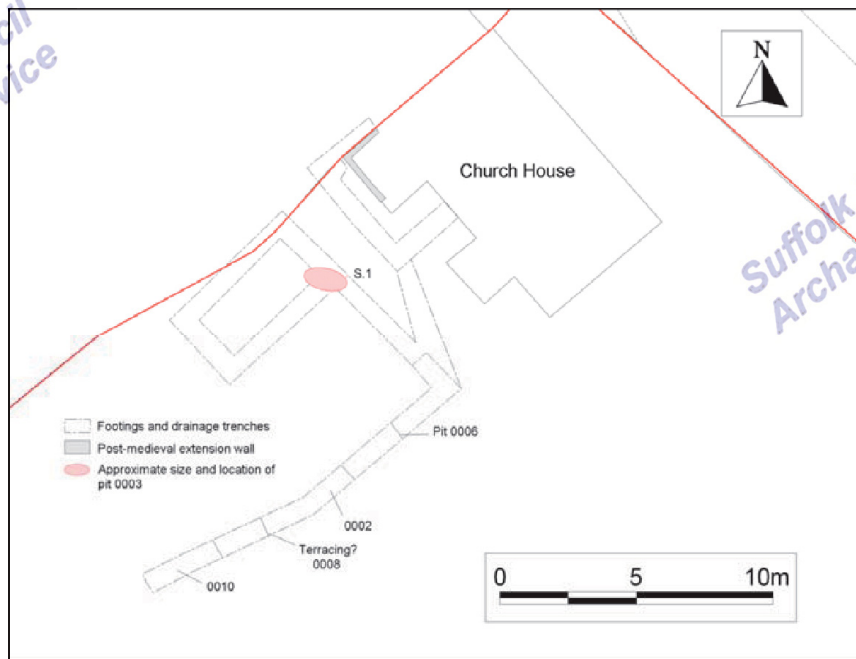
Figure 2. Trench plan with outline of development area (red)

Monitoring identified the remains of a post-medieval pit located in the east corner of the rectangular footing trench and a second possible pit in the long drainage trench leading towards The Black Bourn (Fig. 2). An abrupt change in the sequence of deposits observed in the long drainage trench may indicate an earlier terracing of the site.

An abrupt vertical change at 8.3m from the north-east end of the long drainage trench from natural to mid brownish orange silt (0009) suggested the presence of a possible terracing cut (0008), which, at its south-west end overlay the subsoil deposit.

Rubble layer 0005 was located at the extreme north-east end of the long drainage trench. Only 2m of this light greyish yellow chalky clay deposit was visible. It was likely to have extended further to the south-west, but was truncated by possible pit

0006, which was located between 2m and 4.3m from the north-east end of the long drainage trench. The full profile of this pit was not visible as it was deeper than the trench (0.7m) but it had steeply sloping sides and was filled by 0007, mid brownish grey clay silt. Multiple sherds of TPW (transfer printed ware) were observed in the fill, in addition to glass and CBM fragments. All these finds strongly indicate that this pit was of post-medieval origin. Again, none of the finds were recovered.

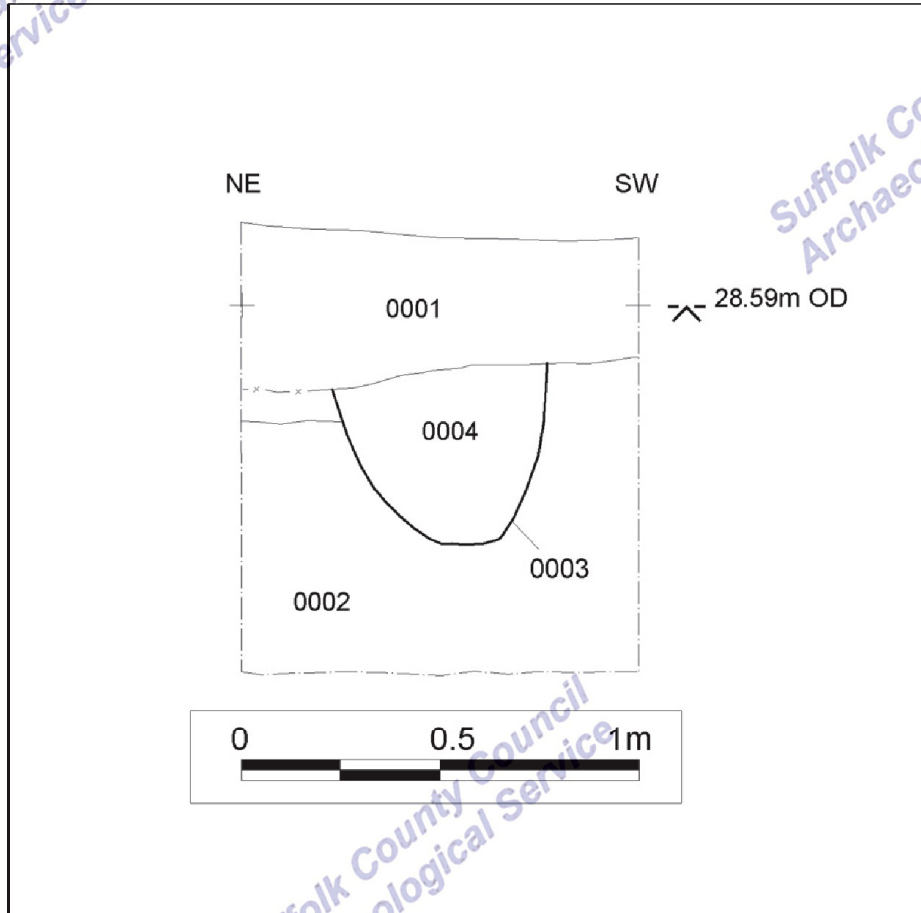
Figure 3. Section 1, north-west facing (*JPEG version*)

Pit 0003 was probably oval – its full extent was not seen – and located in the east corner of the rectangular footing (Fig. 2). It was 0.55m wide by 0.45m deep and had a flat-based u-shape profile (Fig. 3). A single fill (0004) was observed that comprised light greyish yellow loose chalky clay. Occasional very small CBM (ceramic building material) fragments were observed but not collected.

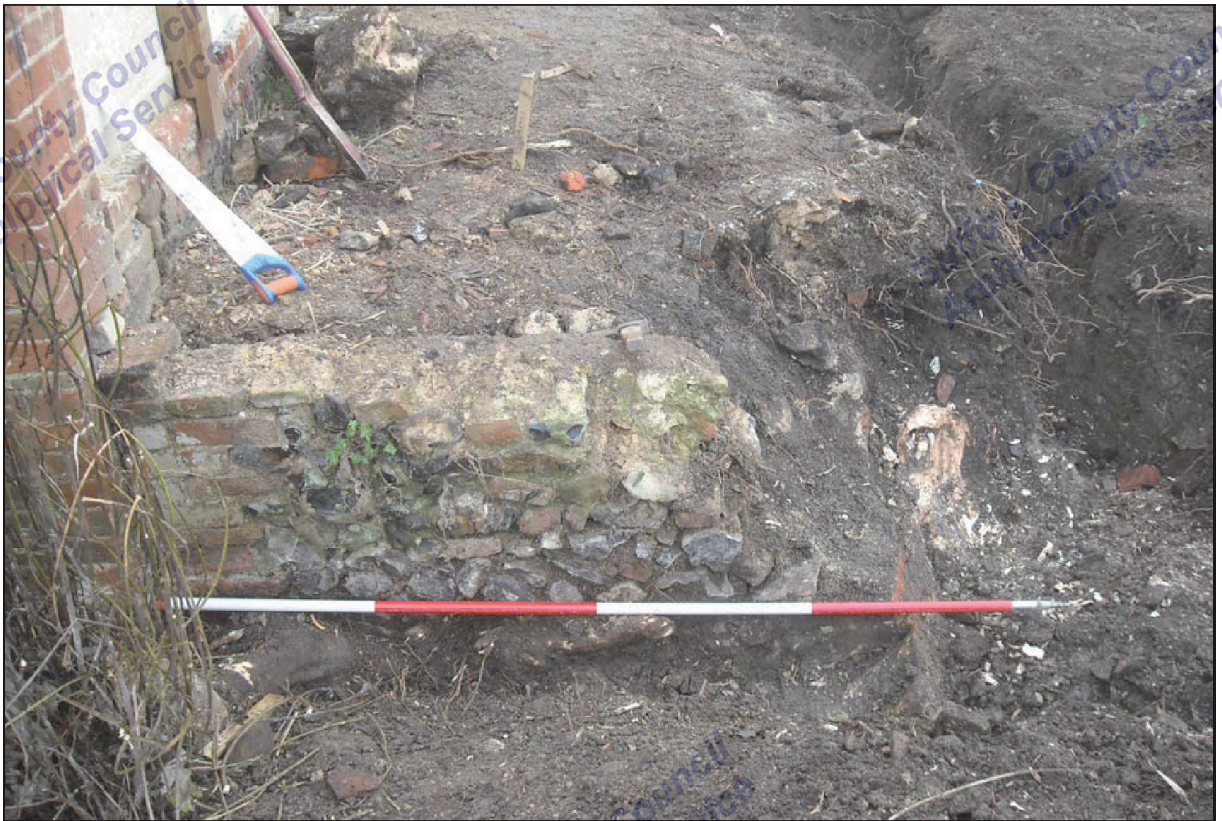
Abutting the rear of Church House were the 1m deep remains of an extension erected in the post-medieval period (Fig. 2). The wall comprised two returns and was composed of irregularly coursed flint with a small amount of brick (Plate 1). Eight (visible) courses of brick formed the end of the wall where it abutted the main house. The walls measured 2.2m by 1.6m and had been truncated down to the present ground level.

Plate 1. North-west facing external elevation of the post-medieval extension abutting the rear of Church House
