# ARCHAEOLOGICAL MONITORING REPORT

## OLD BUILDER'S YARD, CHURCH STREET STRADBROKE (HER ref. SBK 032)

A REPORT ON THE RECORDING OF A SAWPIT  
(Application No. 661/02 & LB/124/02)

Suffolk County Council Archaeological Service Report No. 2009/079  
OASIS Ref. suffolkc1-56591

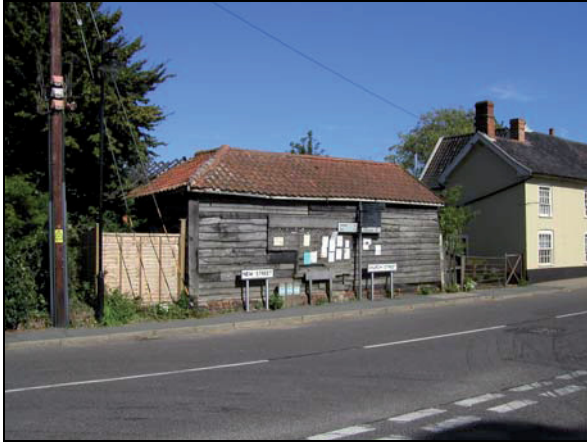
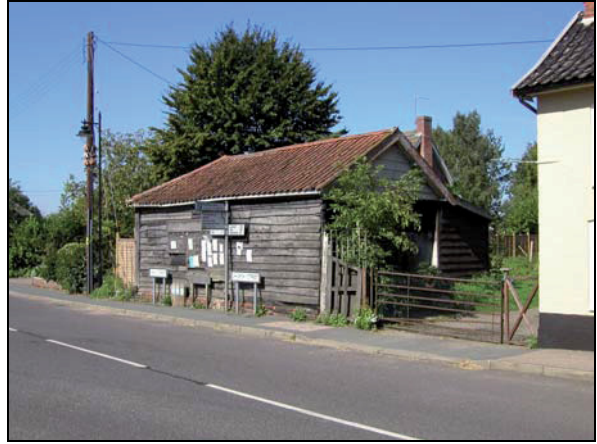
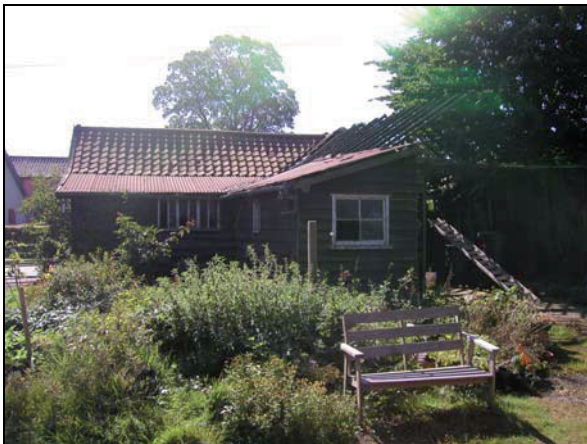
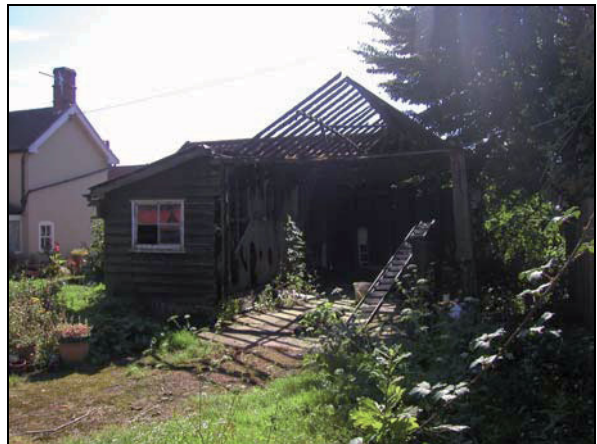
The site was initially visited on the 9<sup>th</sup> September 2004 to investigate the layout of the site and to assess for any possible evidence for the sawpit. At this time the outbuilding was still standing (see Plates I-IV) although the northern arm of the 'L' shaped structure had been damaged by fire. The building was found to be constructed of a light timber frame clad with horizontal planking and roofed in a mixture of pan tiles and corrugated iron sheets. It was not possible to positively date this structure although an eighteenth century origin was suggested by the Buildings Conservation Officer.

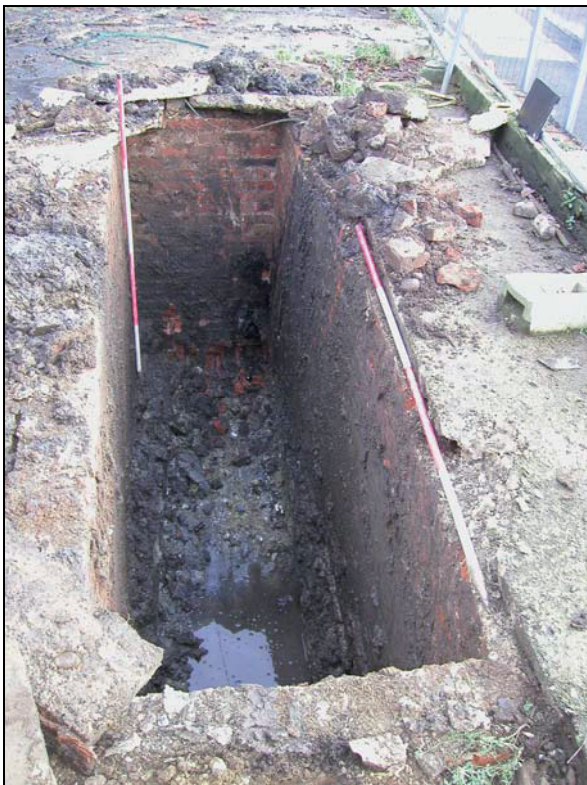
Plate V: View of Sawpit, looking E

The site was again visited, on the 4<sup>th</sup> January 2007 in response to a telephone call from the on-site building contractors when it was found that the outbuilding had been cleared and part of the concrete floor had been lifted to reveal the sawpit, which had been emptied of fill by a machine fitted with a toothed bucket only slightly narrower than the sawpit itself.

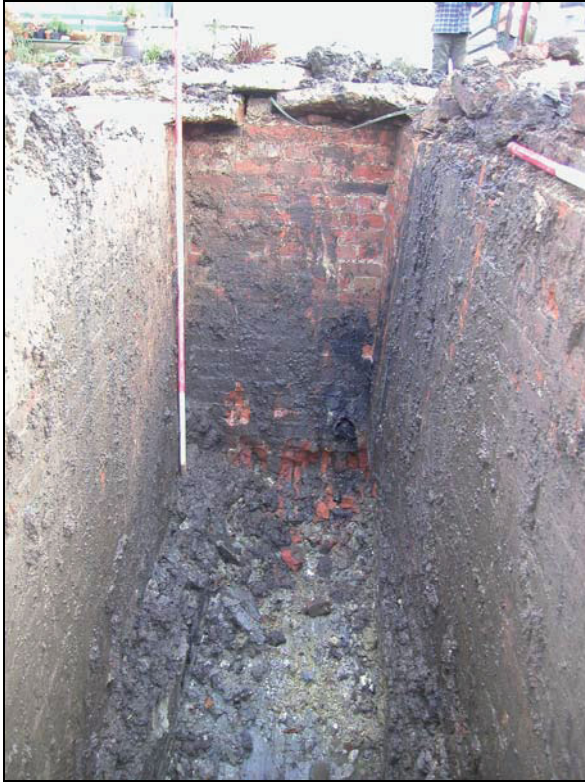
Plate VII: View east end of Sawpit

No obvious internal features were noted other than what appeared to be a circular pipe set in the southeast corner. It was not entirely clear but it appeared to be located at a height of one course of bricks above the base (visible in Plate VII).

No internal features were noted (some have recesses for storage of food, drink, etc. for the bottom sawyer). The pipe seen in the southeast corner, despite being situated slightly above the floor, is probably a drain although where it would drain to is not obvious.

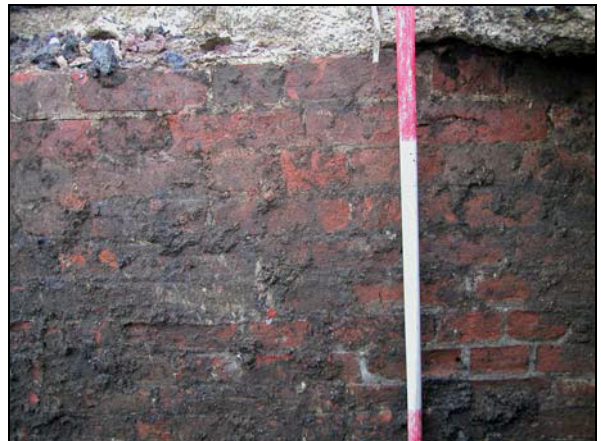
Plate X: Example of brickwork at east end, north wall

The sawpit internally measured 3.63m in length and 0.94m in width, although this increased to 1.02m in the centre. The walls were constructed of soft red bricks laid two bricks wide (*c.* 0.23m) in a random mixture of stretcher and Flemish bonds (Plate X) and cemented with a lime mortar. The brickwork extended to a depth of 1.68m at which point a natural stiff grey boulder clay was encountered. The base of the sawpit had been removed by the machine during its excavation. Based on some examples remaining at the western end it is believed to have consisted of bricks laid flat across the base, the surface of which was probably at a depth of 1.54m.
