**Nuttall Farm,  
Frostenden,  
Suffolk  
FOS 029**

**Archaeological Record**

**Outbuilding at Nuttall Farm,  
Frostenden,  
Suffolk**

**An Archaeological Record**

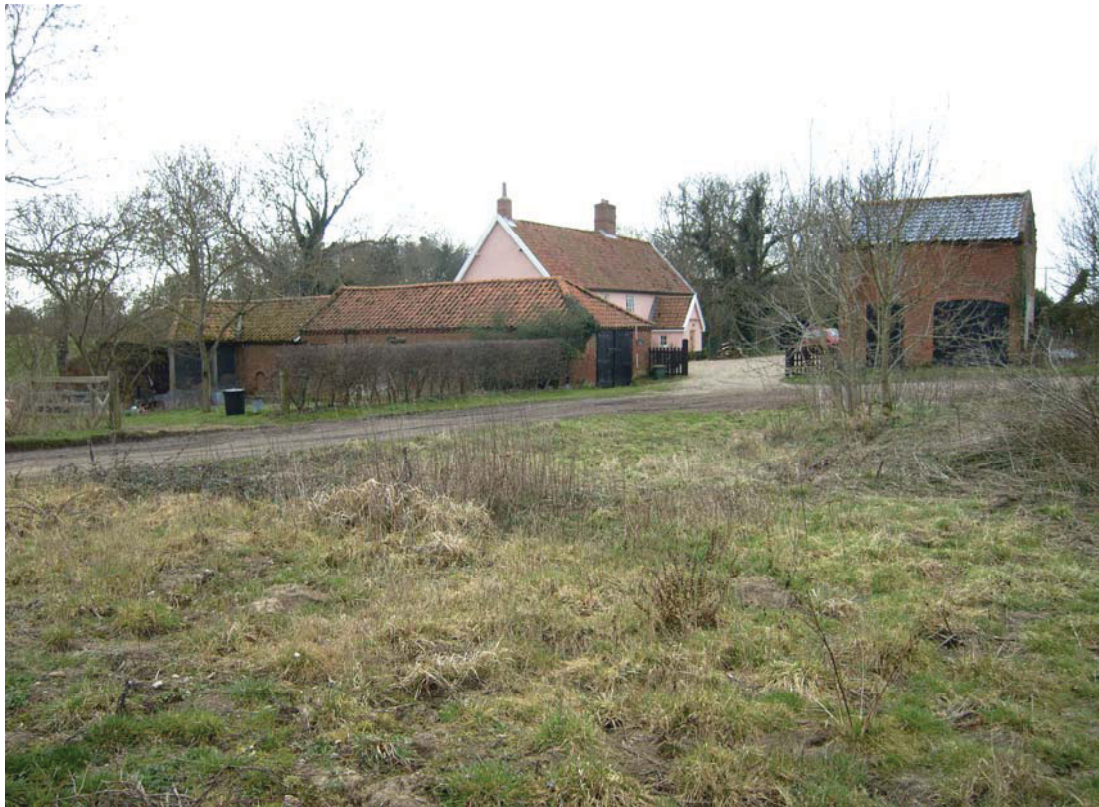
A2.1 General view of site from north-east showing range of brick sheds (1) to left, 16<sup>th</sup> century house (2) in centre to rear & contemporary stable (3) to right.

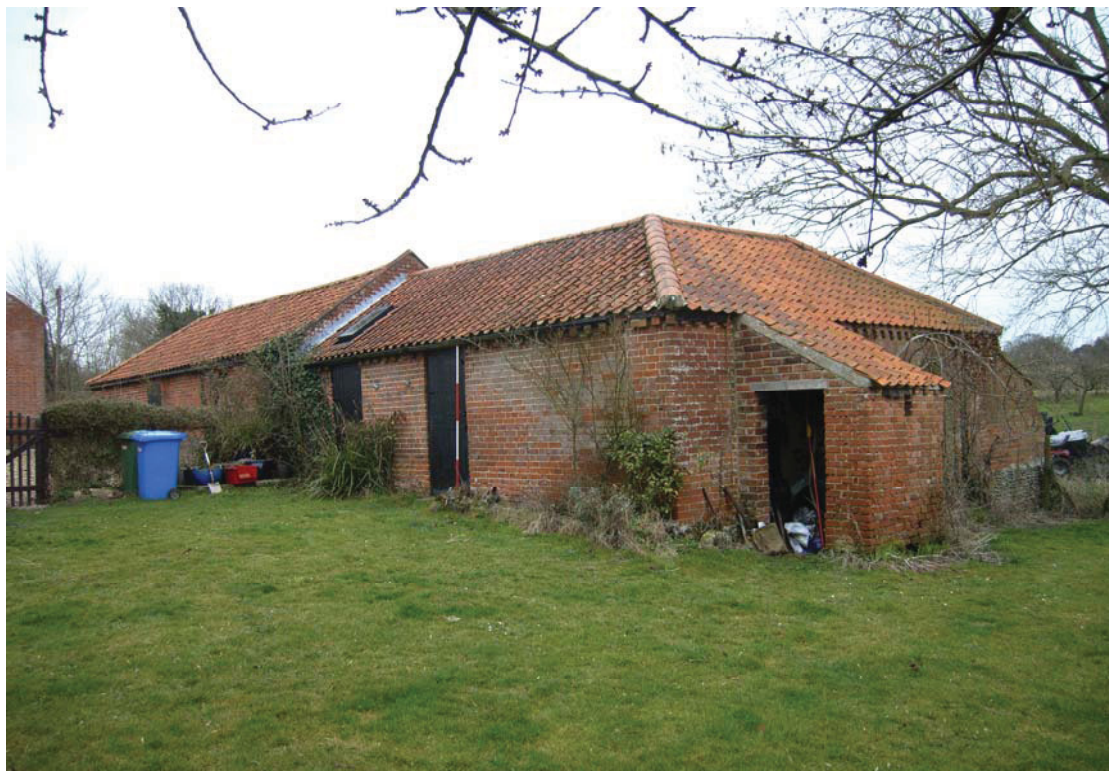
A2.2 Exterior from south-west showing privy against southern gable to right. Note the step in the roof which was designed to accommodate the slope of the ground

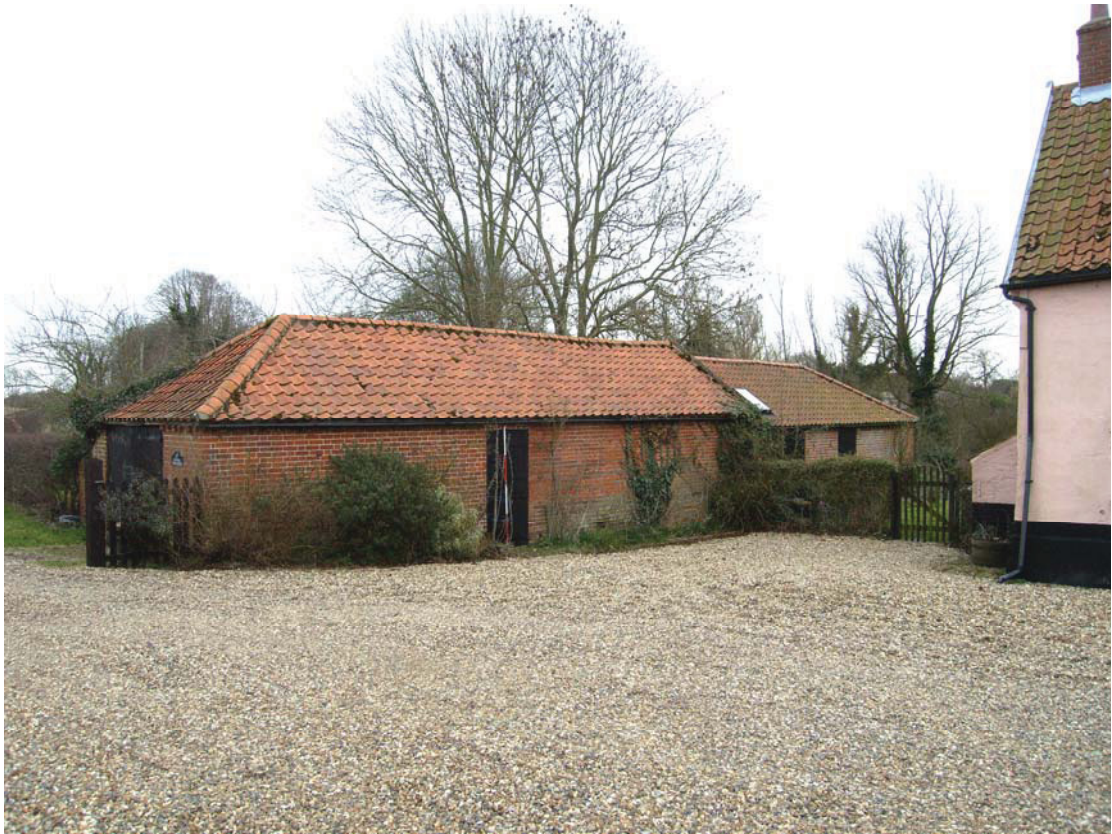
A2.3 Exterior from west showing corner of house to right

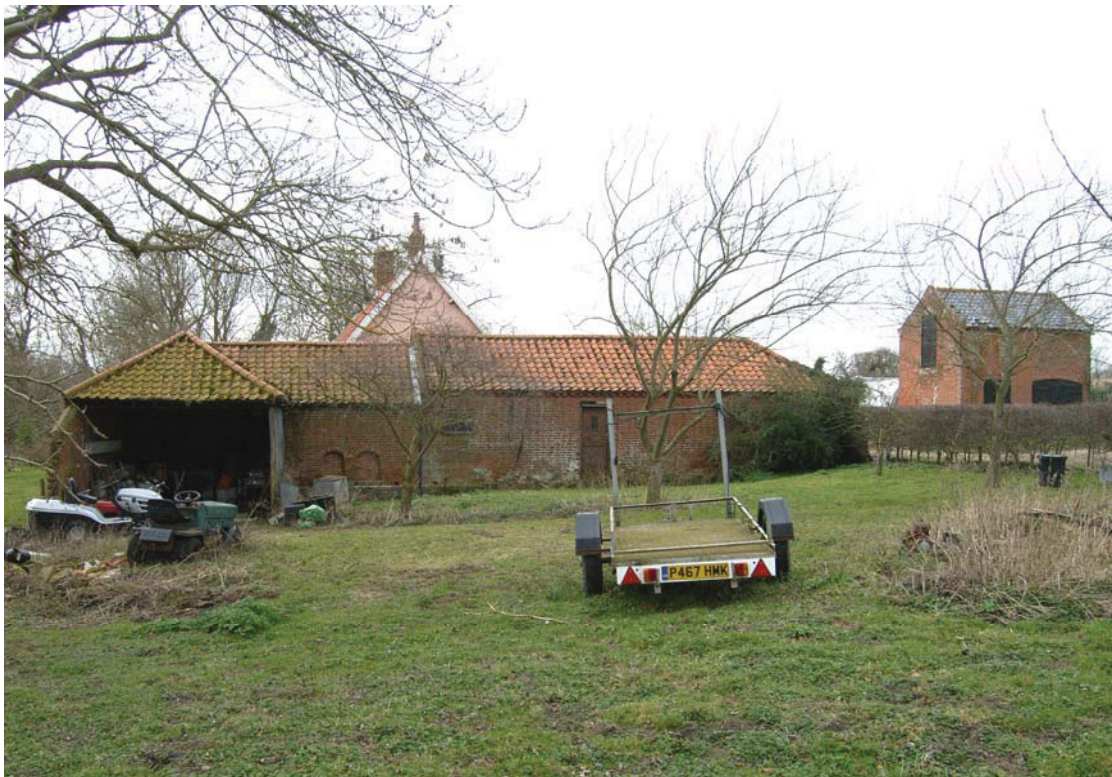
A2.4 Exterior from site of demolished farmyard to east showing gable of house in rear and stable to right

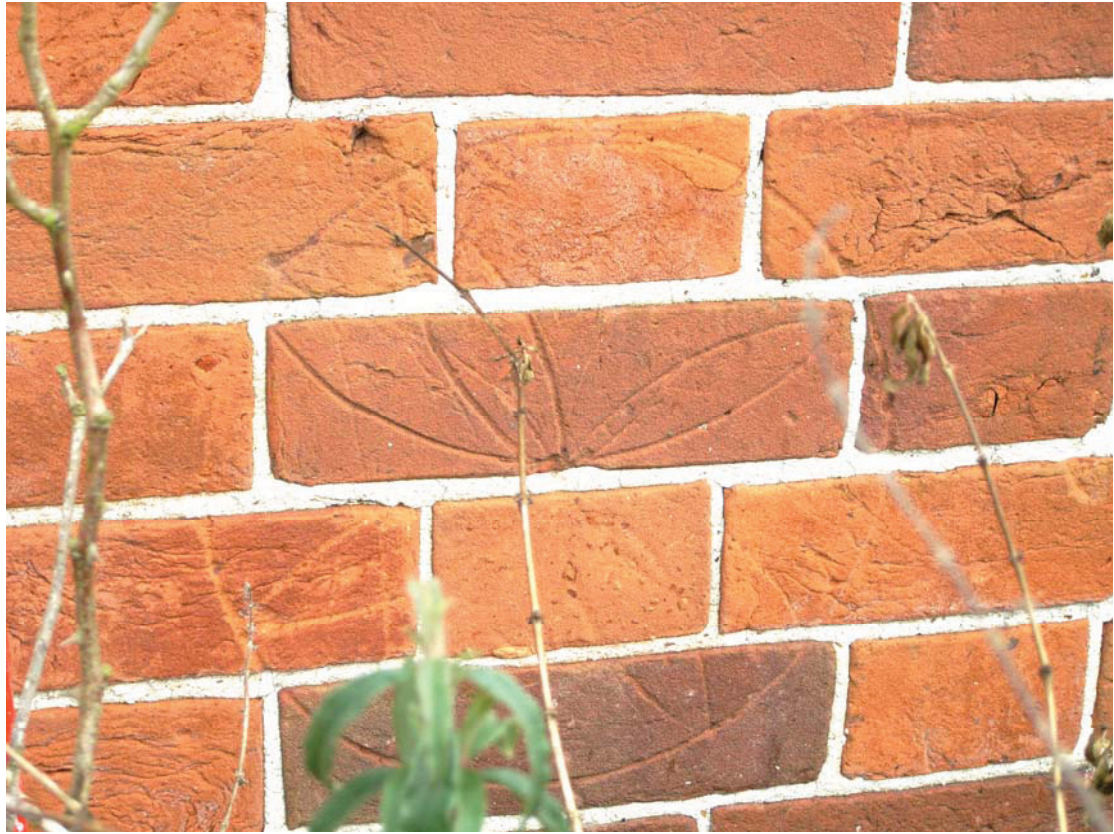
A2.5 Detail of 'daisy-wheel' apotropaic mark incised to brickwork of western external elevation

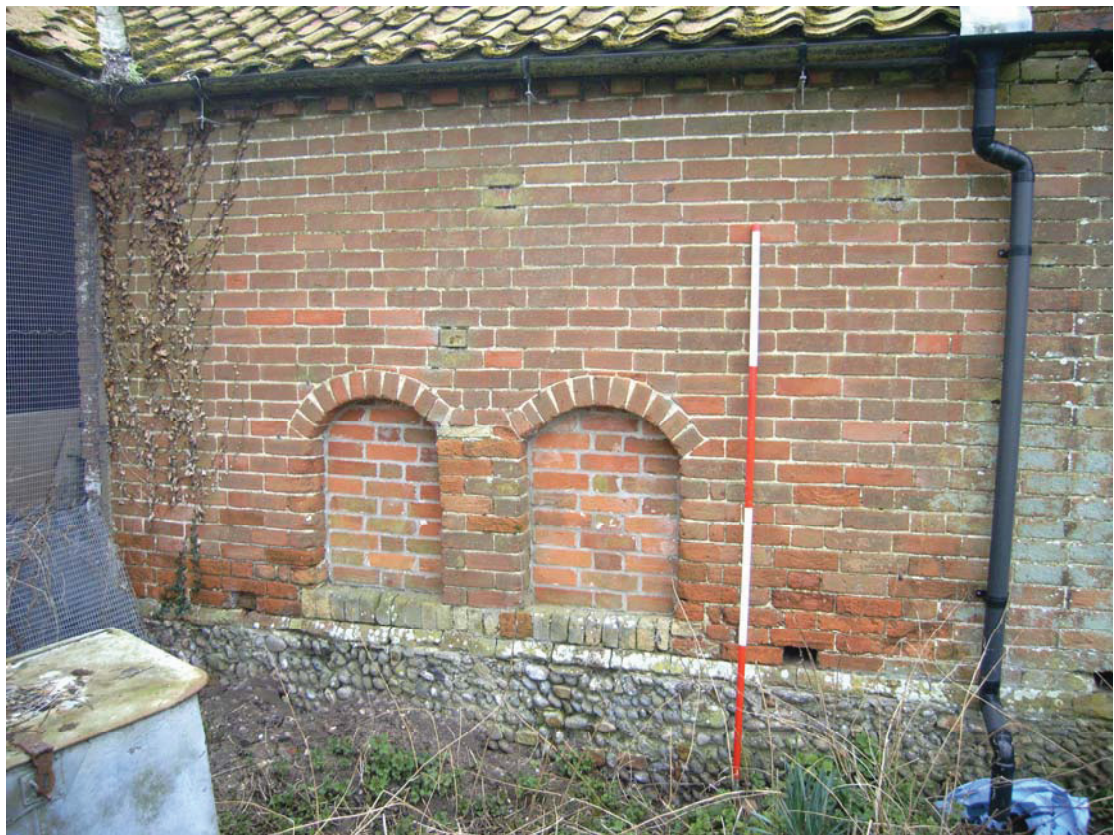
A2.6 External eastern elevation of shed B showing blocked arches

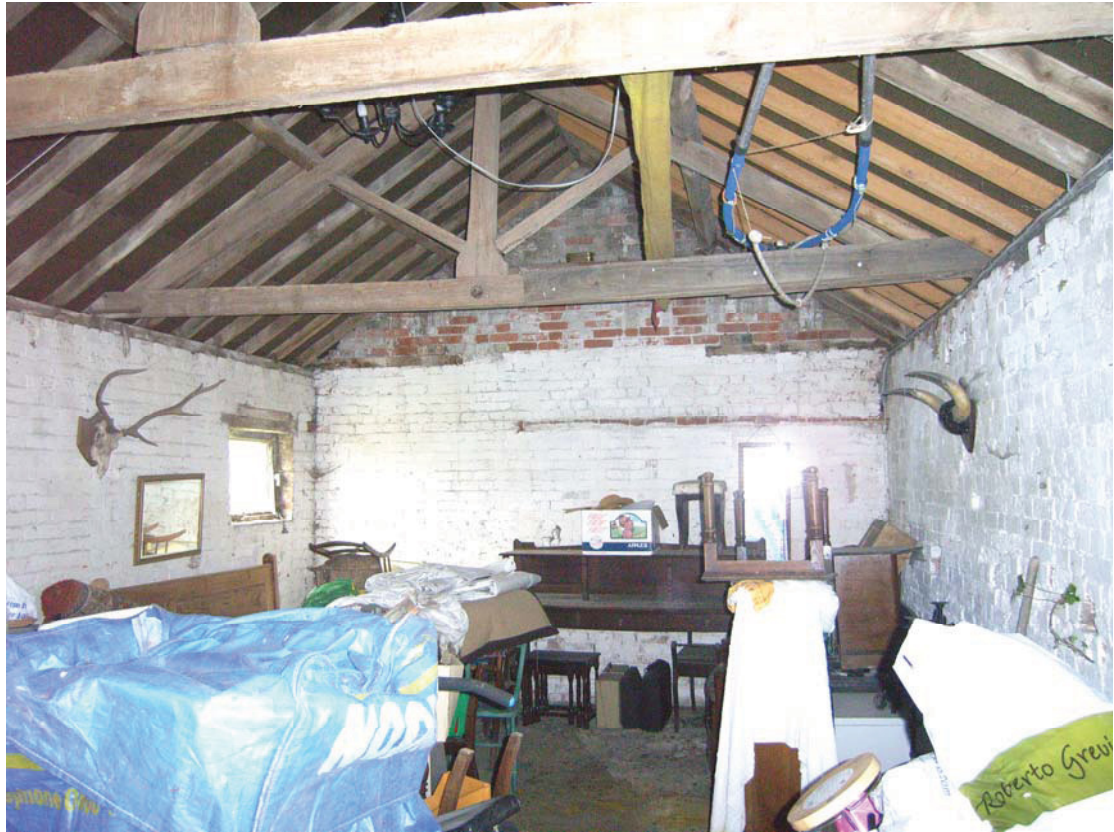
A2.7 Interior of shed C from north showing notches of manger to western elevation to right and original king-post roof

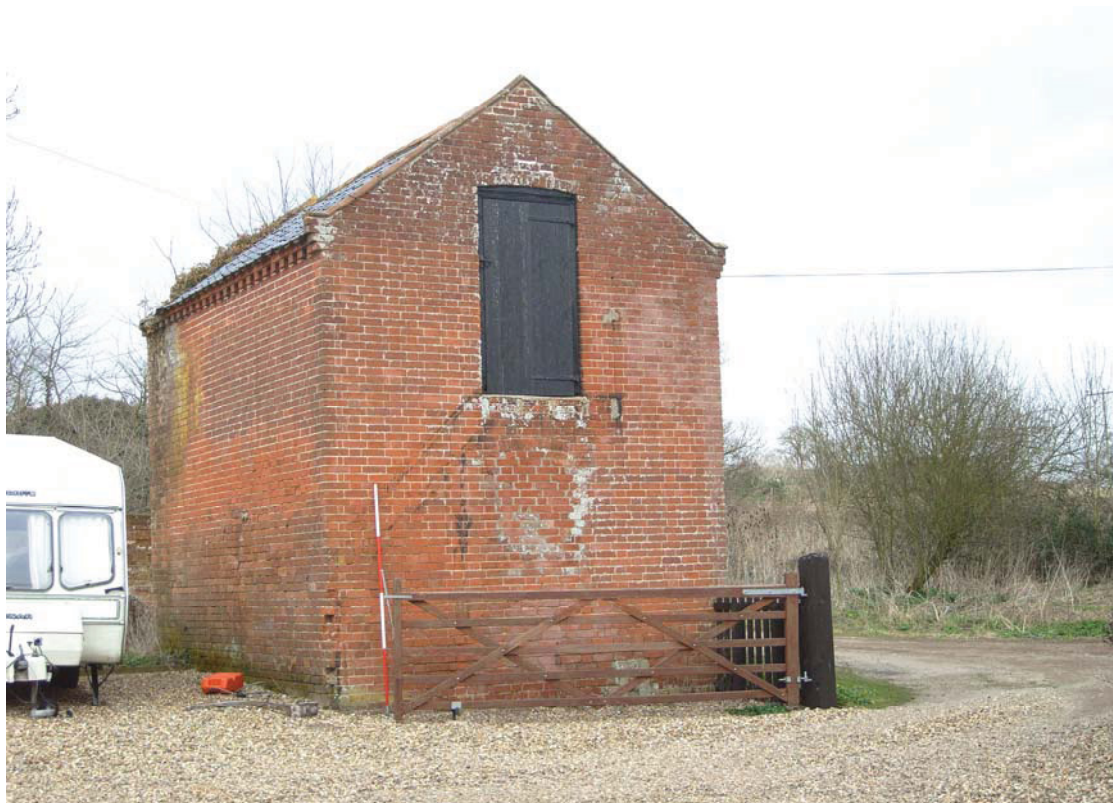
A2.8 Exterior of stable (3) from south-west showing scar of external stair to hay loft. Included for site context
