**Wren Cottage,  
East Bergholt,  
Suffolk  
EBG 038**

**Archaeological Record**

**Outbuilding at Wren Cottage,  
Gaston Street,  
East Bergholt, Suffolk**

**An Archaeological Record**

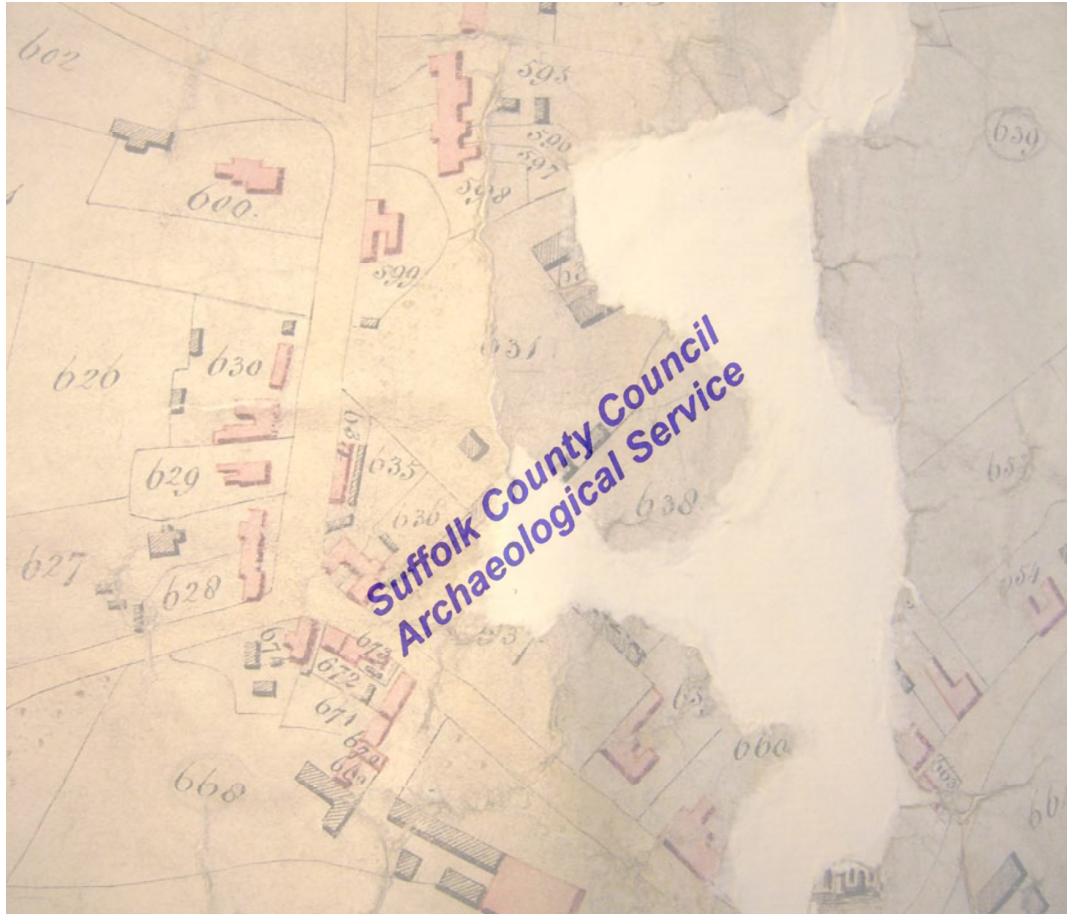
**Figure 2**  
**East Bergholt Tithe Map, 1839**

The map is substantially damaged, but shows the church to bottom left and Wren Cottage (no. 599) top centre. The site of Golding Constable's mansion is numbered 637 and his flower garden 638. Stable Meadow (631) lies between the garden and Wren Cottage, with the 'stackyard' (partly damaged) framed by the thatched barn and possible stable in its north-eastern corner.

The tithe map (figure 2) shows only a small garden or yard surrounding the house, and the land to the east, which now belongs to the property and contains the outbuilding herein recorded, was in the separate ownership and occupation of Walter Clerk Esquire. Clerk owned several houses in the parish along with some 200 acres of land, most of which was let as a separate farm. He lived in a 'mansion' with a lawn, garden and 20 acres of land which he

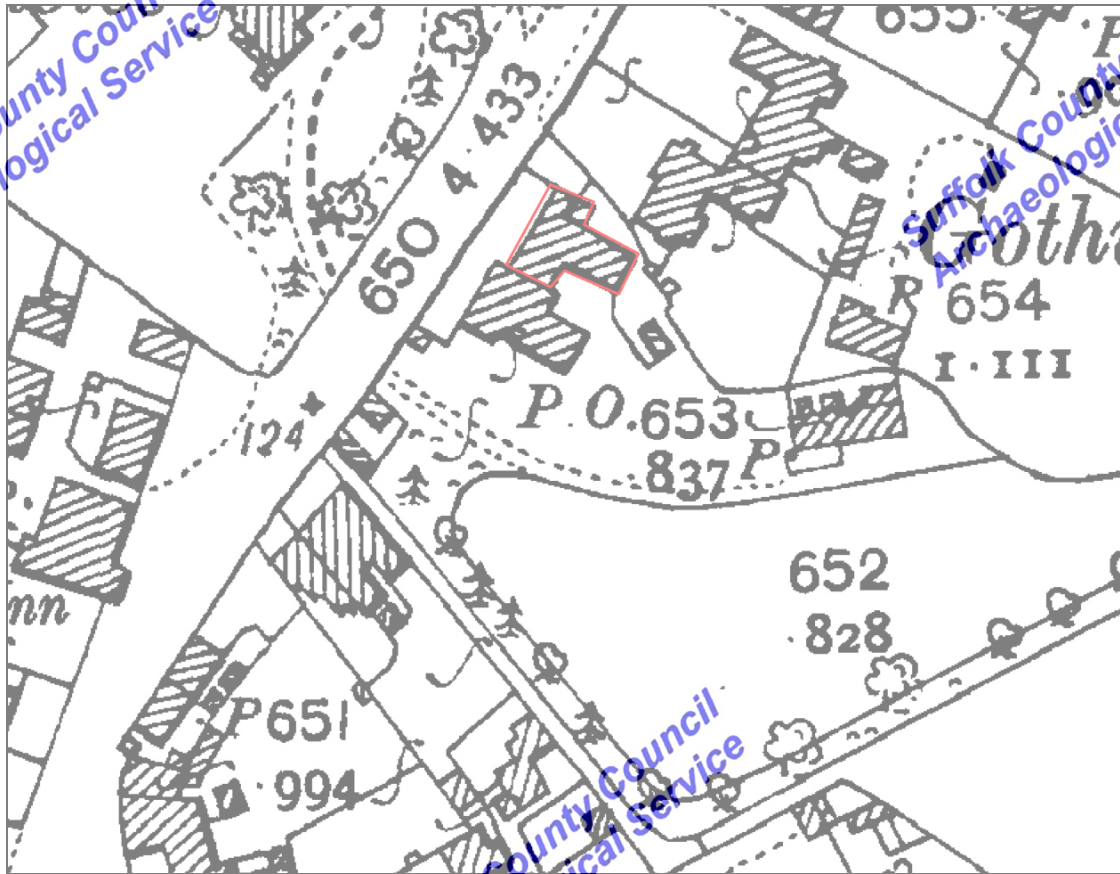
Figure 4  
Second Edition 25 inch Ordnance Survey of 1903. The outbuilding is shown in more detail, with the present pump (P) in the corner of the stable yard. A fragment of the brick wall defining this yard still survives behind the pump.

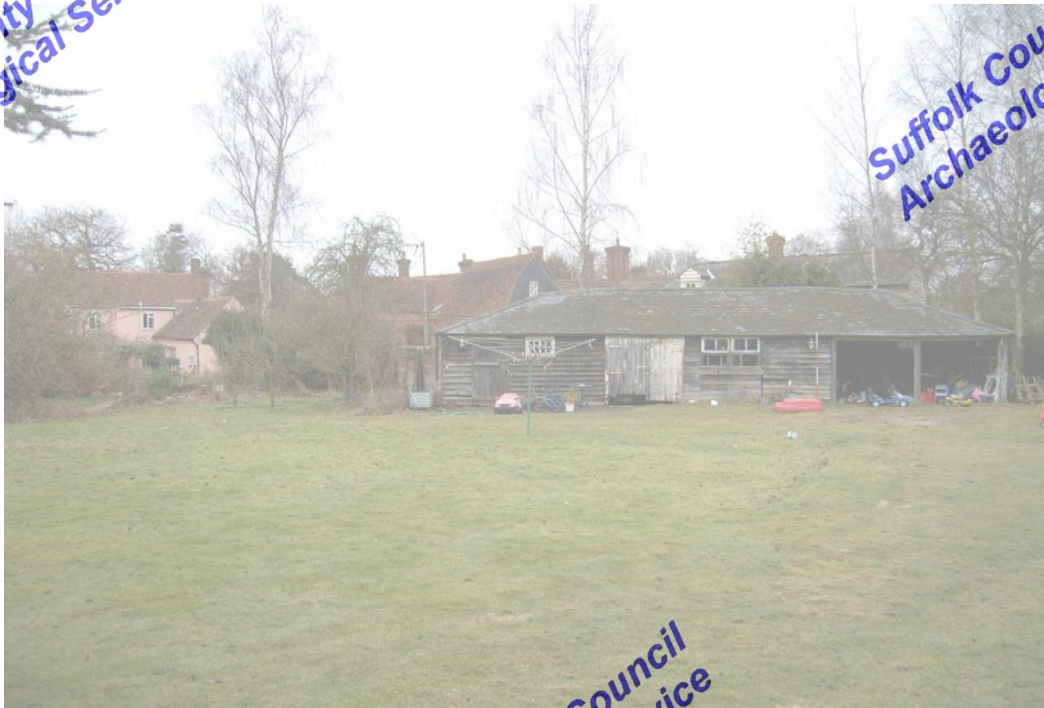
A2.1 General view of site from south showing Wren Cottage with its single-storied rear wing to the left and the outbuilding to the right. Compare Constable's painting below.

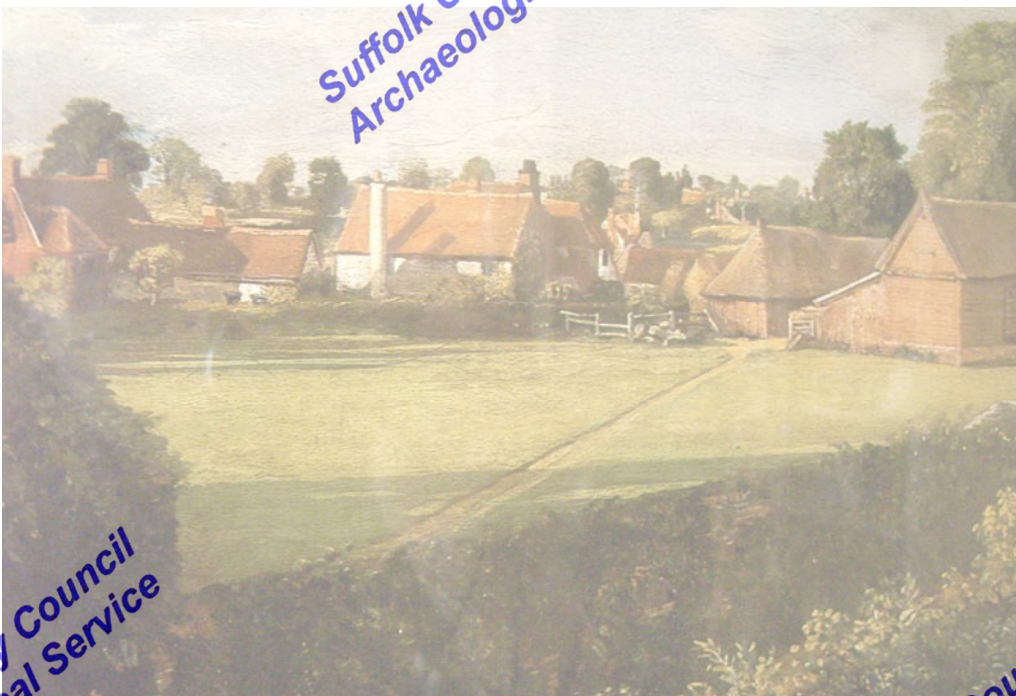
A2.2 Detail of John Constable's 1815 painting of 'Golding Constable's Flower Garden' showing Wren Cottage and its single-storied rear wing to the left (seen from slightly further to the west than in A2.1 above). The present outbuilding occupies the approximate site of the thatched, single-storied farm building behind the 'red' barn to the right

These buildings are shown in the background of John Constable's 1815 painting entitled 'Golding Constable's Flower Garden'; the southernmost structure is a three-bay thatched barn with a central, southern entrance and the northernmost a single-storied thatched building that may have been the eponymous stable (although the adjacent meadow may have taken its name from the more substantial stables which still survive immediately behind the site of the mansion). The weatherboarded walls of the barn are painted red/brown, closely resembling its brick rear lean-to, and illustrate the usual appearance of local farm buildings before the late-19<sup>th</sup> century advent of inexpensive tar as a by-product of town gas production. The single-

storied building appears to be a timber-framed structure with exposed studs and brick infill. Nothing remains of these two buildings, but the present outbuilding occupies the approximate site of the latter. Constable's painting also shows the present single-storied rear kitchen wing of Wren Cottage with its distinctive central chimney behind the boundary hedge. The painting is currently owned by Ipswich Borough Council.

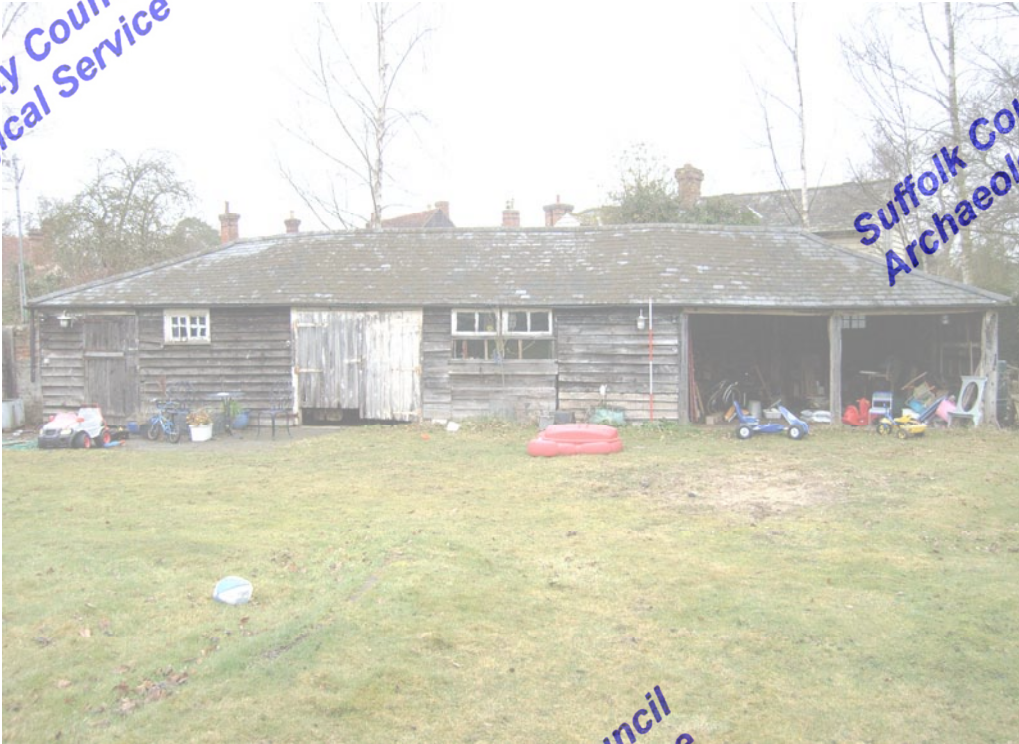
A2.3 External southern elevation showing stable to left and open shed to right

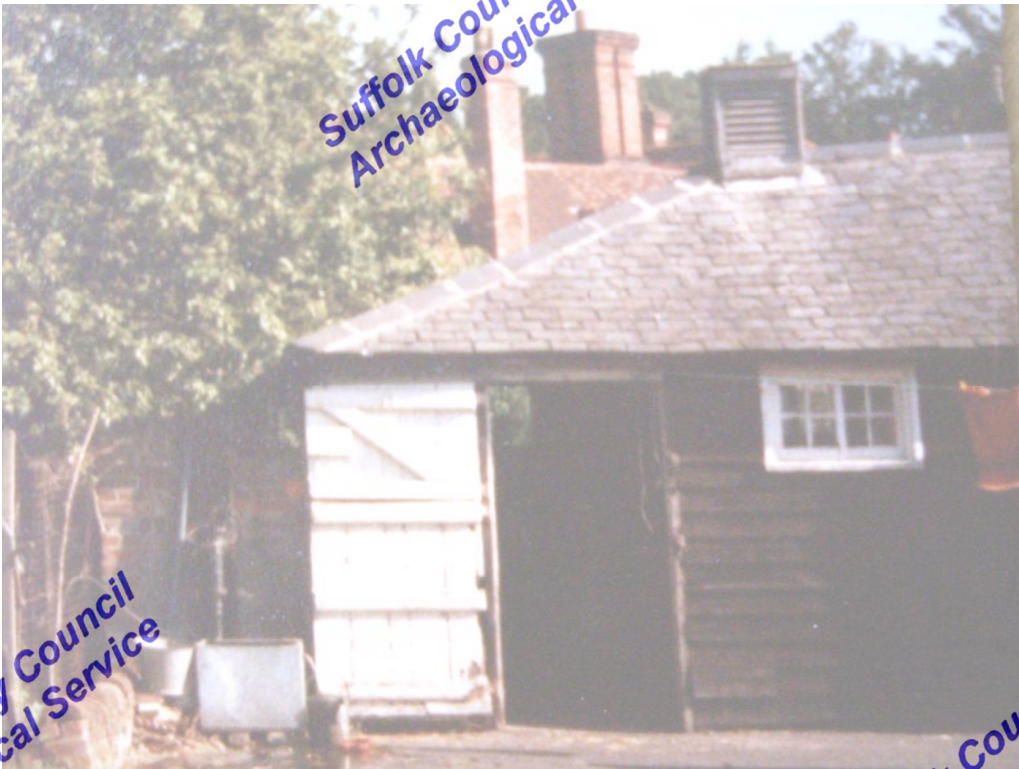
A2.4 Western end of southern external elevation as shown in a late-20th century photograph in the present owner's possession showing the original stable louver

The building was divided into four internal compartments, of which two have since been combined. The western compartment formed a stable of 4.3 m in length (14 ft) with double hung doors to the south and horizontal sash windows to front and rear. It was ventilated by a roof louver which has since been lost, but preserves the wainscot of its original stalls to the northern elevation and both side elevations. The side elevations are curved and terminate at split turned posts with acorn finials. The red-brown pigment of this wainscot contrasts with the whitewashed wall boarding and is likely to reflect the stable's original décor. A small external hatch was provided in the rear elevation to facilitate mucking out. The present floor tiles date only from the 20<sup>th</sup> century.

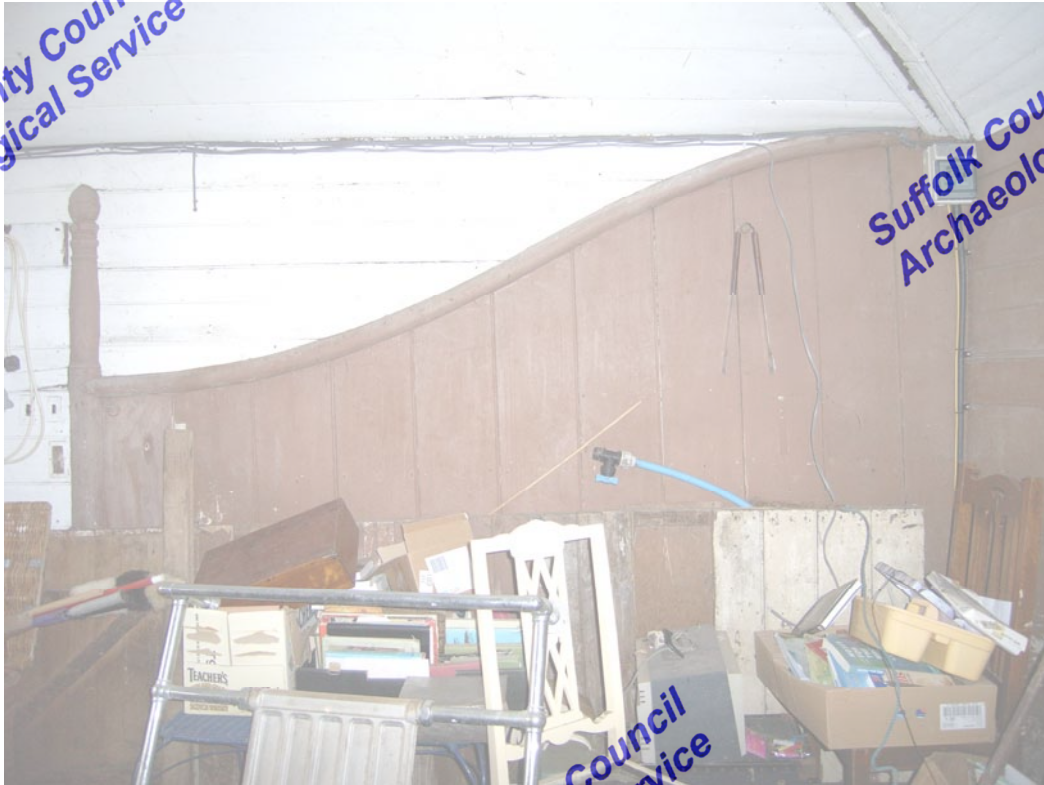
A2.5 Detail of curved stall wainscot to internal western elevation of stable (A)

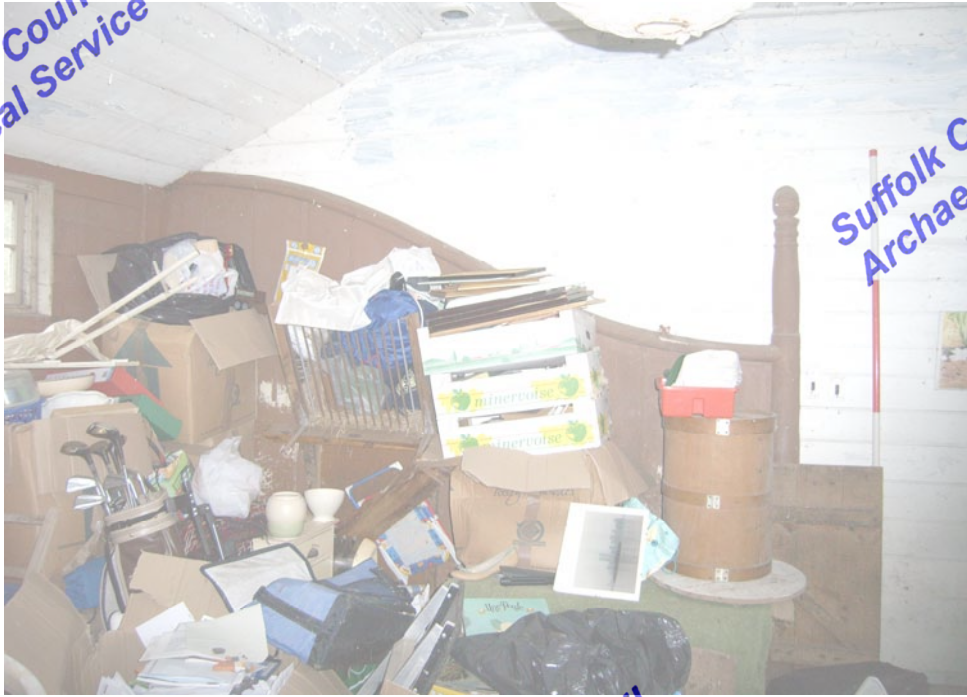
A2.7 Internal eastern elevation of stable (A) showing curved wainscot with turned finial and northern elevation to left

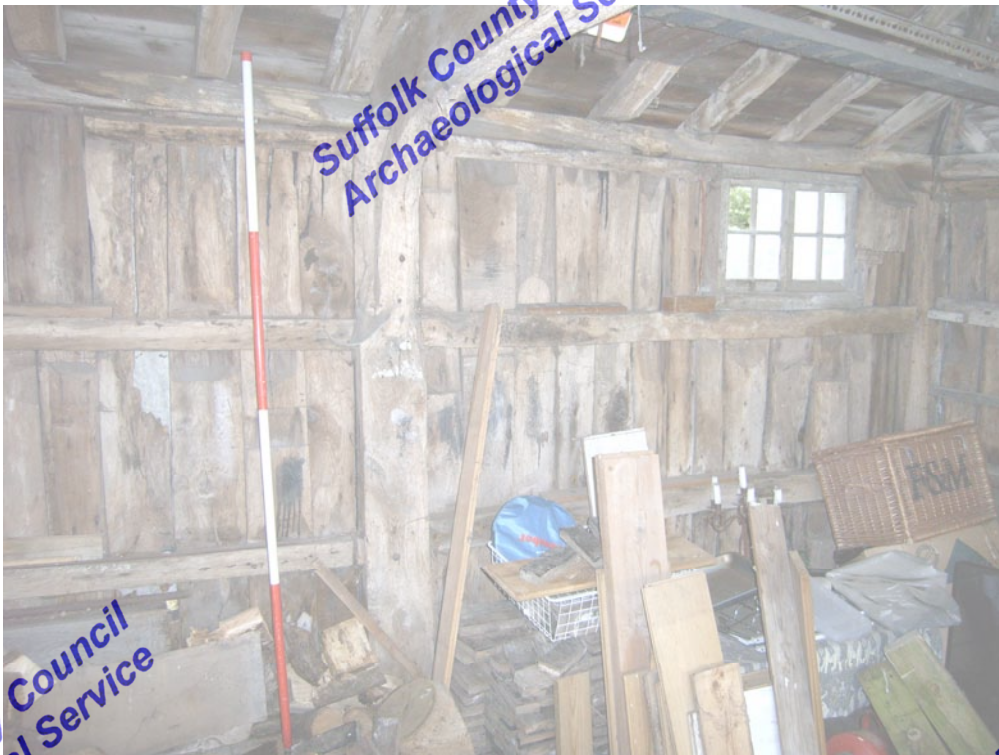
A2.8 Detail of board-and-rail construction of northern internal elevation of open shed (C) with bolted knee-brace to tie-beam. Eastern gable to right

The outbuilding lies in the rear garden of Wren Cottage, approximately 32 m ESE of the house. It extends to 15.8 m in length by 5.2 m in overall width (52 ft by 17) on an east-west axis and rises to 1.9 m (76 ins) at its eaves. The low-pitched clasped-purlin roof structure of machine-sawn softwood with nailed collars and a ridge board rises to 2.8 m (115 ins) at its apex and retains its original slate and hipped gables. An area of new slate above the western hip reveals the position of an original square-sectioned louver which ventilated the stable, as shown in a late-20<sup>th</sup> century photograph in the present owner's possession, but this has been removed. The external walls are clad chiefly in tarred weatherboarding, with some areas of modern fibreboard. Several sections of boarding have been renewed, but much is probably contemporary with the wall fabric and reveals a layer of probably original grey pigment beneath the later whitewash and tar. This grey colouring would have reflected the slated roof to create a strikingly uniform appearance. The stable to the west (A) is sealed by horizontal boarding, but the remaining walls consist of vertical boards nailed to horizontal rails which in turn are tenoned but not pegged to the wall posts. A pair of bolted knee-braces link the tie-beam which spans the open shed (C) to its central posts.

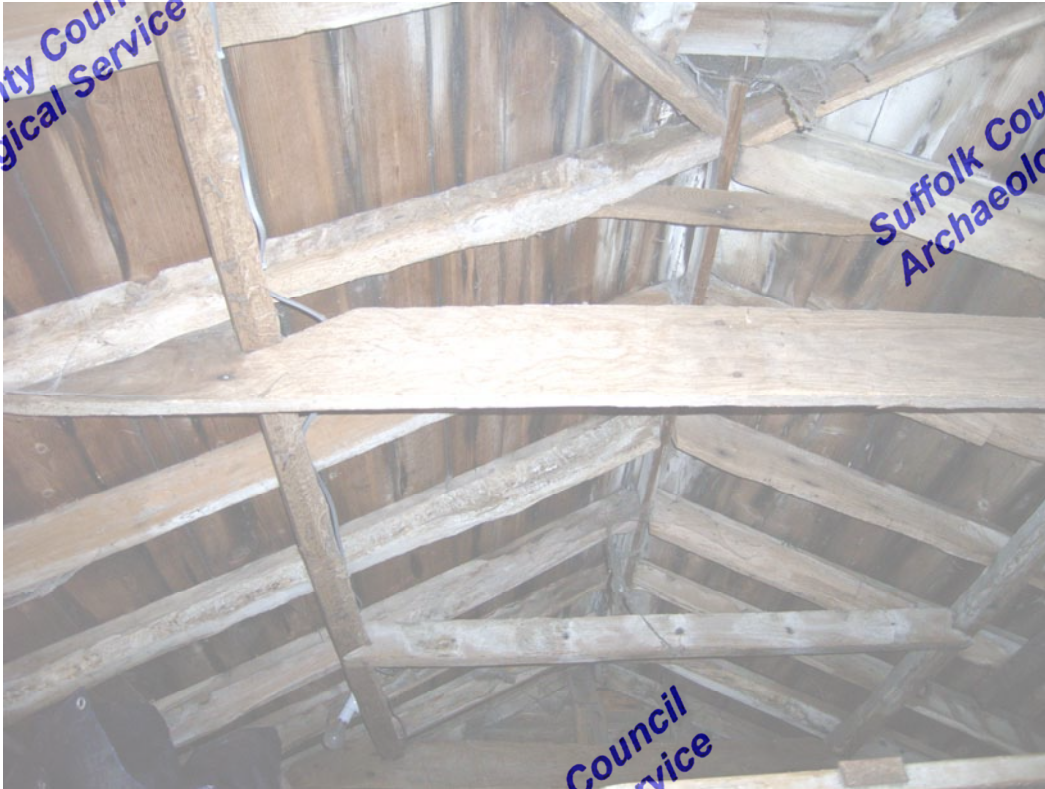
A2.9 Detail of original clasped-purlin roof structure with nailed collars seen from east in open shed

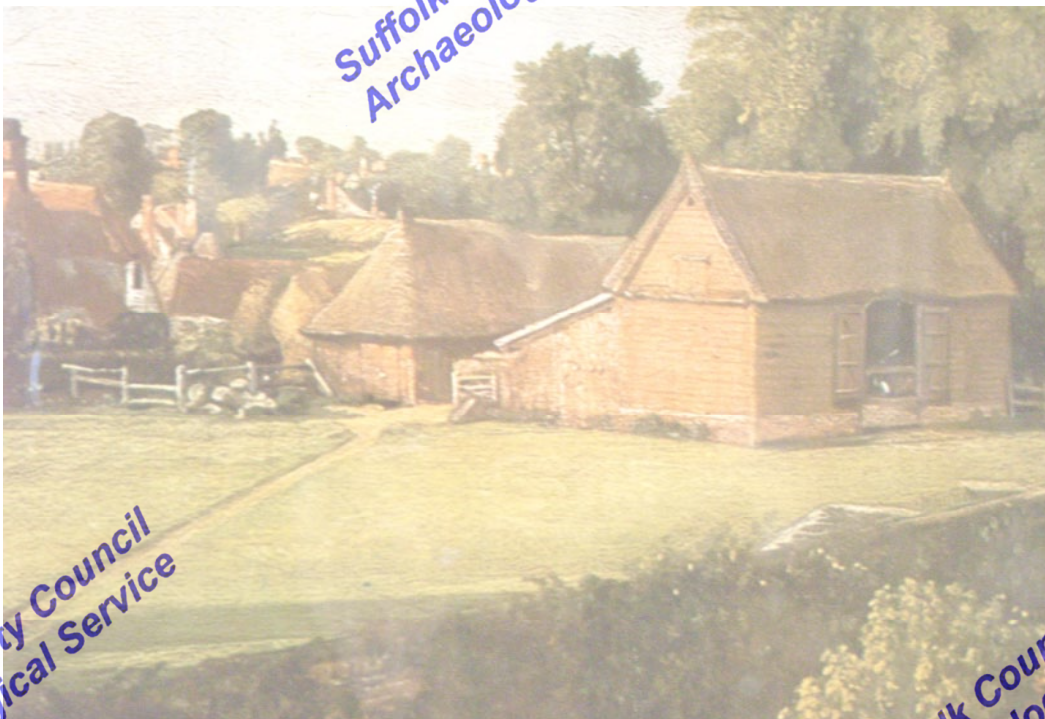
A2.10 Detail of Constable's 1815 painting 'Golding Constable's Flower Garden' showing the earlier buildings on the site. The weatherboarding of the barn is a red/brown colour and illustrates the usual appearance of Suffolk barns before the use of tar in the late-19<sup>th</sup> century
