**New House Farm,
Poslingford,
Suffolk
PSG 018**

Archaeological Record

**New House Farm,
New House Lane,
Poslingford, Suffolk**

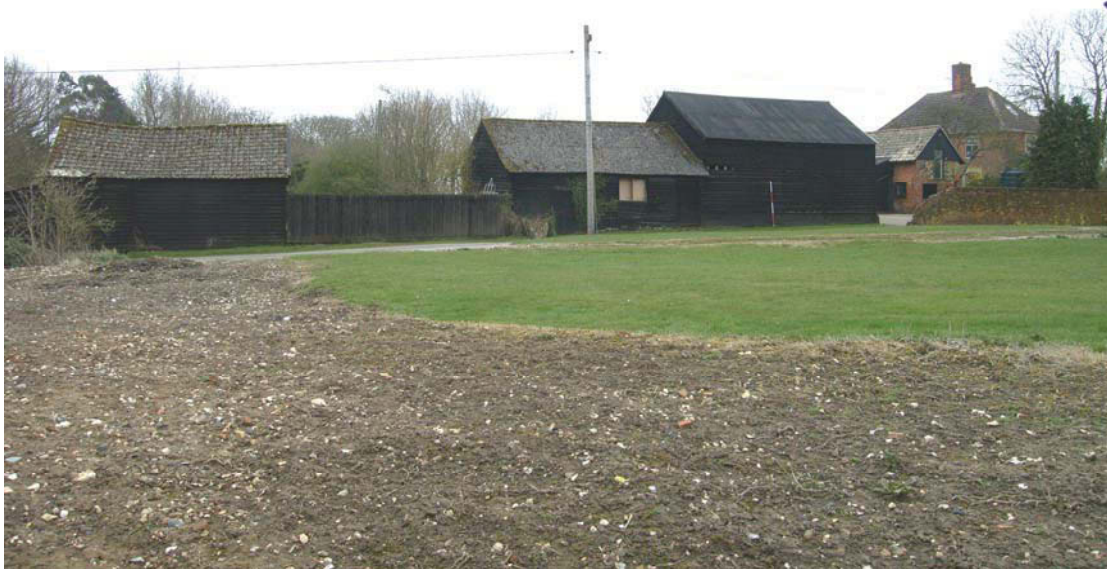
A2.1 General view of site from north-west showing the house and fragmentary remains of the 19th century farm yards to the right

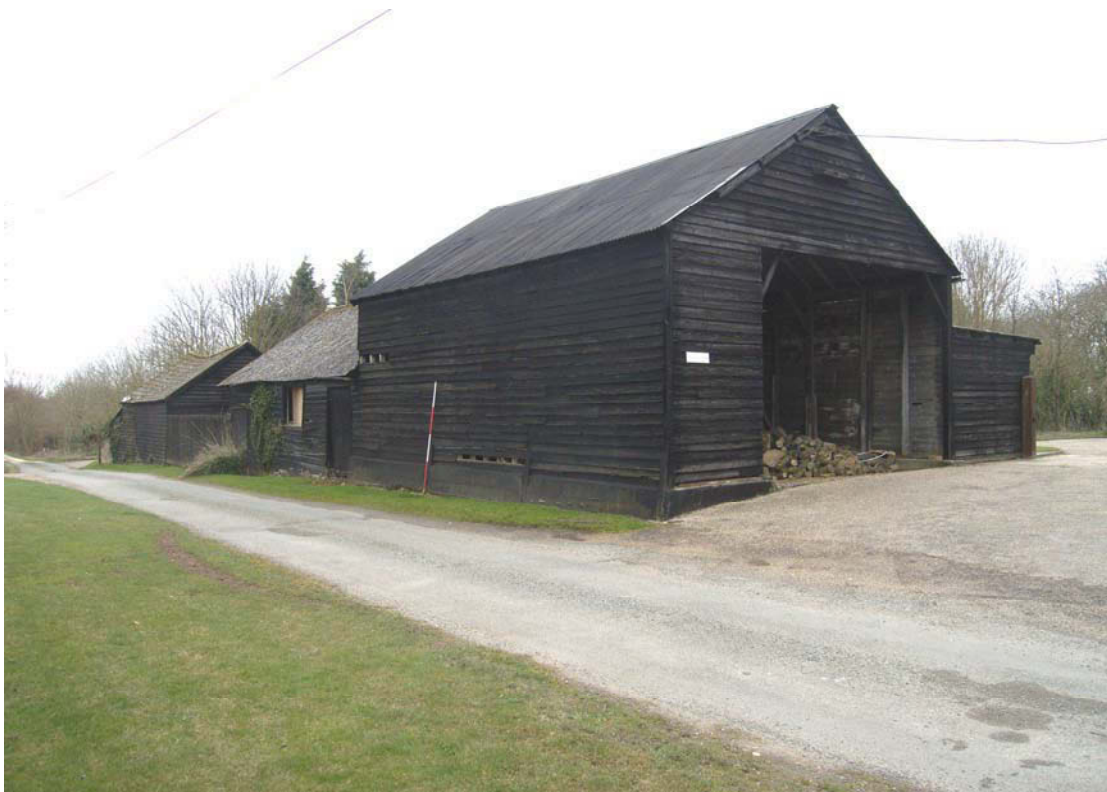
A2.2 General view of roadside sheds from west, showing the enclosed sheds (2) in foreground and the open shed (3) in the rear

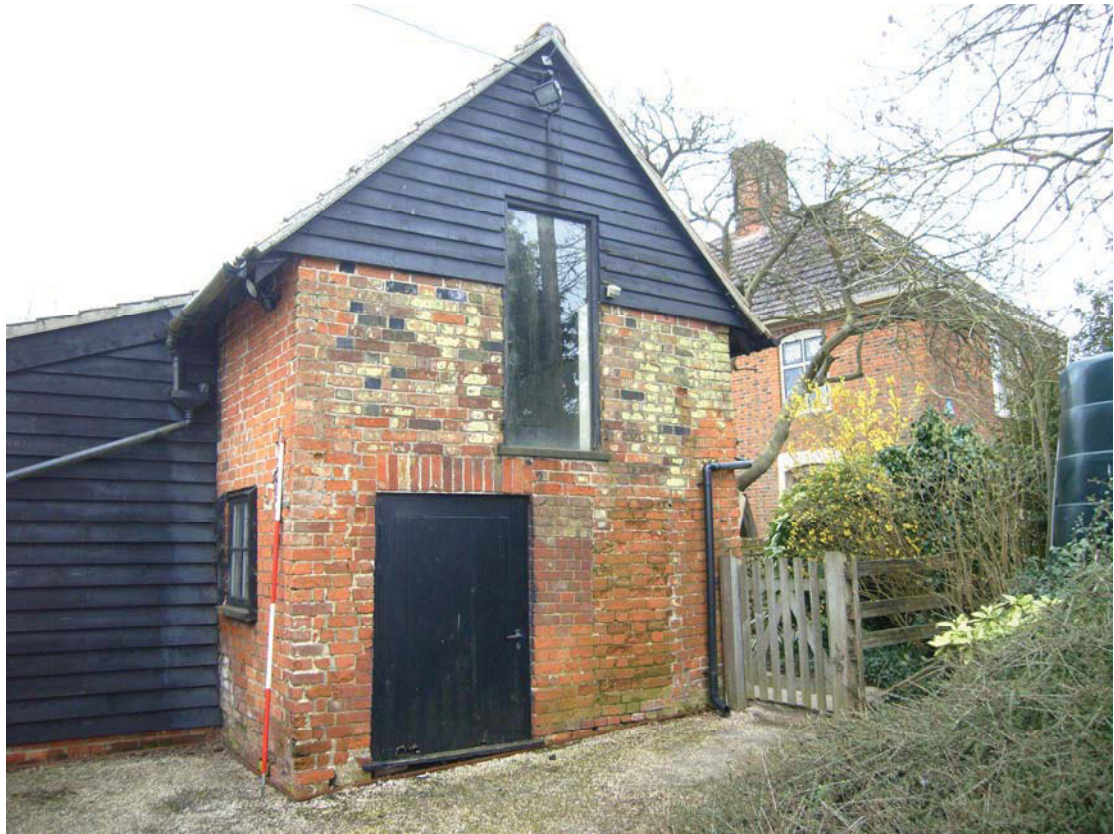
A2.3 Brick shed (1). Exterior of northern gable showing upper window of recent partial conversion and at least four phases of brickwork

The shed has been extensively mutilated in the past, with at least four phases of brickwork discernable in its northern gable, and its interior had been gutted and rendered prior to inspection (apparently as part of an aborted attempt at conversion in recent years). The roof structure had also been renewed, with the exception of an open truss consisting of curved posts resembling upper crucks which rest on renewed brick corbels at a height of 2 m (6.5 ft) and are pegged and tenoned to a low roof collar. This unusual arrangement was designed to increase headroom on the upper storey, but the ceiling has been removed without trace. A tall modern window in the northern gable presumably replaced a loading door to a granary or possibly a hay loft. The lower storey was almost certainly designed as vehicle shed (for a horse trap) as the northern road gable contained a wide doorway indicated by a tier of closer bricks just 73 cm (29 ins) from its western corner. This doorway was subsequently blocked with bricks of late-19th century appearance, and replaced by a window with a normal door to the east, and this window was blocked in turn during the 20th century. The eastern elevation contains evidence of three original narrow window apertures on the lower storey, each approximately 55 cm (21 ins) in width, but the present frames are secondary. The western elevation probably contained a similar pattern of fenestration, but the area of the central window is hidden by ivy, and the southern gable possessed a narrow doorway with a (blocked) window alongside. The central window of the eastern elevation was later converted into a door, which is now blocked by 20th century brickwork and an iron water pump.

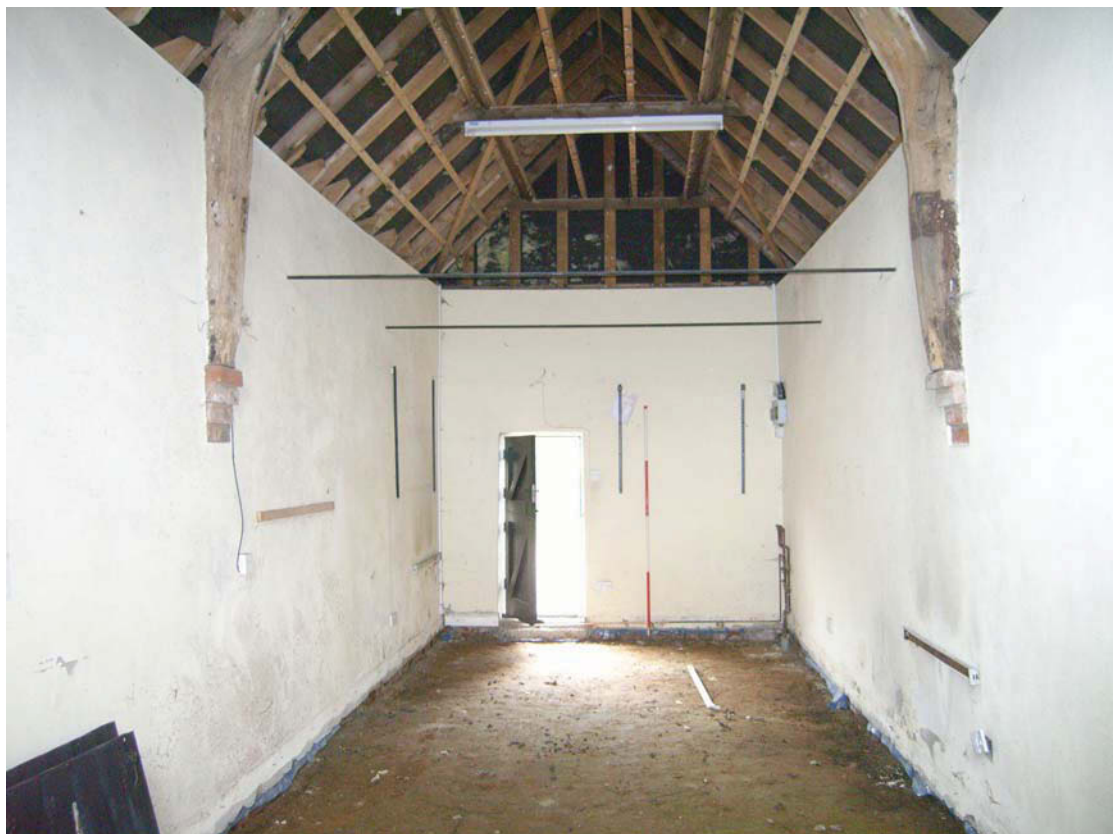
A2.4 Brick shed (1). Gutted interior from north

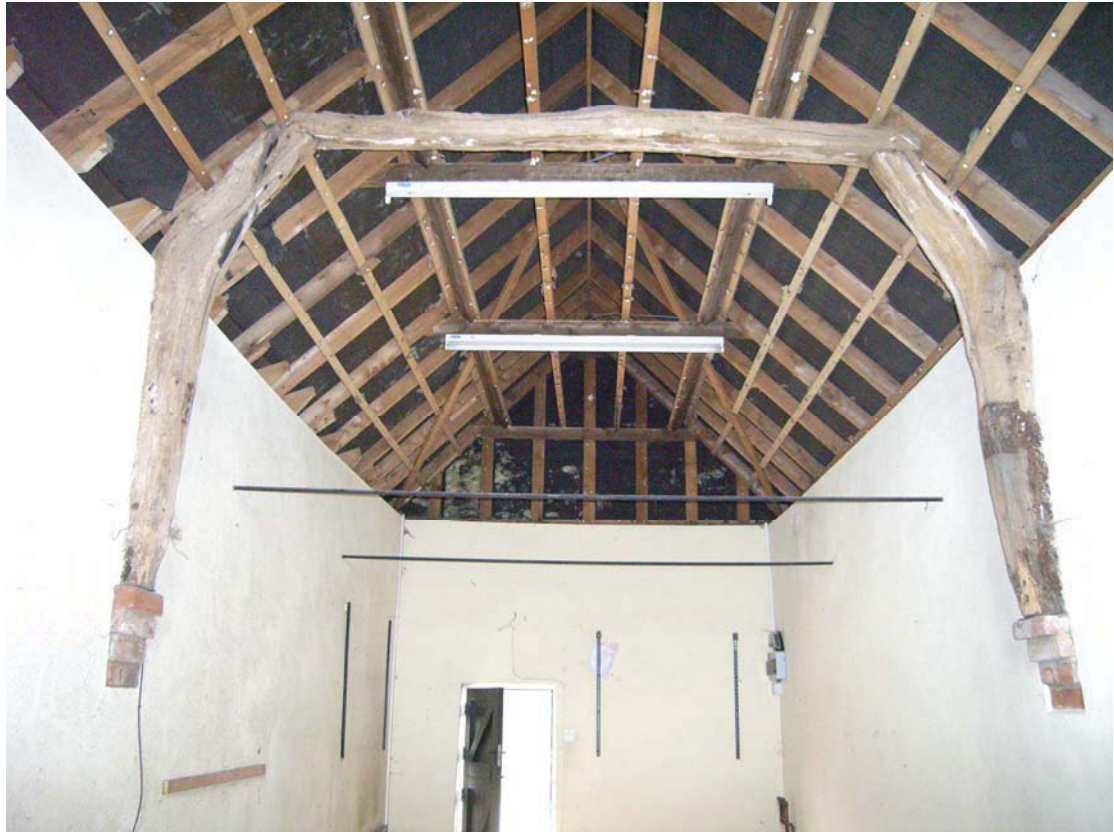
A2.5 Brick shed (1). Apparently original open truss of recently rebuilt roof from north

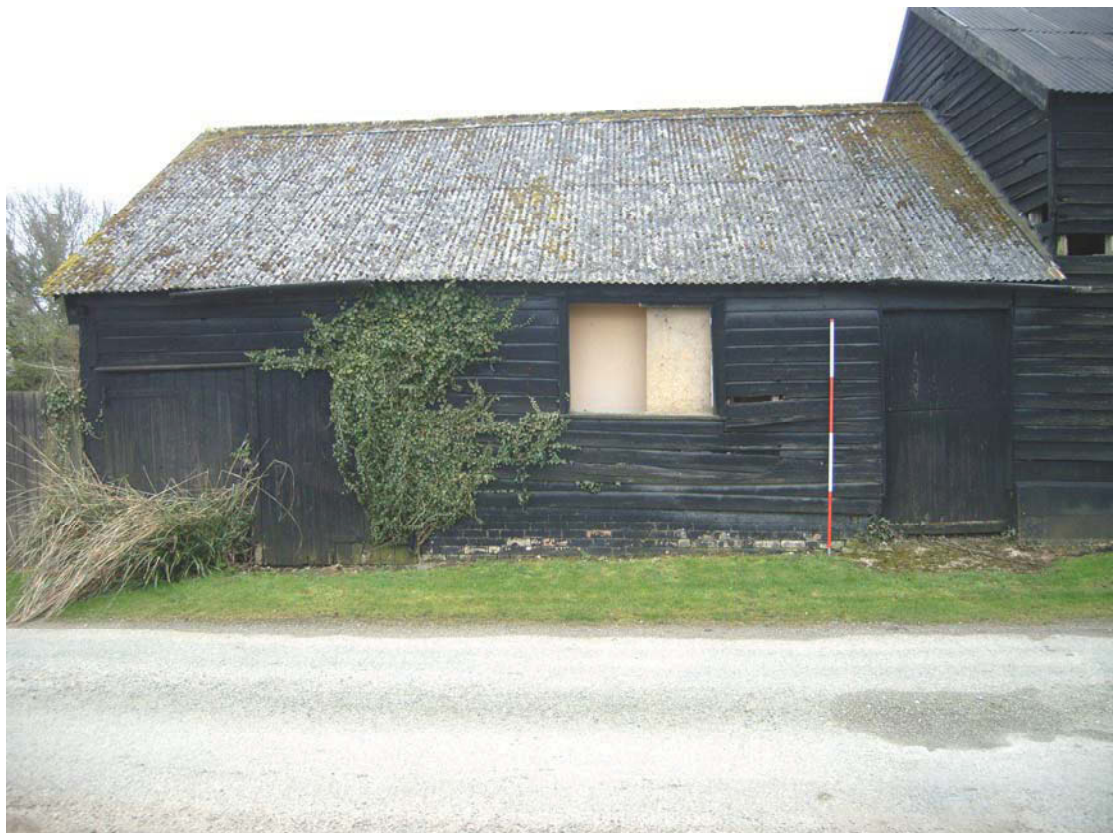
A2.6 Enclosed sheds (2). External northern elevation of eastern enclosed shed, showing double doors to vehicle compartment to left and double-hung doors to right

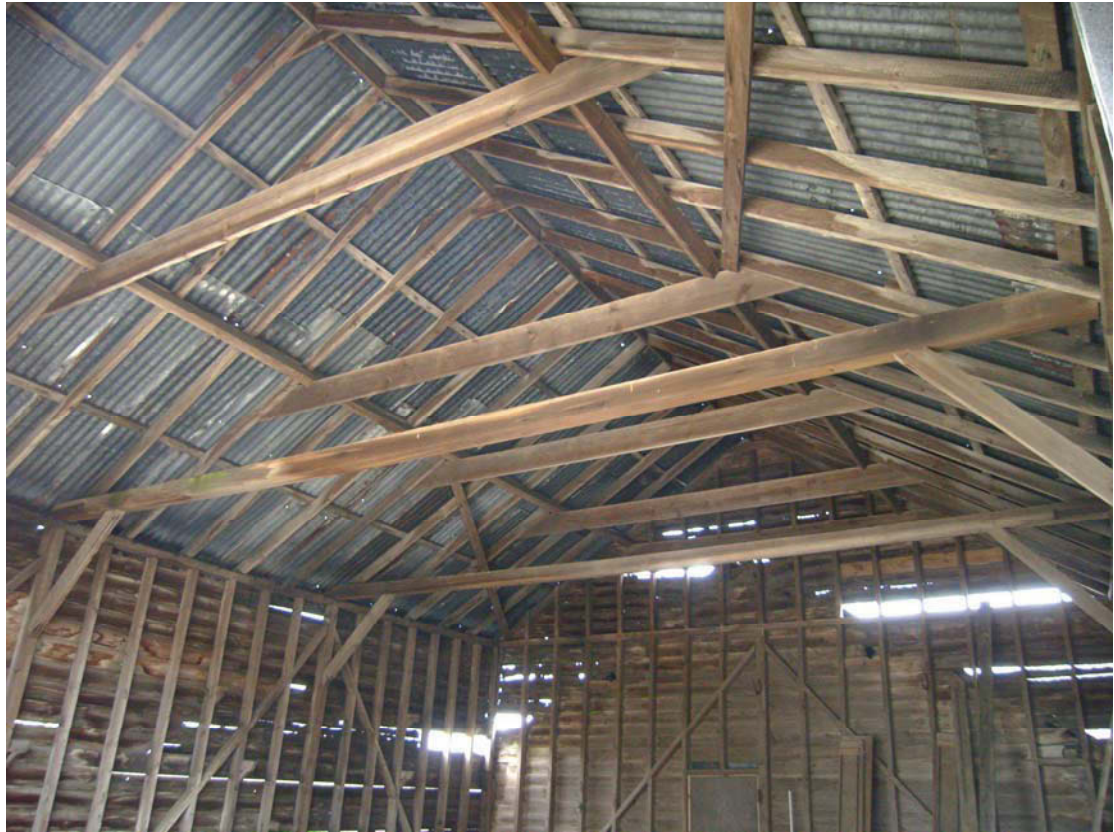
A2.7 Enclosed sheds (2). Detail of original softwood roof structure of western shed viewed from west, showing gable adjoining eastern shed to right

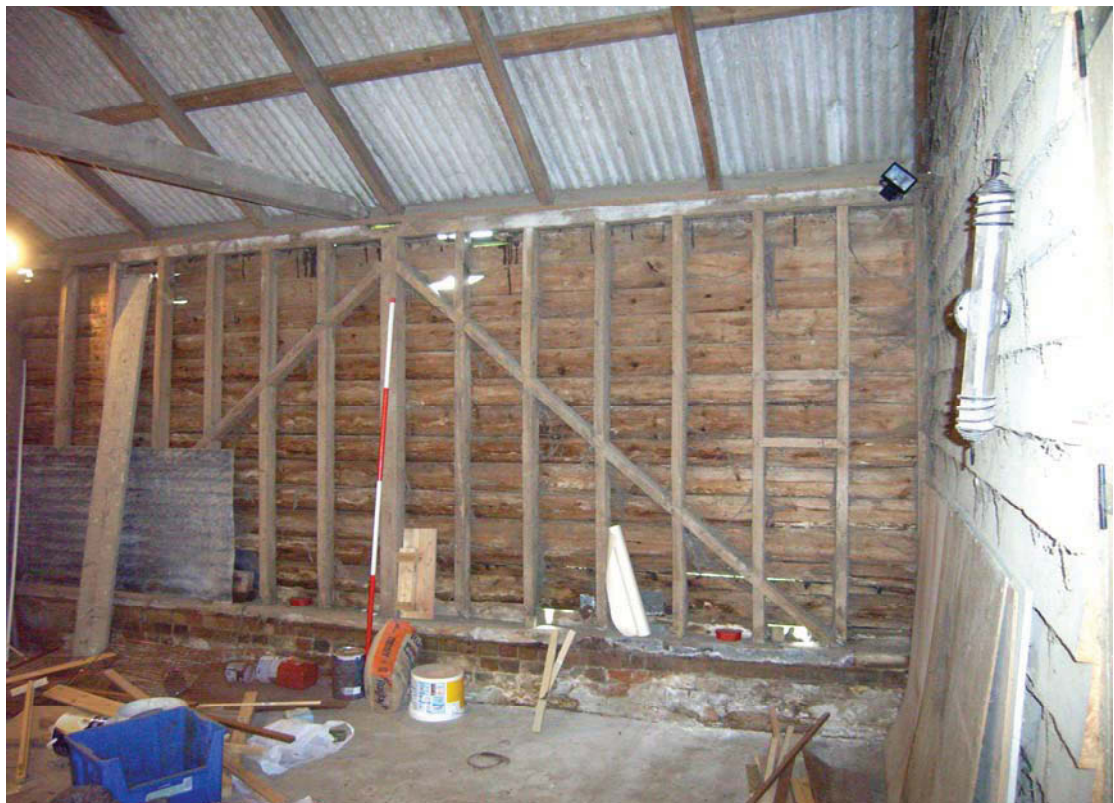
A2.8 Enclosed sheds (2). Internal southern elevation of lower eastern shed showing original 20th century wall fabric.

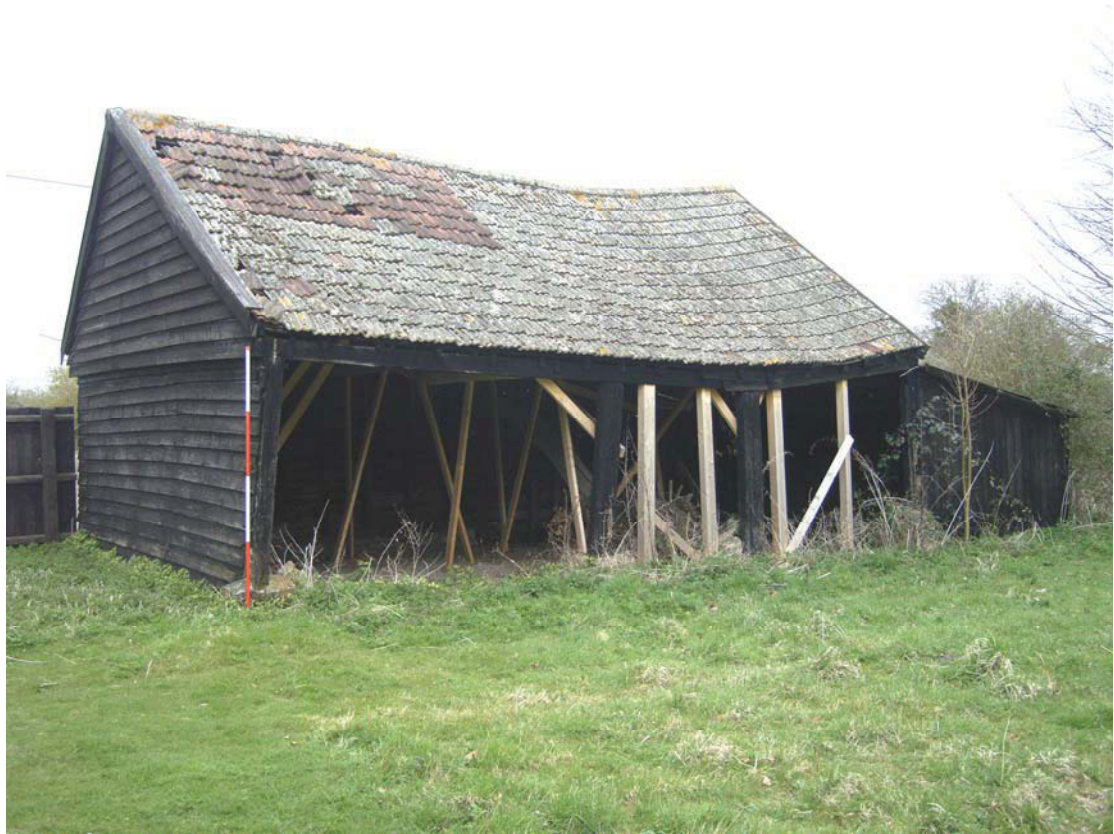
A2.9 Open shed (3). External southern elevation showing western gable to left.

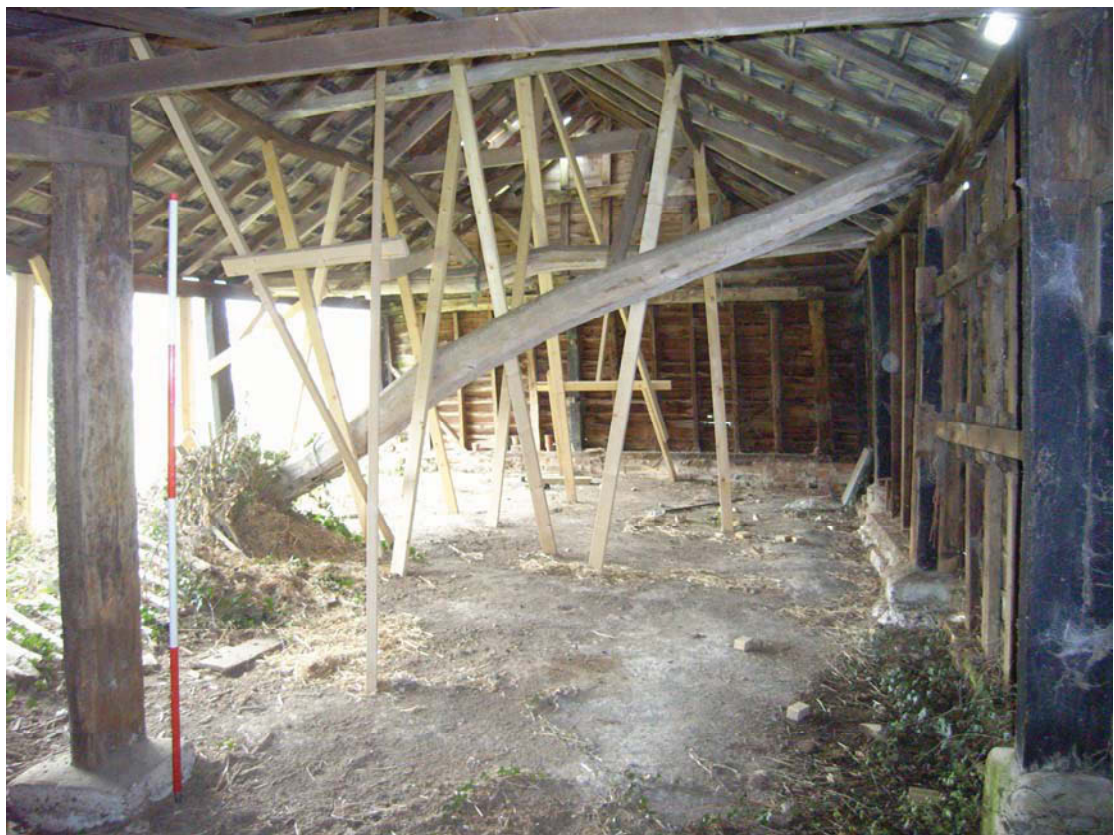
A2. 10 Open shed (3). Interior from east showing modern props and collapsed tie-beam

The easternmost of the roadside sheds is a studwork structure clad in tarred weatherboarding which is open to its southern elevation and to a lean-to against its eastern gable. The building extends to 8.2 m (27 ft) in length (excluding the lean-to of 3.6 m or 12 ft) and 6.1 m in width, with eaves of 2 m (6.5 ft). The roof-plates are spanned by two large tie-beams, one of which has fallen to the ground at its southern end, and the treble-tiled side-purlin roof is now supported by an array of modern softwood props. The walls are crudely constructed with a variety of re-used timber and although a similar building is shown on the site in 1904 there is little to suggest it was not completely rebuilt in the 1920s or 1930s. Most of the shallow brick plinth is a replacement of the late-20th century, and in its present form much of the fabric may be of very recent origin.
