ARCHAEOLOGICAL EVALUATION REPORT

SCCAS REPORT No. 2009/165

Former D&P Meats, Old Norwich Road, Barham BRH 049

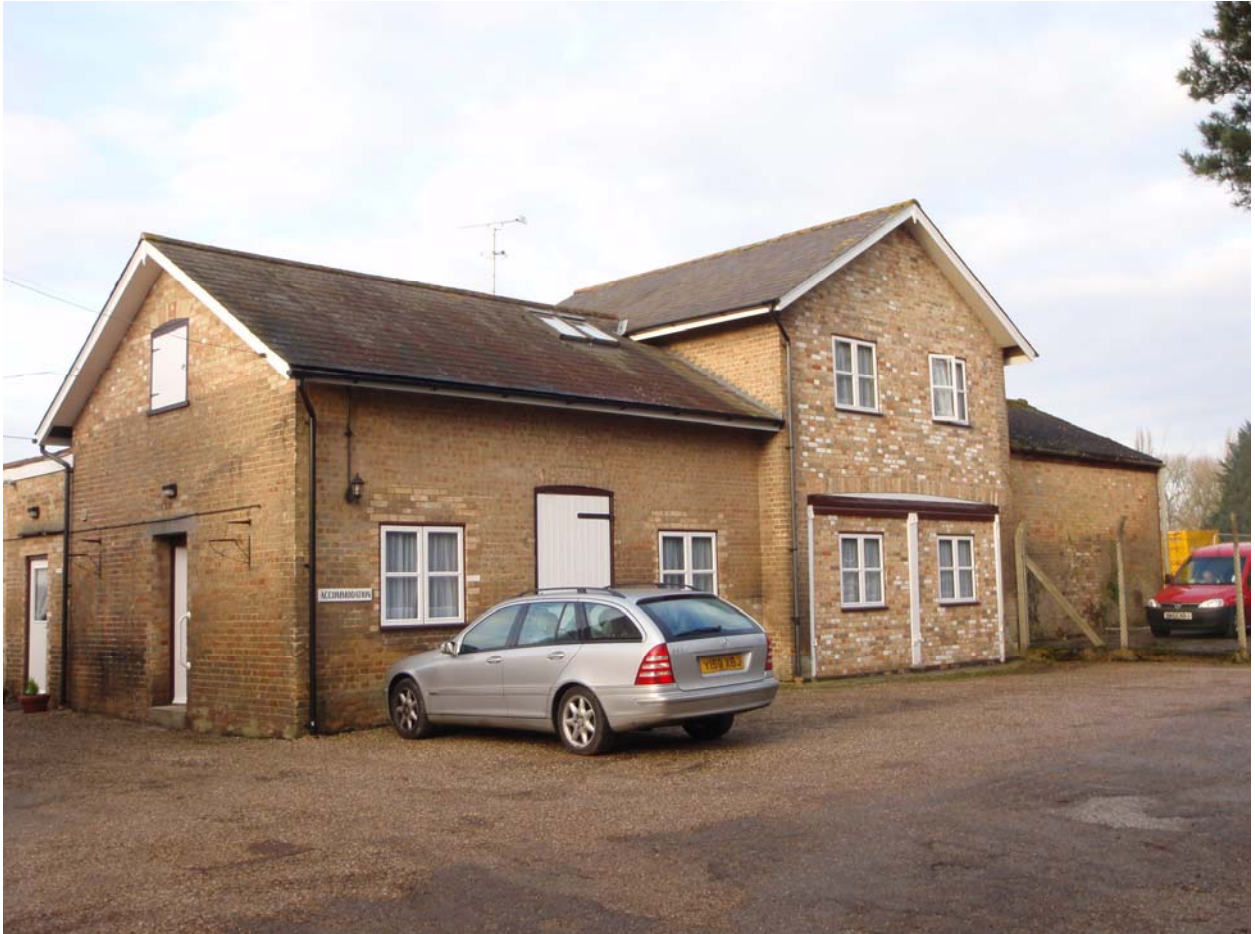
Plate 1. Northwest view of former stabling adjacent Sorrel Horse Inn. The northern wing, visible in to the right-hand side of the picture, was potentially threatened by the proposed development (photo ref GBM 53).

The building recording consisted of a small number of photographs of the exterior of the brick built structure in the southeast corner of the site. The building comprises the northern section of what was presumably stabling associated with the nearby Sorrel Horse Inn. Only the northern wing of the structure was threaten by this development as the remainder of the building is separately owned and is currently occupied. The photographs were taken using a digital camera with a 10 megapixel resolution and are held in the SCCAS Photographic Archive under the references GBM 47 to GBM 54.

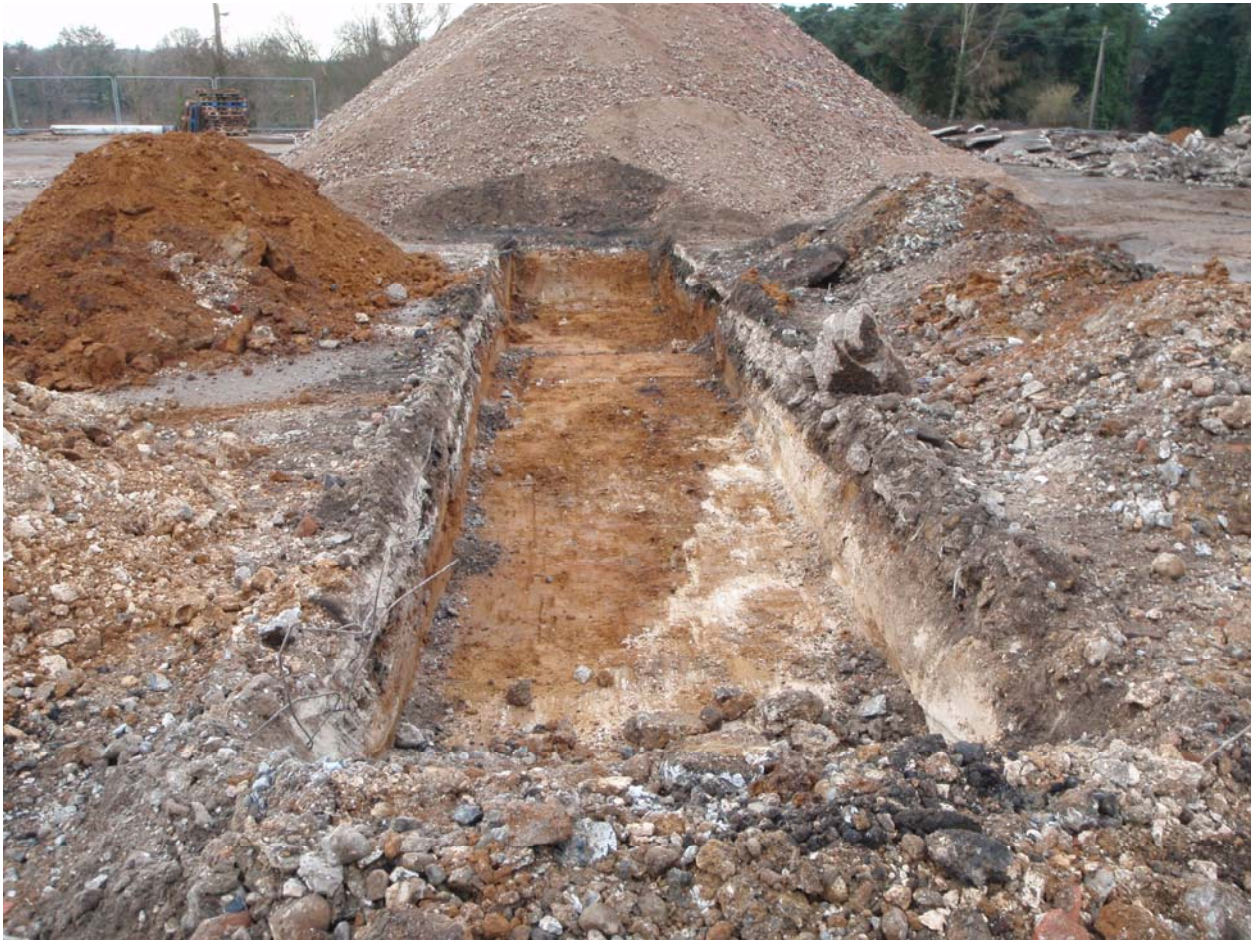
Plate 2. Trench 2, facing west

This trench was 12m long, 2.2m wide and 0.75m deep. The stratigraphy encountered consisted of 0.4m of modern buildup (layers of hardcore and reinforced concrete for the previous floor surface) above 0.35m of mid orangey brown sandy silty clay with

moderate flints and gravels. A band of chalk was visible towards the eastern end of the trench.

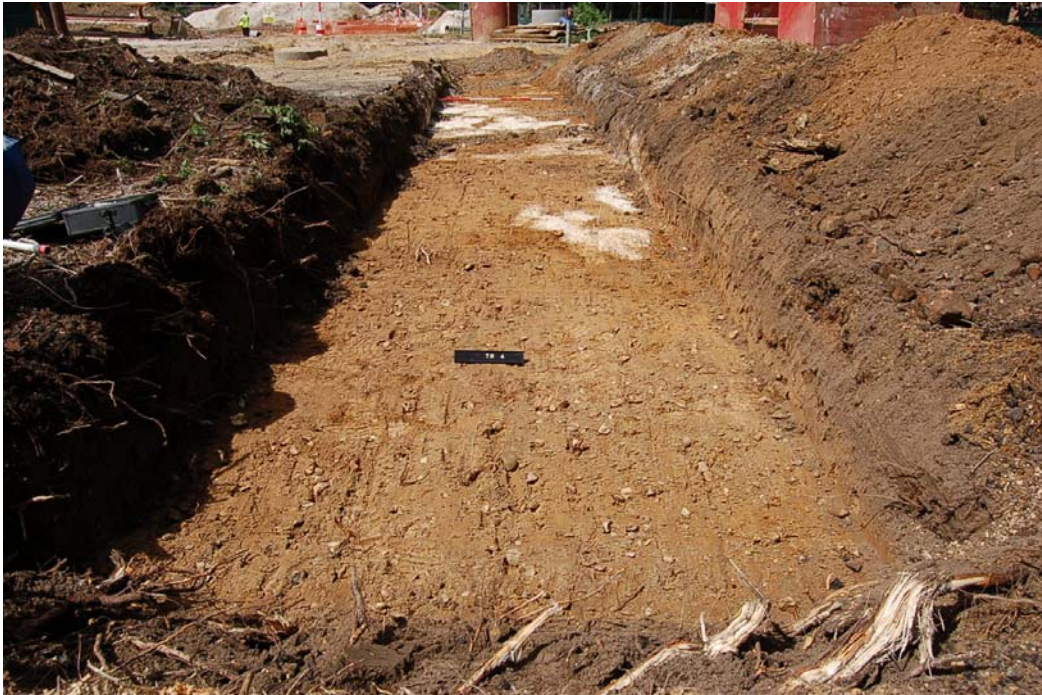
Plate 3. Trench 4, facing west

This trench was 20m long, 2.2m wide and 0.4m deep. The stratigraphy encountered consisted of 0.2m of disturbed mid-grey/blackish brown sandy silt topsoil, with frequent demolition rubble fragments, old tarmac surfacing and modern rubbish (the trench, being very near to the road and footpath, had a number of items thrown into the general vicinity). Below this layer was a deposit 0.2m thick of mid orangey brown sandy silt with frequent stones and flints of various sizes. Natural geology (silty sandy clay and stones

pockets within solid chinks) was encountered at a depth of 0.4m. There were no archaeological finds or deposits visible in this trench.
