HISTORIC BUILDING RECORD

SCCAS REPORT No. 2009/171

SKEPPERS MILL, OULTON MARSH OUL 003

The remains of Skeppers Mill, Oulton Marsh, Oulton, were recorded through digital photography and the construction of a scale plan using data from a measured sketch.

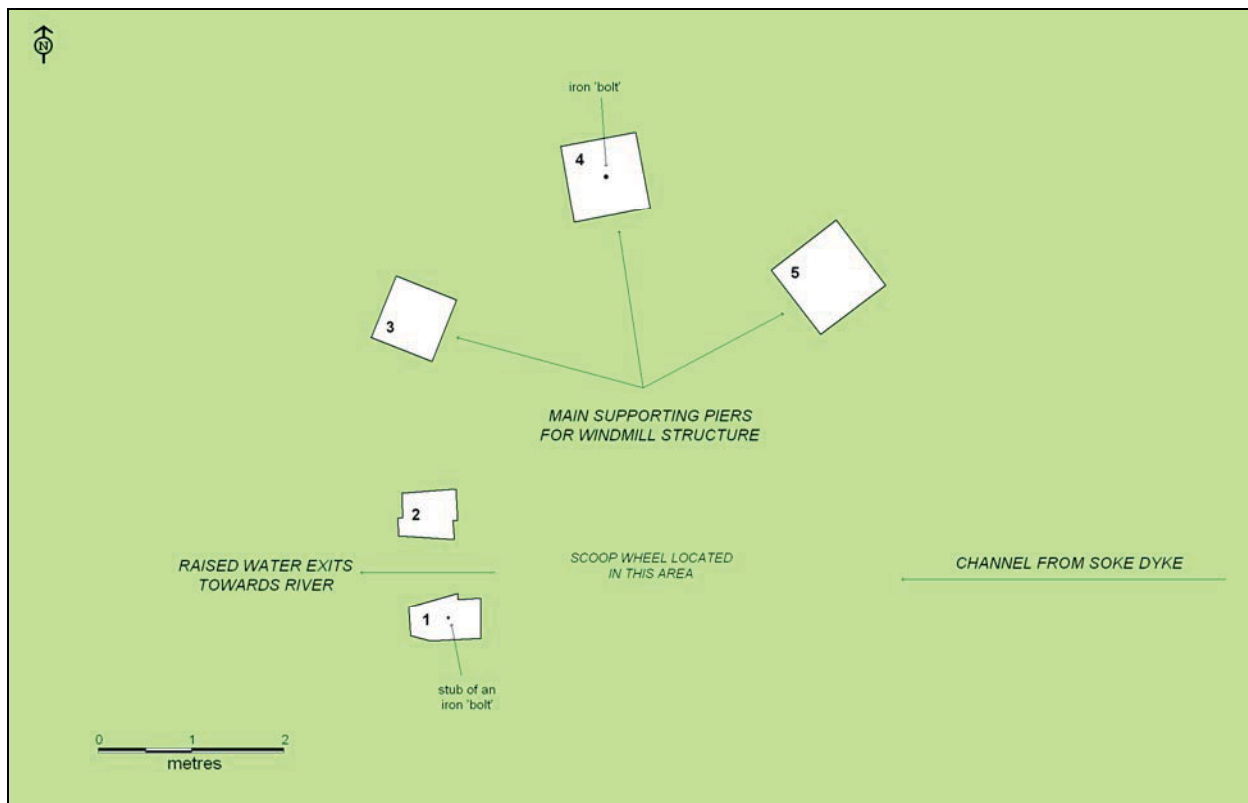
Figure 3. Plan of the mill remains

A measured sketch of the remains was drawn at the time of the survey and this has since been used to create a scale plan (figure 3). In figure 3 each of the individual blocks of brickwork has been arbitrarily numbered to enable each to be identified in the descriptions below. The writing in italics represents likely interpretation of the various components.

Figure 3 shows possible interpretations for the recorded components which are described as follows: Blocks 3, 4 and 5 provided the main support for the trestle whilst Blocks 1 and 2 were associated with the actual channelling of the raised water into Oulton Dyke. It is presumed that the scoop wheel was located to the east of Blocks 1 and 2. Block 4 represents a near complete example and that Blocks 3 and 5 would originally have been similar. The vertical iron rod set into the top of Block 4 would have securely held part of the trestle base.

It seems unlikely that these three blocks alone supported the trestle as one would expect a further support on the south side of the mill. The iron rod noted on the top of Block 1 could suggest that this block played some part in supporting the mill or alternatively a further support or supports may have existed that have since been buried or lost.

The recesses noted in the northeast corner of Block 1 and the southeast corner of Block 2 are aligned and it is probable that these held timberwork associated with the removal of the raised water or the mounting of the scoop wheel. The opposing faces of these two blocks are not stepped but are smooth and appear as an opening funnel which could have acted as the outfall from this mill with the water falling directly into a now filled inlet off Oulton Dyke.

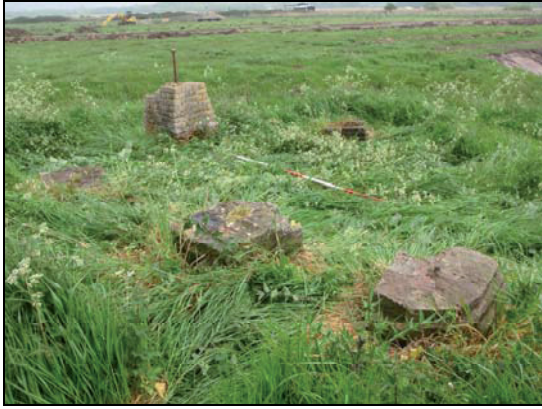
Plate 1

| 1 | General view of mill site, camera facing east-northeast |

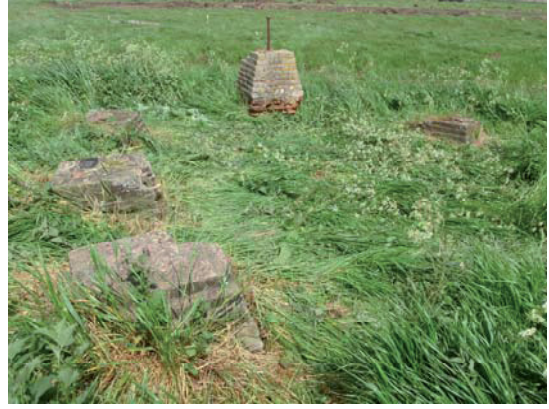
Plate 2

| 2 | General view of mill site, camera facing northeast |

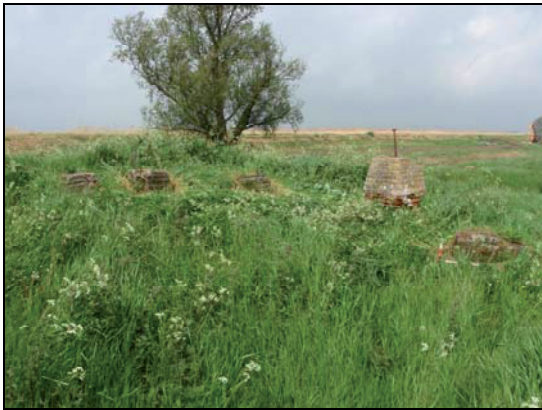
Plate 3

| 3 | General view of mill site, camera facing west |

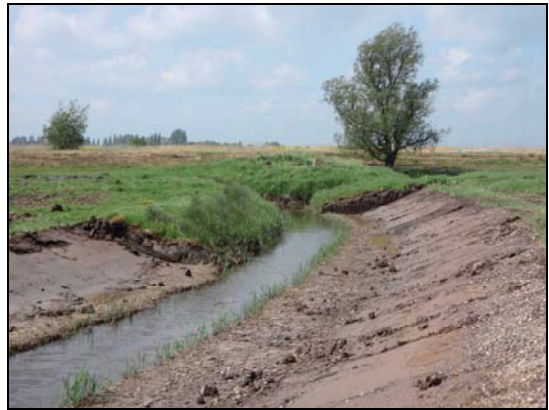
Plate 4

| 4 | View of mill site from soke dyke to the east, camera facing west |

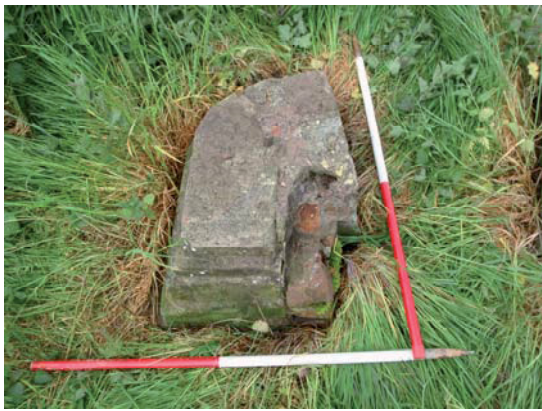
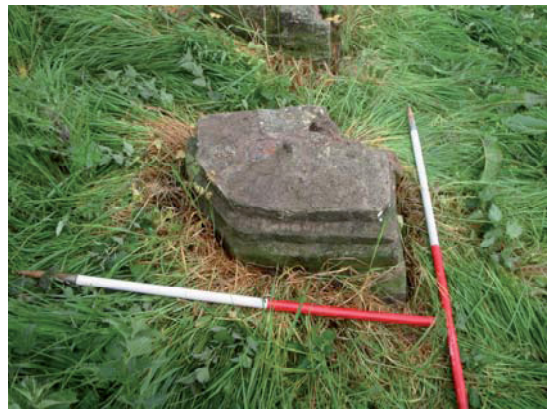
- 1 An irregular-shaped block of brickwork measuring 0.77m by 0.52m (Plates 5 and 6). Five courses of brickwork could be seen giving it a measured height of 0.36m. The brickwork stepped in by c. 20mm on all but the northern face which is smooth. It is constructed of a hard grey bricks although one or two fragments of red brick could be seen, with a cement render on the southern and western faces. The broken off stub of an iron rod or bolt was visible on the upper face. A 60mm by 240mm recess is present in the northeast corner. Not conclusive as to whether the upper face supported further brickwork or is a finished surface.

| 5 | Block 1, camera facing west |
| 6 | Block 1, camera facing north |

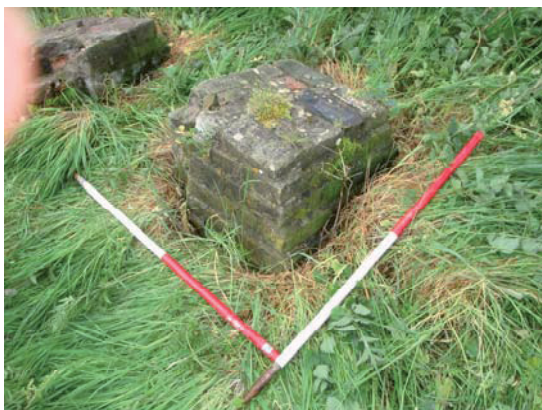
Plate 7

- 2 An irregular-shaped block of brickwork constructed of a hard grey brick with occasional reds. It measured 0.57m by 0.53m at the eastern end, reducing to 0.47m to the west (Plate 7) and stands six courses high giving it a height of 0.45m. The brickwork steps in with each subsequent course by c. 20mm except on the southern face which is smooth. A 50mm by 190mm recess is visible in the southeast corner. The upper face is rough suggesting further courses of brickwork were once present.

| 7 | Block 2, camera facing southwest |

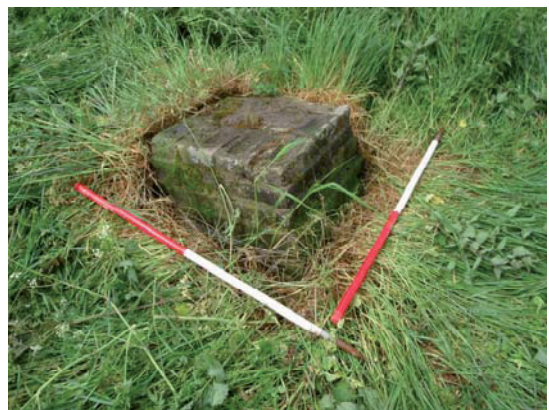
Plate 8

- 3 A 0.70m square block of brickwork standing five courses tall giving it a height of 0.54m (Plate 8). Each subsequent course of brickwork steps in by c. 20mm. The upper face is rough suggesting further courses of brickwork were once present. Constructed from hard grey brick.

| 8 | Block 3, camera facing southwest |

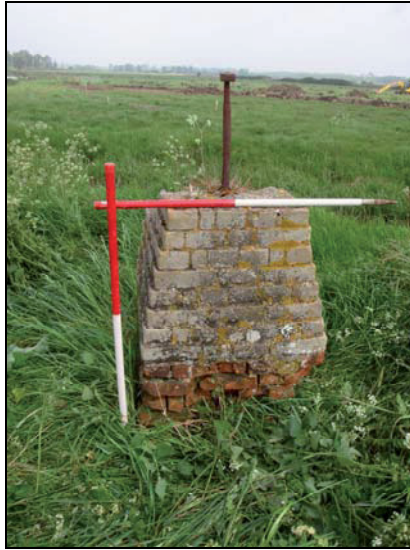
Plate 9

- 4 A column of brickwork measuring 0.85m square at the base (Plate 9). It comprises 13 courses brickwork and stands 1m high. The lower courses consist of soft red bricks which are heavily eroded whilst the upper eight courses are constructed of a much harder wearing grey brick. The edges of the first six courses are flush but the upper eight courses step in on each side so that the upper portion of the column tapers in to be 0.53m square at the top. The upper face appears to be a finished surface although a small number of bricks are missing on the northern side.

The red bricks were very soft and prone to erosion as could be clearly seen where they had been used in block 4. In the other blocks where they were noted (1 and 2) they had been used internally and were therefore protected from erosion.

| 9 | Block 4, camera facing north |

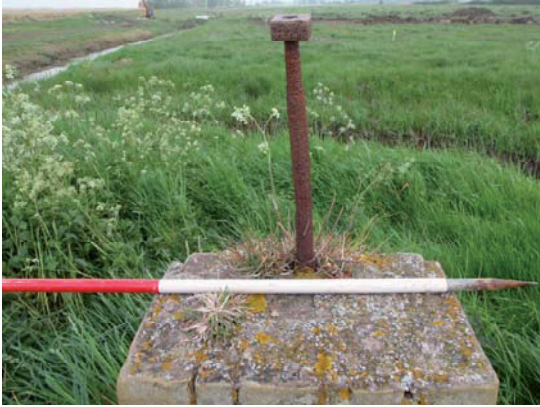
Plate 10

An iron rod or bolt is set vertically into the centre of the upper face (Plate 10). It measures 0.45m in height and is approximately 30mm in diameter at the base. The upper 100mm is reduced in thickness, being approximately 20mm in diameter. This narrower section was probably threaded although the entire surface of the rod is now heavily corroded. A 55mm square nut is screwed onto the very top of the rod.

| 10 | Block 4, vertical bolt detail, camera facing north |

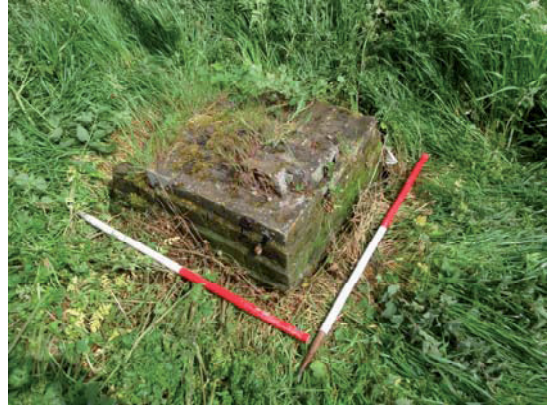
Plate 11

- 5 A 0.87m square block of brickwork standing four courses tall giving it a height of 0.39m (Plate 11). Each subsequent course of brickwork steps in by c. 20mm. The upper face is rough suggesting further courses of brickwork were once present. Constructed from hard grey brick.

| 11 | Block 5, camera facing northeast |

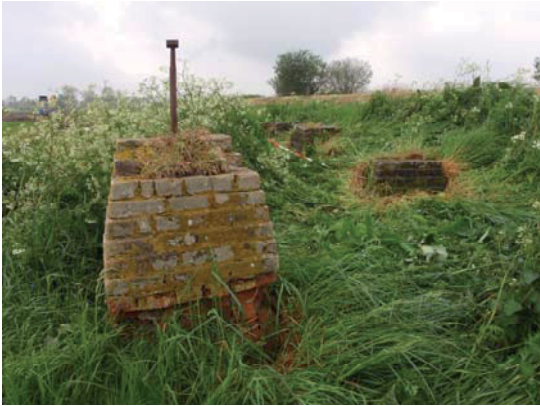
Plate 12

| 12 | Block 4 with blocks 3, 2 and 1 behind, camera facing south |

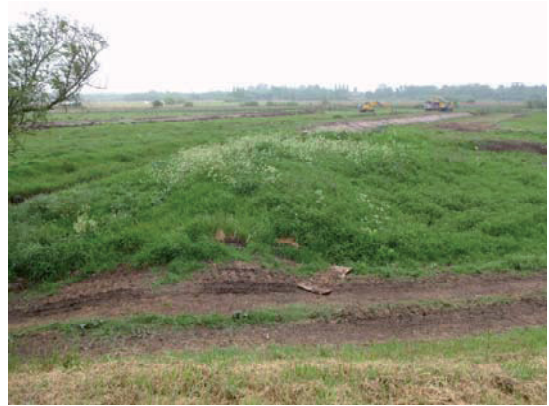
Plate 13

| 13 | General view of mill area and in-filled inlet, from bank of Oulton Dyke, camera facing west |

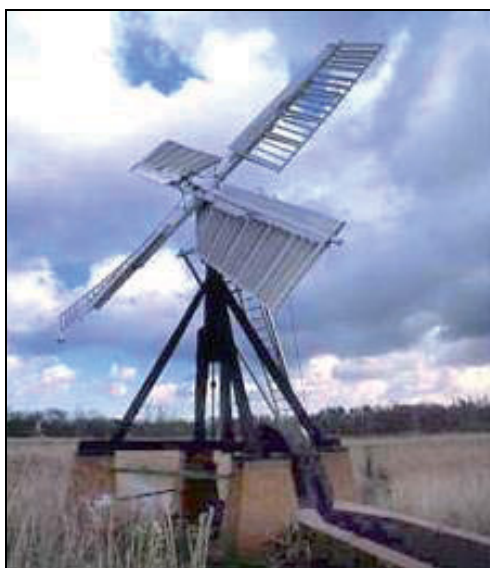
The recorded structural remains appear to be the remnants of a trestle type wind-powered pump. These are simple timber-framed machines mounting a small rotatable cap with wind-driven sails which in turn via a geared shaft would rotate a large wheel mounted on a horizontal axis, the outer edge of which would be fitted scoops. As the wheel rotated water would be captured in the scoops from a channel running from an adjacent soke dyke and raised up. As the wheel continued its turn the water would be tipped from the scoops, collected in a trough and allowed to run out into a nearby drain or river.

Plate 14, below, illustrates an extant example of a trestle mill which is located within the Norfolk Broads (believed to be Clayrack Drainage Mill, River Ant, Norfolk). Skeppers Mill is likely to have been of a similar design although the recorded remains indicate that they were not identical.

Plate 14: An extant example of a trestle mill

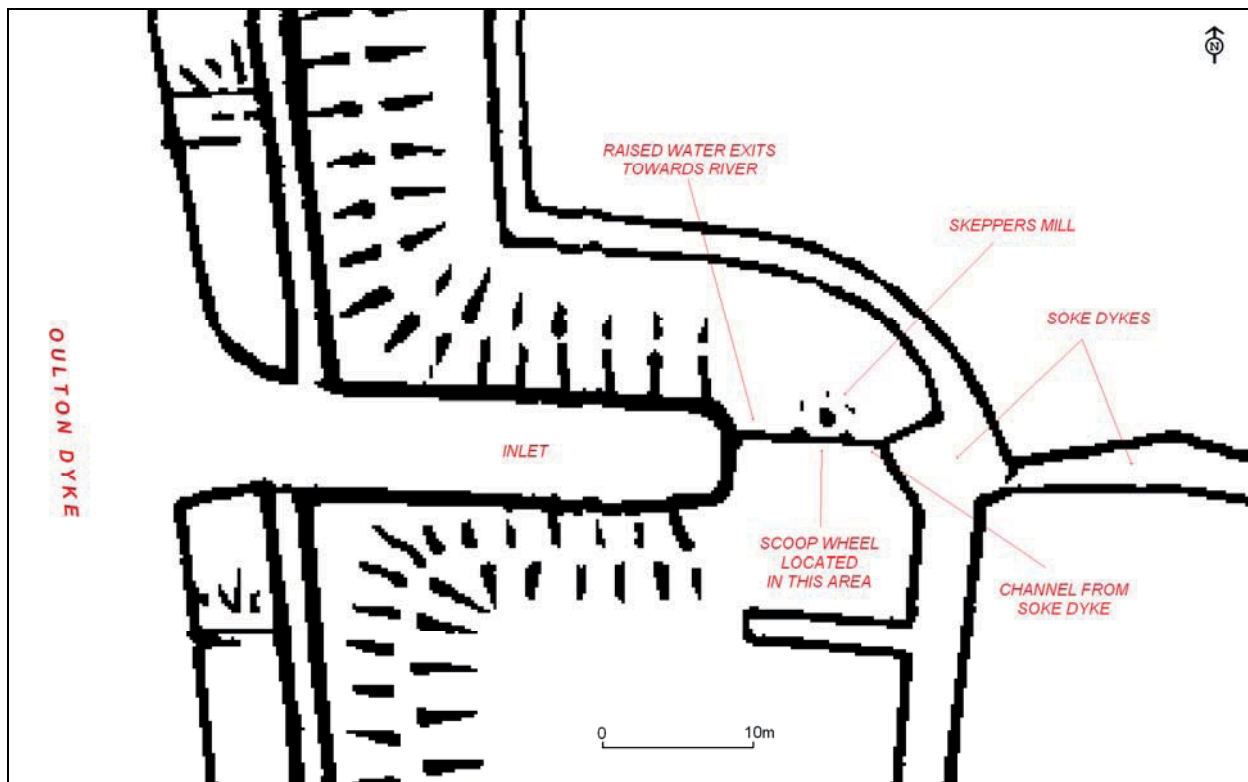
Figure 4. The Skeppers Mill site as recorded on the 1st Edition Ordnance Survey 1:2500 scale sheet (rescaled extract)

The mill appears as a series of six dots and an east-west line. The east to west line is likely to represent a channel from the soke dykes whilst the dots represent the mill itself. The large central blob is probably the main upright that held the sails whilst the three northern dots represent Blocks 3, 4 and 5. Two dots are apparent on the east west line, the western one of which may possibly represent Blocks 1 and 2.

In summary it would appear that the map shows a mill formed from a central upright surrounded by five supports alongside a channel from the soke dykes which is pumping water into the inlet off Oulton Dyke. The site of the mill is not noted and no name is marked which could suggest that it is out of use when the survey was undertaken.

From examination of the early Ordnance Survey maps it can be seen that what is probably this mill is marked on the 1st Edition 1:2500 scale survey of c. 1880. Figure 4 is an extract from the 1st Edition OS with some interpretive annotation. Flint and Dolman (1979 and 1978) state that the mill was present in 1835 and 1892 (presumably from map evidence) but was gone by 1903.

These marks are absent for the 2nd Edition OS map of c. 1900 suggesting the main body of the structure had been removed, possibly for re-use as a mill elsewhere or just to recycle its components.
