**Paper Mill Farm,
Paper Mill Lane,
Bramford, Suffolk**

Historic Building Record

May 2009

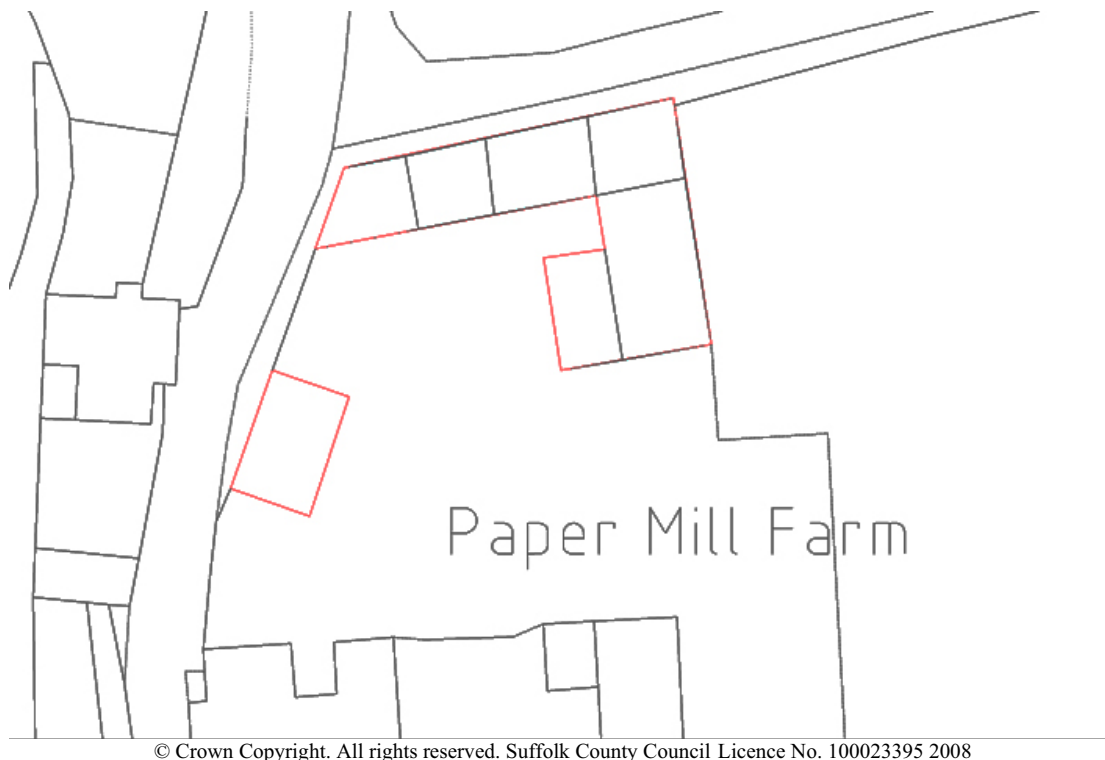
Figure 1
Existing Ordnance Survey Site Plan
Outlining the farm buildings in red and showing Paper Mill Lane to the west with part of Paper Mill farmhouse to the south.

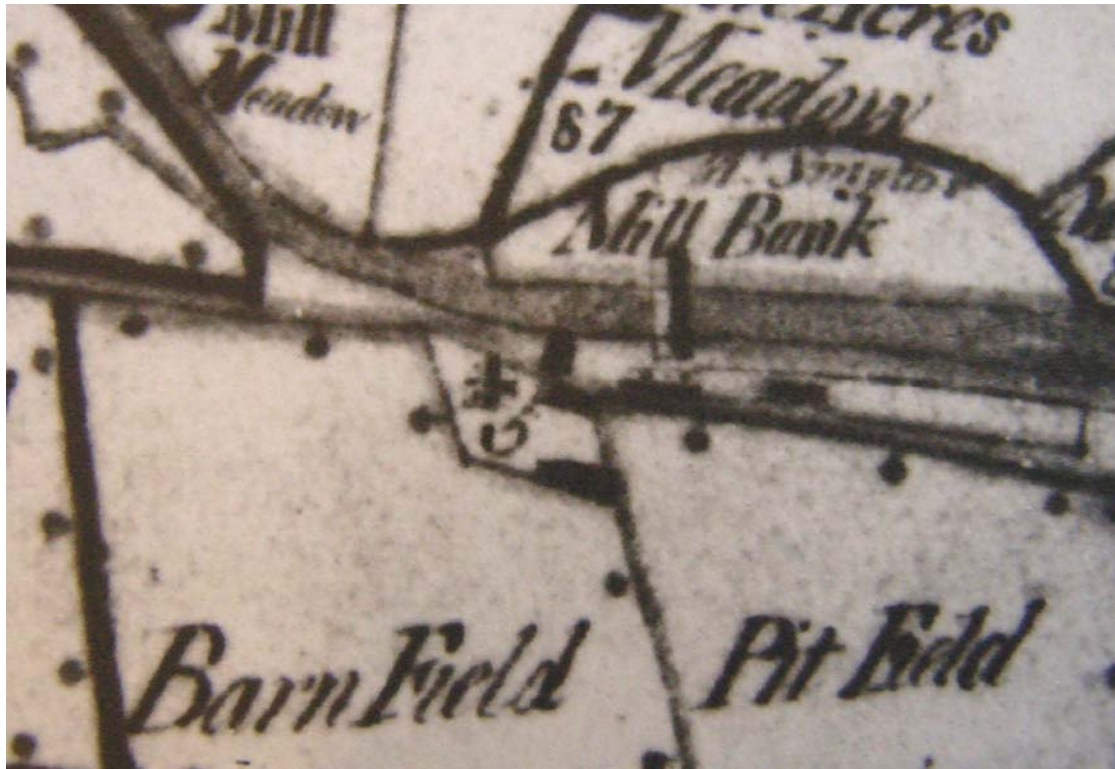
Figure 2

Detail of the Bramford Hall estate map of 1782 with north to right, showing the yard of Paper Mill Farm (numbered 5 in centre). The farmhouse is depicted in its present form, facing south with a central entrance and adjoining the lane to the west. The barn (4) is also shown, adjoining 'Barn Field' in the north-eastern corner of the yard, along with the roadside granary (2). (The Suffolk Record Office holds only a black and white photograph of the original coloured estate map, ref. P471/1)

The farmhouse is not listed but is evidently a timber-framed structure of the 16th century or earlier, and is depicted on a plan of the Bramford Hall estate drawn in 1782 (figure 2). It is accurately shown in its existing form, with a central entrance in its southern façade, although it appears originally to have formed only the jettied cross-wing of a larger house which faced the road to the west. The 16th century timber-framed barn in the north-eastern corner of the yard is also shown on the plan, along with a building on the approximate site of the roadside granary (buildings 4 and 2 in figure 6 respectively). The yard and surrounding fields bear numerals, but unfortunately the map is not accompanied by a key. The site then lay in open arable countryside but the mill was already engaged in the commercial production of paper as the field to the south of the farm is named as 'Paper Mill Field' and the meadow on the western side of the Gipping as 'Paper Mill Meadow'. A detailed manorial survey of Bramford survives from 1568, and it may well be possible to establish the 16th century occupant of the house with further research ('The Book of Bramford', Bramford Local History Group, 2003). The mill is recorded in Domesday, and is mentioned in early documents as a fulling mill. It was producing paper by the 17th century, as the parish register for 1688 records the death of an unknown man who drowned at the paper mill ('The Origins of Bramford Street Names', Bramford Local History Group, n.d.).

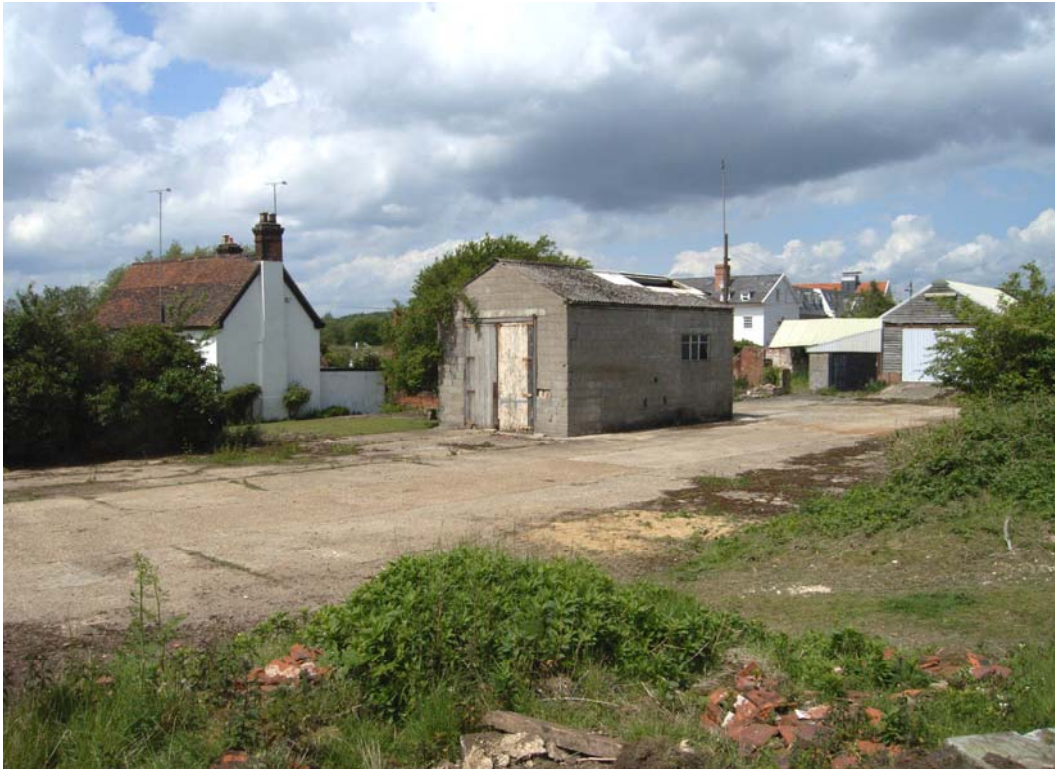
A2.1 General view of site from south-east showing the farmhouse (1) to left, 20th century block-work shed (6) in centre and the timber-framed barn (4) to right. Bramford Mill is visible in the rear

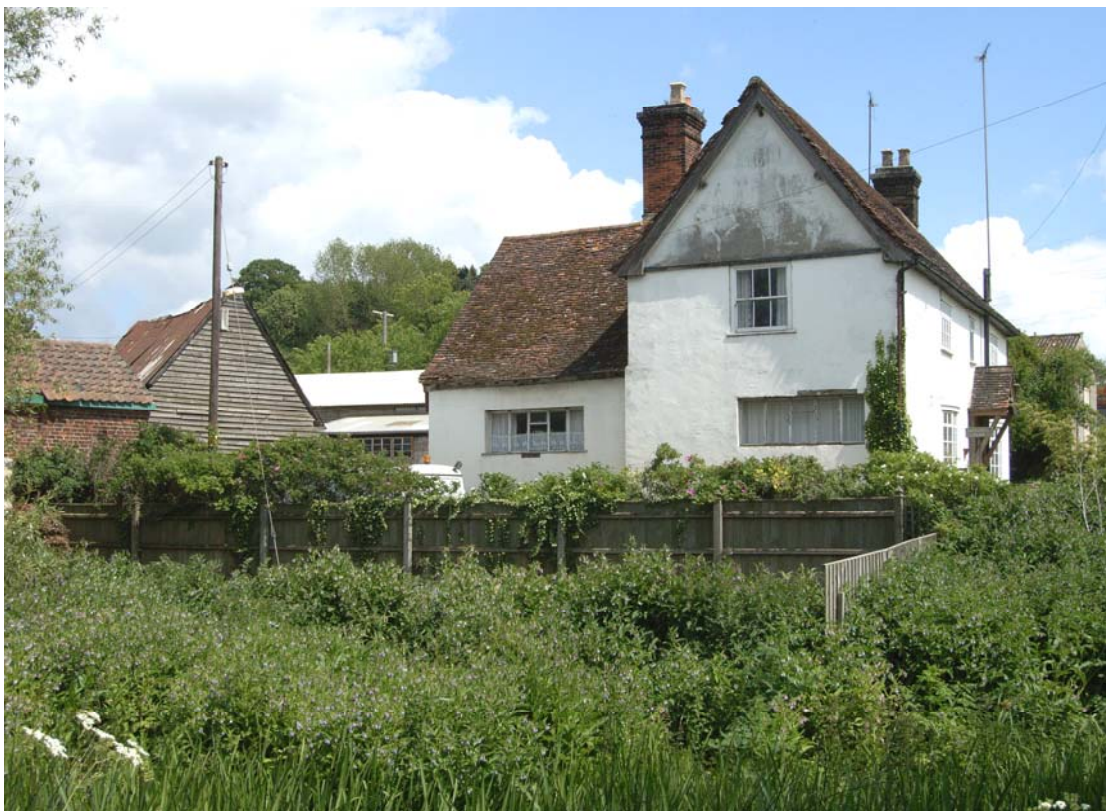
A2.2 General view of site from River Gipping to west showing the granary (2) to left

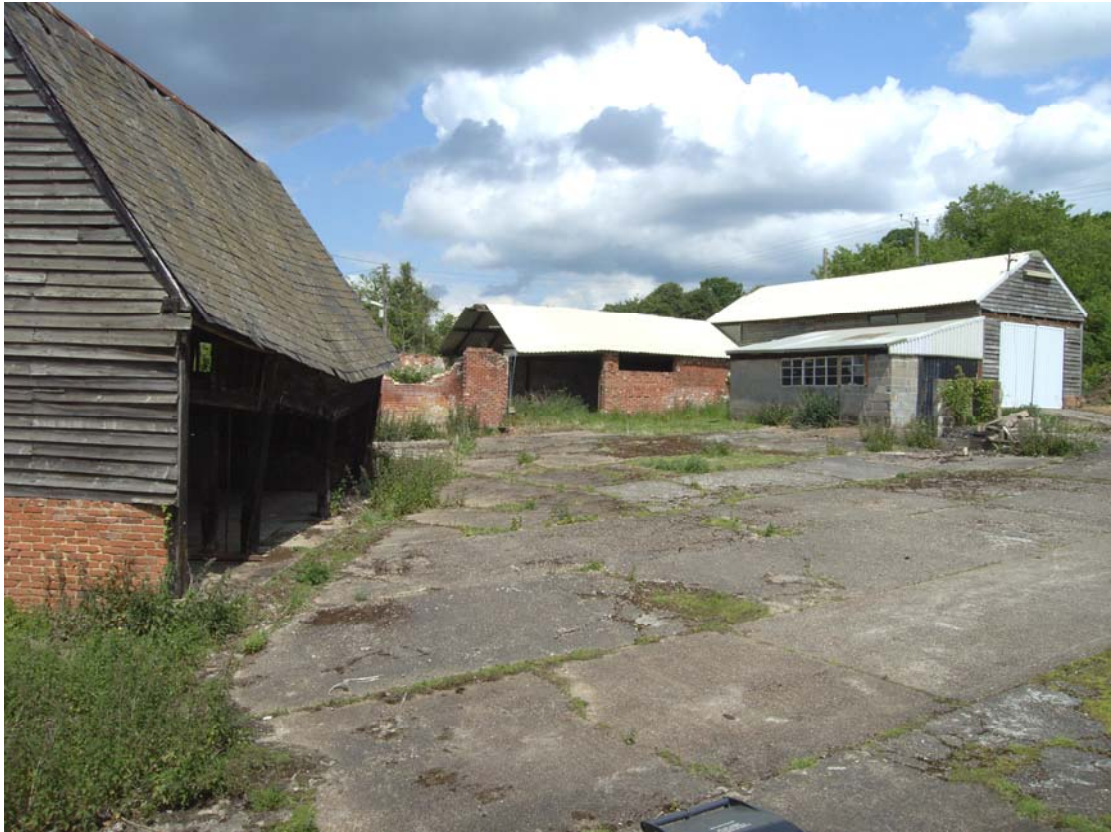
A2.3 General view of yard from the farmhouse to south showing the granary (2) to left with the brick shed (3) in centre and barn (4) to right

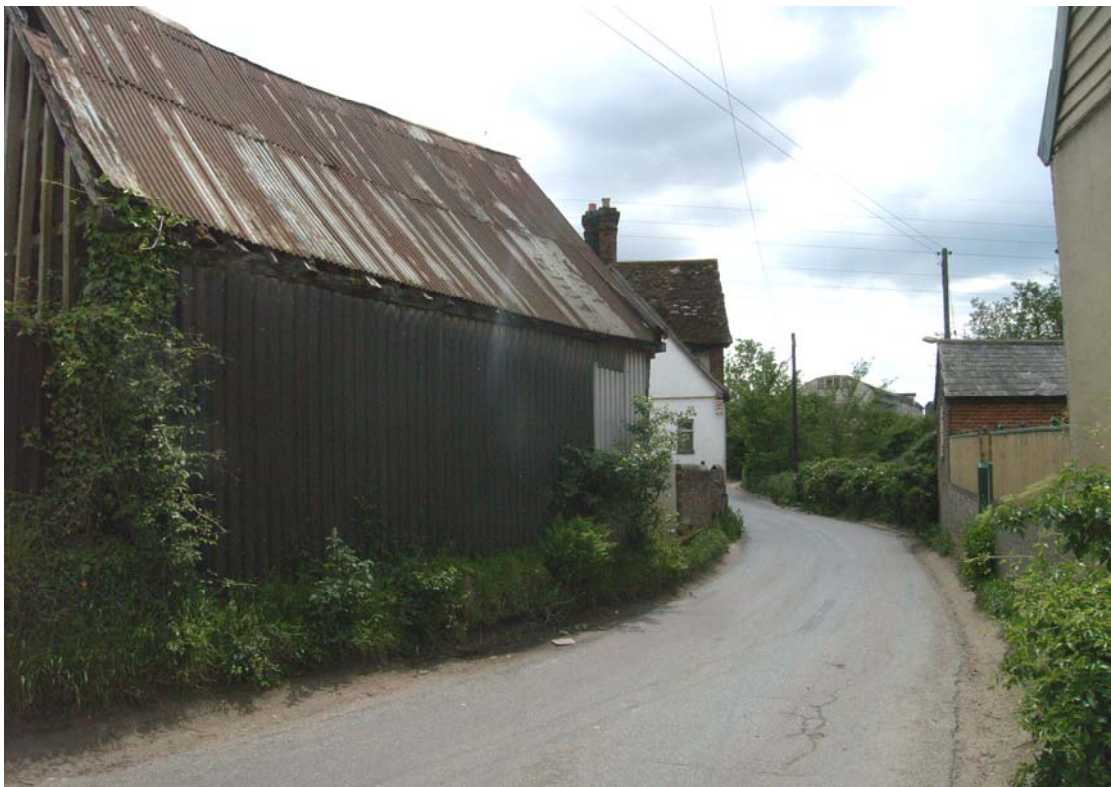
A2.4 Western external elevation of the granary seen from Paper Mill Lane to north-west, showing corrugated iron roof and cladding with farmhouse in rear

The building has been considerably mutilated and is leaning by up to 75 cm (2.5 ft) from west to east. The entire western elevation has been recently rebuilt beneath its roof-plate in metal sheeting, the granary floor has been removed from the southern bay, and the mid-rails of the eastern elevation are lacking or renewed. Both gables have been wholly or partly rebuilt and the Ordnance Survey's of the late-19th and early-20th centuries show another structure adjoining the northern gable and continuing to the brick shed (i.e. building 3 in figure 6). The external cladding of the eastern elevation extends by 40 cm (15 ins) beyond the principal corner post and suggests the building may have been extended in the 19th century to meet the demolished structure to the north.

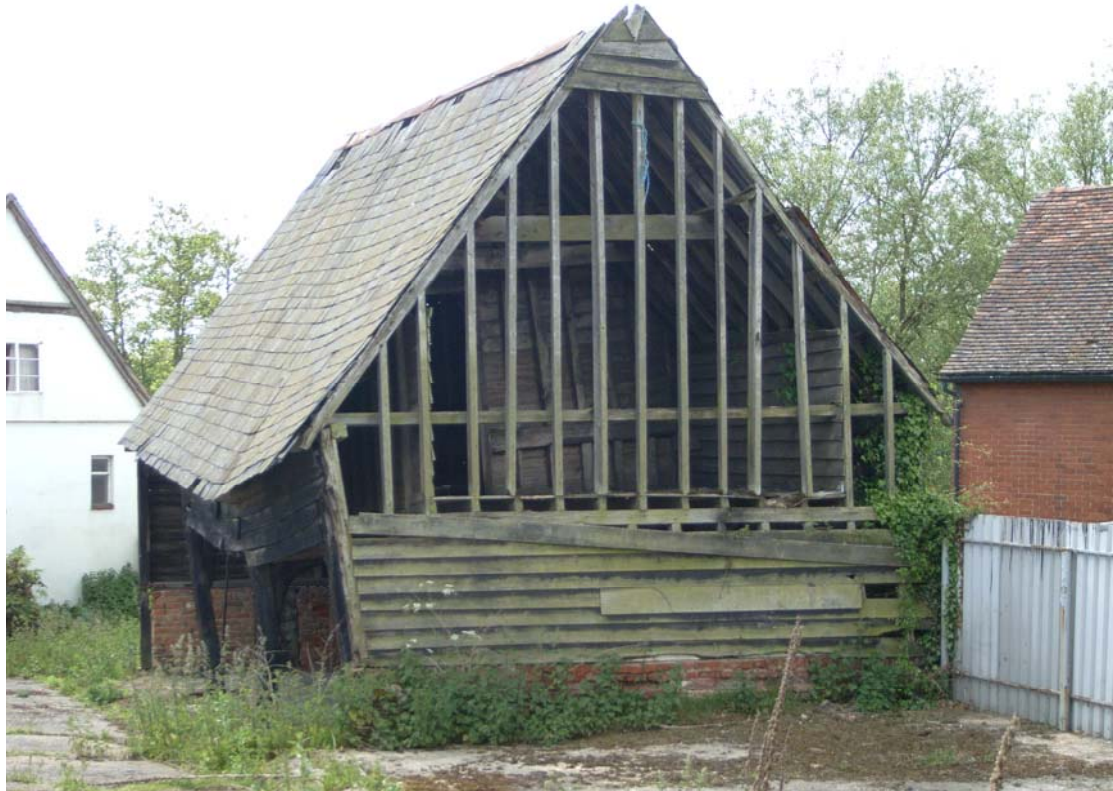
A2.5 Northern external elevation of granary showing internal partition through exposed studwork and open eastern elevation, with farmhouse in rear to left

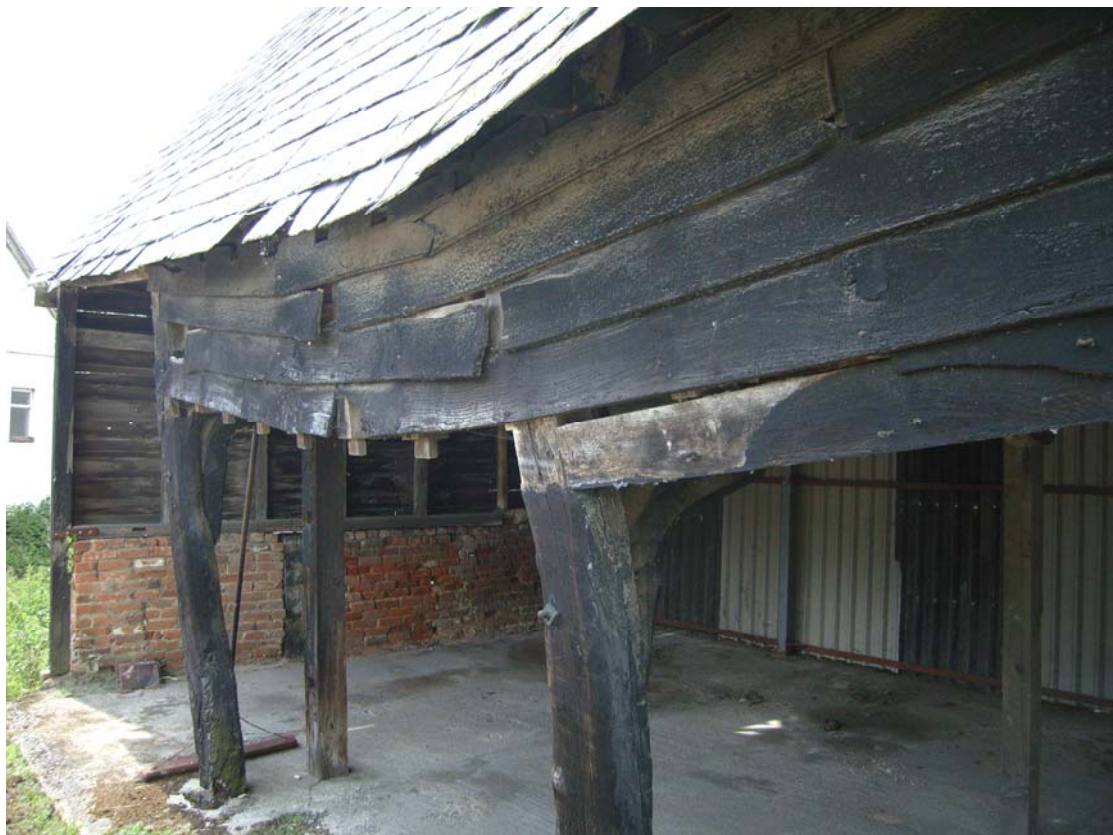
A2.6 Detail of external eastern elevation of granary from north-east showing tarred weatherboarding to granary storey and removed mid-rails to central and southern bays

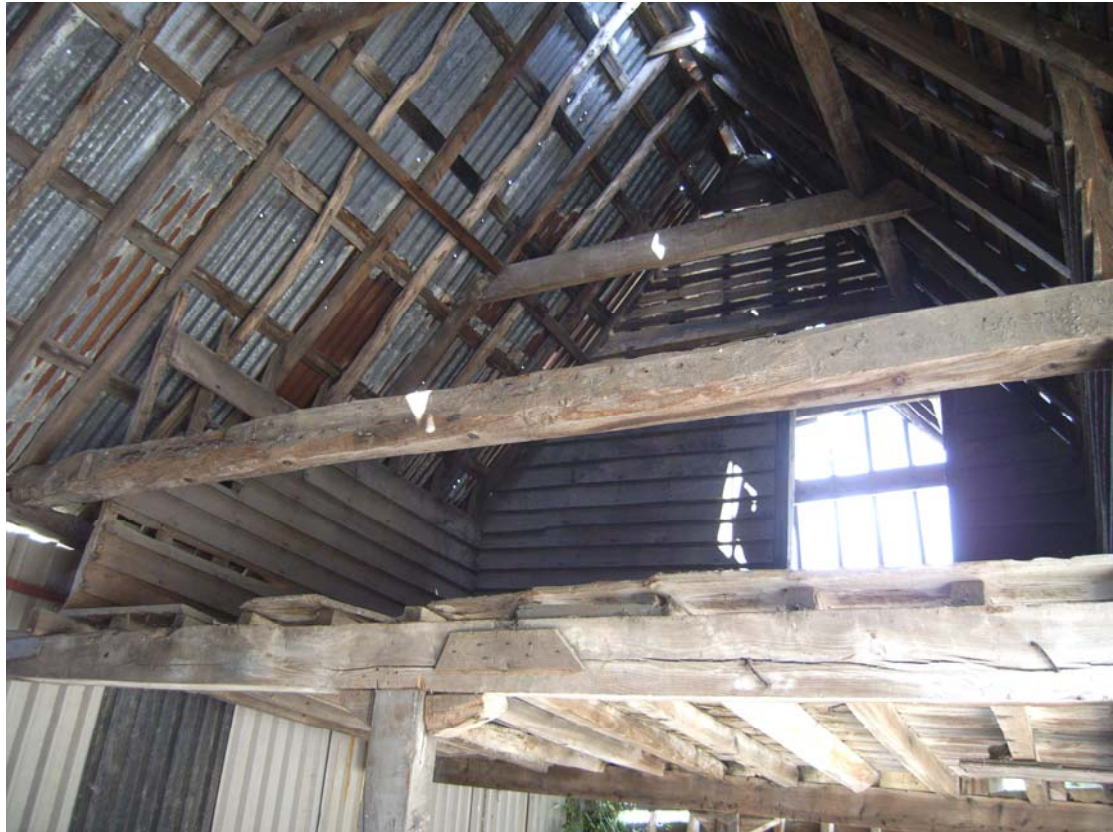
A2.7 Interior of granary from south showing original clasped-purlin roof structure and boarded granary floor with doorway to northern compartment (floor removed from southern bay in foreground)

The structure contains a ceiling of tall-sectioned joists lodged on binding joists 60 cm (2 ft) beneath its roof-plates and supported from the storey posts by bolted knee braces. The upper storey contained a granary with boarded sides entered by an external stair in the southern gable (since removed). The northern bay is divided from the two southern bays by a full-height partition with an internal door, and the eastern elevation is open to the farm yard beneath its mid-rails in the typical manner of an East Anglian cart lodge. The external weatherboarding to the upper section of the same elevation is heavily tarred and may be original, but the external boarding to the gables is secondary. The relatively steep pitch of the original clasped-purlin roof suggests it was designed for thatch but now supports 19th century slate; slate is rarely found on steeply pitched roofs, however, even in secondary contexts, and it is possible, given the site's proximity to a navigable river, that it represents a rare early use of the material. The covering of the western roof slope has been replaced by corrugated iron.

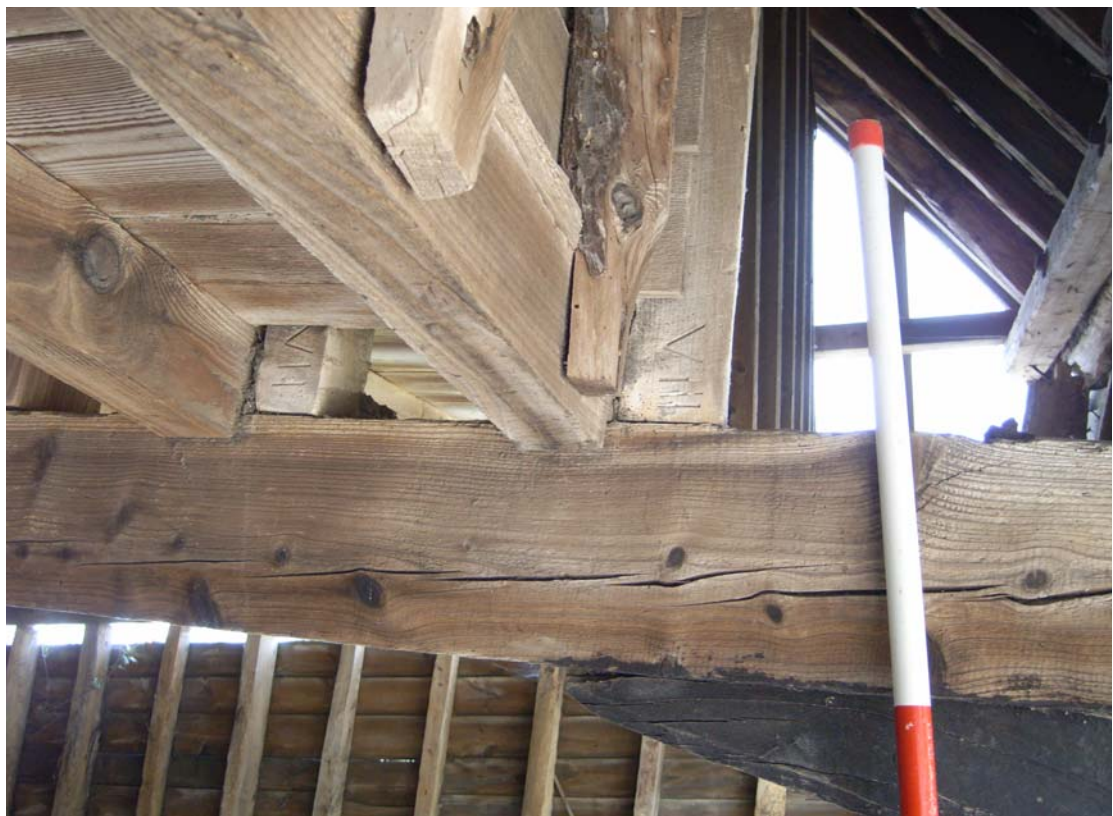
A2.8 Detail from south of granary floor showing carpenters' numerals to internal studs

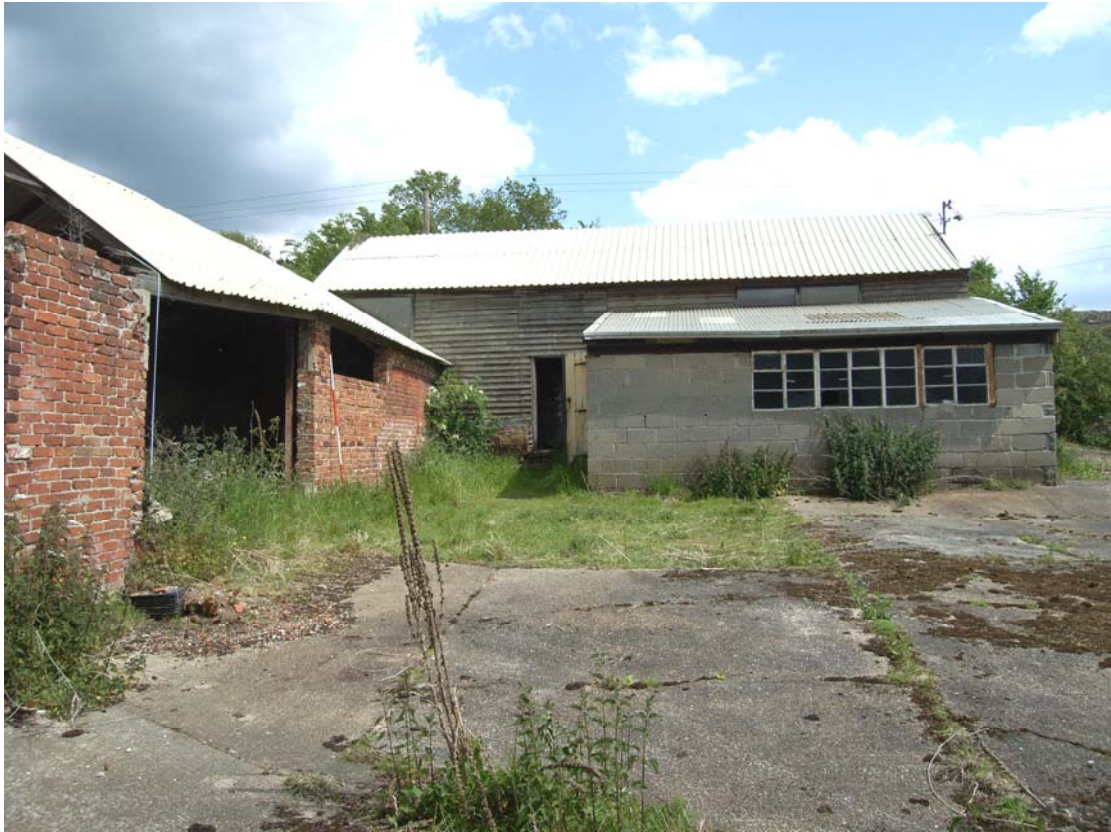
A2.9 Western external elevation of timber-framed and weatherboarded barn (4) showing brick shed (3) to left & block-work lean-to shed (5) to right

The barn in the north-eastern corner of the yard is a timber-framed and weatherboarded structure of four bays on a north-south alignment which now possesses a modern low-pitched roof of corrugated metal sheeting. The original building extended to 13 m in length by 5.8 m in width overall (43 ft by 19 ft), but was extended to its present length of 16 m by the addition of a red-brick lean-to shed against its northern gable in the mid-19th century (integral with shed 3 above). The roof-plates rise to 3.2 m (10.5 ft) above the concrete floor, including a brick plinth of 60 cm (2 ft). In recent years the barn has operated as a vehicle or storage shed with double doors in its southern gable, and the external weatherboarding has been renewed; earlier boarding of 19th century appearance survives within the 20th century lean-to shed (5) against its western elevation.

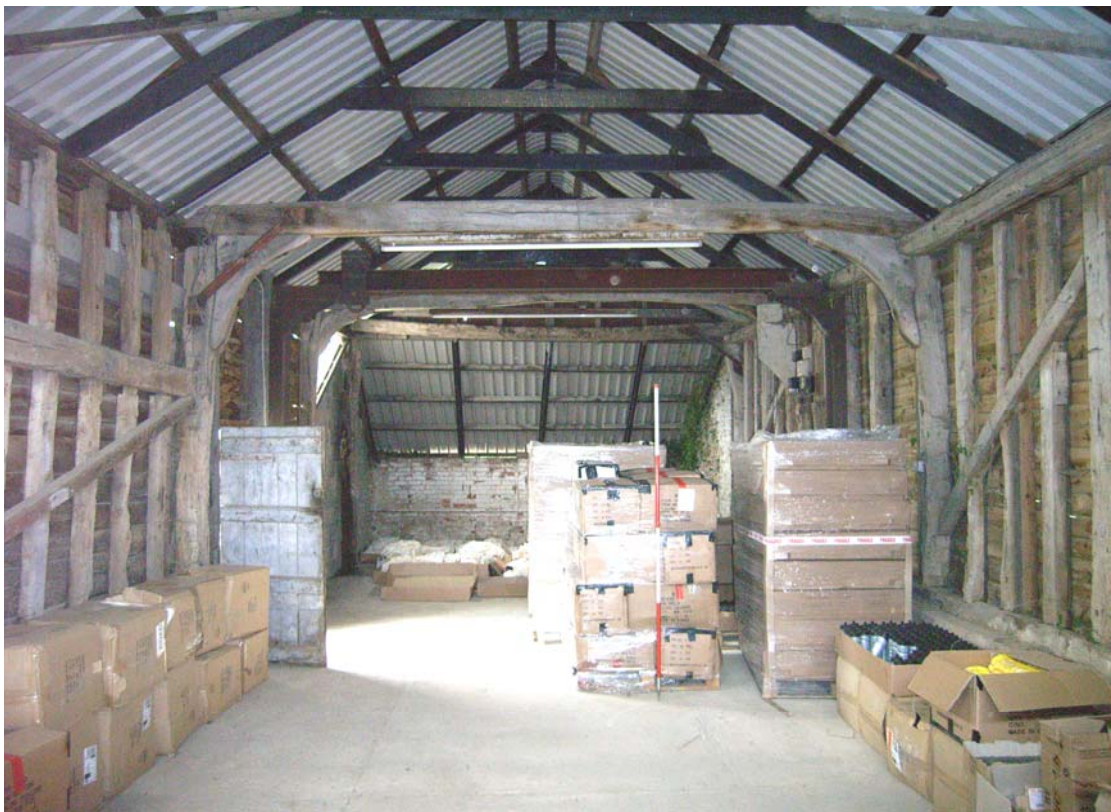
A2.10 General internal view of barn from south showing modern roof structure with 16th century timber-framing of western elevation to left

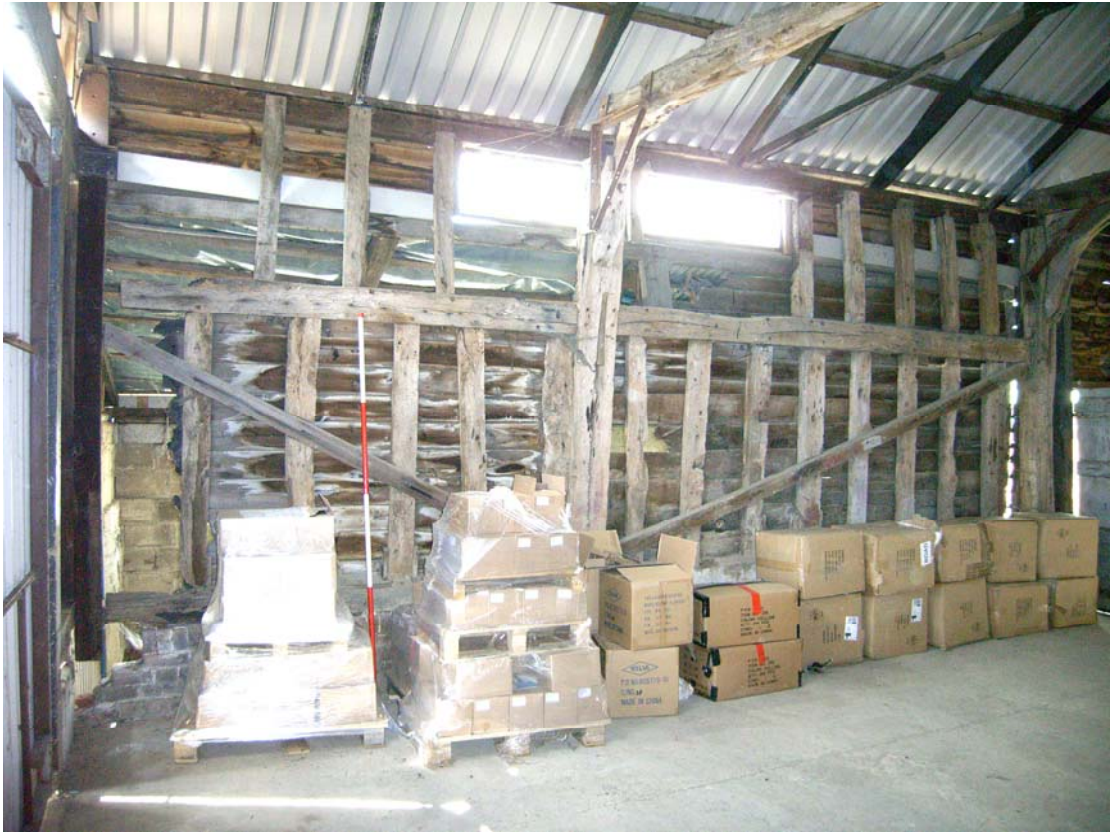
A2.11 Internal western elevation of barn showing 16th century framing with intact mid-rails but lacking roof-plate and evidence of arched doorway to left (diagonal braces are secondary)

The timber frame contains elements of at least two different periods. The two southernmost bays of the western elevation ostensibly date from the early-16th century and contain original mid-rails some 91 cm (3 ft) beneath its roof-plate, although the latter has been renewed. The jowled storey post between these bays contains the empty mortise of an arch brace which is reflected by its counterpart in the eastern elevation and in the soffit of the tie-beam. This open truss appears to be *in situ*, but the eastern post lacks mid-rail mortises and the adjacent framing of this elevation has been rebuilt. Several common studs in the western elevation have been moved, and the ground sill renewed, but most appear to be *in situ*. A gap of 90 cm in the stud mortises at the southern end of the mid-rail (66 cm or 26 ins from the southern gable) reveals the position of an original doorway with a 'Tudor' arched head, as indicated by a corresponding mortise and chamfer on its northern jamb; the southern jamb has been replaced, but the external edge of the mid-rail is also chamfered. The lack of mid-rail to the rear, eastern elevation is consistent with the building's present orientation, as late-medieval structures often directed more expensive and ostentatious framing towards public roads. The remaining tie-beams lack mortises for arch braces, and appear to be contemporary with the framing of the eastern elevation which contains a face-halved scarf joint and primary diagonal bracing in the style of the 18th century. In its present form the barn is essentially a mid or late-18th century structure which incorporates substantial elements of a 16th century predecessor that may be contemporary with the farmhouse. The presence of arched door heads in early barns is rare but not unprecedented.

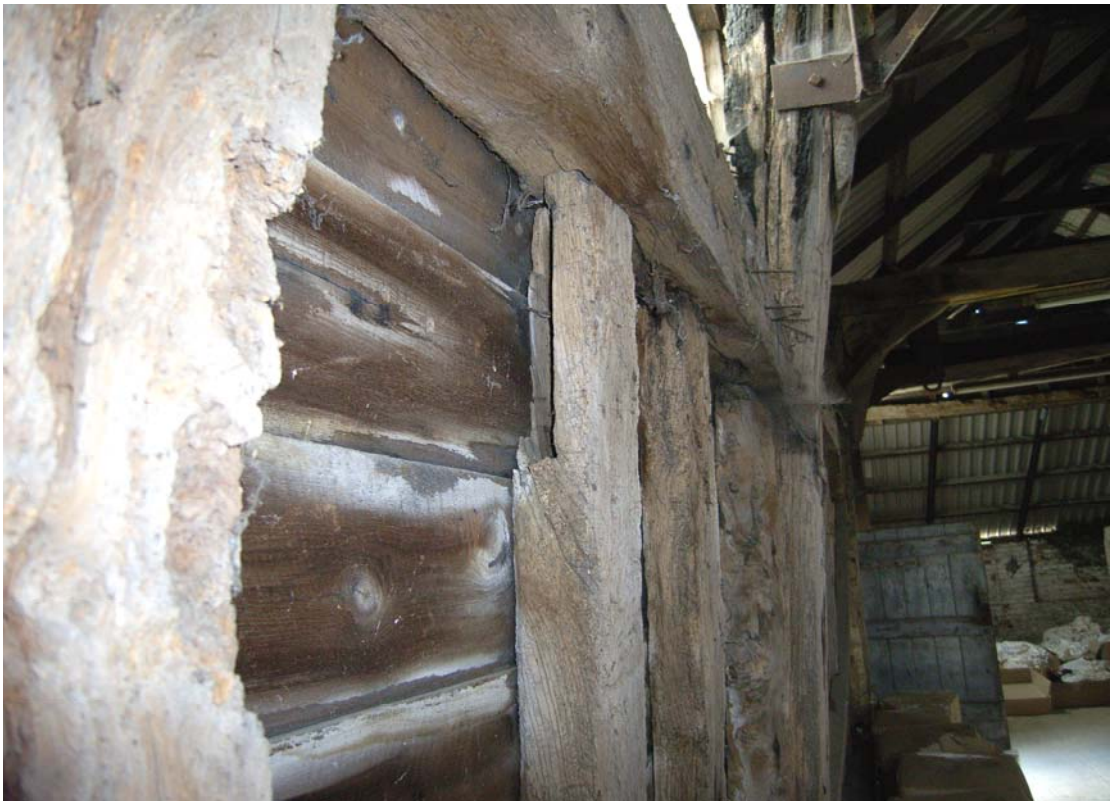
A2.12 Detail from south of door head mortise and external chamfers beneath mid-rail in western elevation of barn
