Wickerstreet Cottage, Kersey, Suffolk KSY 021

Historic Building Record

**Wickerstreet Cottage,
Wickerstreet Green,
Kersey, Suffolk**

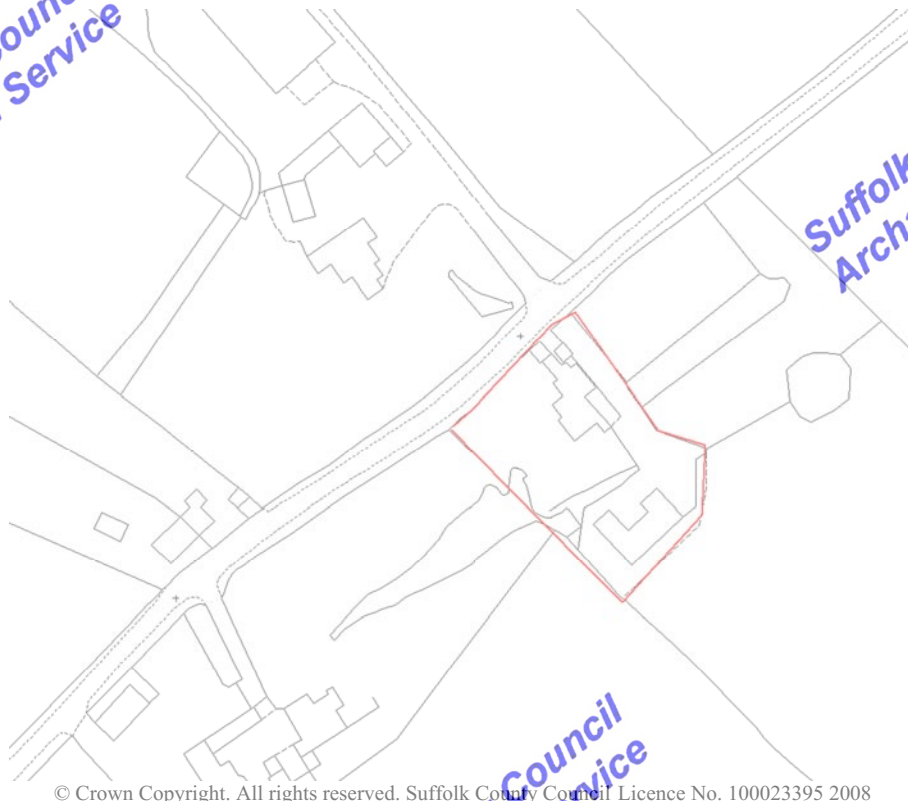
Figure 2
Existing Ordnance Survey Site Plan

Outlining the site in red, and showing the area of Wickerstreet Green to the south-west. The house lies in the northern corner of the enclosure, with a block of modern stables and sheds to the south.

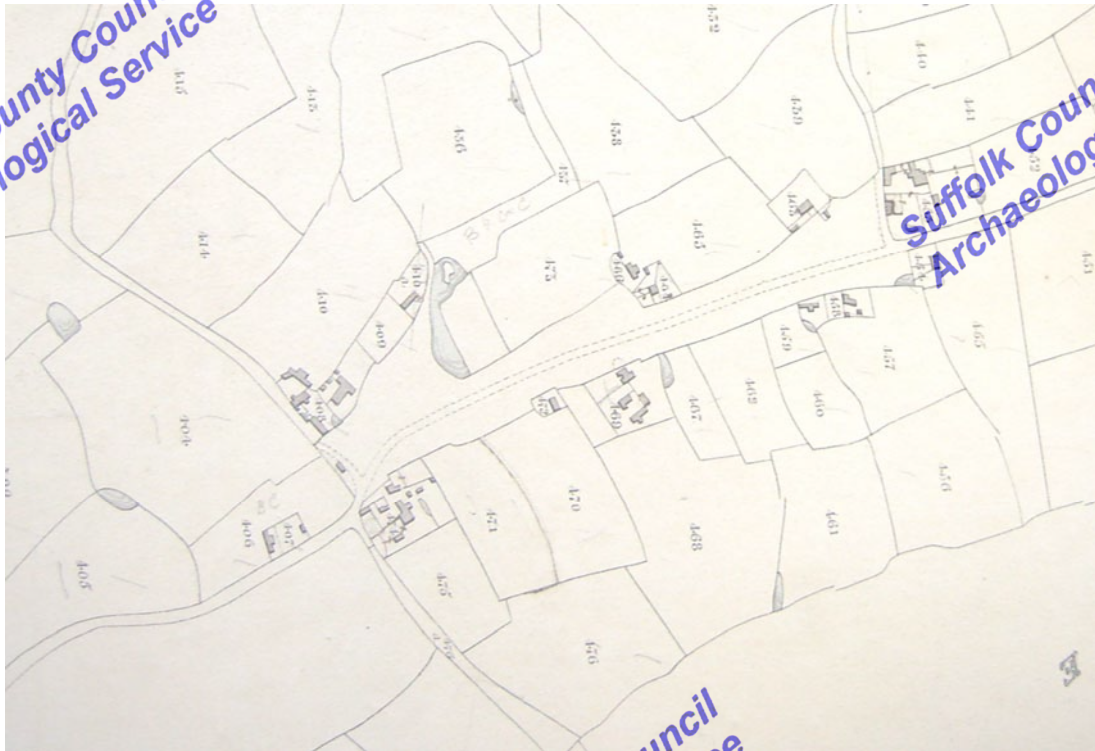
Figure 2

Detail of the Hadleigh Hamlet tithe map of 1843, showing Wickerstreet Cottage occupying a highly conspicuous location at the north-eastern end of a linear green. (Orientation of original altered to shown north to top.)

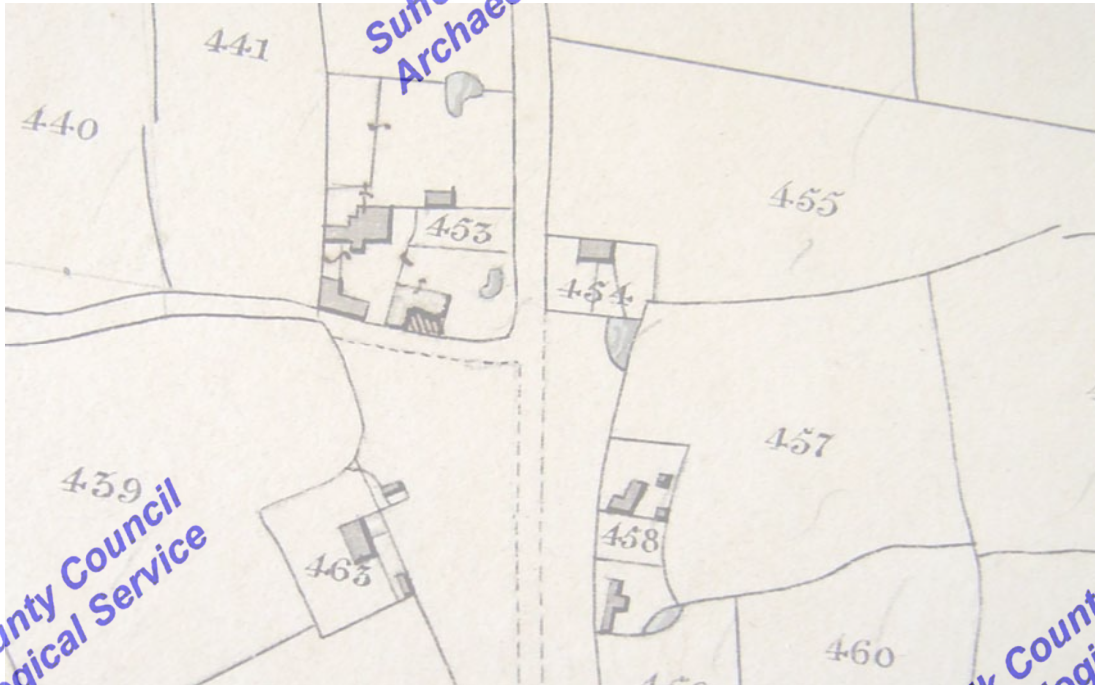
Figure 3

Detail of the tithe map (with north towards top left-hand corner), showing the cottage with a simple rectangular outline (no. 454). The blue pond in the corner of the green still survives, and appears to the left in photo A2.2. Curtis Farm, to which the cottage belonged, is no. 453 on the opposite site of the road.

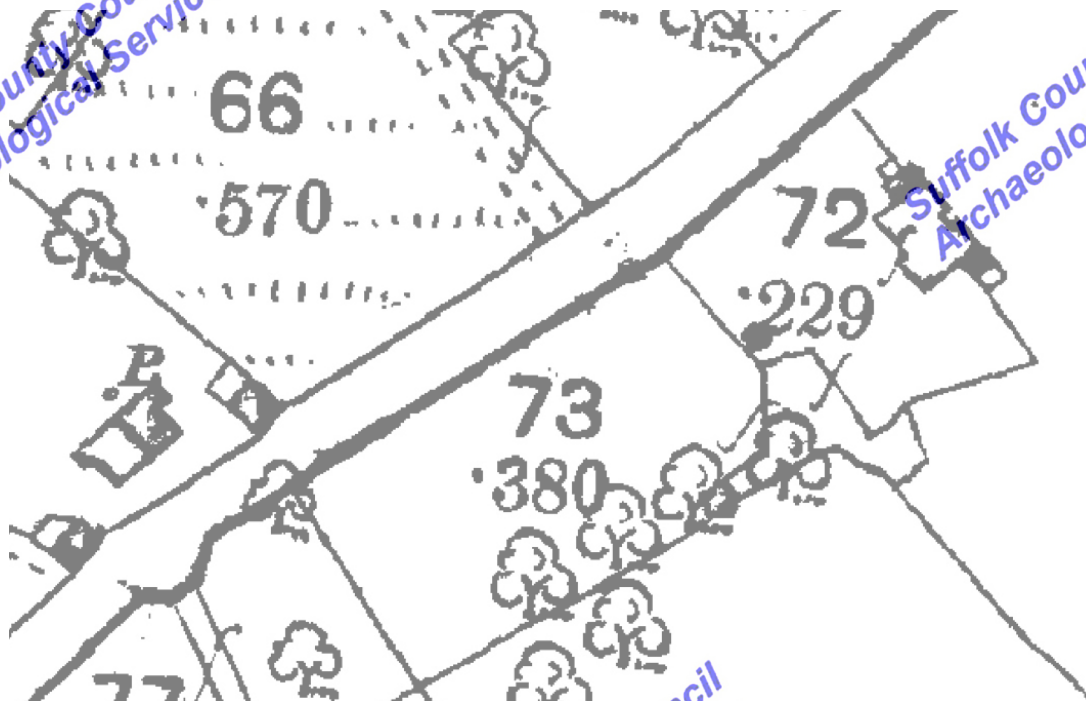
Figure 4

First edition 25 inch Ordnance Survey of 1886, showing Wickerstreet Cottage to the right with a more complex and accurate outline than in figures 2 & 3. The green had been enclosed since 1843.

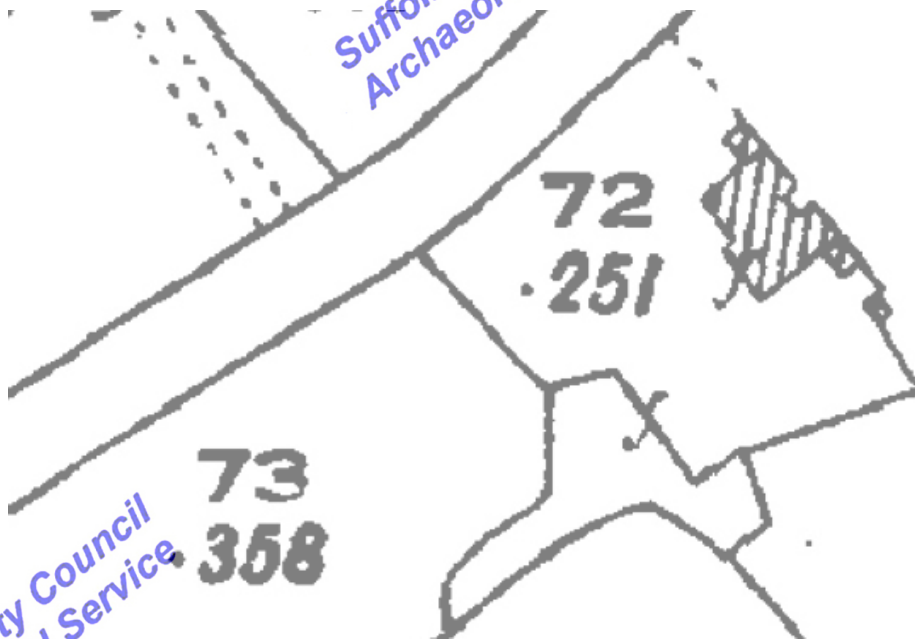
Figure 5

Third Edition 25 inch Ordnance Survey of 1926, showing the present outline of the historic cottage with small sheds or lean-to structures against the rear (north-eastern) wall

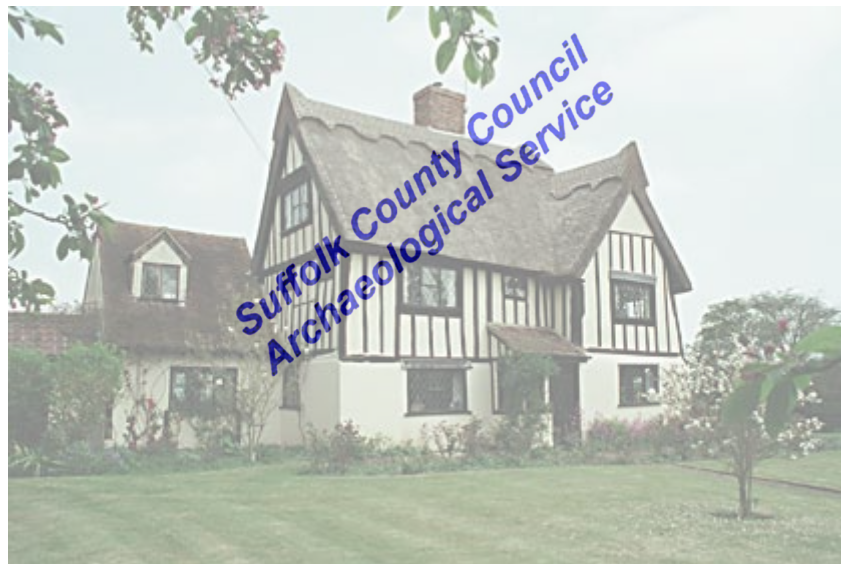
Figure 6

Wickerstreet Cottage from the west in 2003, seen before the loss of its thatch – which appears to have been a modern reed replacement rather than traditional straw thatch. Note the lack of tie-beam in the truncated right-hand cross-wing. The kitchen to the left is ostensibly modern, but may occupy the site of an earlier bakehouse wing as the 17th century window of the hall gable is off-set to accommodate it.

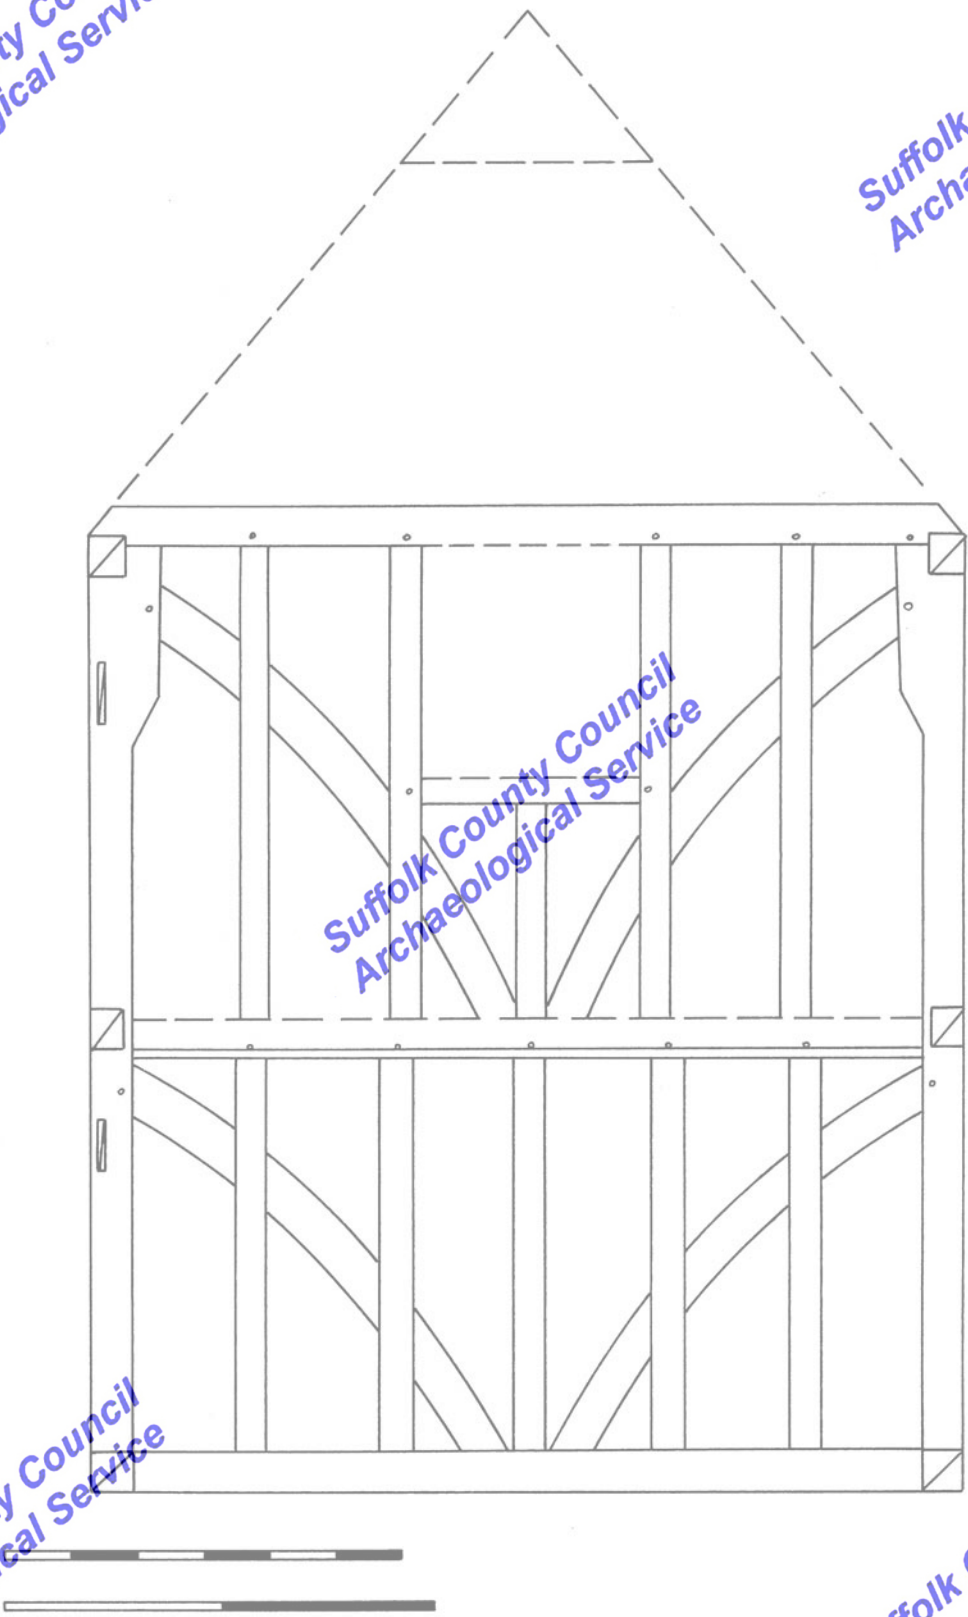
Figure 9. Cross-wing: Internal elevation of rear gable
Reconstruction

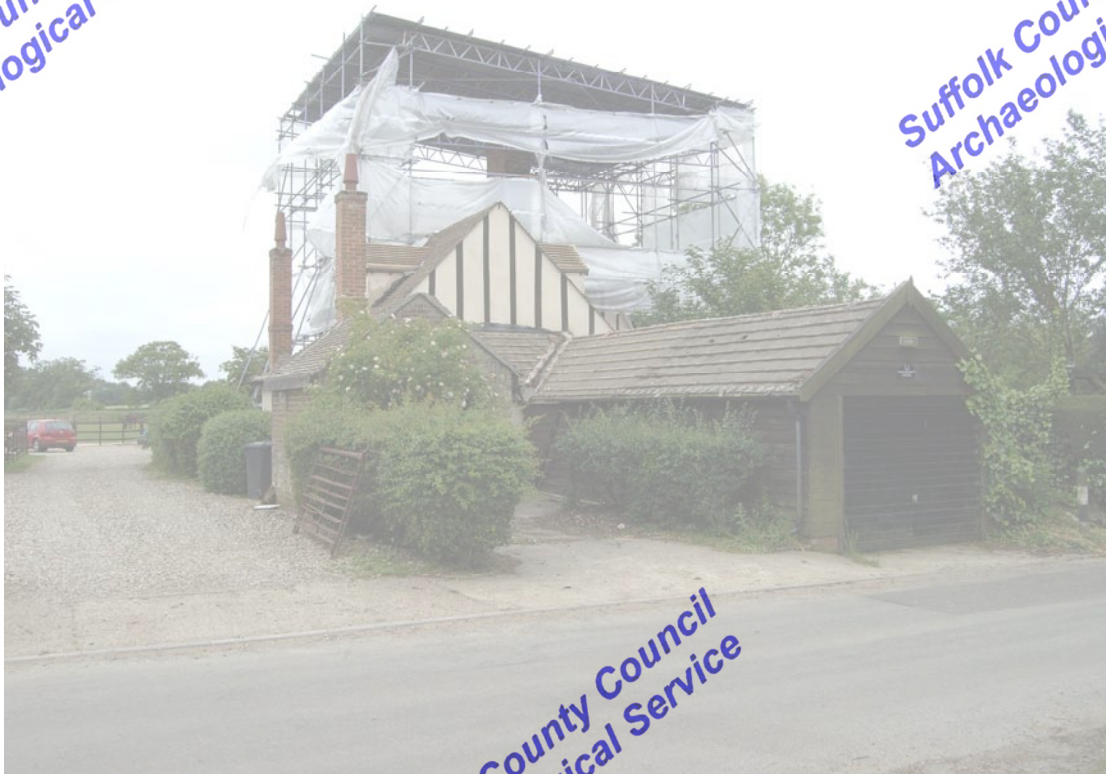
A2.1 General view of existing entrance to site from road to north, with the remains of the medieval linear green which the house originally faced visible to the right

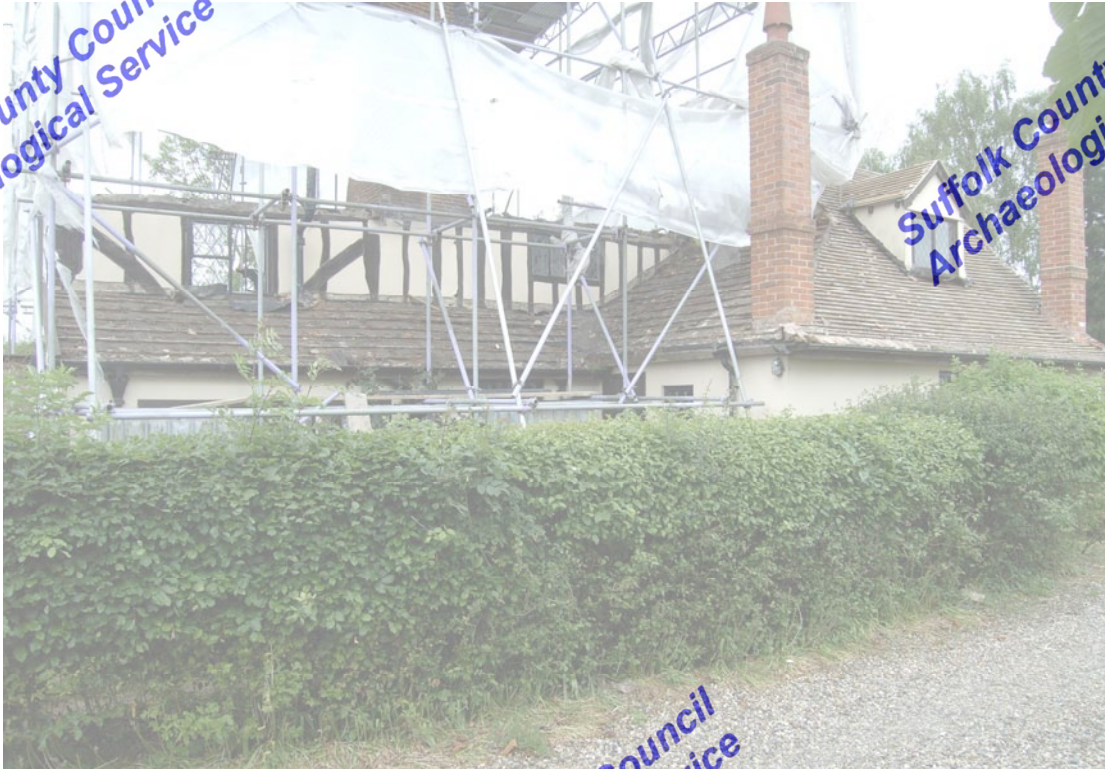
A2.3 Rear elevation from east showing the symmetrical braces of the medieval cross-wing's hipped gable to the left and the intact 17th century four-light ovolo-moulded window to the right

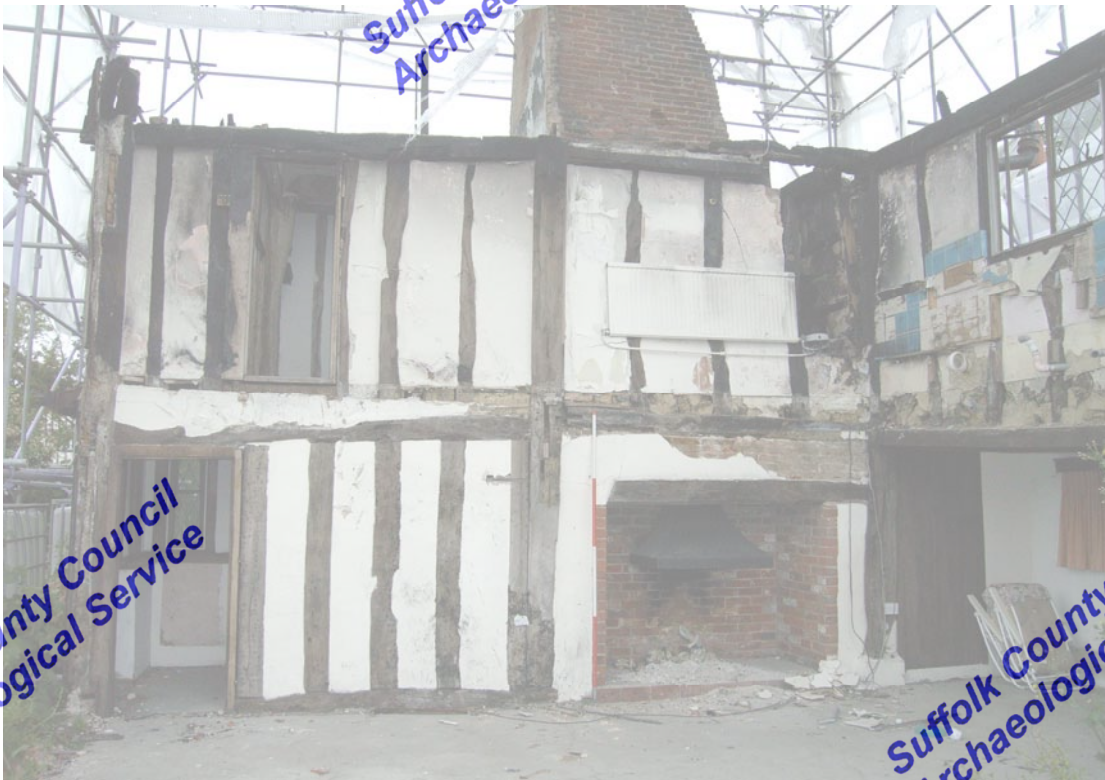
A2.4 Internal northern elevation of the medieval cross-wing (J-E-C), showing the 17th century chimney to the right. The structure originally continued by at least one bay to the left. The right-hand bay was originally partitioned and its internal studs are soot-encrusted

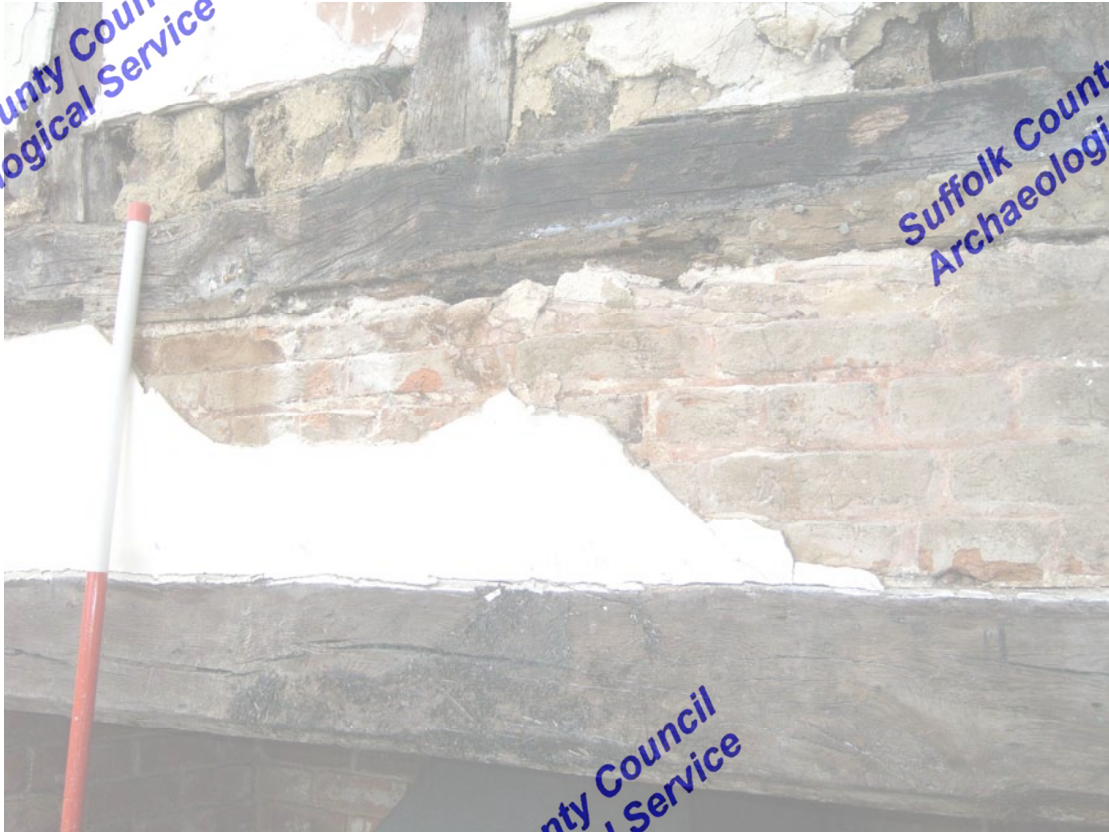
A2.5 Detail of mid-rail in bay E-C showing well-preserved reddled 17th century brickwork and an unusually narrow medieval window shutter rebate

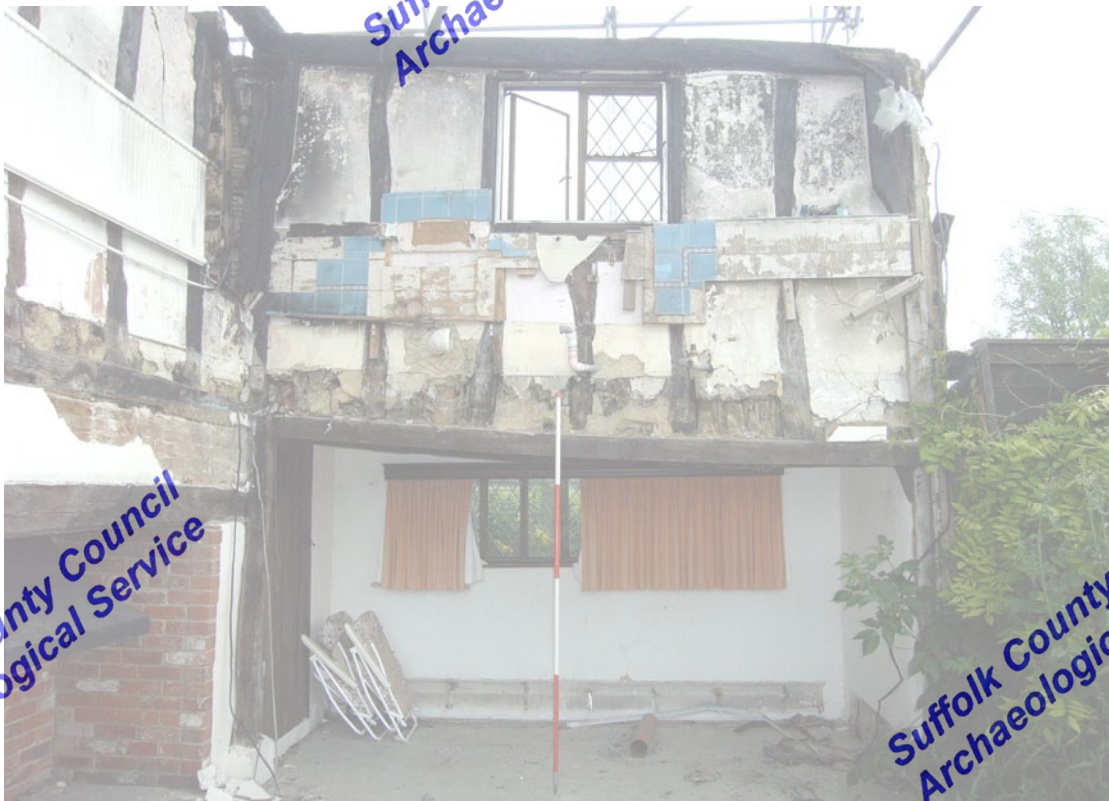
A2.6 Internal elevation of rear cross-wing gable C-D, showing an original first-floor window without a shutter rebate and extensive sooting to all studs and daub

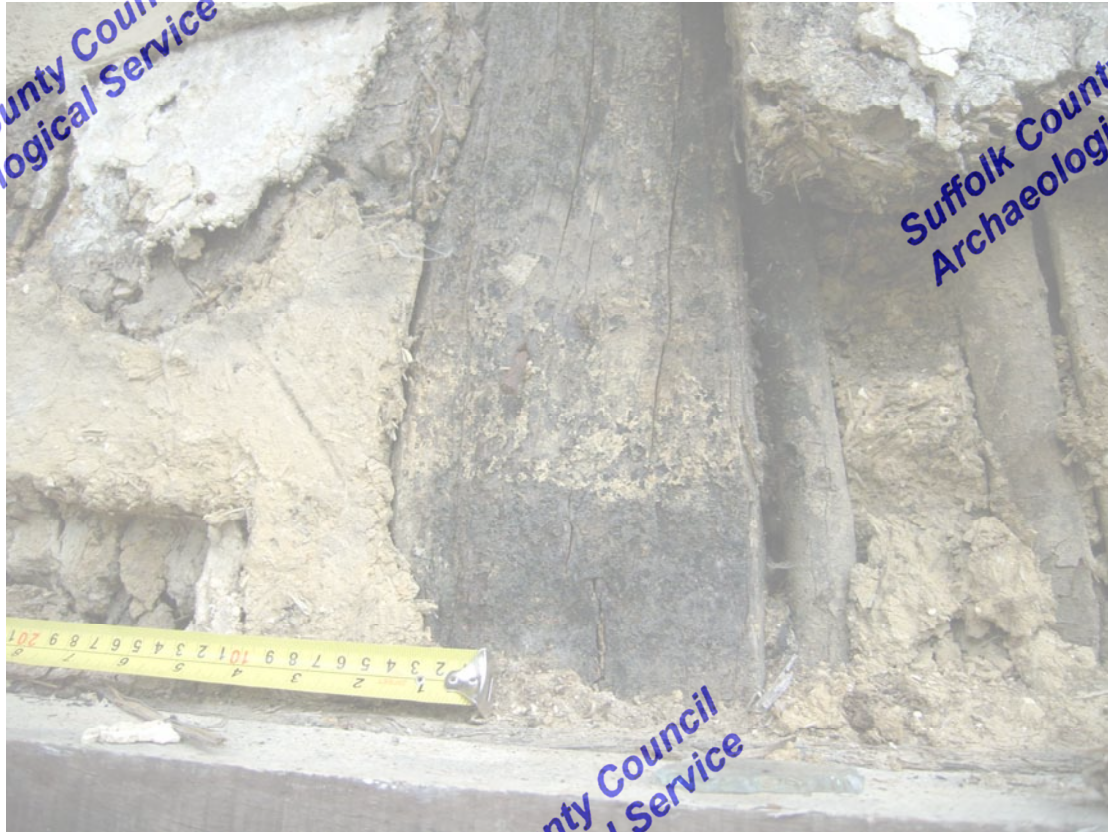
A2.7 Detail of sooted original stud and daub beneath later plaster of internal gable C-D

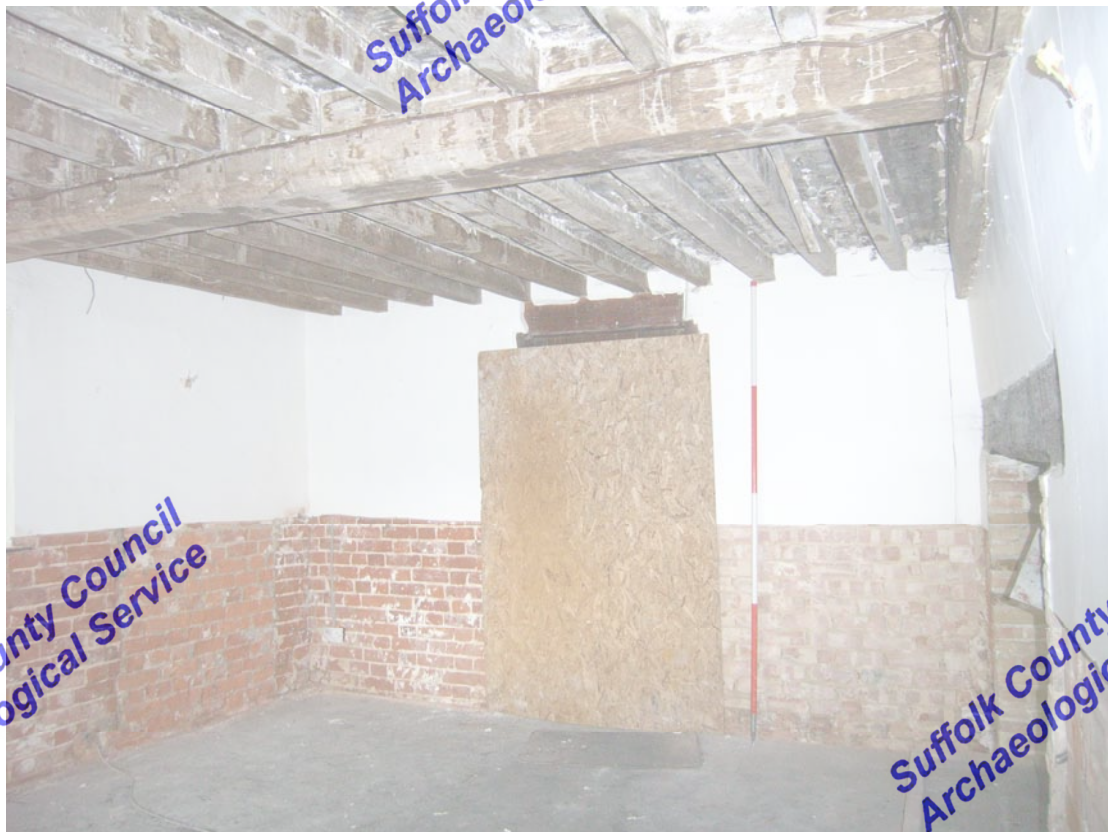
A2.8 Ground floor of 17th century hall from west, showing intact ceiling and secondary door in elevation A-B with fireplace to right and blocked door in northern gable to left

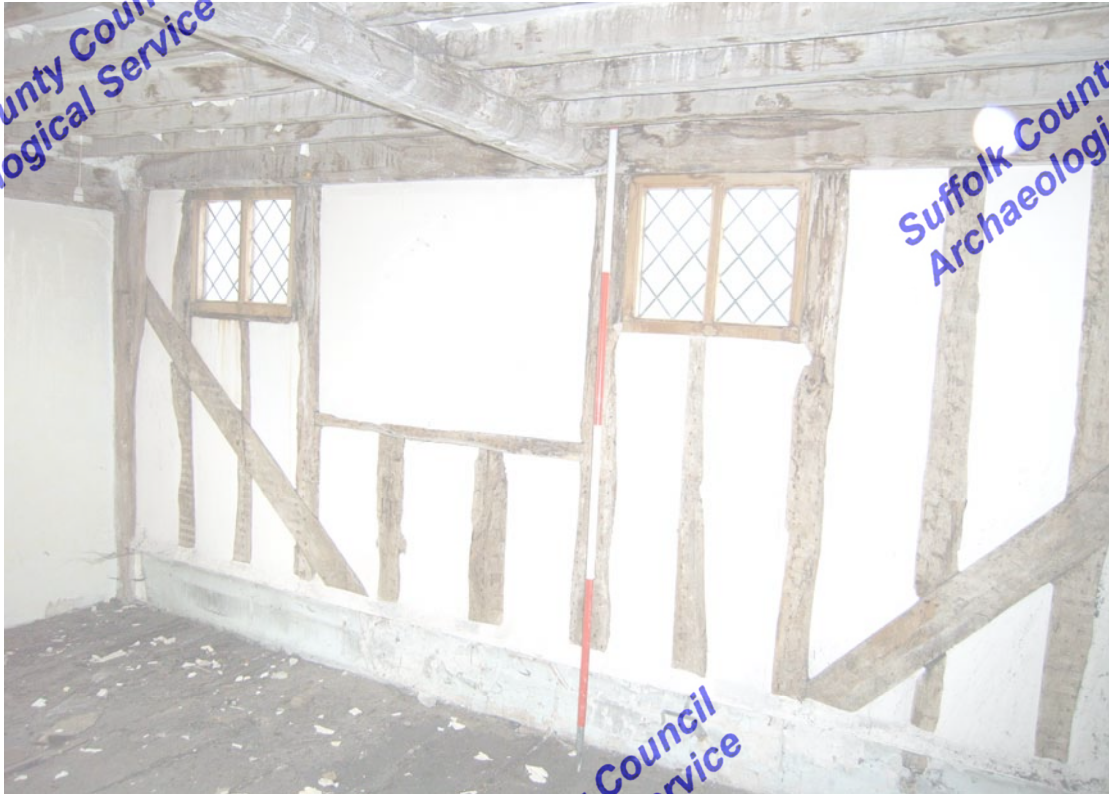
A2.9 Internal elevation of northern gable G-A of hall chamber, showing original ceiling joists and off-centred tripartite window with original sills but modern mullions

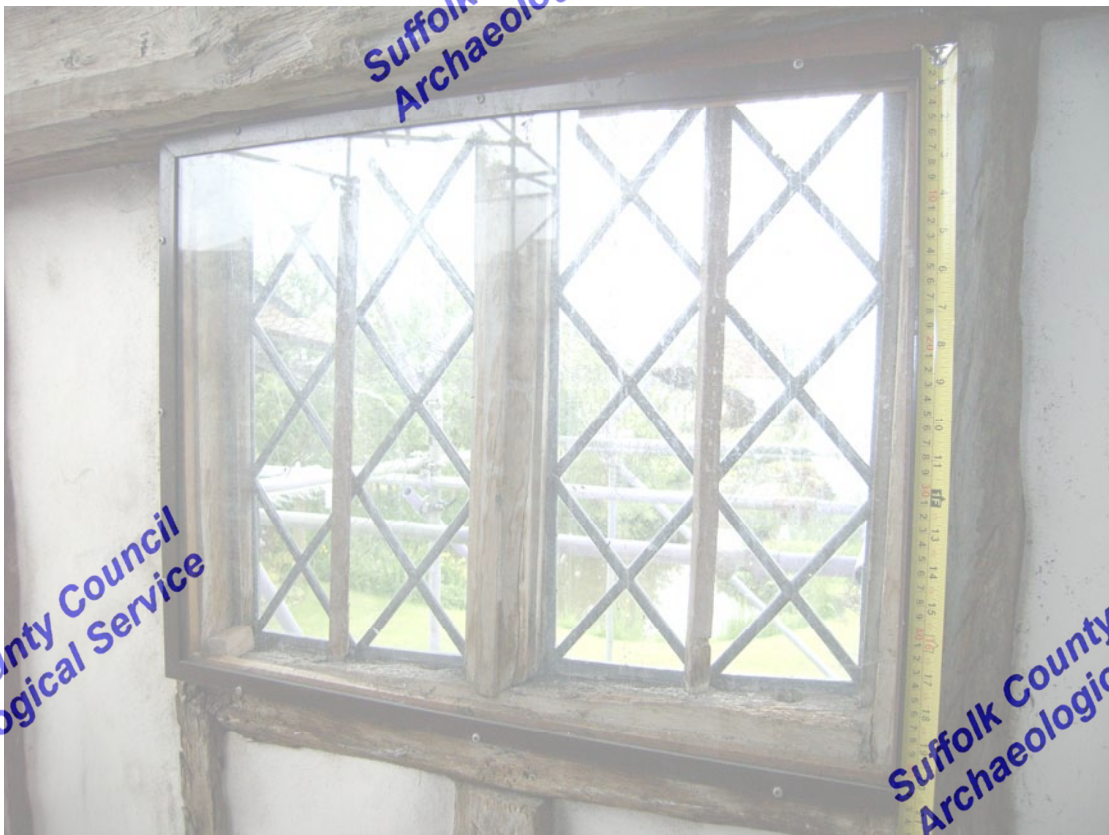
A2.10 Detail of original ovolo-moulded first-floor window in western elevation of chimney bay, retaining mullion and diamond-section wooden saddle bars

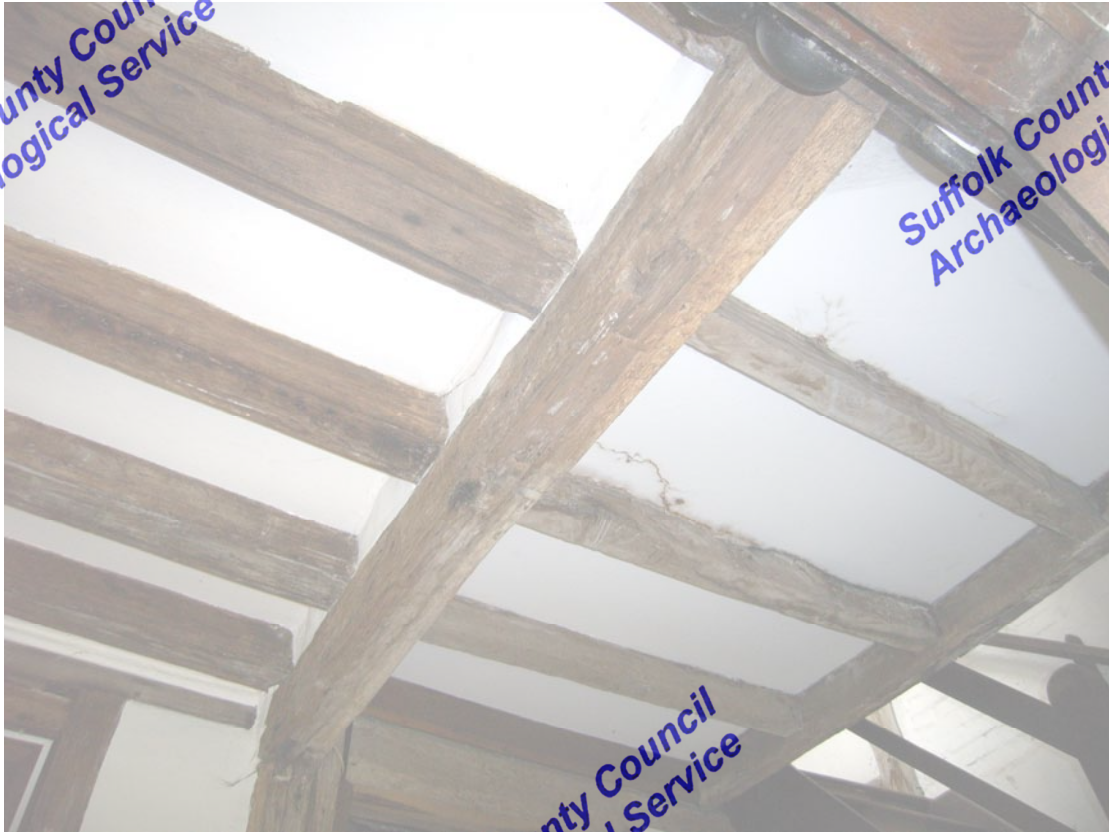
A2.11 Ceiling of entrance lobby from south showing mortises of 17th century door in mid-rail with stair trap to right and re-used roll-moulded timbers of modern porch to left

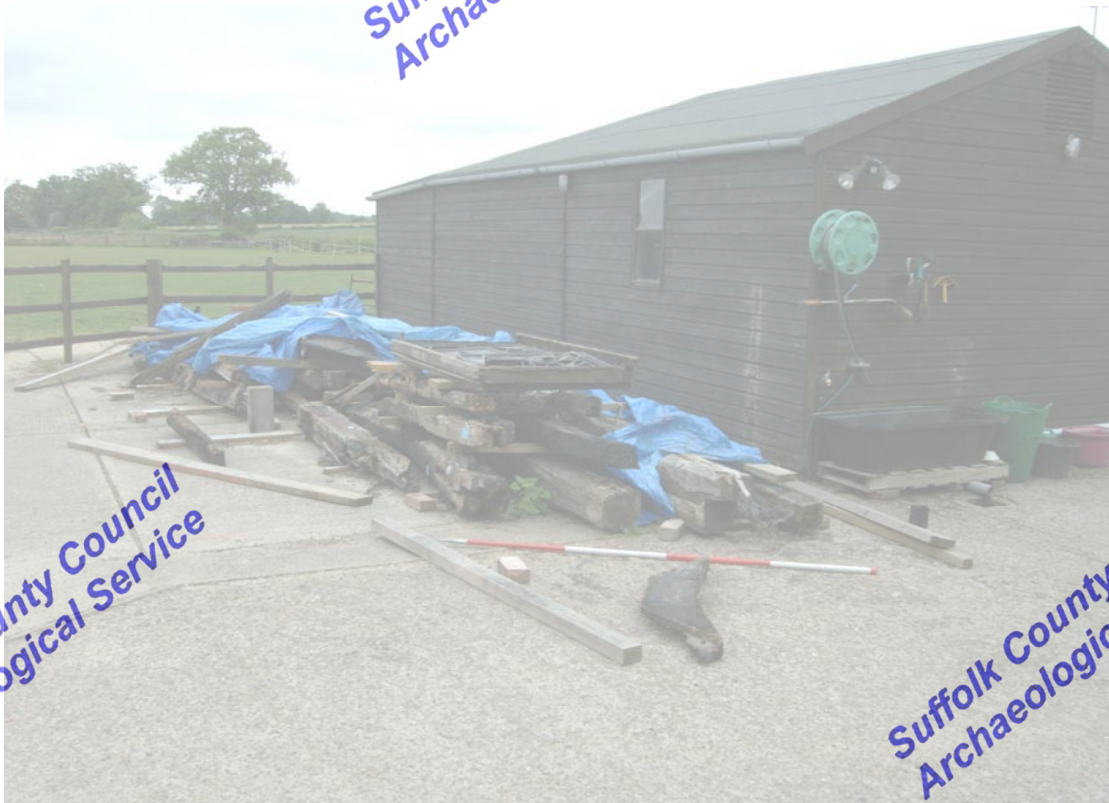
A2.12 Substantial pile of dismantled timbers to south of site, labelled for re-assembly but not fully examined. Note the tie-beam arch brace in the foreground (probably from truss J-K).
