**The Granary,
Red House Farm,
Stradbroke, Suffolk
SBK 034**

May 2009

**The Granary,
Red House Farm,
Fressingfield Road,
Stradbroke, Suffolk**

An Archaeological Record

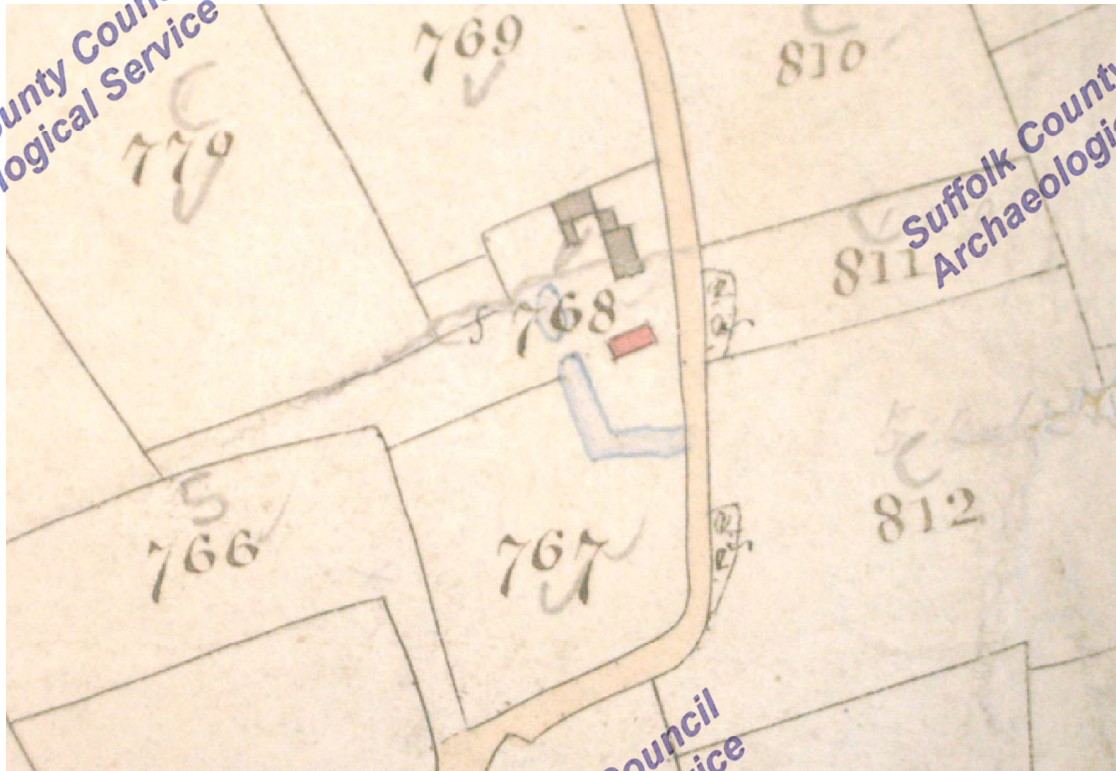
Figure 2

Detail of the Stradbroke tithe map of 1841 (Suffolk Record Office) showing the previous farmhouse in red. The granary had not yet been built, and its site is occupied by a pond which may represent a continuation of the medieval moat.

Figure 1 shows the site in 1841, as depicted on the Stradbroke tithe map. The rectangular predecessor of the present farmhouse is shown in red on the approximate site of its square replacement. A group of farm buildings in grey lies to the north of the site, but the granary had not yet been built and its position is occupied by a pond which may represent a continuation of the moat. The property formed a tenanted holding of respectable but modest proportions, with 79 acres of land owned by Thomas Sandcroft Holmes and occupied by Jonathan Davy (27% pasture and the rest arable). The farm site is described as ‘premises’ in the schedule which accompanies the map (plot 768) with Long Field to the north (769) and Corner Meadow to the south (767).

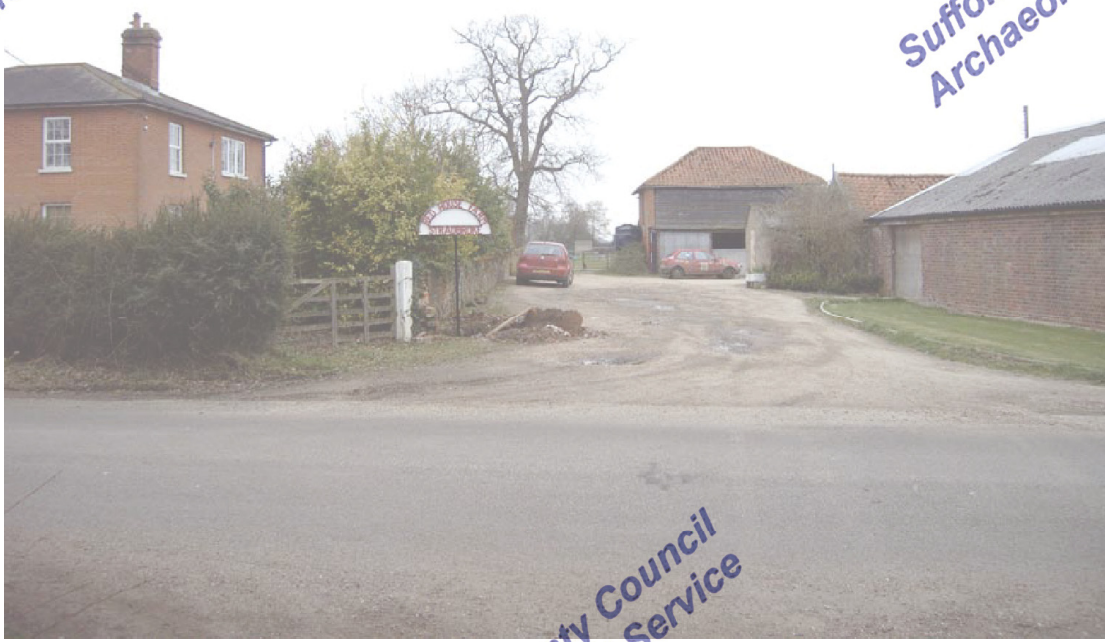
A2.1 Entrance to yard from road to east, showing farmhouse to left and granary in rear to centre with 20th century farm sheds to right

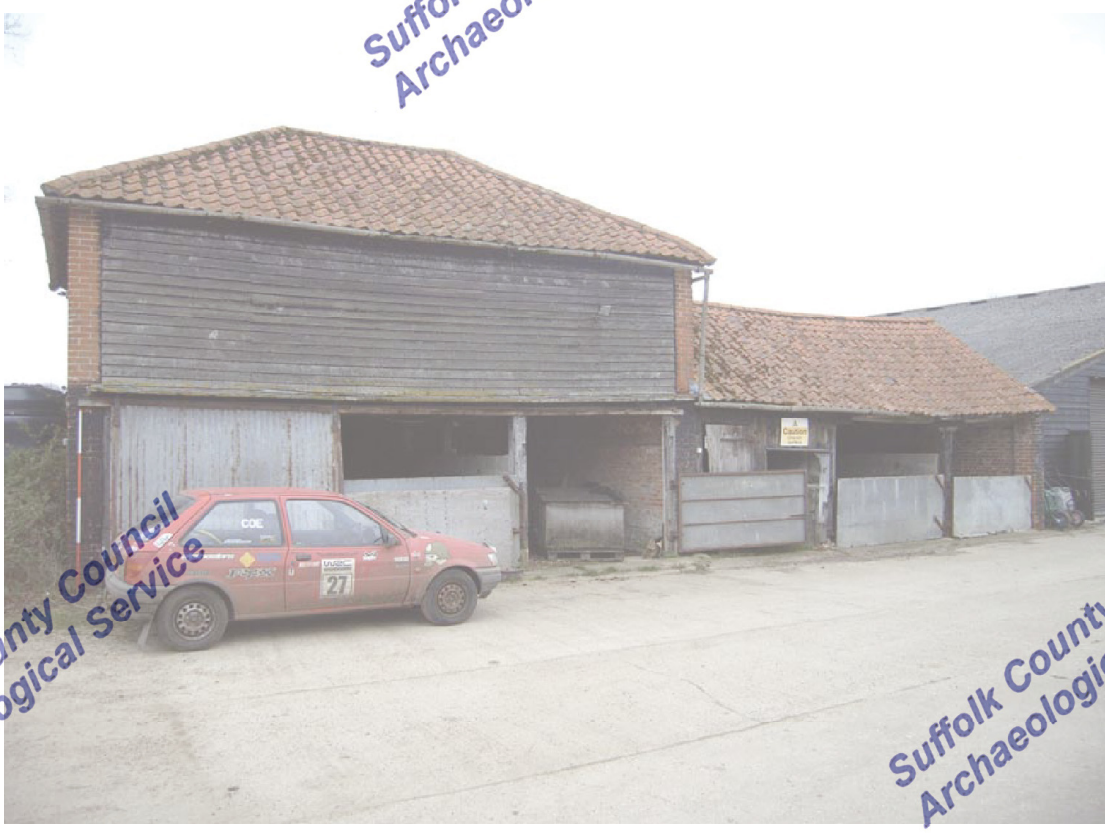
A2.2 Eastern external elevation of granary showing open arcade to ground floor and later single-storied shed to right

The granary is a red brick structure of two storeys on a north-south axis with an open cart lodge on its lower storey and a grain floor above. The open arcade of the cart lodge faces east towards the entrance to the site from the Fressingfield Road, but was partly enclosed with block-work and doors to form cattle stalls during the mid-20th century. An iron hay basket against the rear internal elevation bears witness to this conversion. The building extends to 8.7 m in overall length by 5.8 m in width, and its walls rise to 4.5 at the eaves. The rear, western elevation and both gables are of 35 cm-thick Flemish-bond brickwork, but the eastern elevation consists only of weatherboarded studwork above its open lower storey. The softwood ceiling lies 2.5 m above ground level and consists of tall-sectioned common joists lodged on two binding joists with chamfered and pegged central Sampson posts. Fragments of original lime plaster keyed on reed survive on the soffits of the floorboards. The southern bay has been divided from the rest by a secondary boarded partition and a half-height block-work wall divides the two northern bays into a pair of stalls. The arcade posts and rails retain what is probably an original layer of light grey pigment beneath secondary tar, and the Sampson posts are reddled. The granary floor is now reached by a secondary internal stair against the southern gable, but was originally accessible only by an external door in the same gable in the usual manner. The granary is lit by two louvered windows in the western elevation and another in the northern gable, each retaining the fragmentary remains of boarded internal and vertically hinged shutters. The gable window is now blocked by a secondary single-storied 19th century brick shed. The remains of boarded grain bins lie against the eastern elevation and the butt-purlin roof structure retains its original whitewashed render beneath its pan-tiles. A lean-to wood shed of mid-20th century block-work adjoins the western elevation, but the late-19th century Ordnance Surveys suggest that a similar structure formerly occupied the same site.

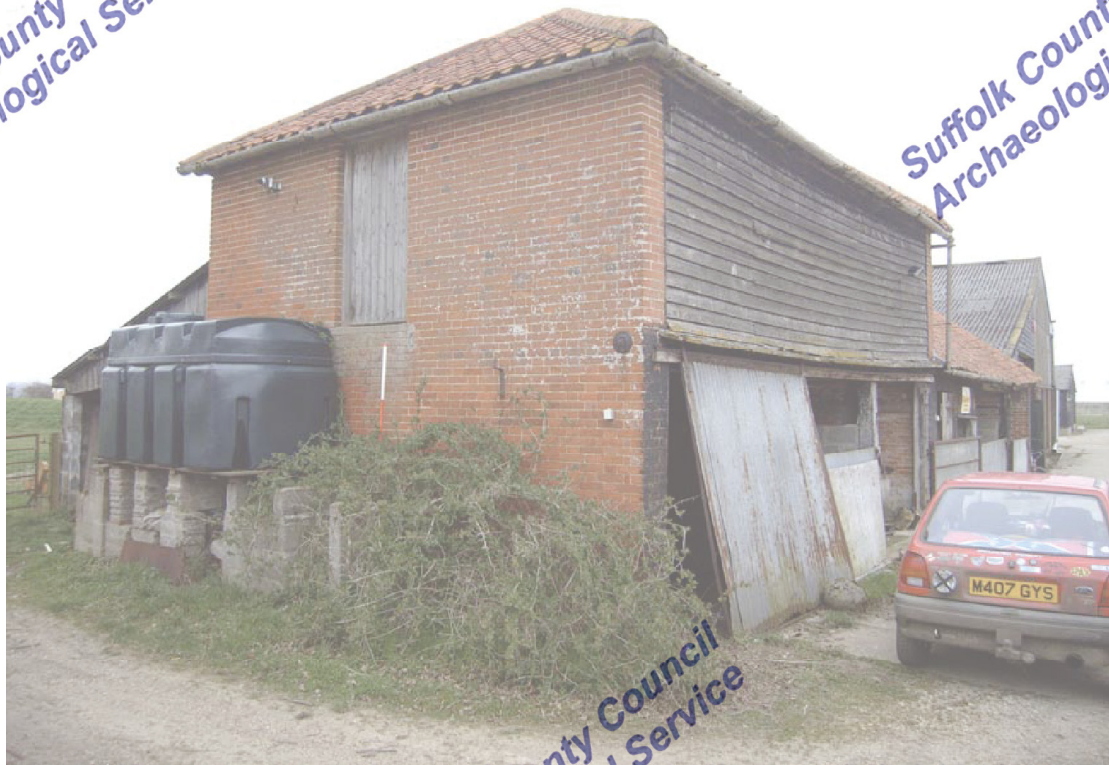
A2.3 Exterior from south-east showing original granary door in southern gable

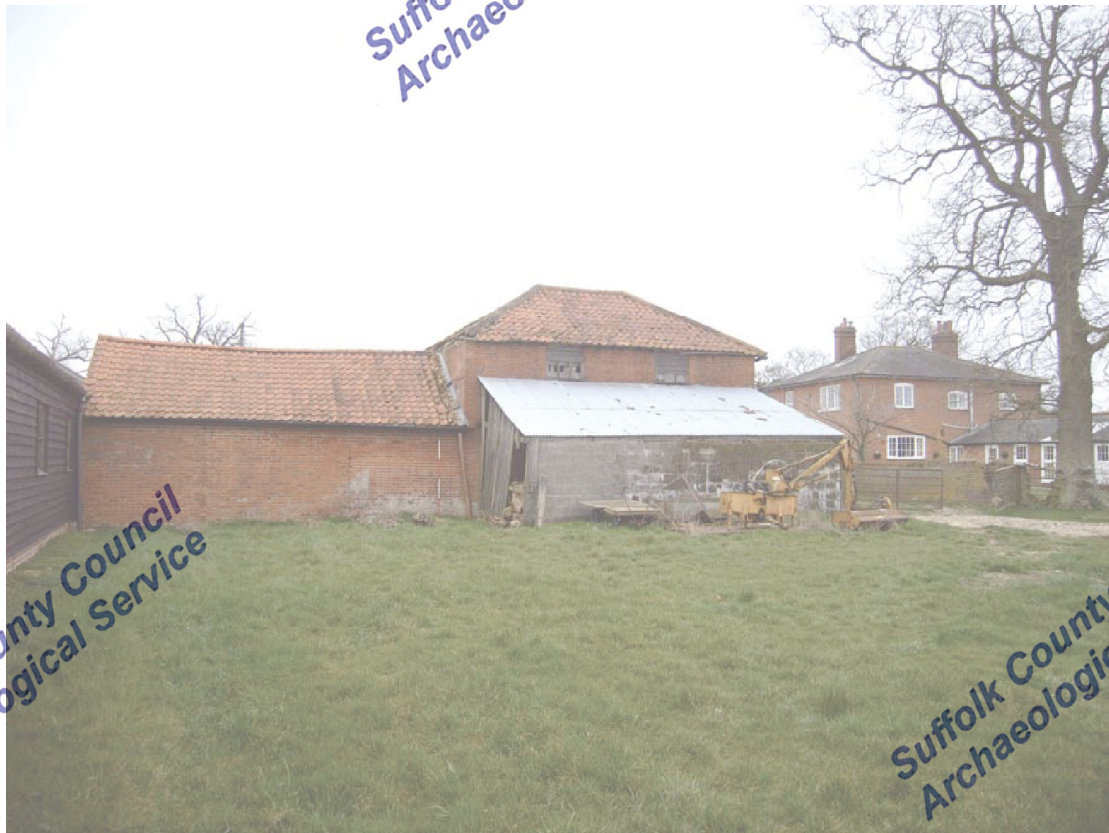
A2.4 External rear (western) elevation showing farmhouse to right and original granary windows above 20th century blockwork lean-to

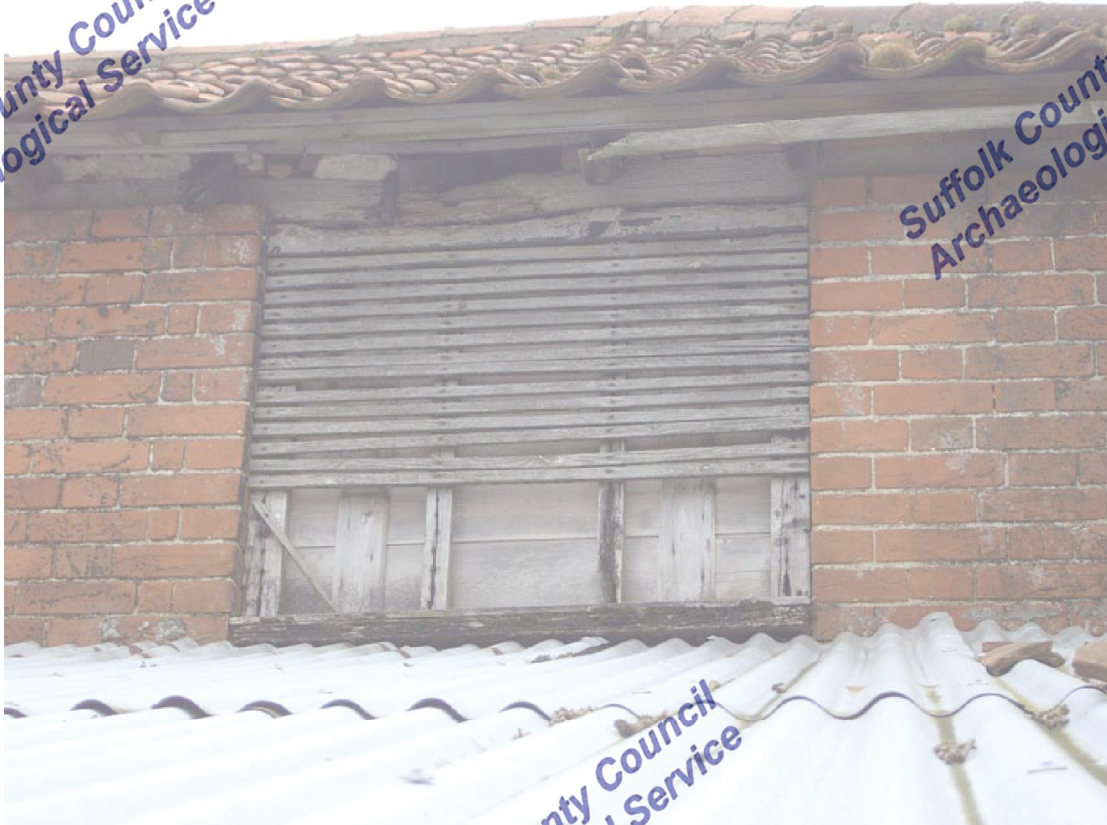
A2.5 Detail of original louvered window in western external elevation of granary

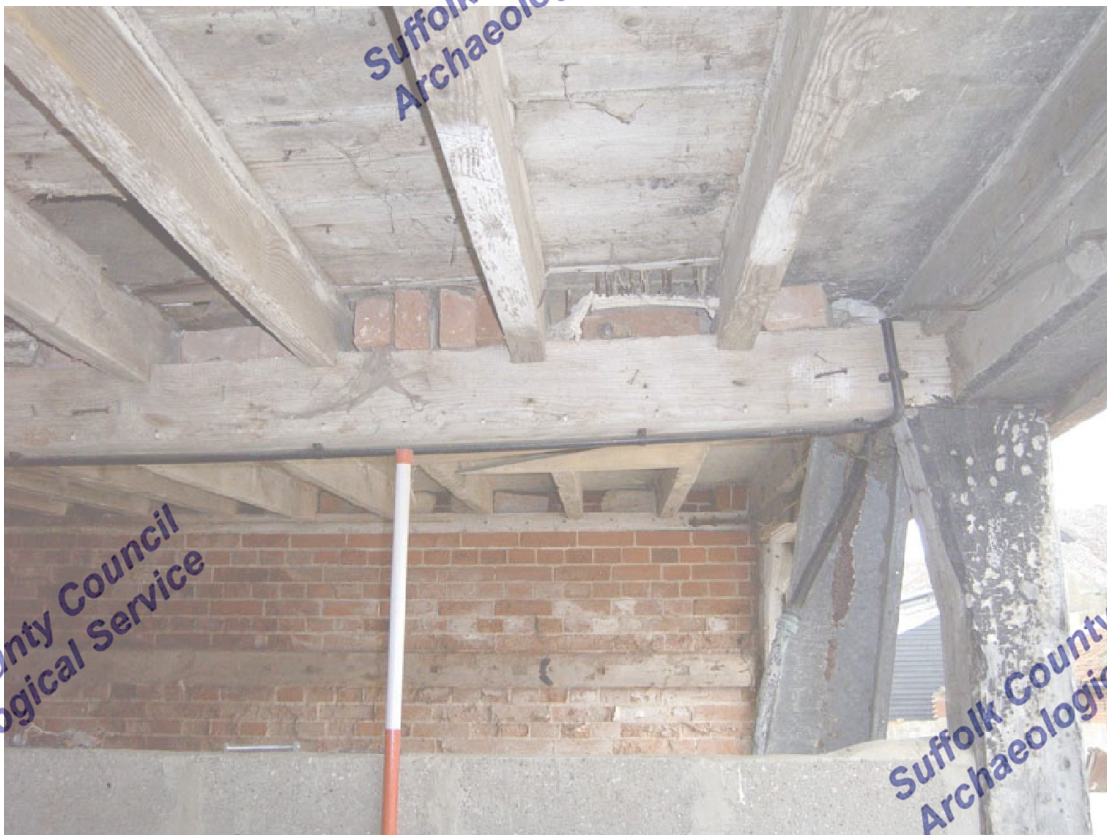
A2.6 Detail of softwood ground storey ceiling from south, showing post of open arcade to right

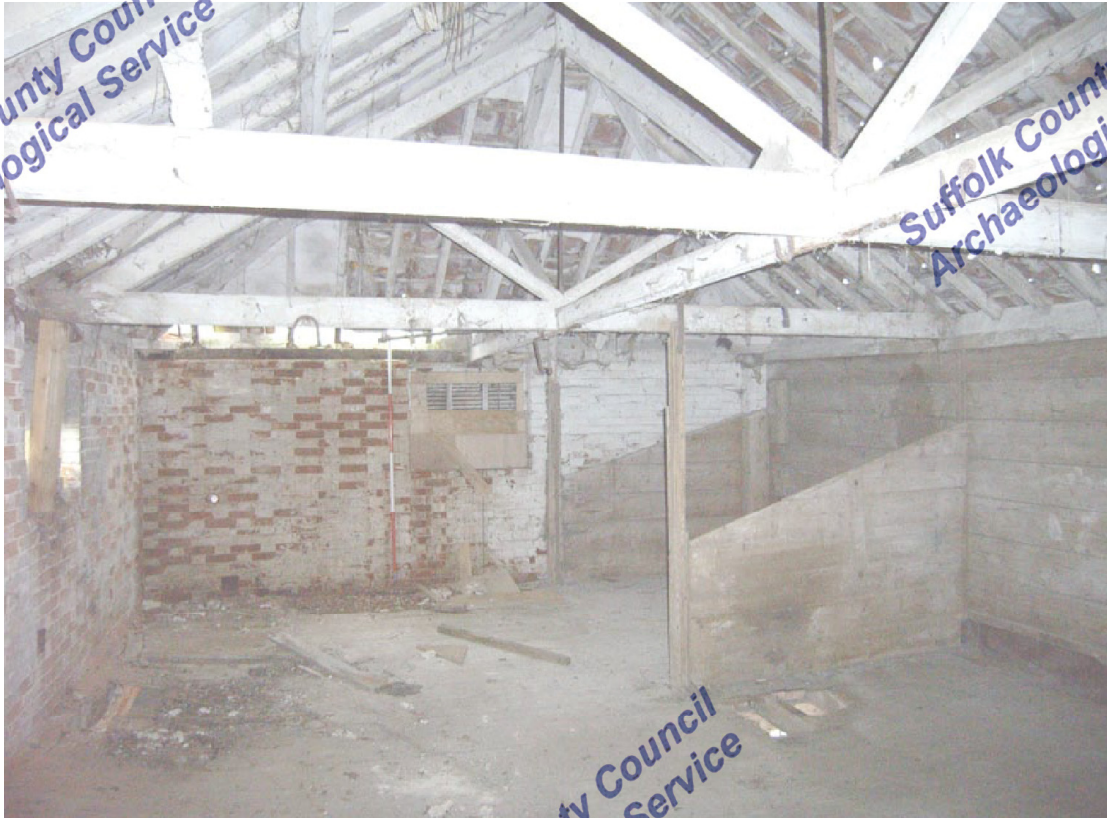
A2.7 Interior of granary on upper storey from south, showing boarded grain bins to right and central window in northern gable blocked externally by secondary shed

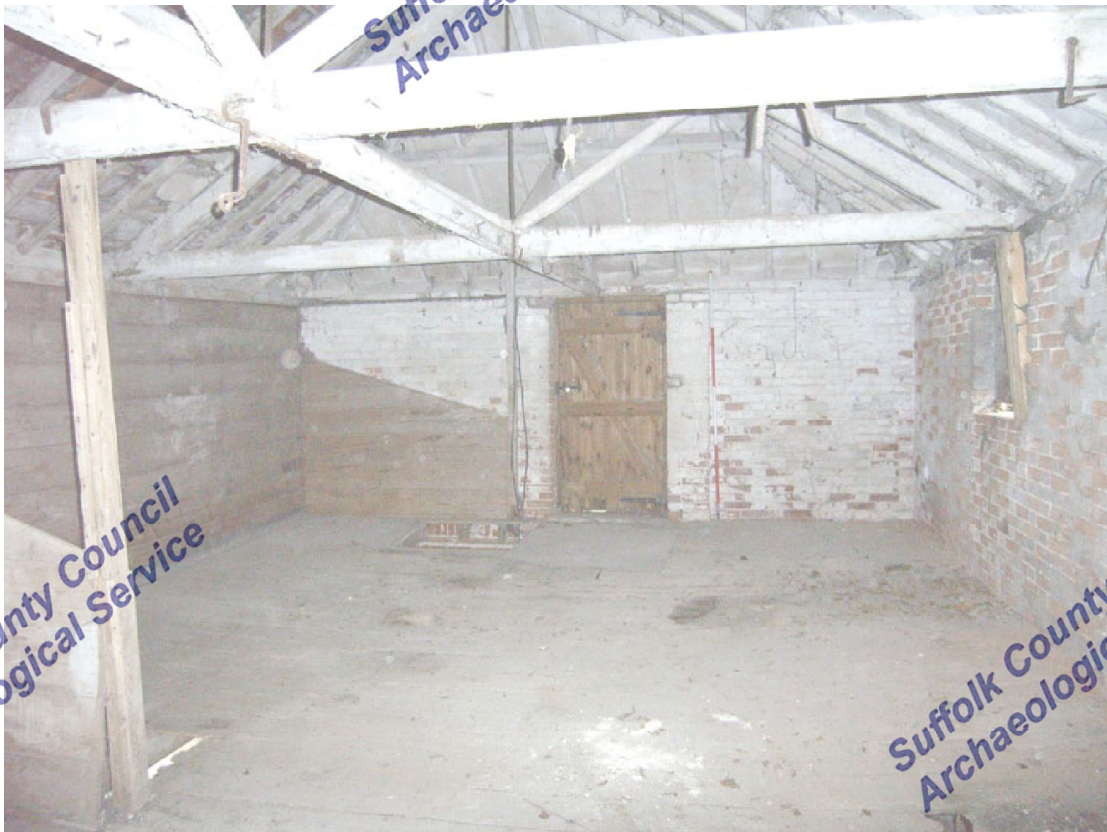
A2.8 Interior of granary showing original gable entrance door adjacent to existing internal stair trap
