**Historic Building Record**

# The Barn, Picknotts, Cross Green, Cockfield, Suffolk

## Historic Building Record

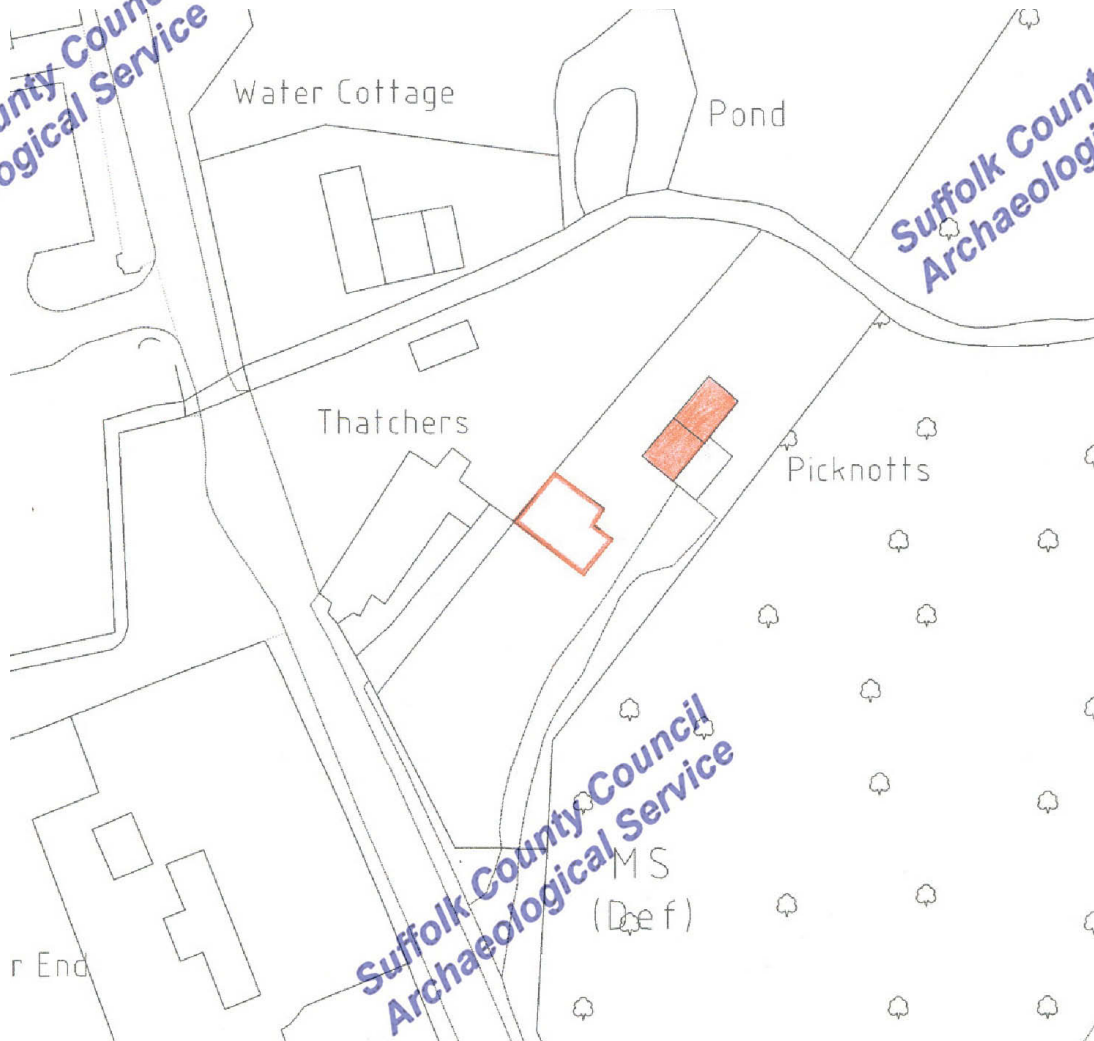
Figure 1

**Existing Ordnance Survey Site Plan**

**Showing the barn shaded in red with its internal partition into two sheds. A modern lean-to garage adjoins its south-western elevation, and the house (Picknotts) is outlined in red. The park of Pepper's Hall is shown to the right.**

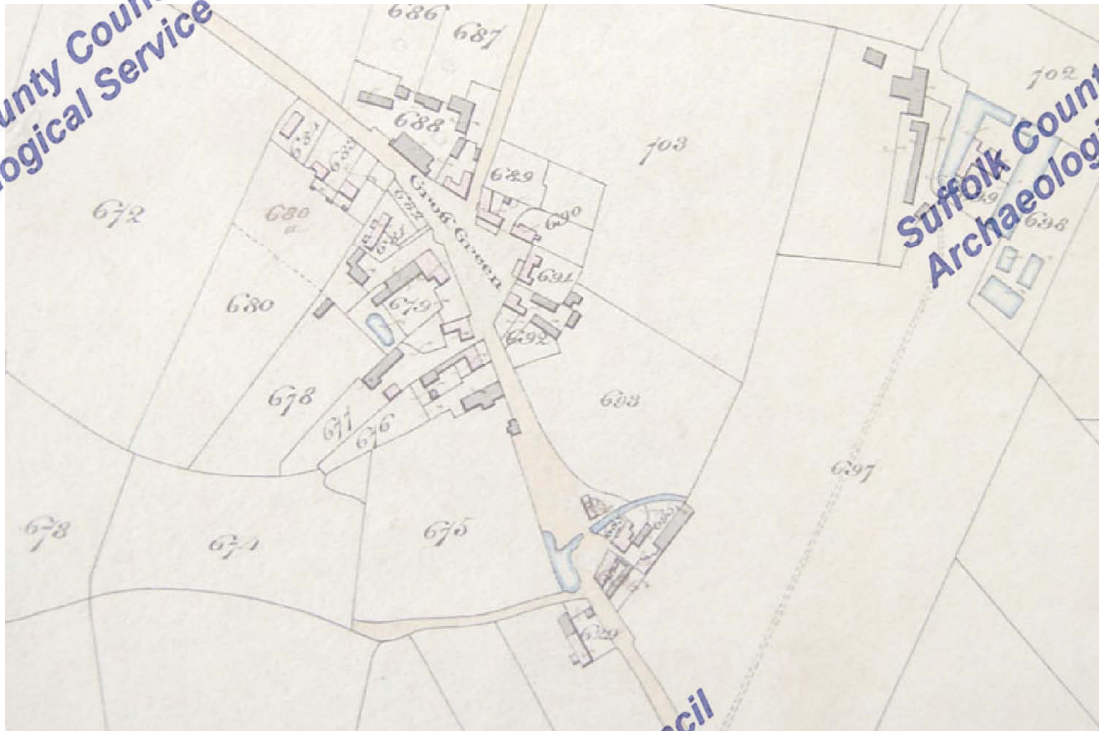
Figure 2

Cross Green as shown on the Cockfield tithe map of 1845 (SRO Bury branch) showing the moated site of Peppers Hall to the right with Picknotts bottom-centre (see detail below). The green consists of two triangles bounded on the south by Thatchers Restaurant and Picknotts, but the field boundaries suggest it originally formed a much larger triangle including the field to the north of Picknotts (693).

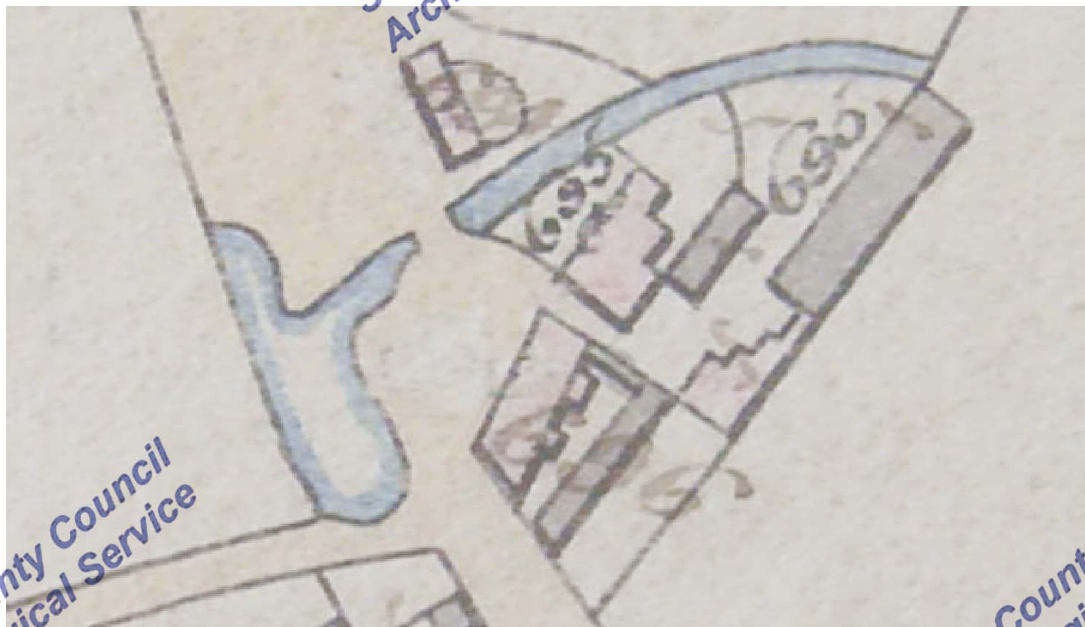
Figure 2a

Detail of 1845 tithe map

Picknotts is shown in pink to the right, with a large attached outbuilding to the north-east (695). A second house, now demolished, lies immediately to the west (695a), and the King's Head Public House (now the Thatchers) to the south-west (696). The small building on the green to the north-west is a cottage and blacksmith's shop (694).

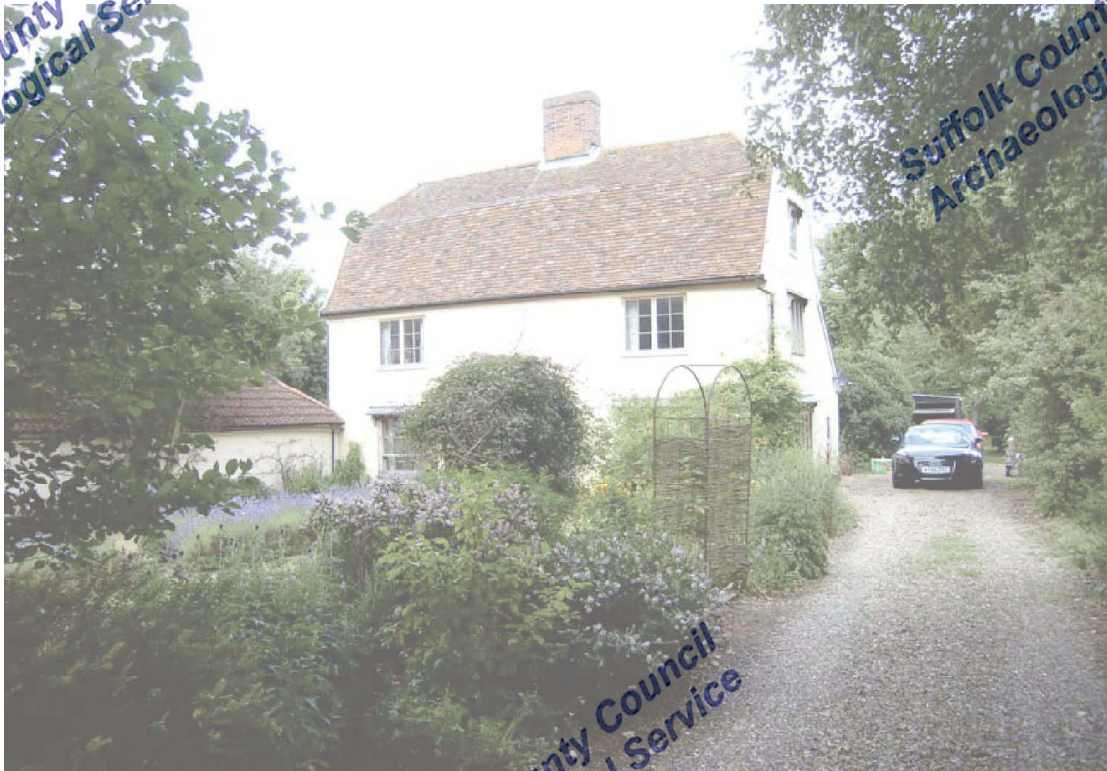
A2.1 Approach to site from south-west, showing the facade of Picknotts house with the barn in rear to right and the single storied shed belonging to the Thatchers to left

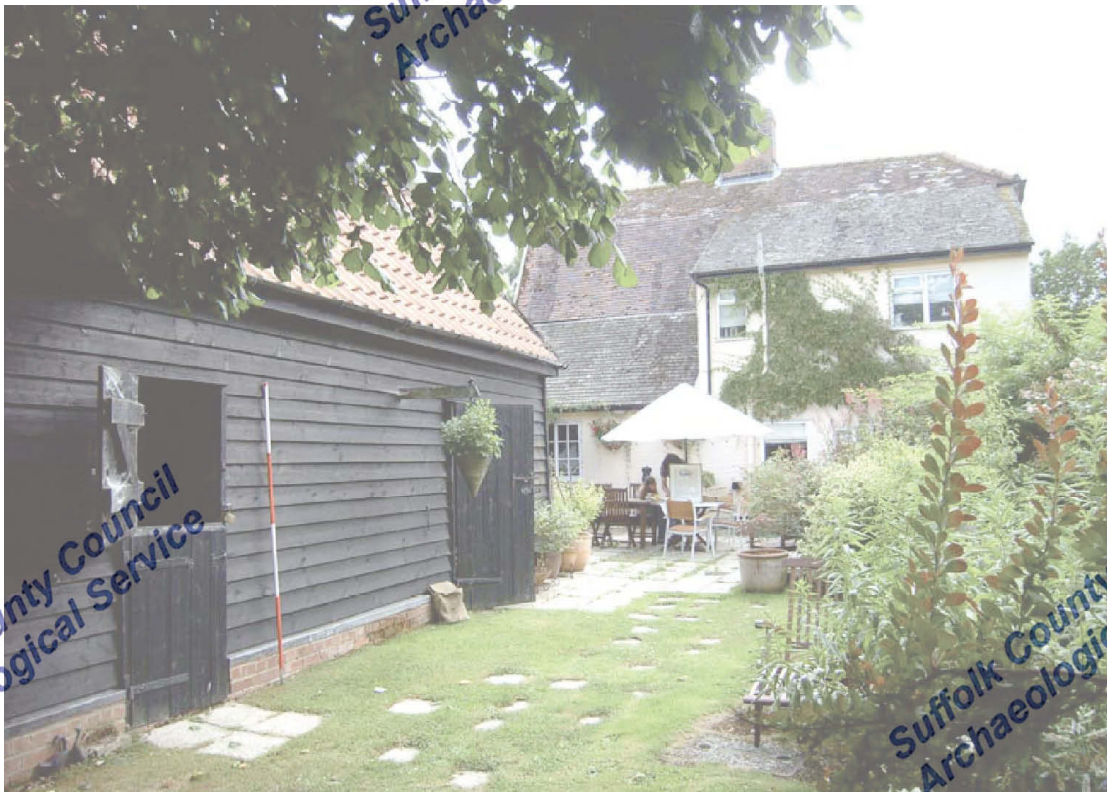
A2.2 Exterior of barn from north showing shed doors in western façade with rear elevation of house to right

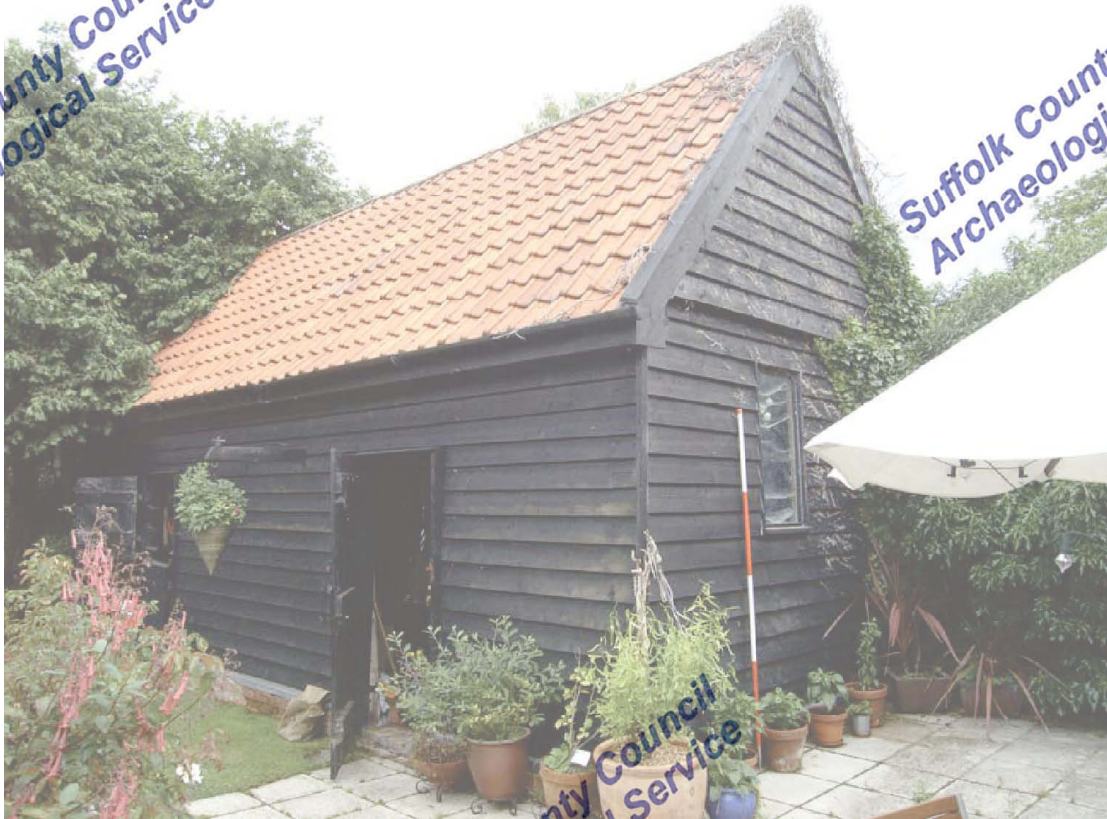
A2.3 Exterior of barn from west showing modern tiles and cladding with entrance to southern shed to right and northern shed to left

The structure has been extensively renovated in recent years (ostensibly within the last decade), with substantial areas of studwork renewed in softwood, new external weatherboarding and new pantiles. The lean-to garage against the south-eastern elevation is an addition of the late-20<sup>th</sup> century. The external door frames are modern, but probably occupy their original positions as tenons for earlier lintels survive alongside both (pegged in the case of the northern shed but not the southern). The present windows in the two gables and the south-eastern elevation (opening onto the garage) are also modern, and there is evidence of a removed collar-height ceiling in the southern shed (its whitewash does not extend to the apex of the roof). Although the present tiles are recent, the relatively low pitch of the rafters (at approximately 45 degrees) suggests they were designed for tile rather than thatch or slate – but possibly for peg-tiles rather than pantiles. It is not clear whether the exterior was weatherboarded from the outset or rendered, but given the original infill of the internal gable the latter is more likely – at least for the older northern shed.

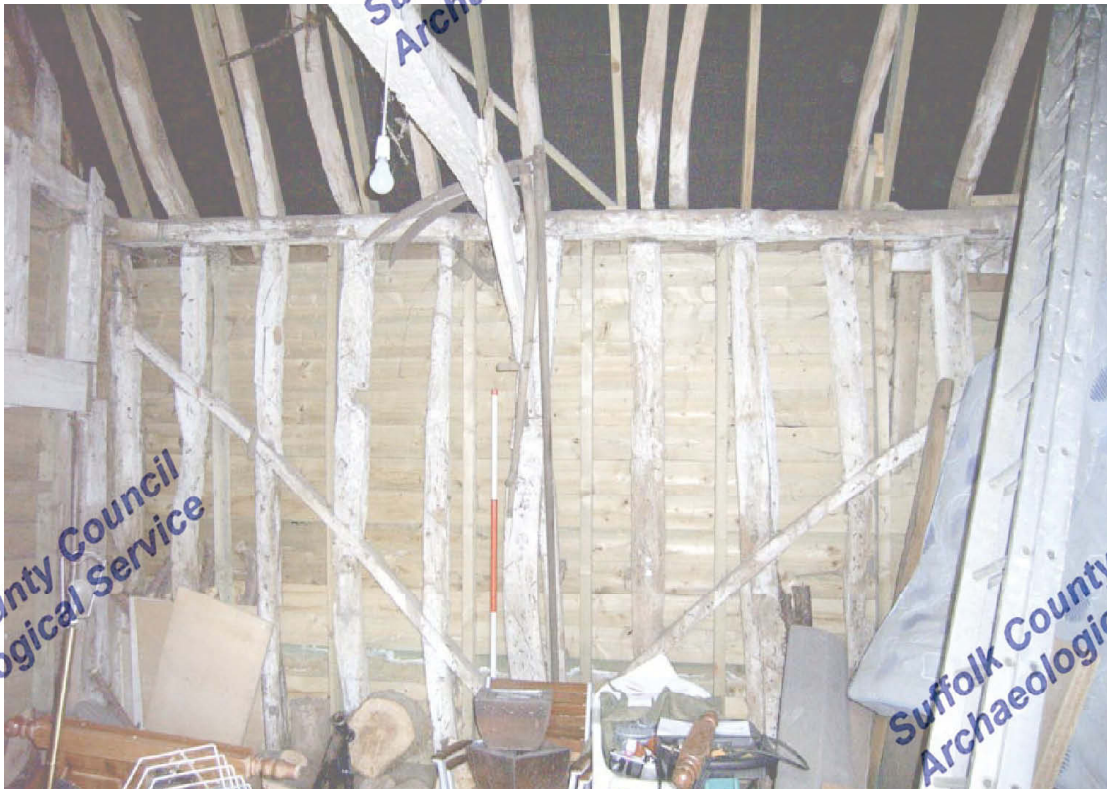
A2.4 Internal rear elevation of northern shed showing original studs and primary bracing with open truss in centre

The timber frame of both compartments consists of vertical studs interrupted by primary diagonal braces which are nailed rather than tenoned to the principal posts. The common studs vary in scantling, with evidence of re-use from an older frame, and are tenoned but not pegged and in some cases nailed to the roof-plates, sills and tie-beams. The original roof consists of clasped-purlins with nailed collars, but most of the existing rafters and collars are

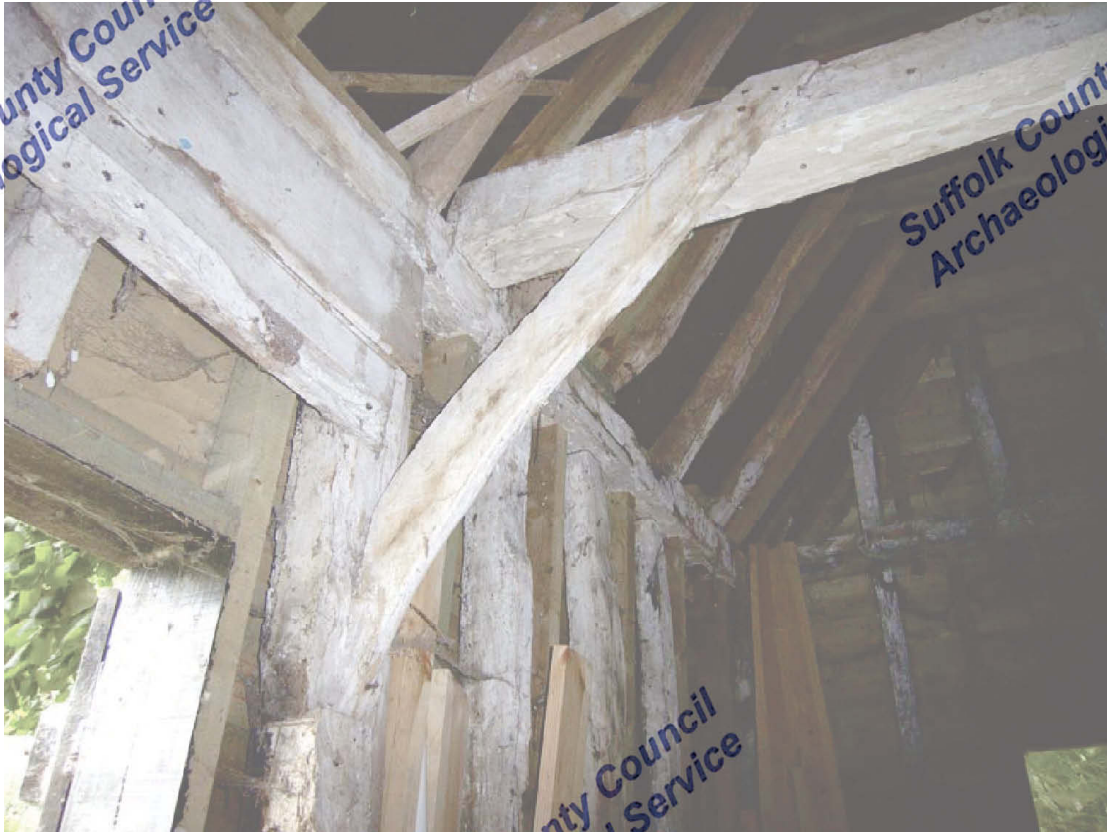
A2.5 Detail of from south of open truss in northern shed, showing tenoned and pegged junction with wall post and nailed attachment to tie-beam, with external door to left.

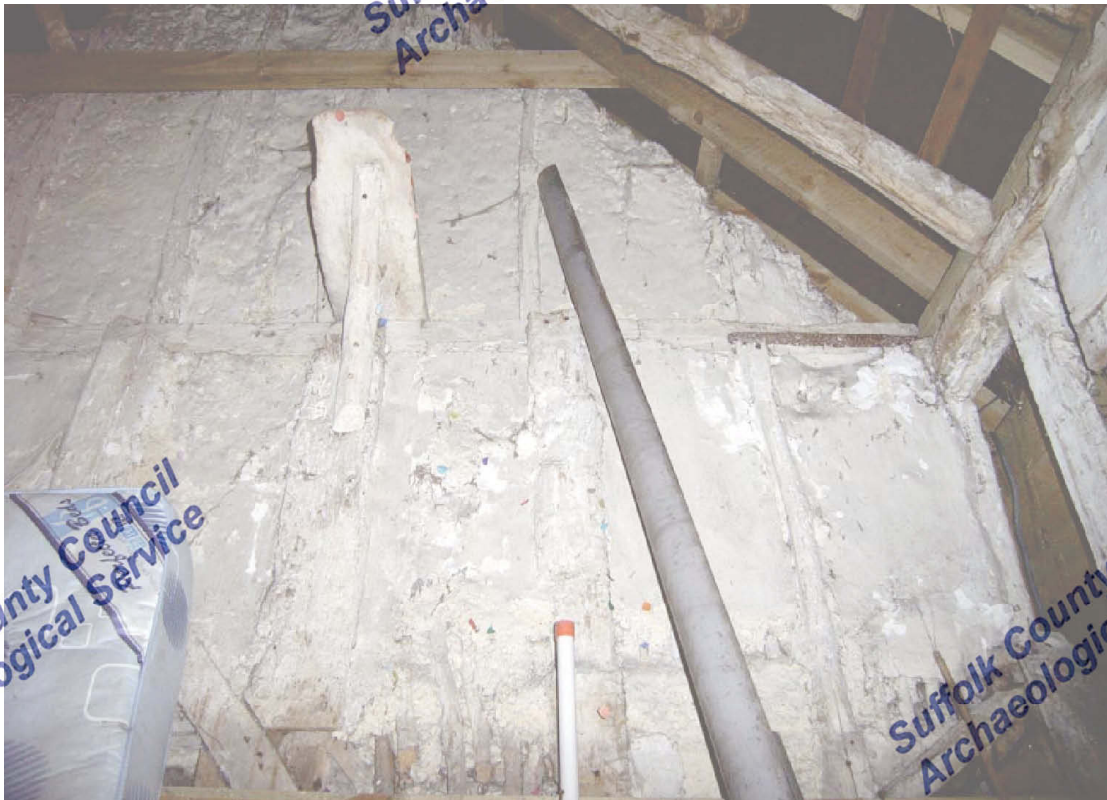
A2.6 Detail of internal partition from northern shed showing projecting hook with wattle-and-daub infill.

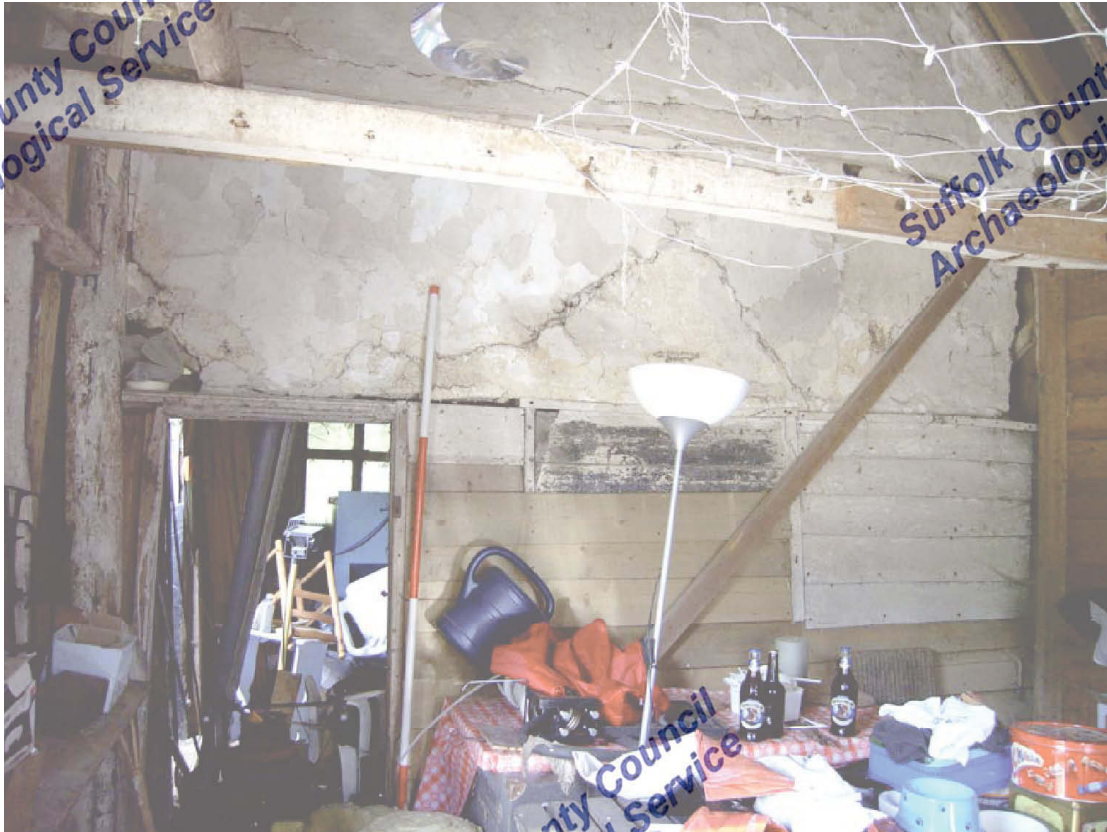
A2.7 Internal partition seen from southern shed showing blocked central window and connecting door to left

The two sheds were entered by separate doors from the north-west, as at present, and there is evidence of a large blocked window between the original gable of the northern shed and the door of the southern addition. There is no obvious evidence of an original window in the northern shed, however, but small windows or vents may have existed between its studs. There is no conclusive evidence of the original purpose of the two areas, but the two bentwood hooks which project from the southern gables of each shed are normally associated with stables (where they secured harness). The central lateral drain in the northern shed is also typical of stables, but other functions cannot be ruled out. The documentary evidence discussed above indicates that the remaining sheds formed only a small part of a much larger range of buildings and that semi-industrial activities occurred on the site; the small scale of the sheds is consistent with their interpretation as the stable mentioned in the insurance document of 1892 rather than the more expensive and therefore more substantial barn or the slaughterhouse with interconnecting butcher's shop – but the latter cannot be entirely ruled out.

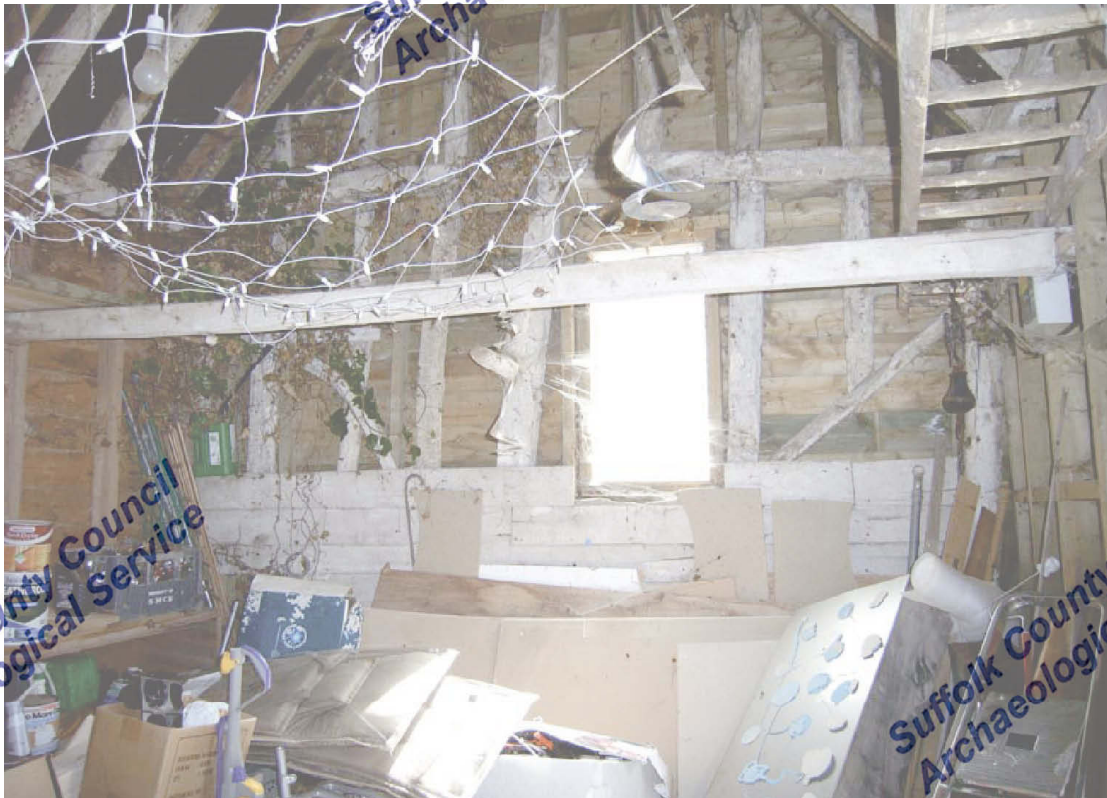
A2.8 Internal southern gable showing original studwork with primary bracing and bentwood hook to left of modern window
