**The Outbuildings,
'Redwood',
Earl Soham, Suffolk
ESO 014**

Historic Building Record

The Outbuildings, 'Redwood', Earl Soham, Suffolk

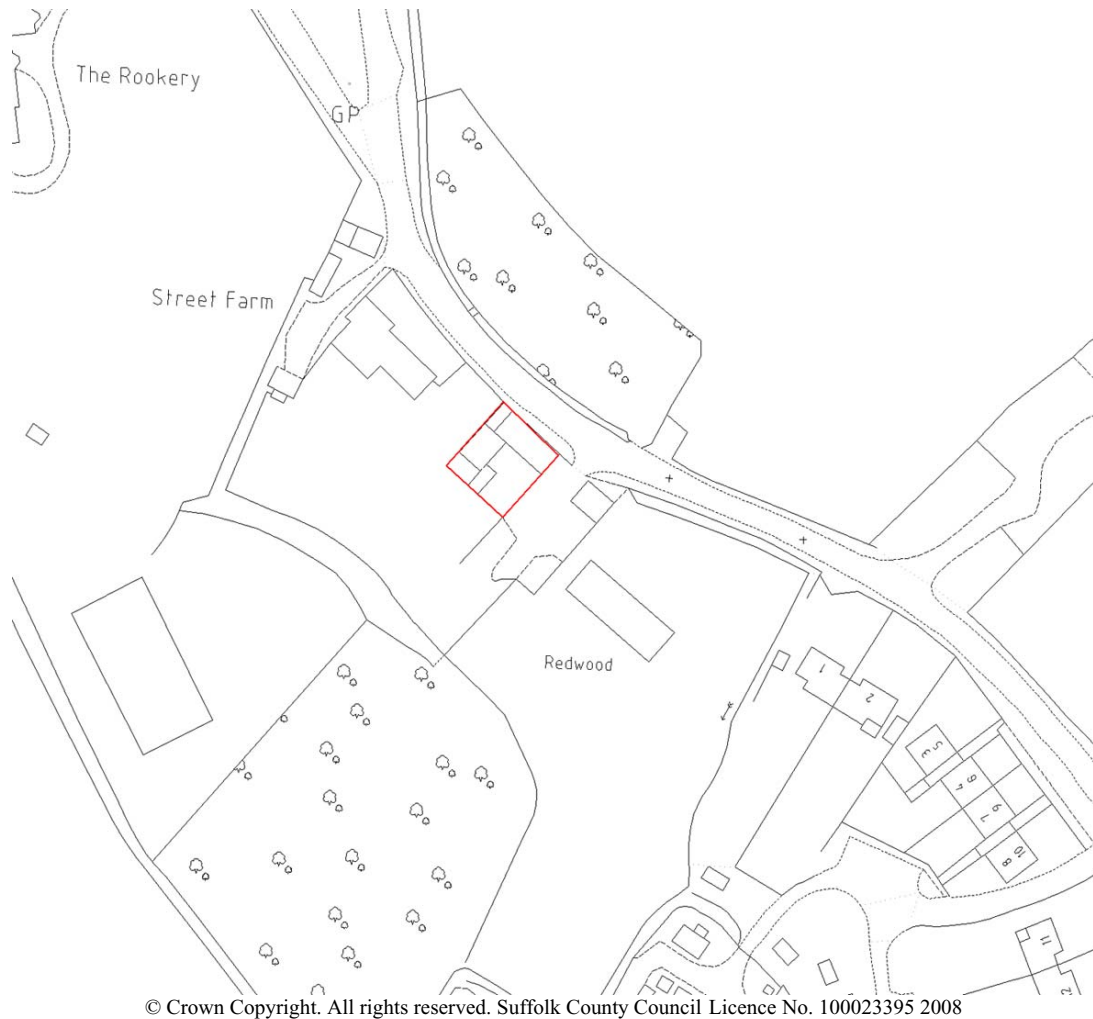
Figure 1
Existing Ordnance Survey Site Plan
Outlining the complex of agricultural buildings in red, and showing the Brandeston Road to the north-east, Street Farm (to which the buildings originally belonged) to the north-west and the modern house ‘Redwood’ to the south-east. The fork of Fair Green is shown to the north.

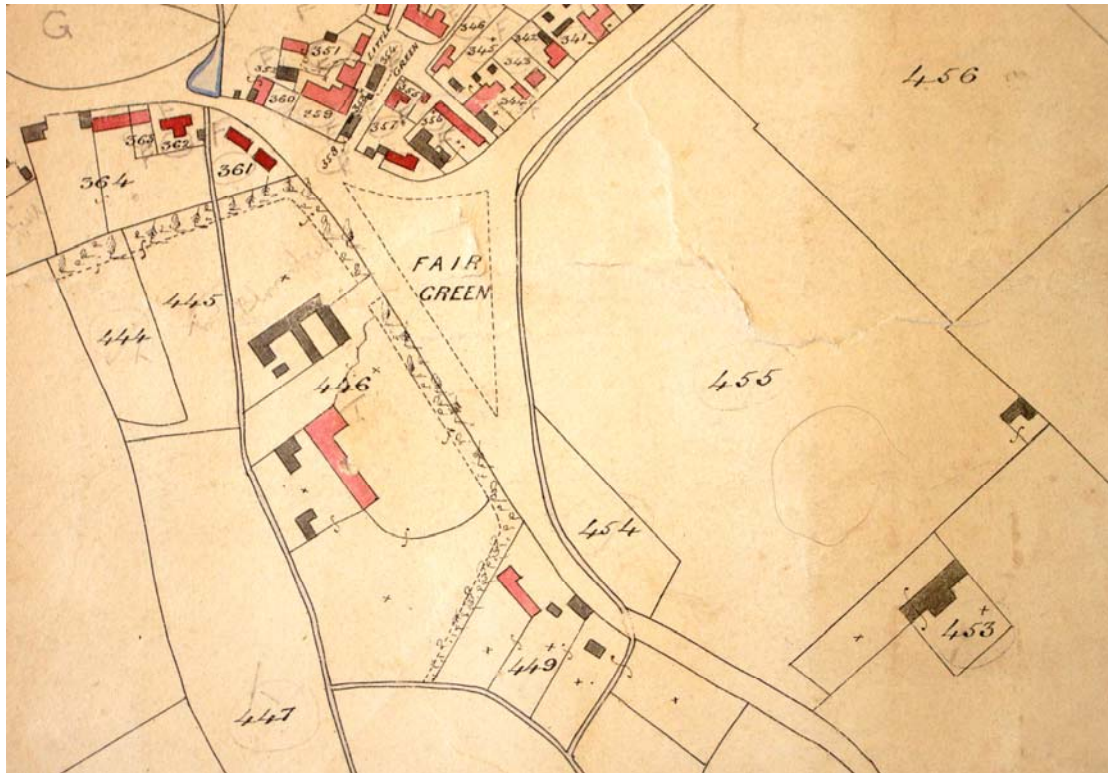
Figure 2.
Earl Soham Tithe Map of 1840 (SRO Ipswich branch)
Street Farm is shown at the southern tip of Fair Green with the main village to the north
and its barn (453) on the opposite side of the Brandeston Road to the right.

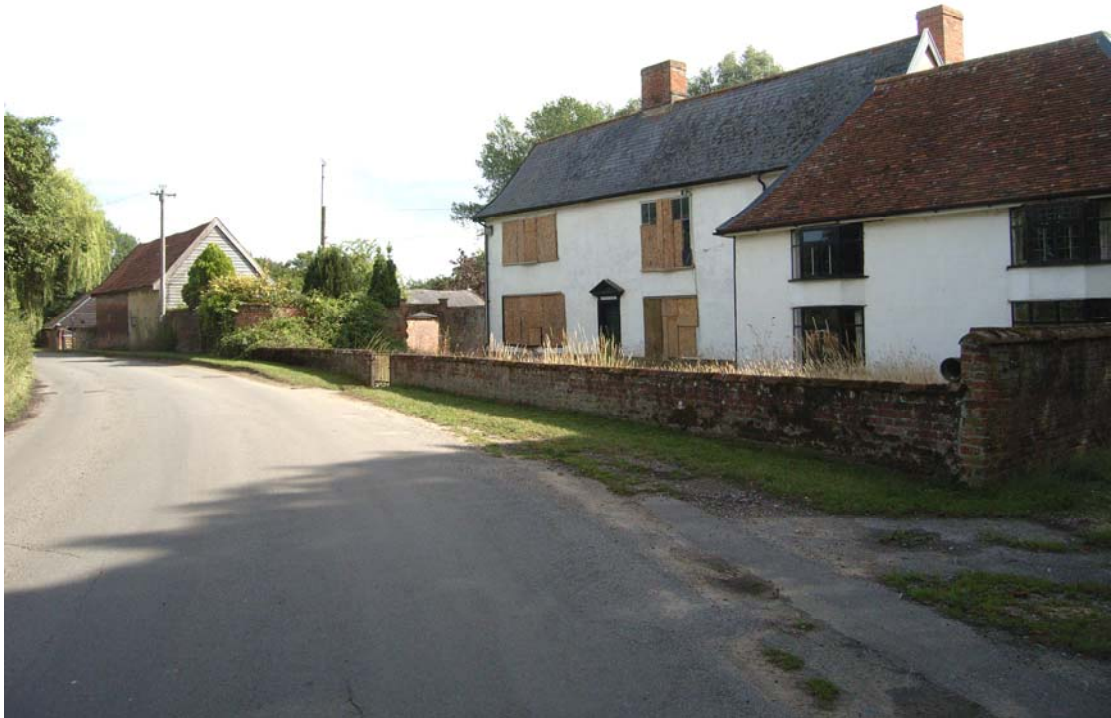
A2.1 General view of site from Brandeston Road to north showing Street Farmhouse on right & roadside stable in rear to left

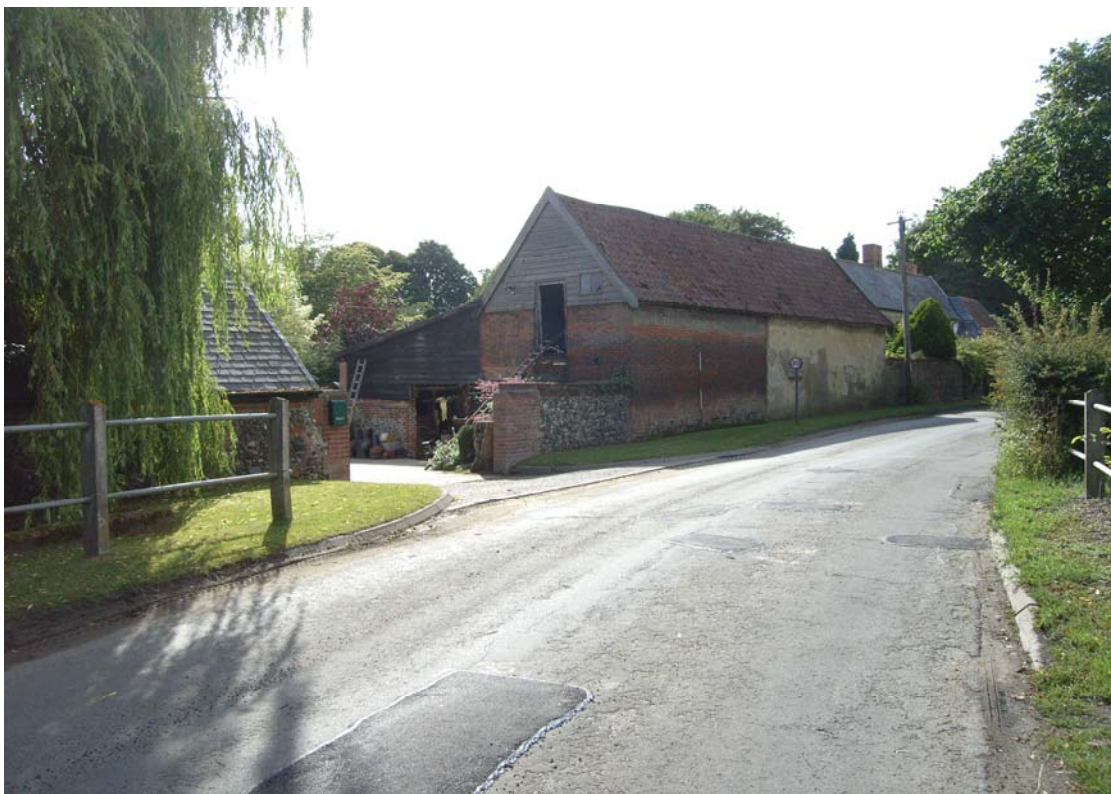
A2.2 General view of site from east showing site entrance to left and stable to right to left

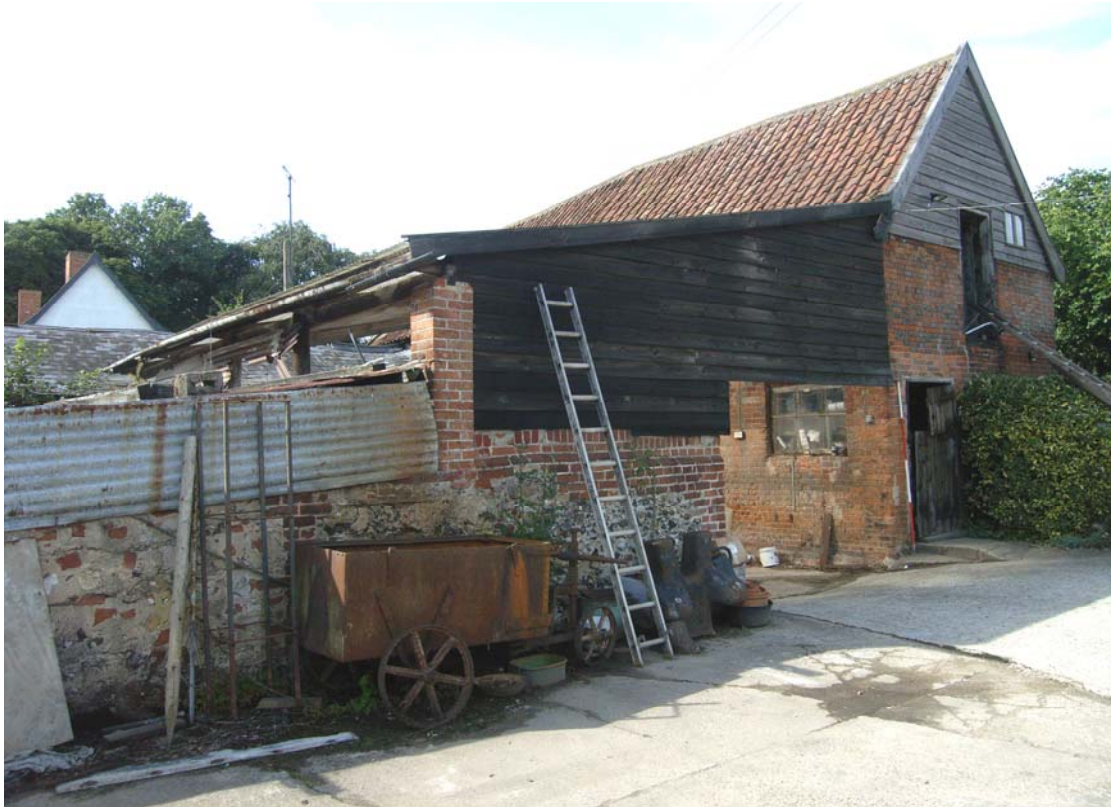
A2.3 External elevation of yard wall and 20th century shelter (5) from south showing gable door to first-floor granary to right (with modern ladder access)

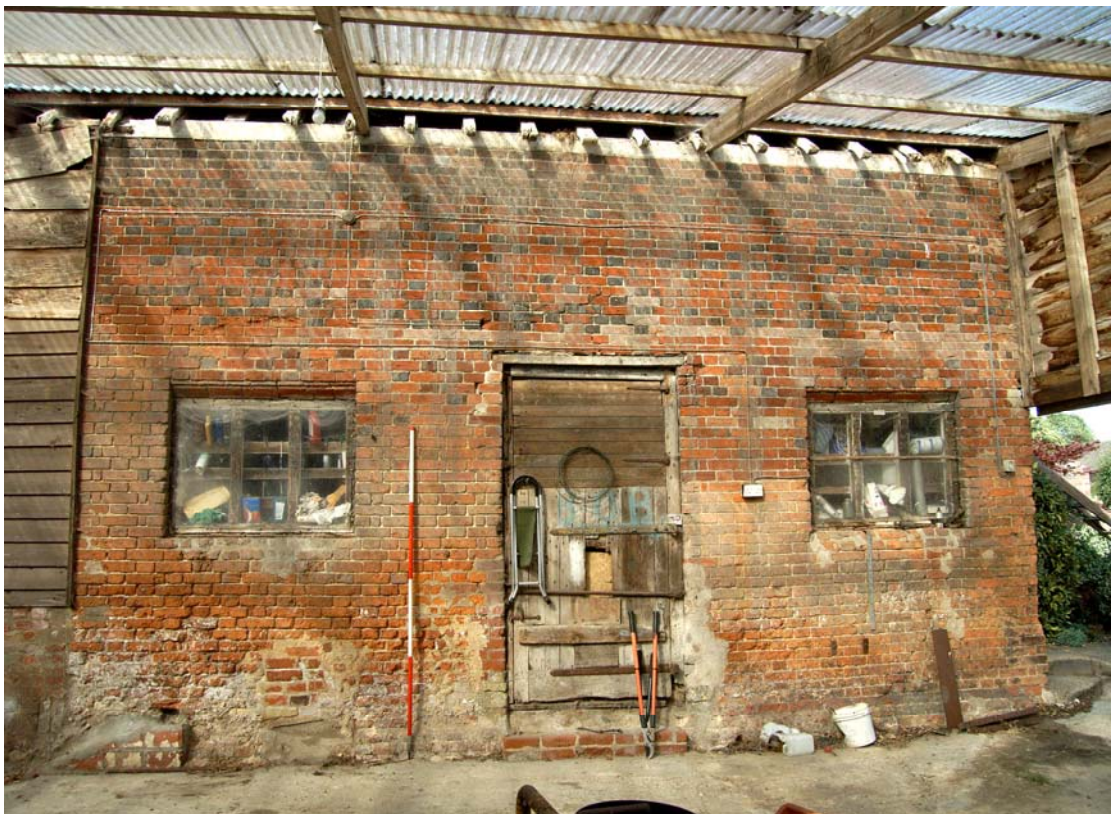
A2.4 External south-western facade of brick stable (1) from covered yard showing original door and windows

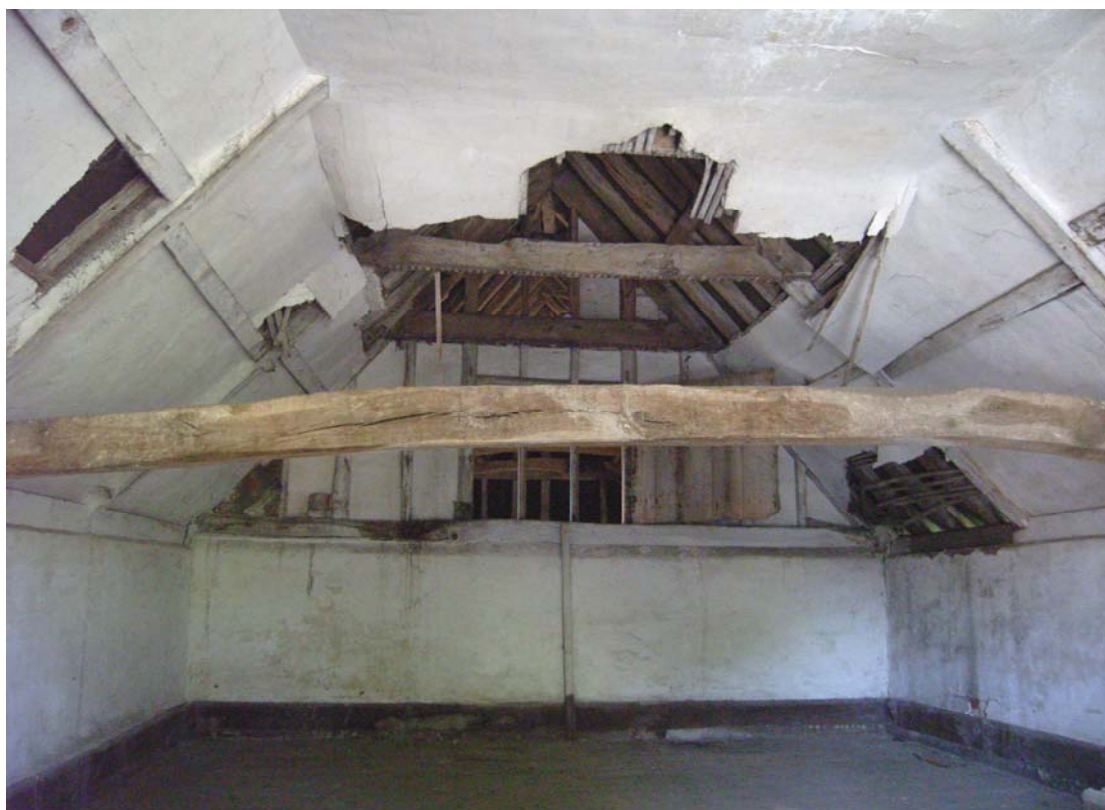
A2.5 Interior of granary with original plaster ceiling above brick stable (1) seen from south-eastern entrance.

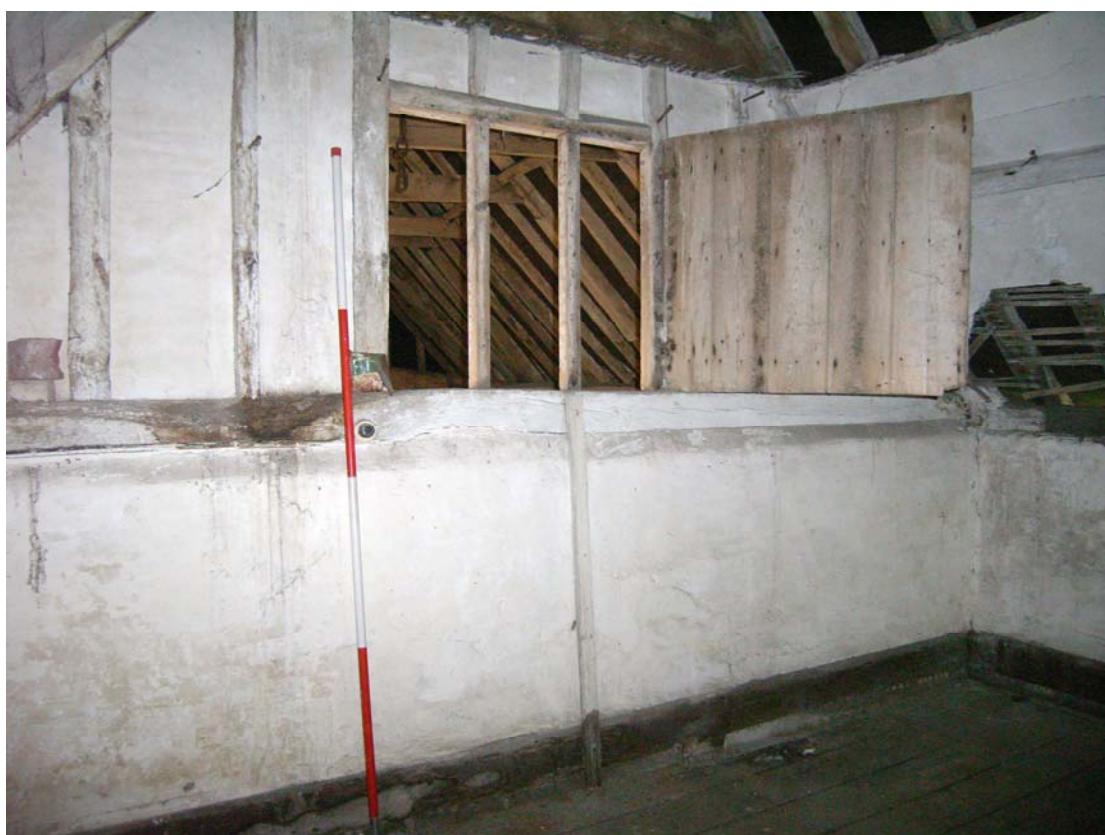
A2.6 Internal north-western gable of first-floor granary (1) showing original window & hinged internal shutter

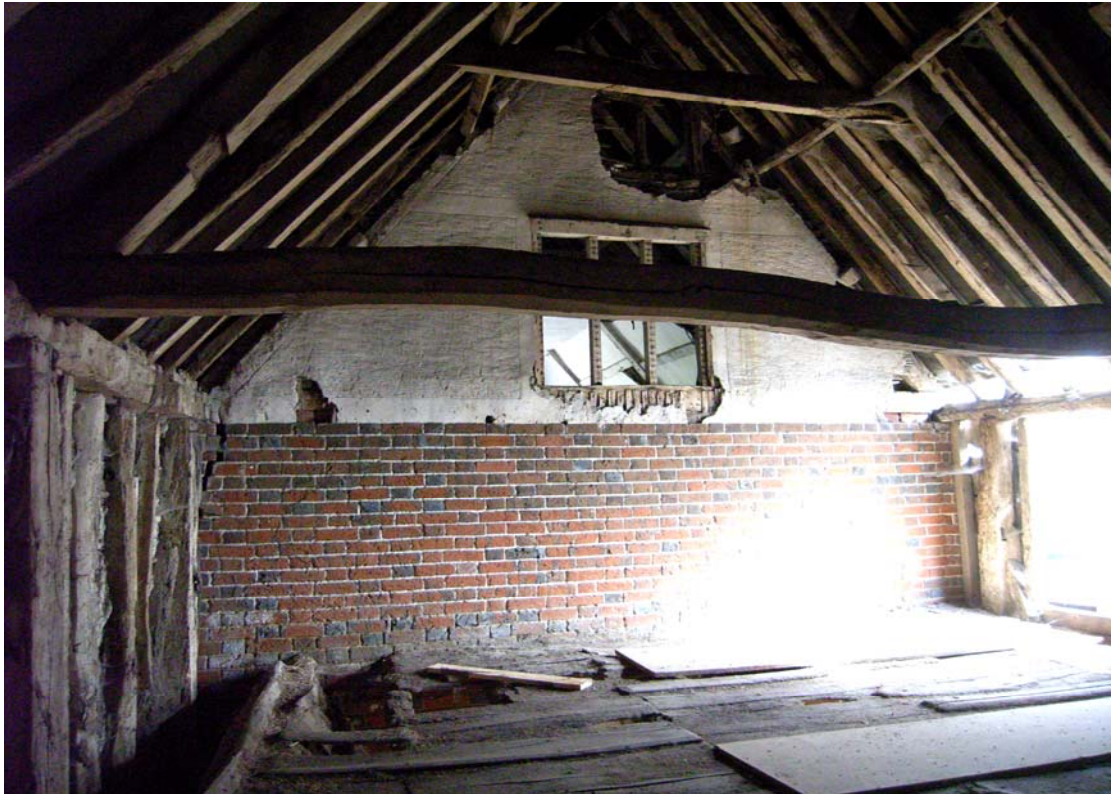
A2.7 North-western external gable of brick stable & granary (1) seen from roof of later stable (2), showing original pargeted but unpainted lime plaster above brickwork. The remains of the hay rack and loading vent in the loft floor are visible to bottom left

The brick stable and granary of *circa* 1800 in the north-eastern corner of the yard is a particularly good example of its type, which survives largely intact despite the loss of its internal fittings. The well-preserved pargeting of its original north-western gable, facing the farmhouse, is a rare survival of considerable historic significance. Protected by the construction of the adjacent timber stable within a few decades it illustrates the predominantly white appearance of Suffolk's rendered buildings in the 18th and early-19th centuries, as depicted in the paintings of local artists such as Constable and Gainsborough. Despite this feature the building is not of sufficient age or rarity to meet the criteria for listing in its own right, although its conspicuous roadside location and local importance would certainly justify the retention of as much of its character as possible. The timber stable and brick shelter shed are typical of many built during the agricultural revolution of the mid-19th century and having been stripped of their original fittings they are not of special historic interest.

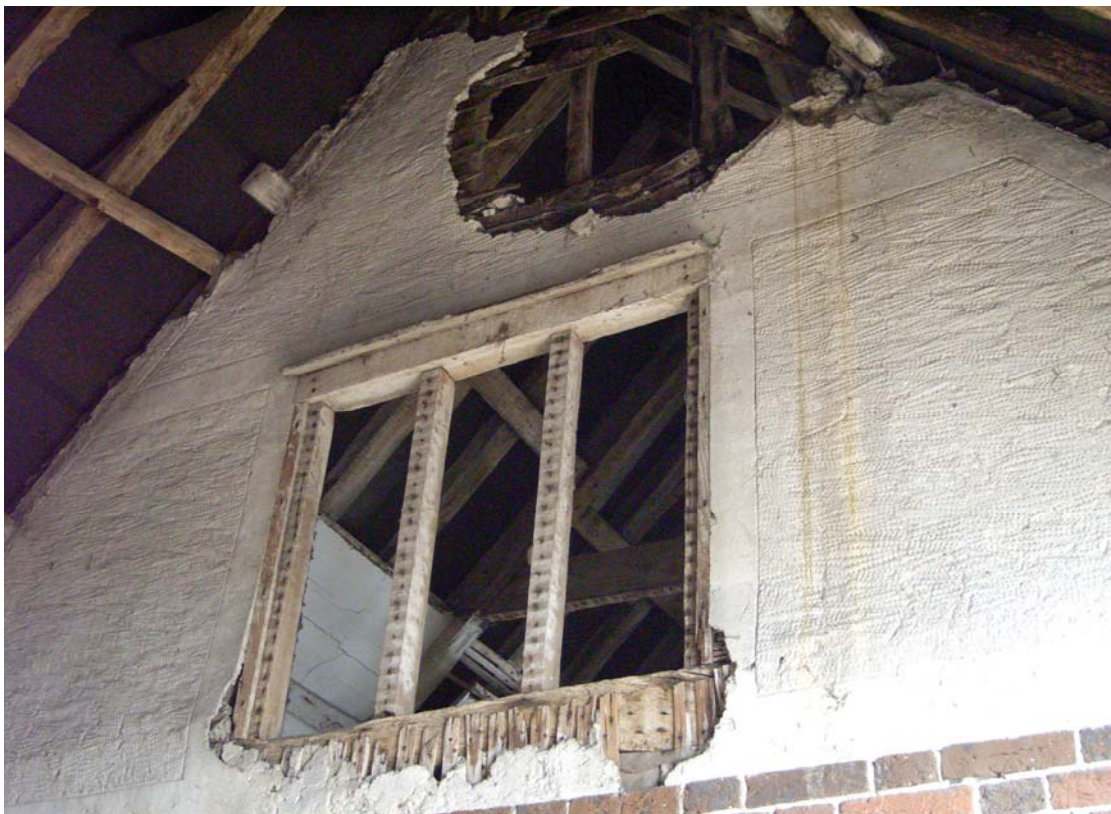
A2.8 Detail of window and pargeting to north-western gable of granary (1) from roof of later stable (2). The original window mullions contain nails for missing louver slats

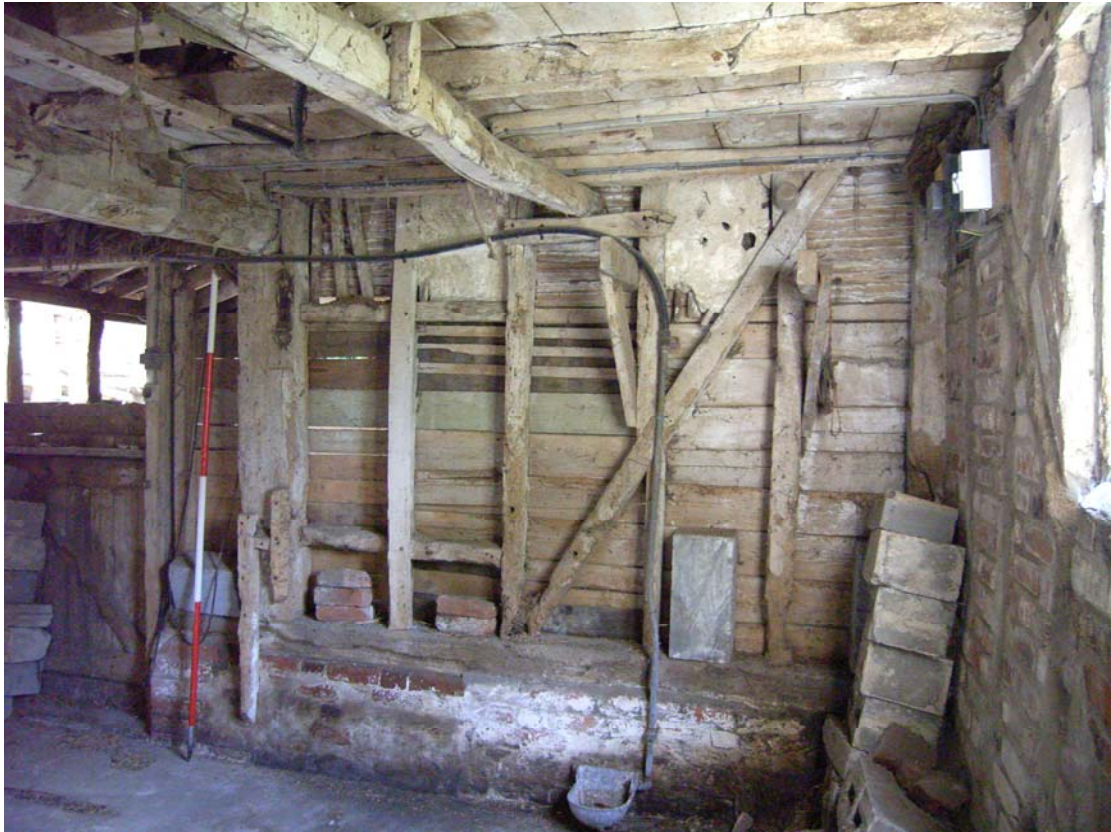
A2.9 Internal south-western elevation of stable (2) showing primary bracing of studwork and harness hooks to right.

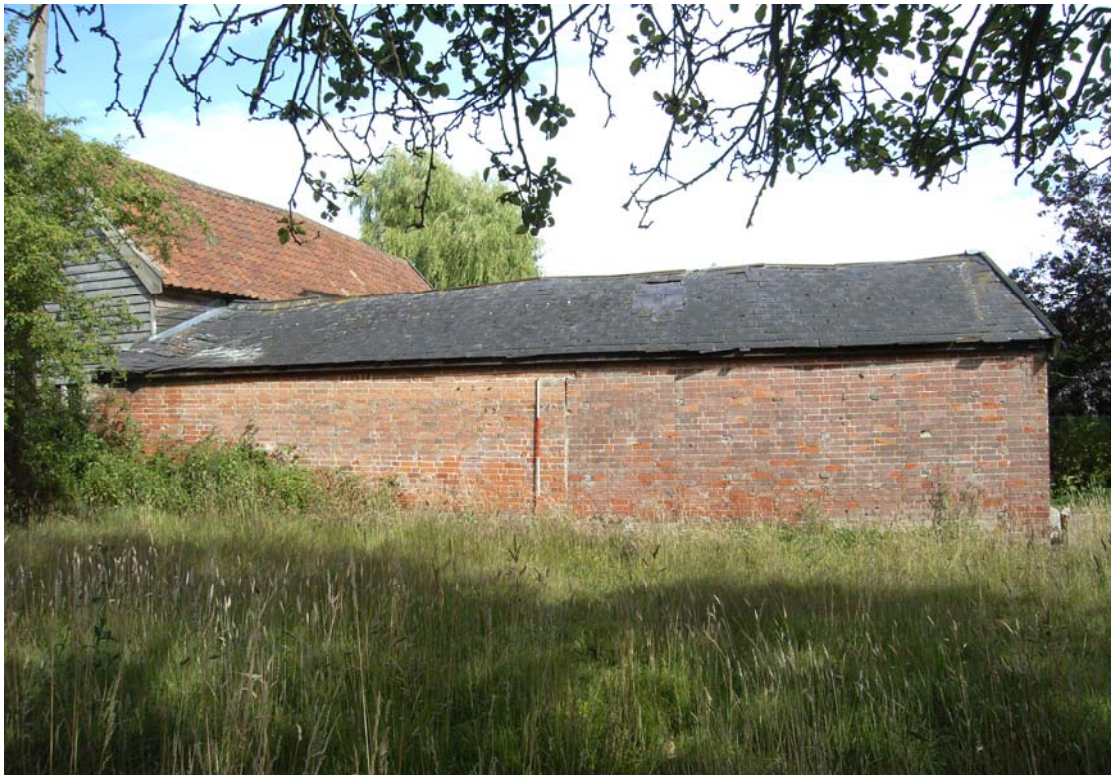
A2.10 External north-western elevation of the shelter shed and loose box (3 & 4) showing the north-western gable of the timber stable (2) left and the joint in the brickwork to the right of the scale rod

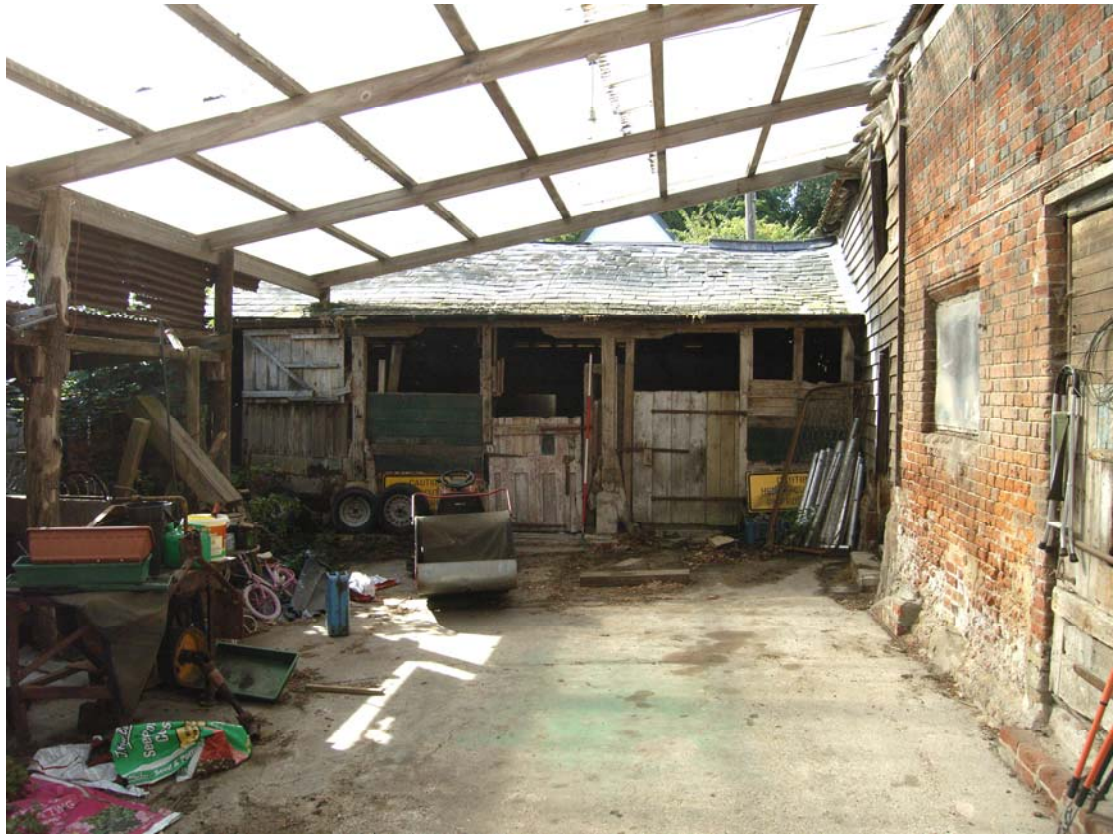
A2.11 Covered yard from south-east showing the open-sided shelter shed (3) with two original arcade posts and later loose-box doors in rear

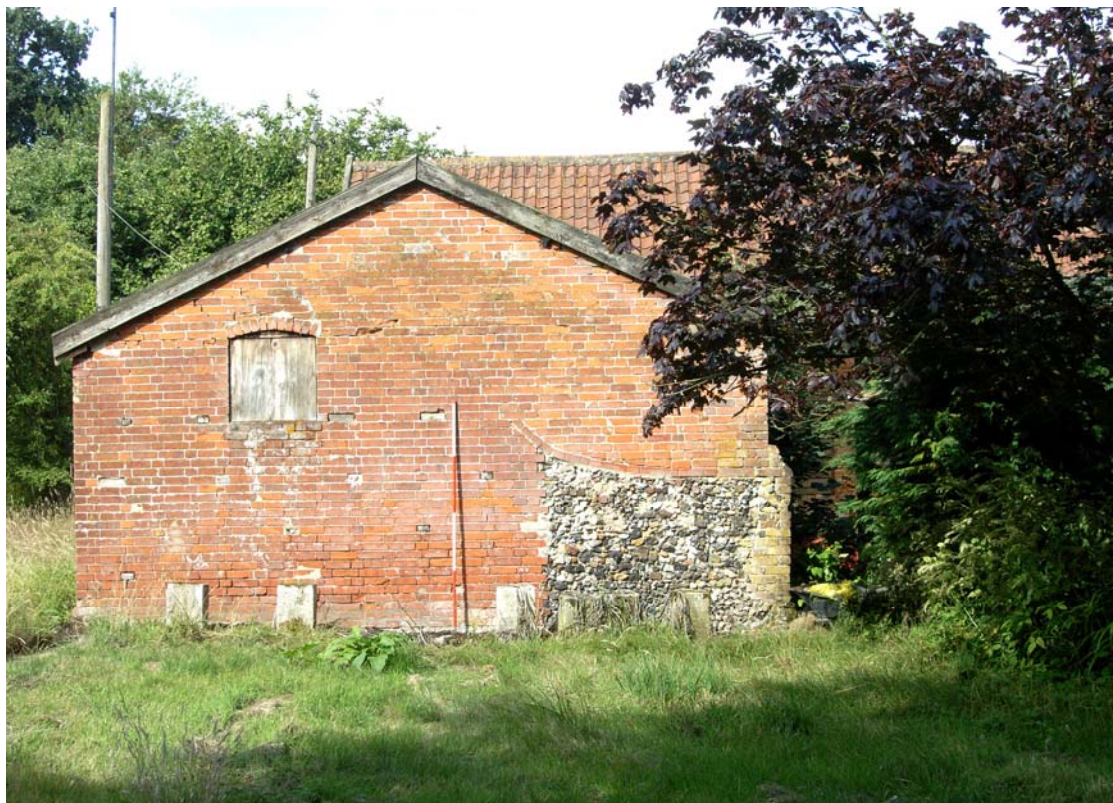
A2.12 South-western external gable of loose box (4) showing curve of earlier flint gable to right
