**Yew Tree Farm,
Laxfield,
Suffolk
LXD 058**

Historic Building Record

The Historic Farm Buildings, Yew Tree Farm, Station Road, Earl Soham, Suffolk

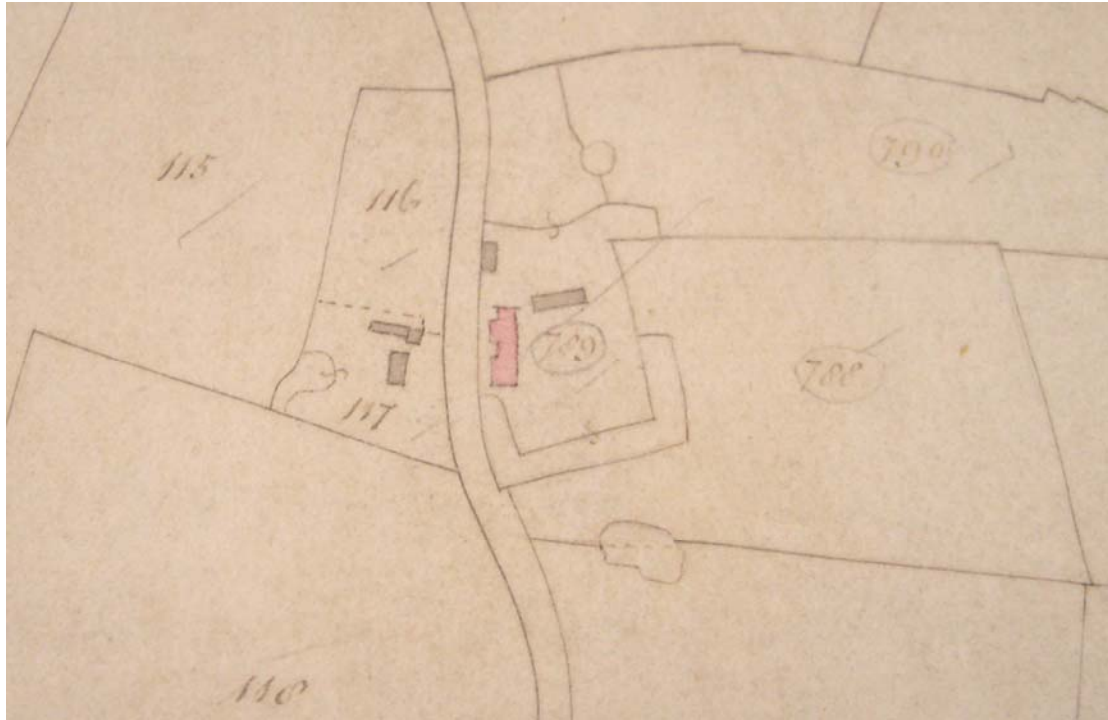
Figure 2

Laxfield Tithe Map of 1840, showing north to top-right (SRO Ipswich branch). The farmhouse is shown in red with the moat in much the same form as today. Two outbuildings lie to the north-west of the house, one of which occupies the approximate site of the existing western yard (A in figure 5), and another group lies on the opposite side of the road. The existing farm buildings had not yet been built.

At the time of the Laxfield tithe survey in 1840 the farm was a substantial tenanted holding of 169 acres owned by Robert Butcher and occupied by Robert Huson. All but approximately 40 acres of the land was arable (77%), and the rest pasture. The existing outline of the house is shown on the tithe map (figure 2 below), as is that of the moat, but the remaining farm buildings had not yet been built. The map shows instead a single large building behind the farmhouse (presumably a barn) with a smaller structure adjoining the road and a group of buildings alongside a pond on the opposite side of the road (their site now occupied by an area of concrete hard-standing).

The site of the house is named only as 'house and yards' on the 1840 tithe apportionment (no. 789 on the map), with 'Backhouse Meadow' (788) adjoining the moat to the rear and laid to pasture. The purpose of the farm buildings on the opposite side of the road (117), which are named as 'yards', is indicated by 'Neathouse Piece' (116) to the north-west and 'Great Neathouse Piece' (115) to the west (i.e. they probably included a cow-house, known locally as a neat-house).

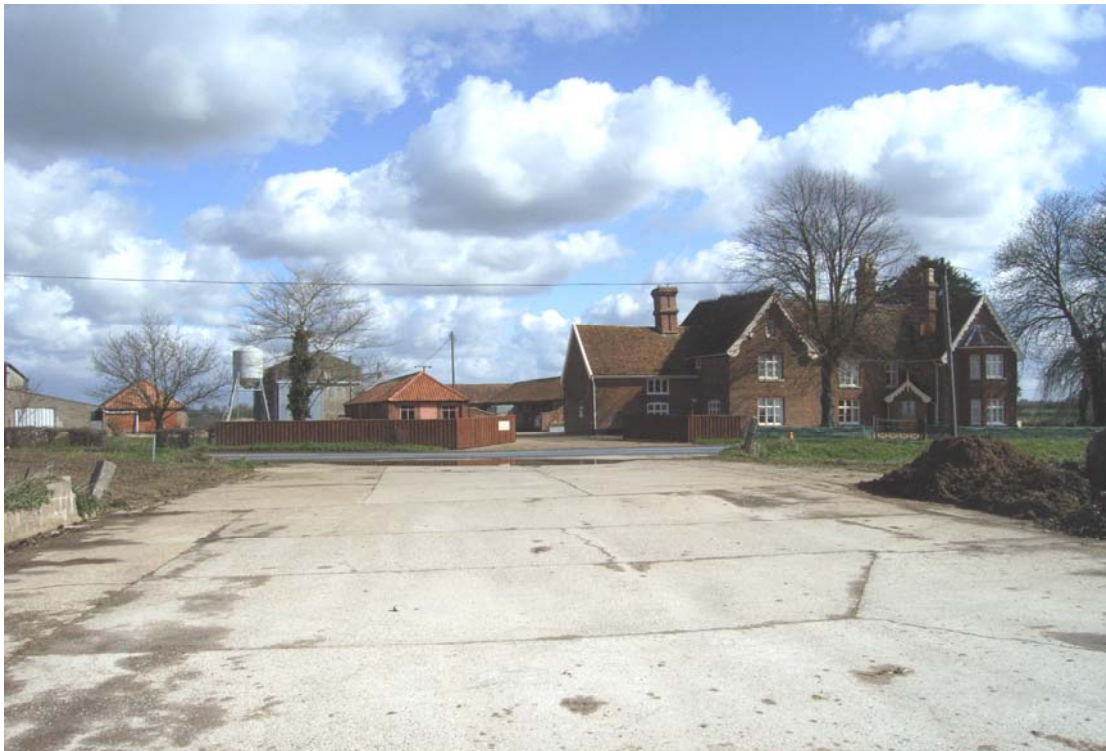
A2.1 General view from concrete hard-standing on site of demolished early-19th century farm buildings to south-west, showing listed farmhouse to right with yard complex in rear and detached former cartlodge to left

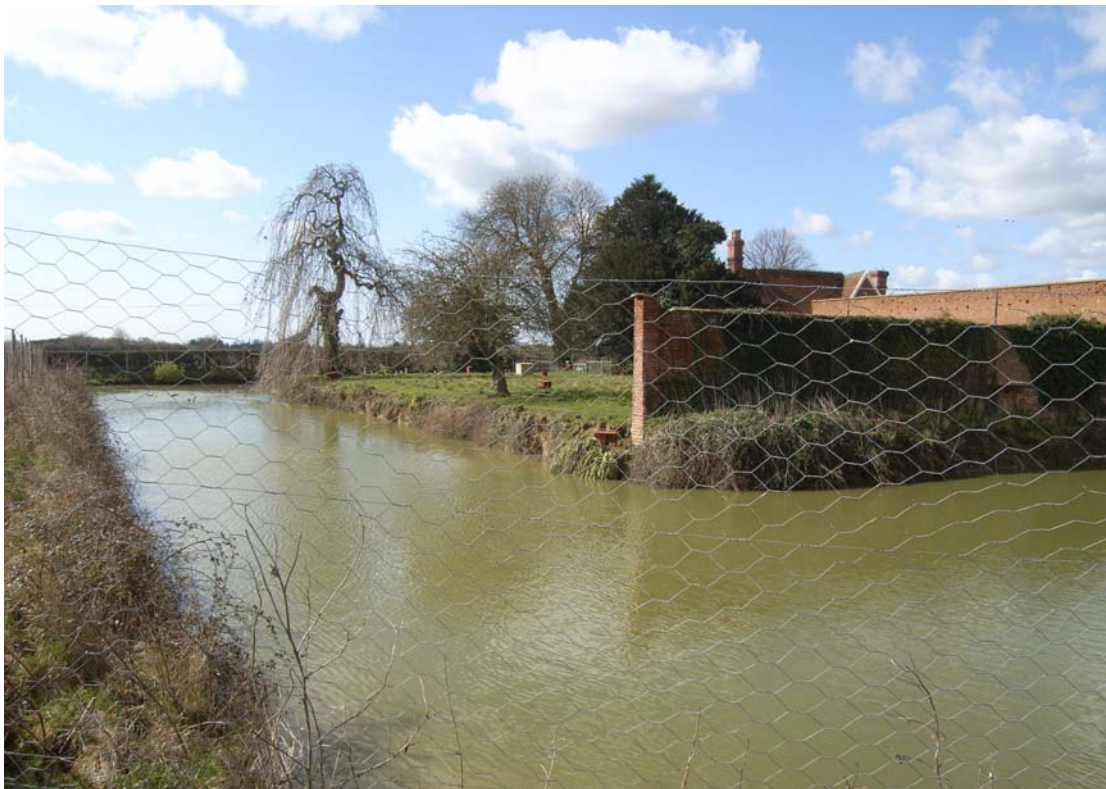
A2.2 General view from north-east across moat showing proximity of farmhouse in rear to left and high wall of eastern shelter shed (12) in rear to right

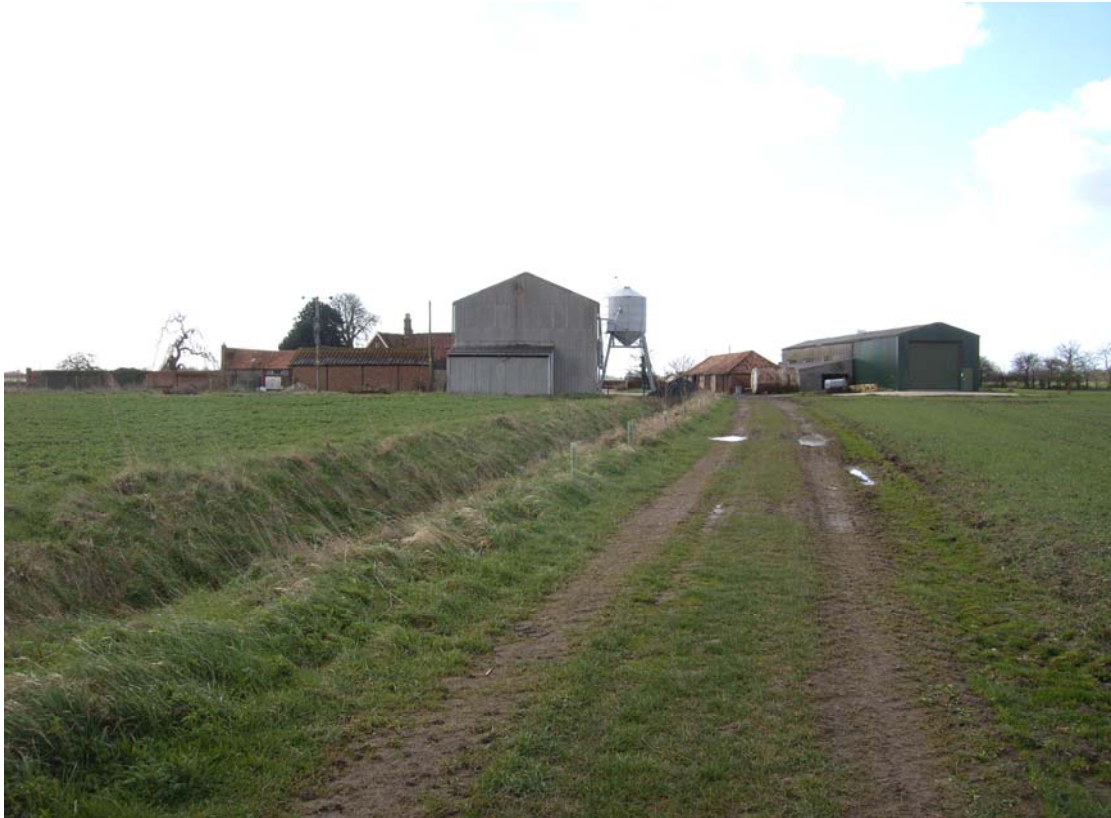
A2.3 General view of site from field to north-east showing modern sheds and silo in centre foreground with yard complex and farmhouse to left and detached cartlodge to right

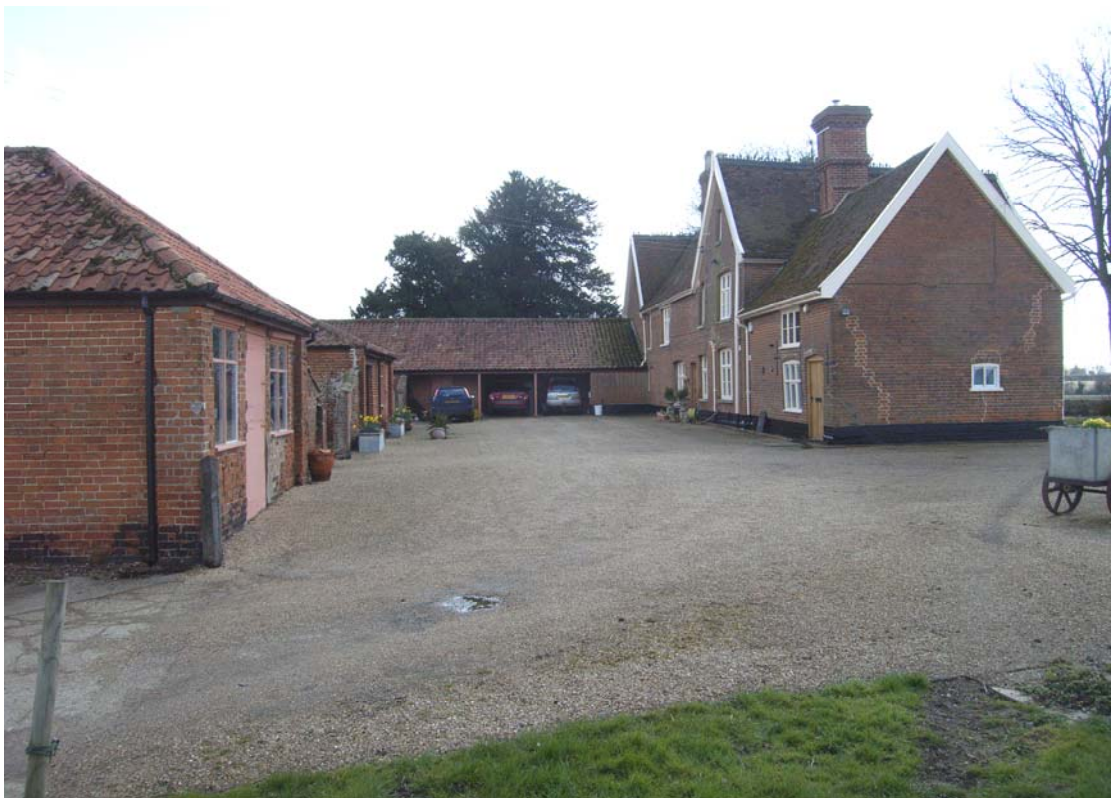
A2.4 Southern gables of yard sheds from west, showing proximity of farmhouse to right

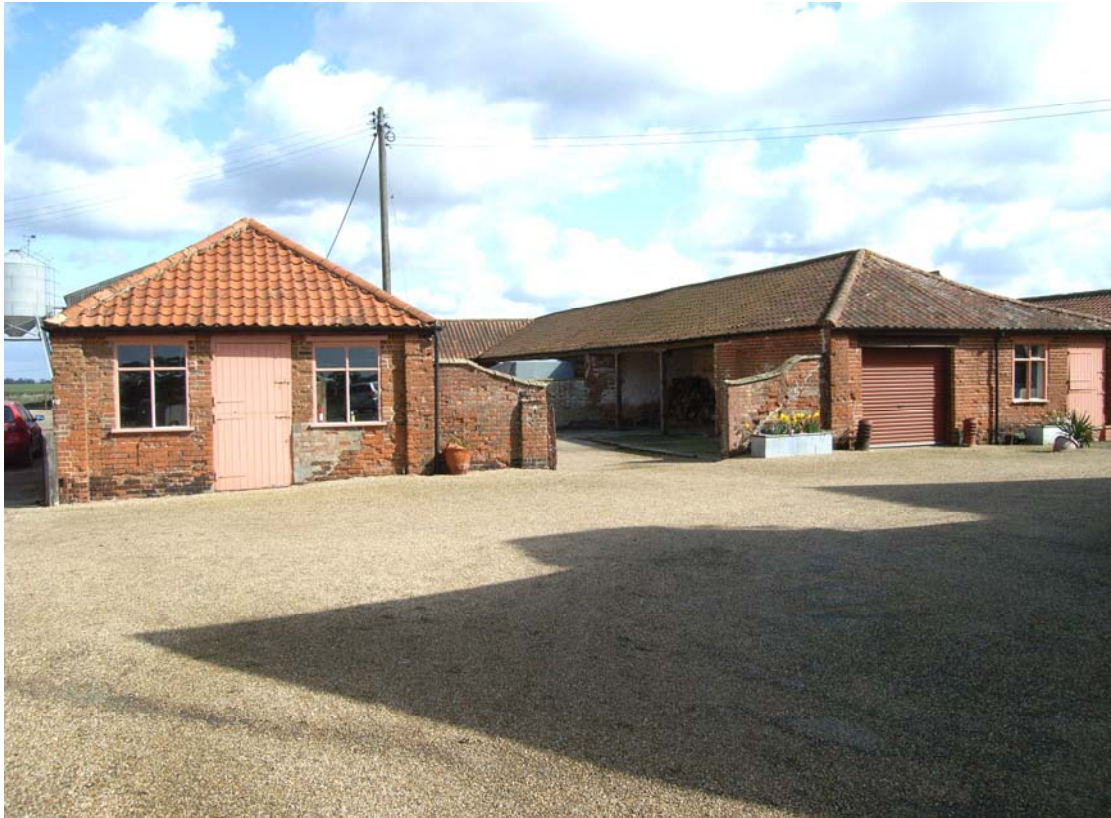
A2.5 Southern gables of yard ranges from south-east, with feed store (1) to left, central range to right and entrance to yard A in centre.

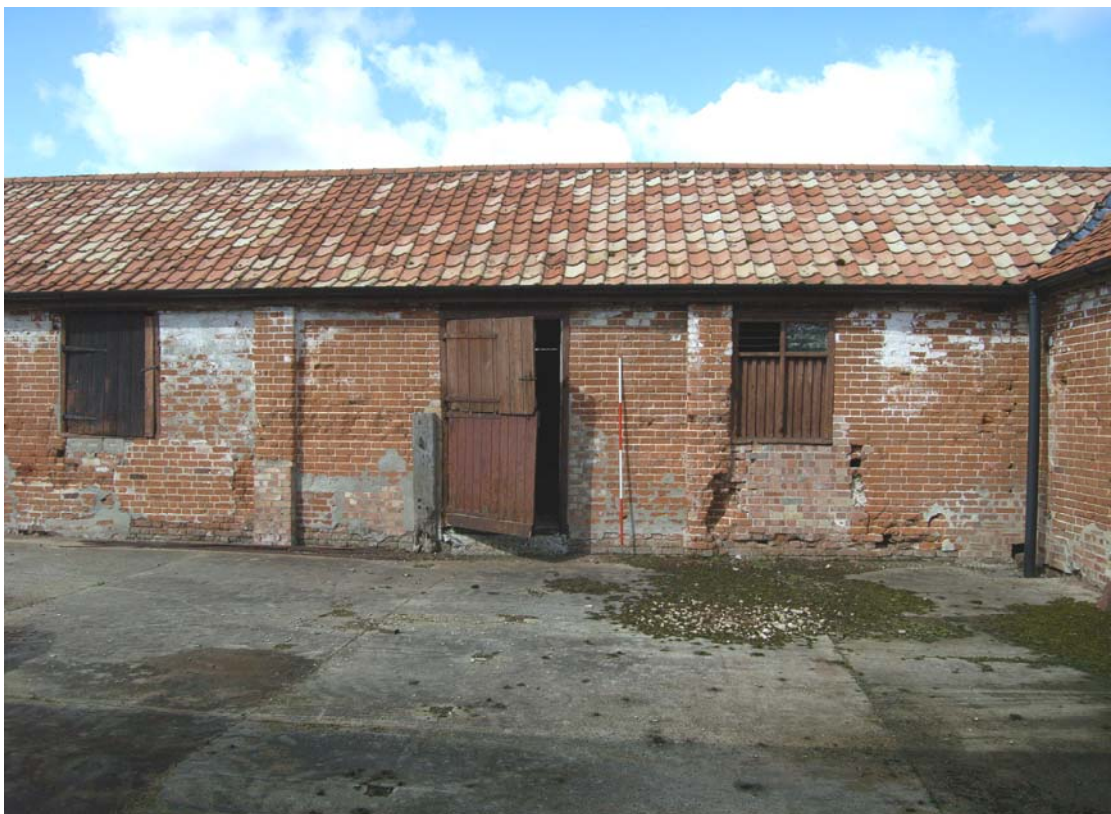
A2.6 North-western corner of yard A (right) showing the original doorway and window to shed 3

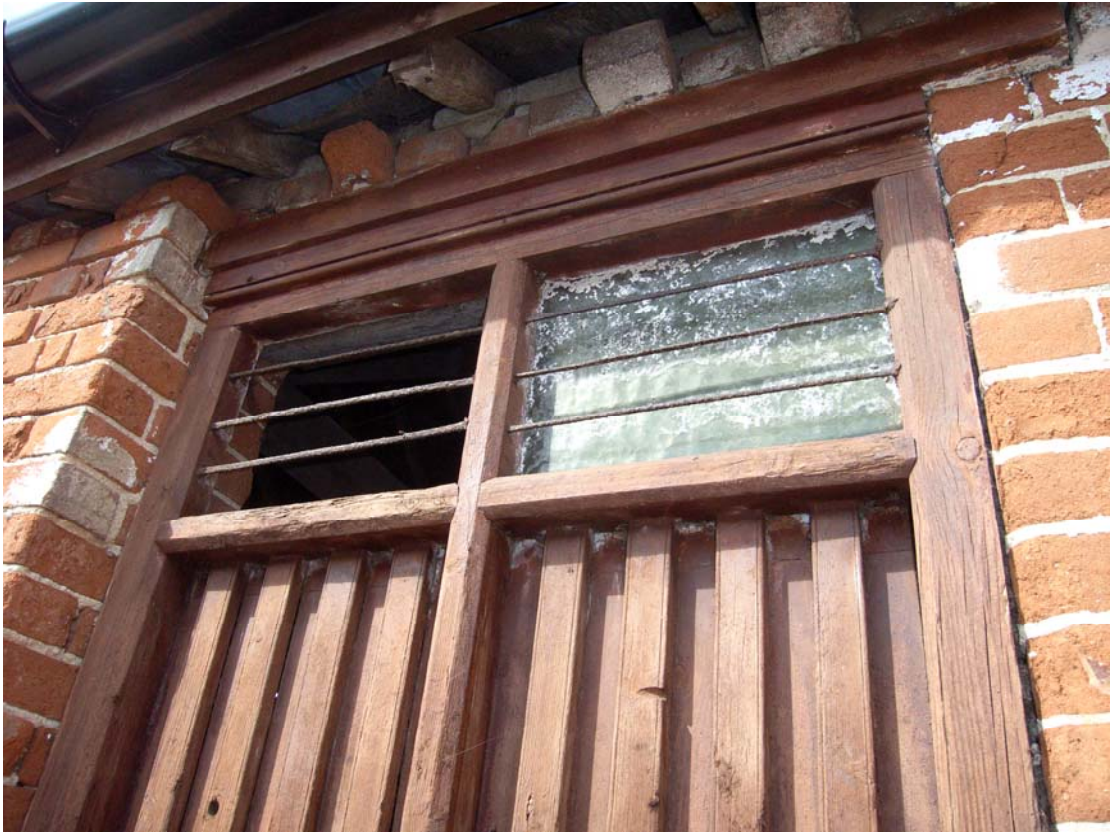
A2.7 External detail of original window to shed 3 from yard to east, showing glazed upper lights with vertical louver beneath

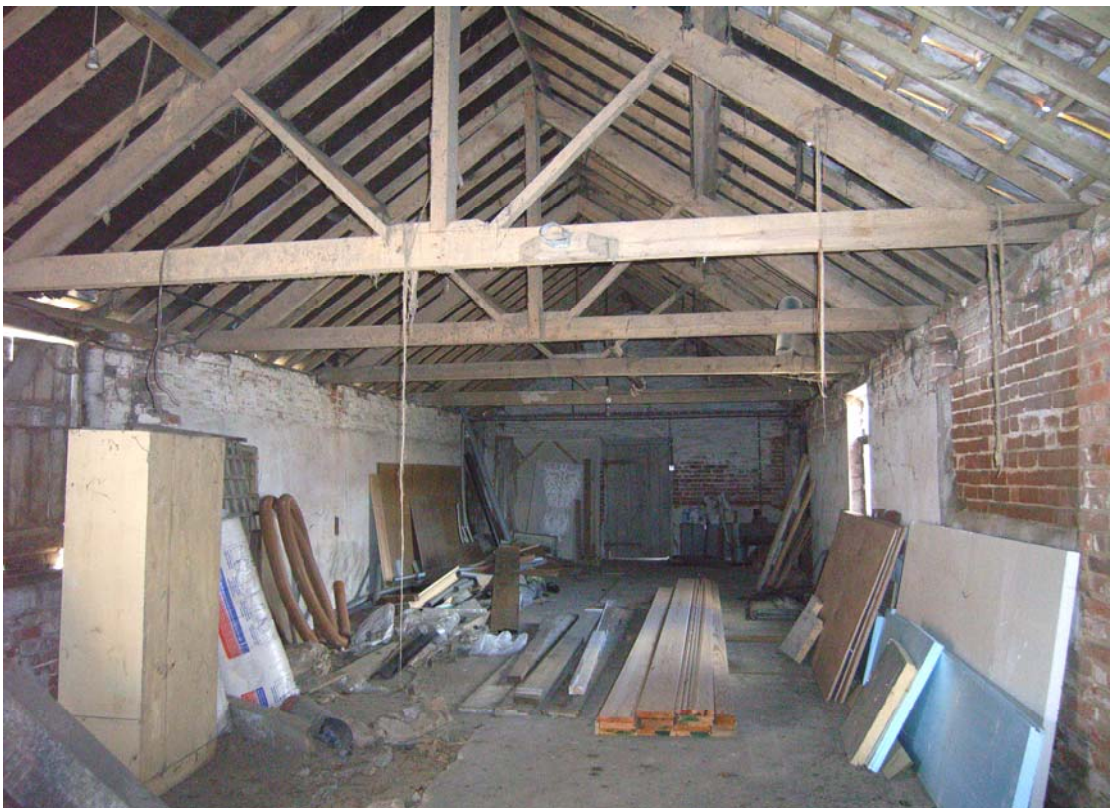
A2.8 Interior of shed 3 from north looking to shed 2 (the internal partition removed) and showing the central door to the feed store in rear

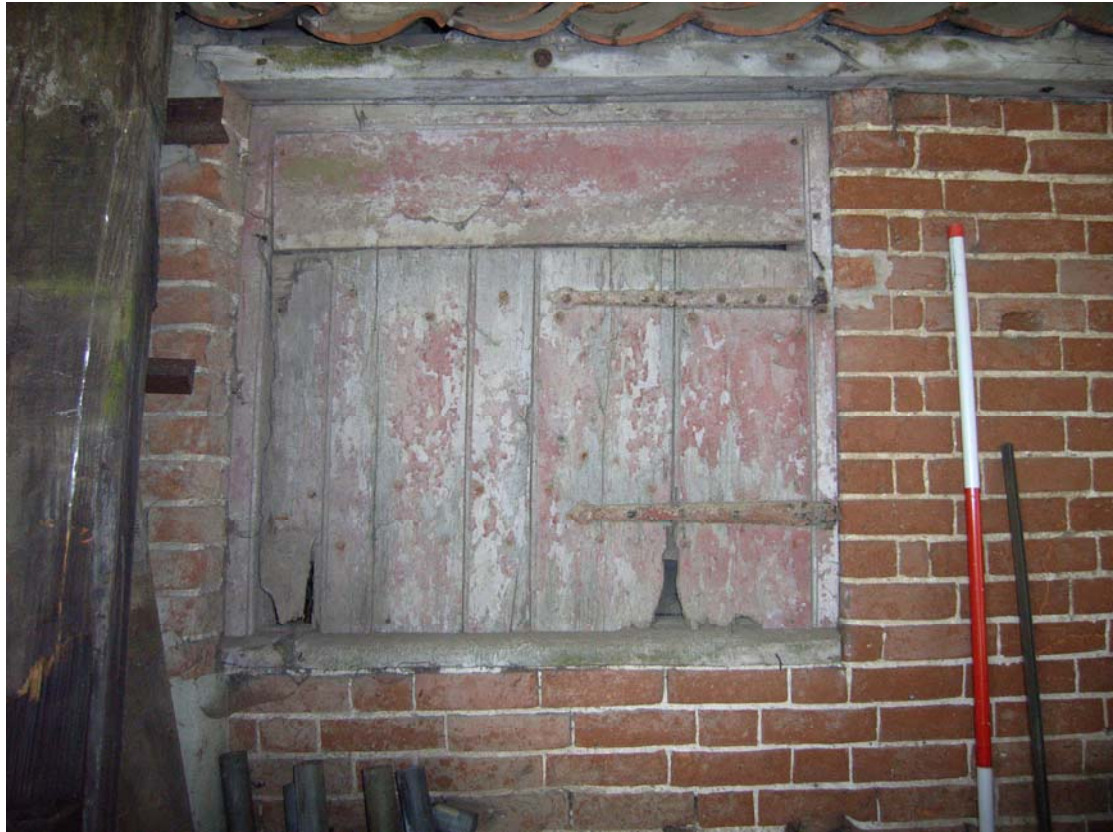
A2.9 Detail of reddled hatch in external northern elevation of shed 4 (within area of apparent horse mill shown on Ordnance Surveys).

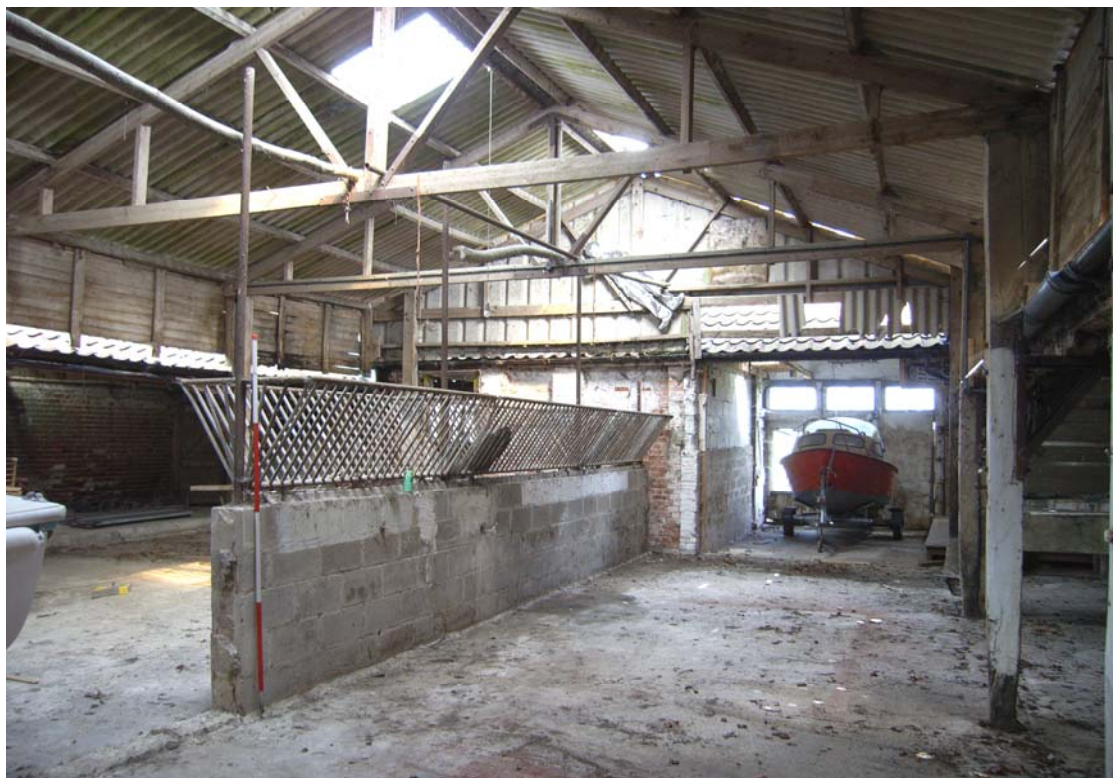
A2.10 Northern end of yard B beneath 20th century roof showing shelter shed 10 to left and shelter shed 12 to right (all posts renewed) with 20th century cattle hay rack in centre
