**The Limes,  
Wattisfield,  
Suffolk  
WSF 058**

**Historic Building Record**

# **‘Barn’ at The Limes, The Street, Wattisfield, Suffolk,**

## **Historic Building Record**

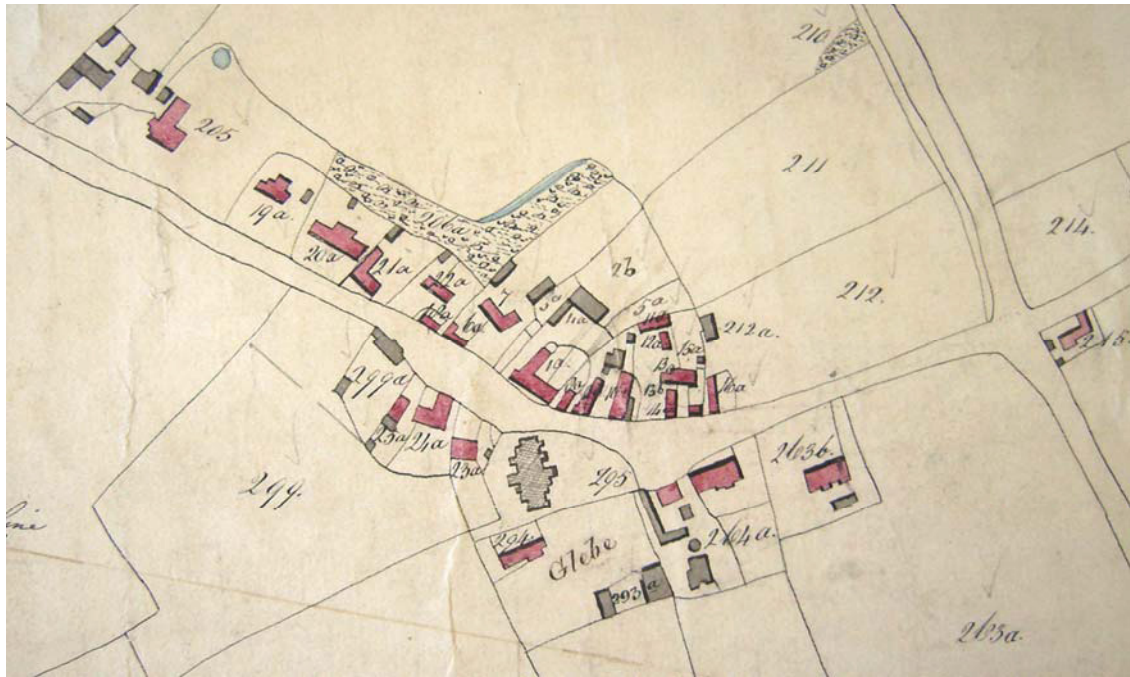
**Figure 2**  
Wattisfield parish tithe map of 1838 (showing north and the modern A134 to the right).

The Watisfield parish tithe map of 1838 shows the outbuilding as a separate domestic property, described in the accompanying apportionment as a 'cottage and garden' owned by Thomas Thornhill Esquire and occupied by James Farrow. The Limes was owned by the same

Although it formed a separate cottage in the early-19<sup>th</sup> century, as shown on the tithe map (figure 2), the outbuilding’s abnormal layout and close proximity to the service gable of a broadly contemporary house of standard domestic plan (12.5 ft or 3.8 m), strongly suggests it was designed as the ancillary bake-house and kitchen of The Limes. ‘Boot-shaped’ halls were intended to maximise storage space in conjunction with small open halls, but are rare in domestic contexts: the only example known to the author in Suffolk formed part of a semi-detached tenement at 11-13 Stoke Road in Nayland. The form is more usually associated with multi-purpose outbuildings often termed kitchens today but typically referred to in early documents as bake-houses and brew-houses. A similar example from Chiddingstone in Kent has been reconstructed at the Weald-and-Downland Open Air Museum in Singleton, West Sussex. The absence of a normal hall window, rising to the roof-plate, supports this non-domestic interpretation, and any opportunity to establish the proportions of the actual window should also be taken when the relevant studs are exposed.

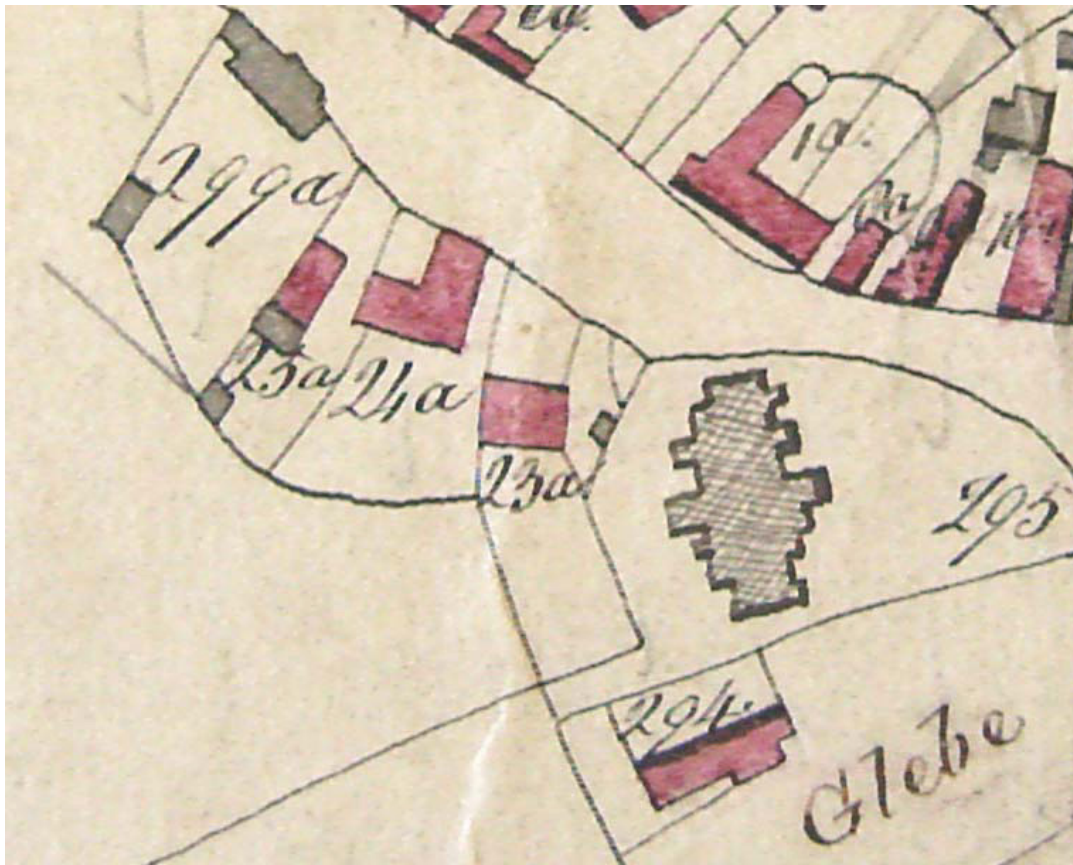
**Figure 2a**  
Detail of 1838 tithe map, showing the distinctive L-shaped outline of The Limes (24a) and the outbuilding as a separate cottage (25a) with an outbuilding attached to its eastern gable and a detached outbuilding (presumably a privy) in the eastern corner of its yard.

individual but occupied by 'Whitmore'. Thomas Thornhill owned a total of 7 tenanted cottages in the parish, including that between The Limes and the churchyard (23a), together with an outlying farm and maltings of 90 acres occupied by William Farrow (now Beech Tree Farm on the Hinderclay road). The field to the west of the site (299) was named as a 'barn and meadow', and the outbuildings to the south (299a) as 'buildings and yard'. Thornhill, 'Whitmore' and James Farrow are not named in White's Suffolk Directory of 1844, but William Farrow is listed as a farmer and maltster and Josiah Farrow as a cattle dealer; the occupant of the outbuilding 1838 may well have been linked with a cattle dealing business on the adjoining land. The colour convention of the map uses red to indicate the domestic part of his cottage and grey to indicate what was probably a boarded outbuilding attached to its eastern gable and a detached shed in the yard.

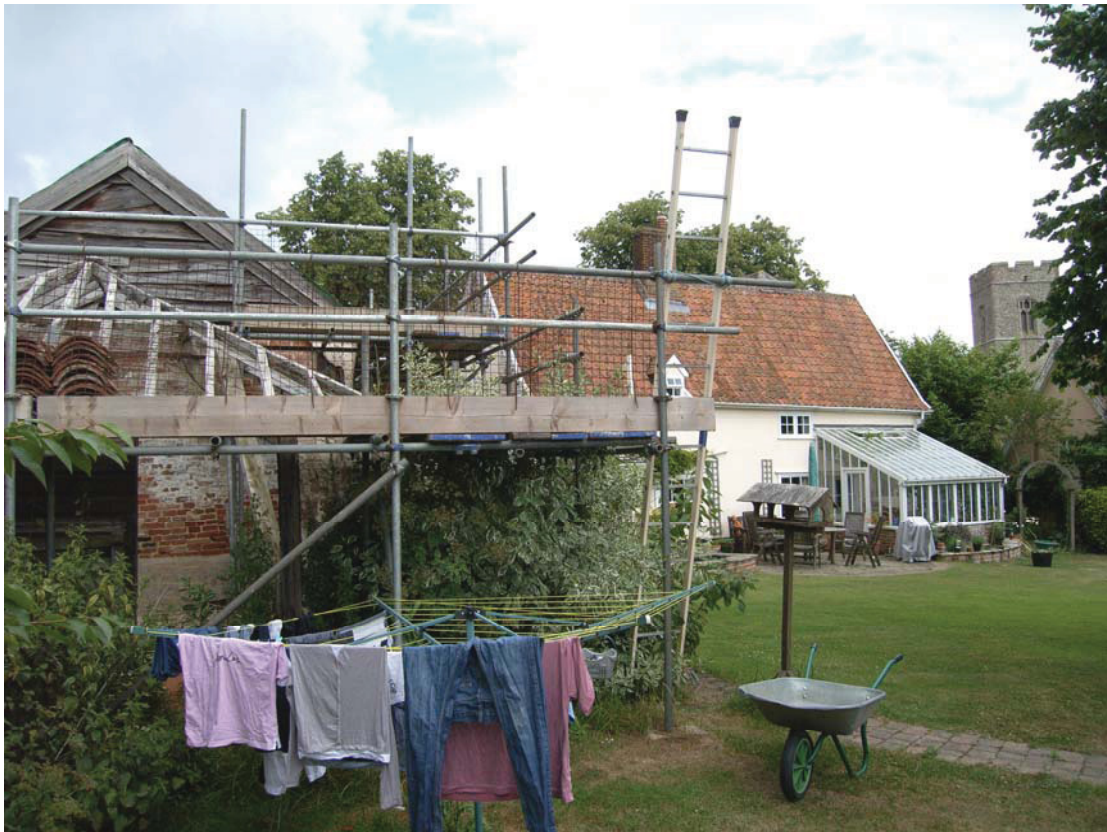
A2.1 General view of site from south-east showing the proximity of the outbuilding (left) to The Limes in the centre and St Margaret's church to the right

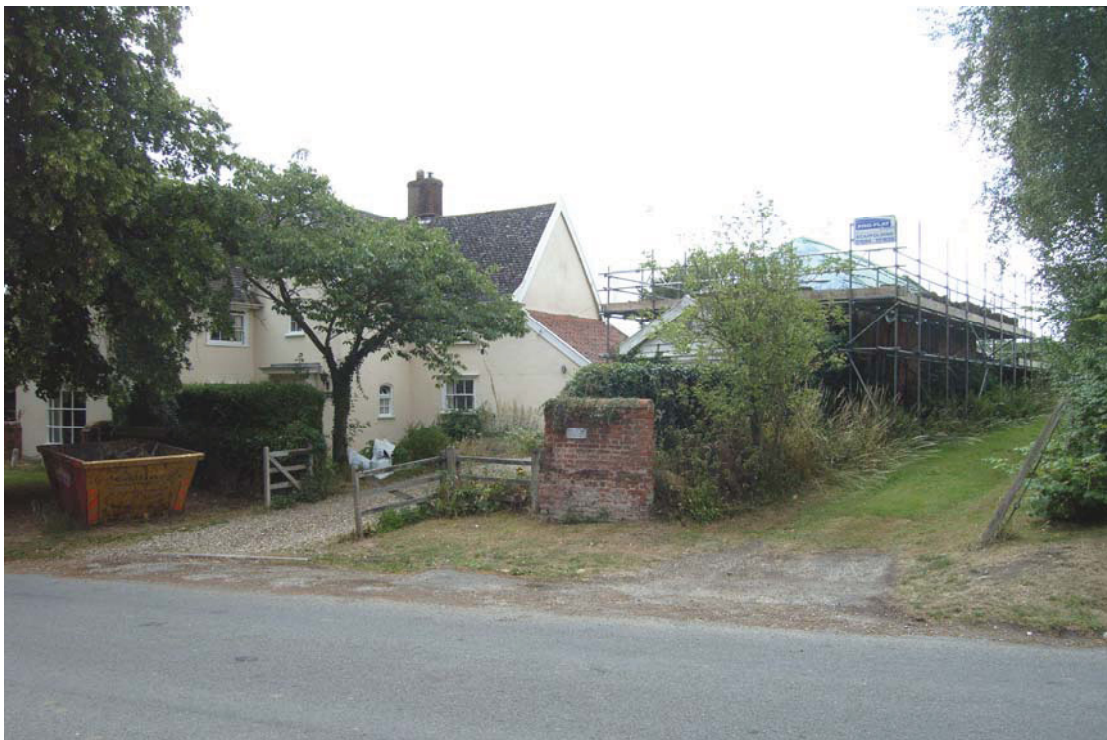
A2.2 General view of site from The Street to west showing The Limes to left & the outbuilding to the right (adjoining a field access on the south)

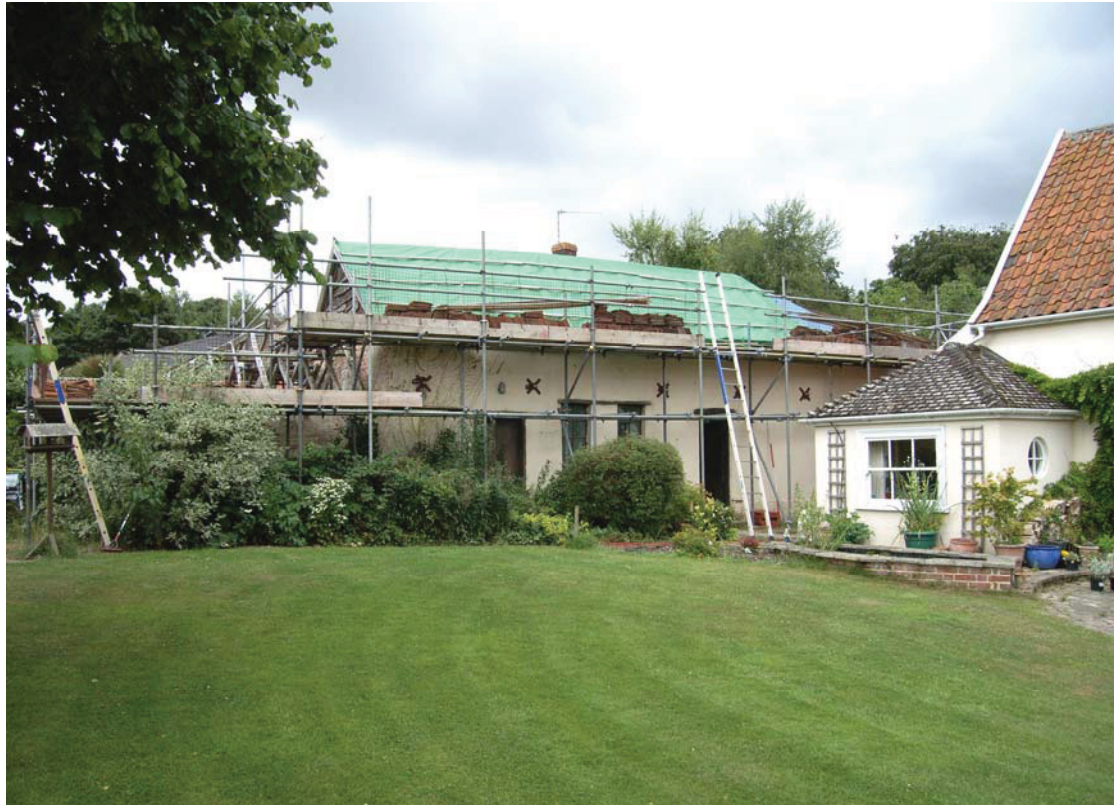
A2.3 Northern external elevation of outbuilding showing proximity of The Limes to right

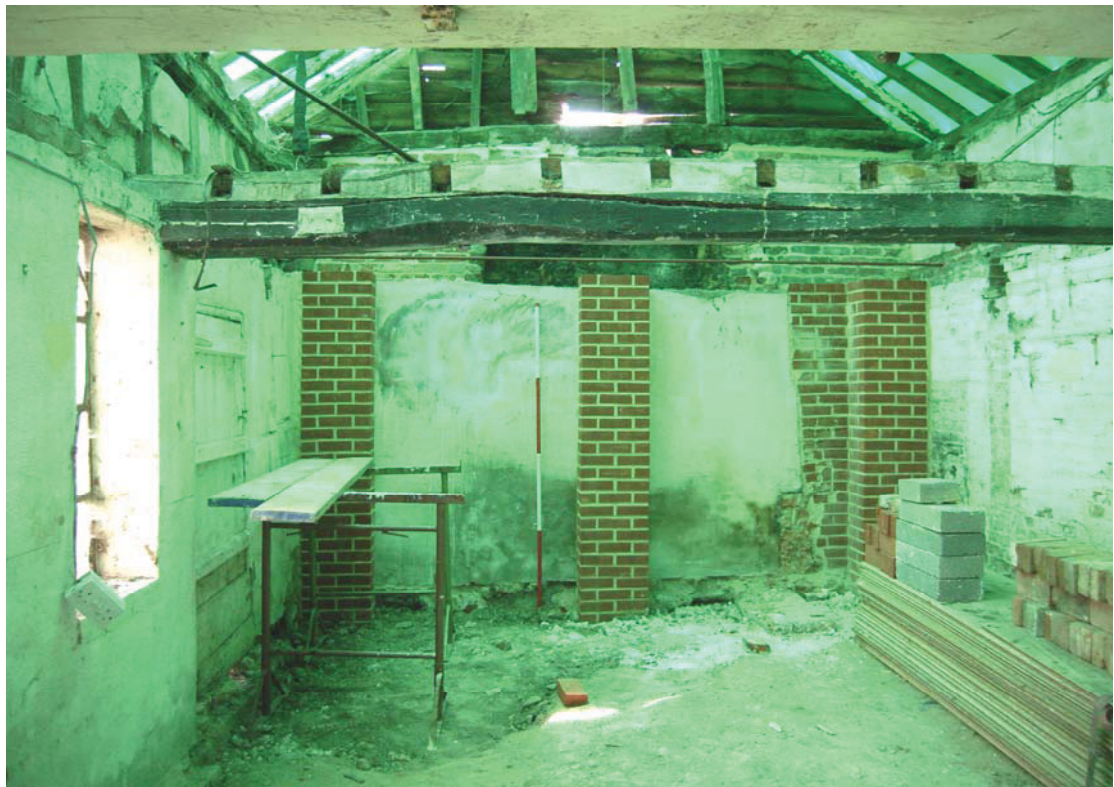
A2.4 General view of interior from west showing binding joists of 17<sup>th</sup> century inserted ceiling and position of former fireplace against eastern gable (green tint caused by colour of tarpaulin covering stripped roof)

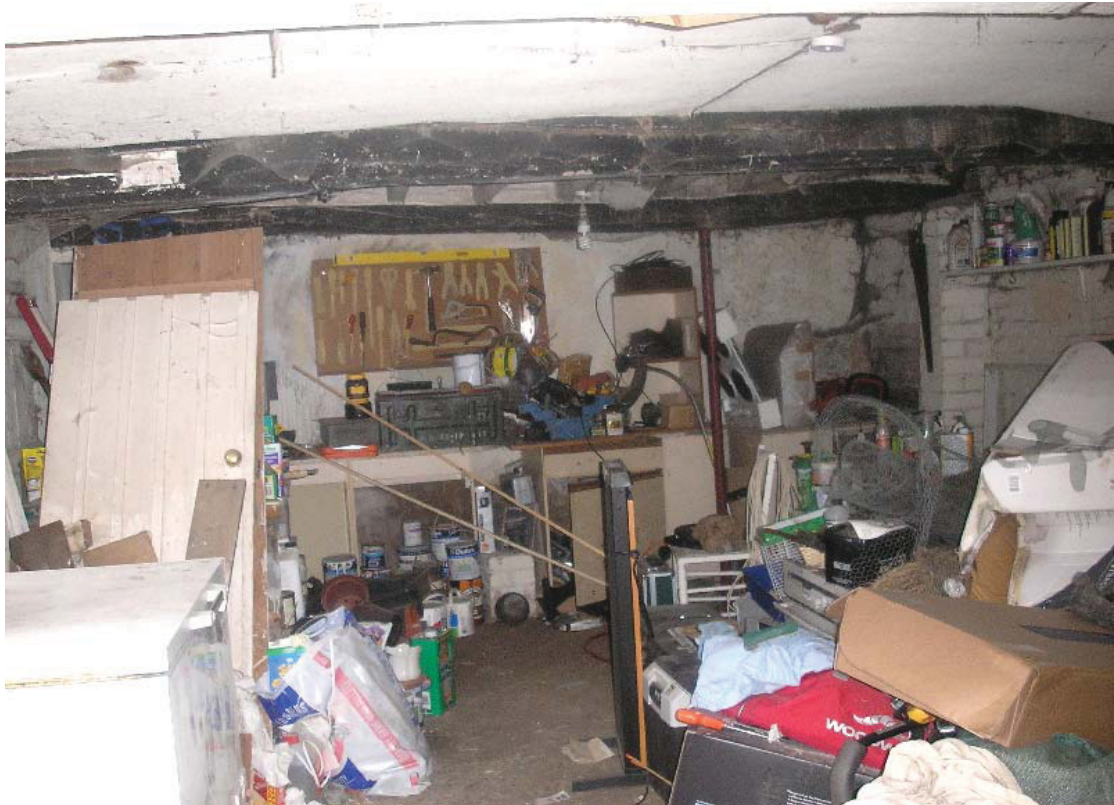
A2.5 Similar view to A2.4 above taken in January 2008 before building work commenced (i.e. general view of interior from west showing eastern gable and intact 17<sup>th</sup> century ceiling).

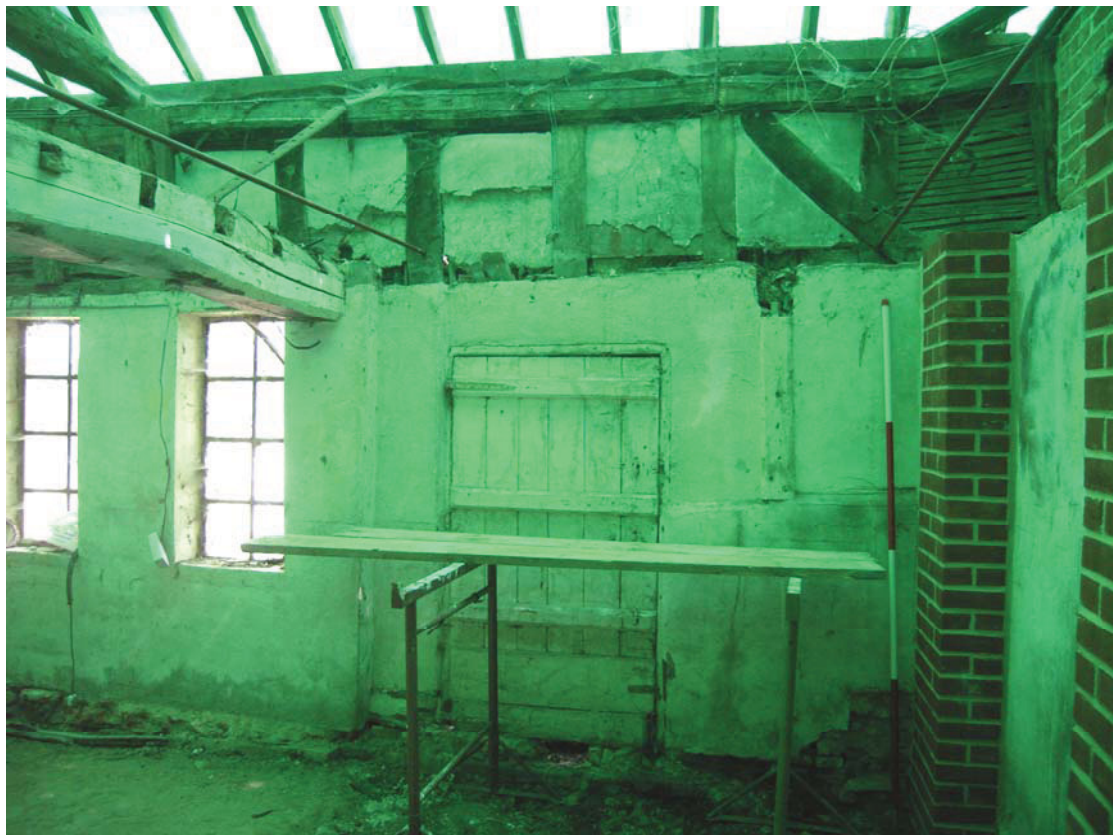
A2.6 Eastern end of northern internal elevation (bay A1) showing heavily sooted studs and internal corner brace – the lower part of the timber frame is hidden by 19<sup>th</sup> century render.

The eastern bay of 3.75 m in internal length (12.5 ft) contained an open hearth and the exposed original studs of the northern elevation are thickly sooted in the highly distinctive manner of medieval open halls (two unsooted studs are later replacements). There is no evidence of the usual hall window however, but unfortunately only the upper 75 cm (30 ins) of the elevation is exposed and any evidence of a window beneath this level was hidden by 20<sup>th</sup> century render at the time of inspection. The sooting does not extend from the eastern bay (A1) to the central bay (A2) and there is evidence of a missing lateral partition between them: the jowled storey post is notched for the staves of wattle-and-daub and is clearly sooted to its eastern edge but not its western. The eastern gable has been rebuilt in brick, but its internal corner braces survive and its tie-beam contains evidence of a hipped roof and five evenly spaced studs; there is no suggestion that the building continued further in this direction.

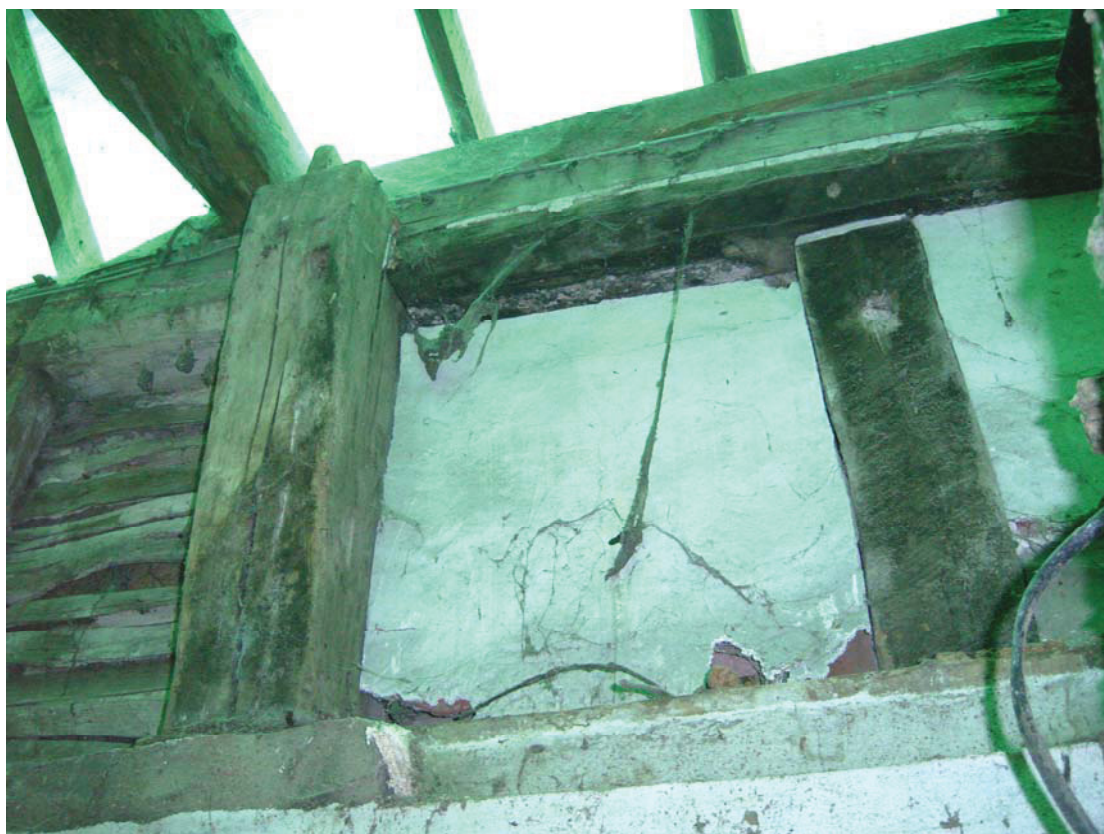
A2.7 Detail of jowled storey post dividing the sooted studs of bay A1 (right) from the unsooted studs of the central bay A2 (left). The storey post is sooted to its right-hand edge only, and contains notches for the wattle and daub of a missing lateral partition.

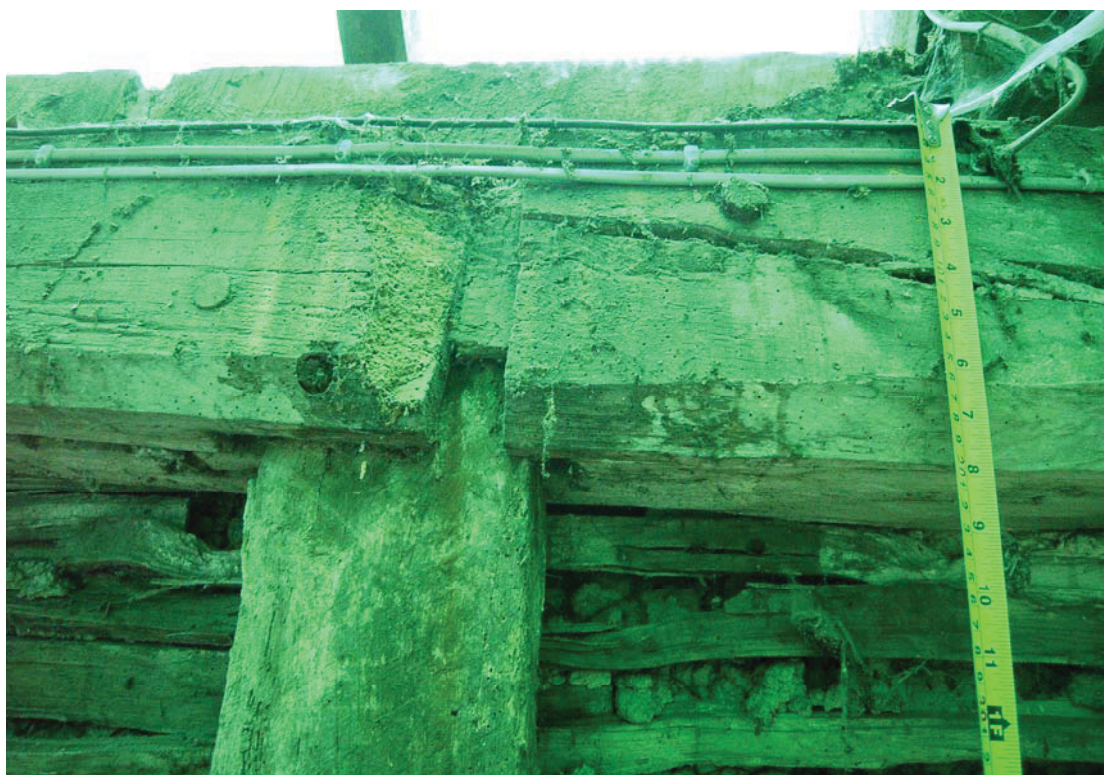
A2.8 Detail of unusual scarf joint in northern roof plate of central bay (A2). (Short face-halved joint with housed blade.)

Close dating is difficult given the building's abnormal layout (as described below), the absence of decorative features and the loss of the original roof. The sophisticated scarf joint in the central bay is a short face-halved example which is no longer than its blades and in which the eastern blade is housed (i.e. it does not extend to the soffit of the roof-plate). Face-halved scarfs came into common usage only during the 17<sup>th</sup> century but short versions such as this can be found in the 15<sup>th</sup> and 16<sup>th</sup> centuries – albeit more typically in ground sills and jetty timbers. Given its carpentry and the presence of an open hearth the building probably dates from the late-15<sup>th</sup> or early-16<sup>th</sup> century, but a slightly earlier origin cannot be ruled out.

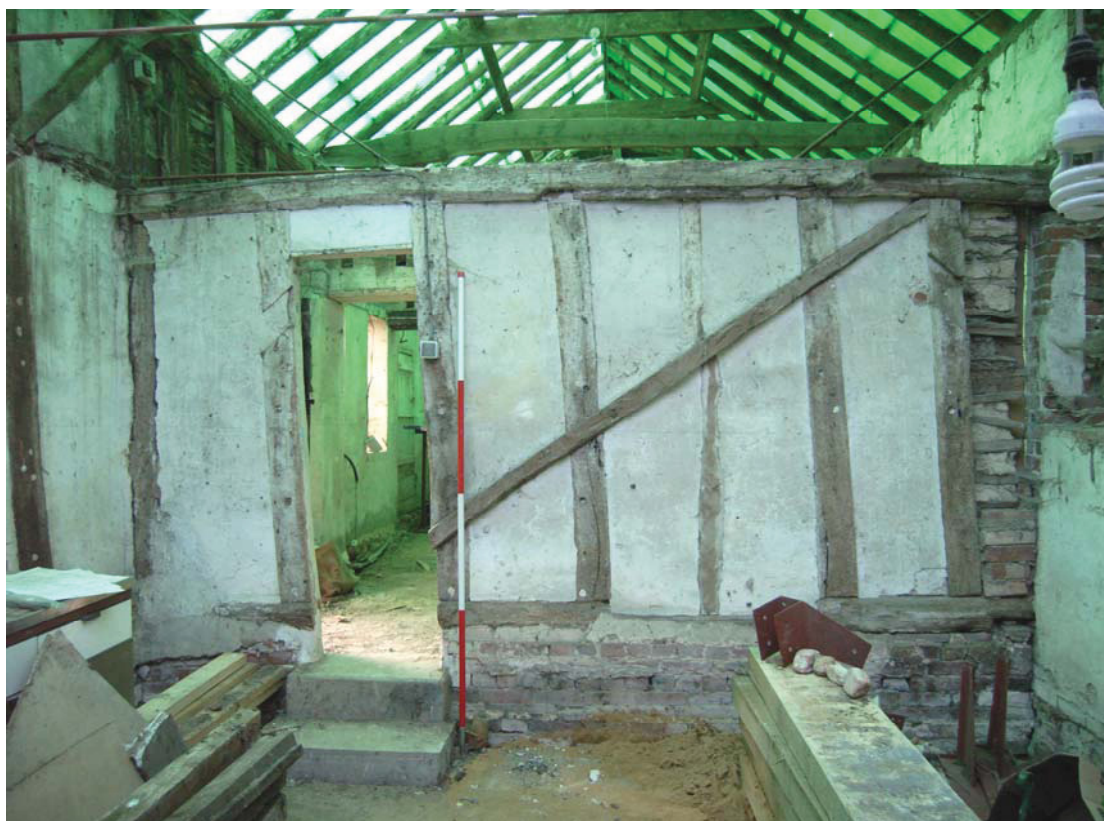
A2.9 Original 'service' partition seen from west (bay A3) showing existing door to left and blocked original door to right (the diagonal brace is secondary).

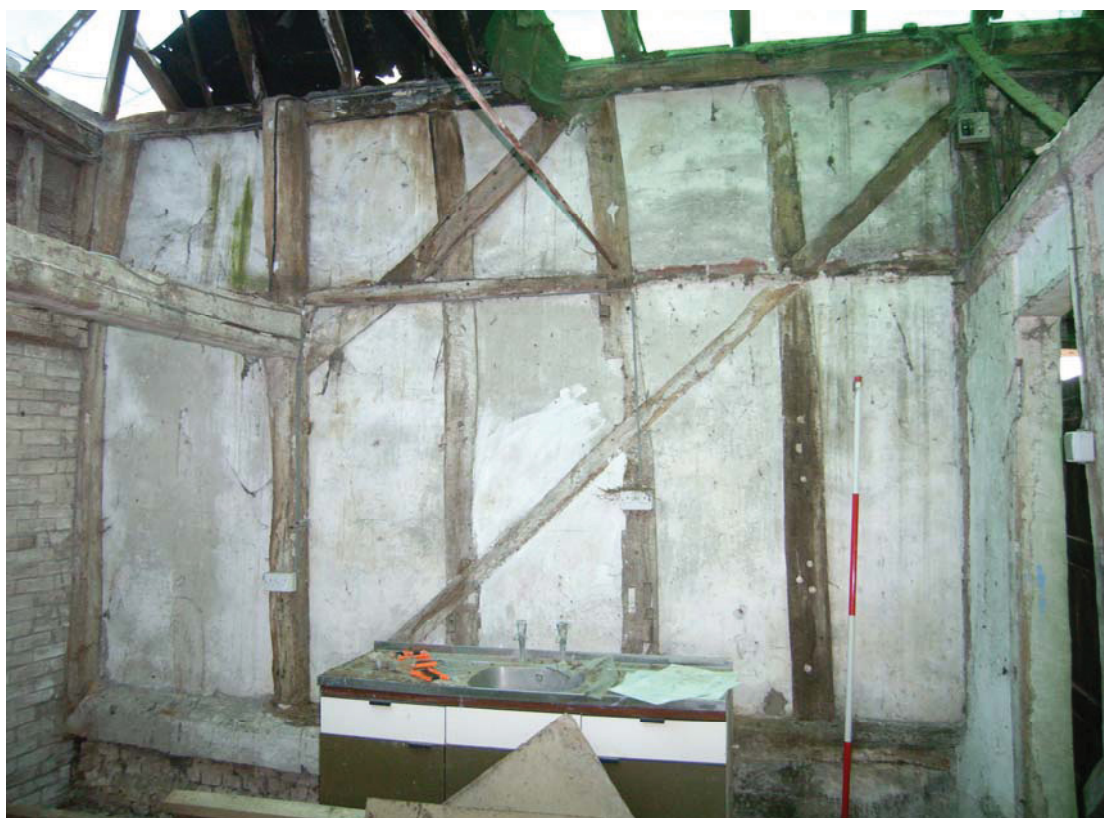
A2.10 Internal northern elevation of western bay (A3) showing original service partition to right and narrow 17<sup>th</sup> century extension (B) to left.

The outbuilding was extensively altered in the mid-17<sup>th</sup> century when a new ceiling was inserted into the central and eastern bays and the western bay was extended by 1.2 m (4 ft) as shown in figure B. The new timber-framed gable incorporated a mid-rail with a central window of 1.5 m (6 ft) in width beneath, and the jowls of its corner posts were aligned at right-angles of those in the original structure in order to form a hip. The earlier western gable was evidently removed and the extension created a larger ‘service’ room of 4.25 m (14 ft). The new ceiling consisted of tall-sectioned joists tenoned to a pair of binding joists with neatly cut chamfers and lamb’s tongue stops. These binding joists survived at the time of inspection, but the common joists had been removed to leave the lower storey entirely open to the roof (they are shown in photo A2.5 below – the only internal photograph which pre-dates the current building work). The eastern gable was rebuilt in brick at much the same time, leaving only the tie-beam and wall braces of the original structure intact; its remaining brickwork preserves the sooted outline of a demolished central flue, and the foundations of the piers of a corresponding 17<sup>th</sup> century fireplace were visible in the clay floor at the time of inspection (as shown in figure A). The new extension, ceiling and gable chimney of the 17<sup>th</sup> century may reflect the conversion of the former kitchen to a domestic house in its own right.

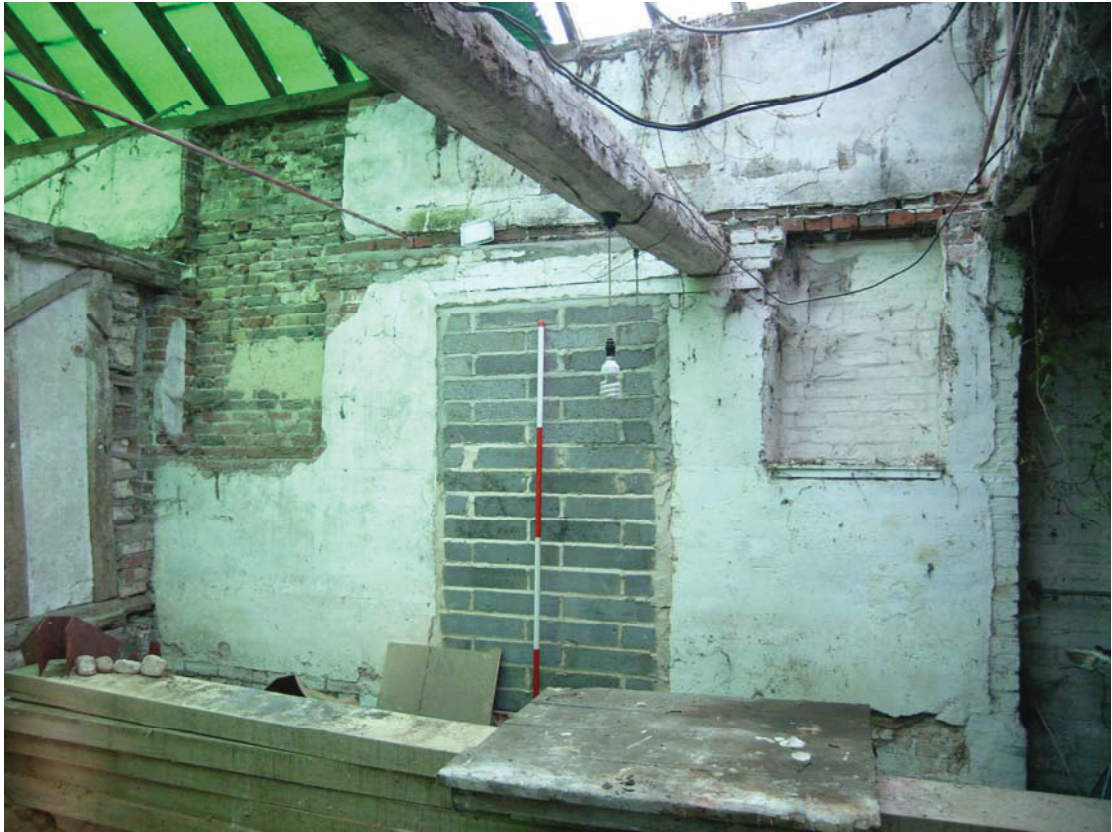
A2.11 Southern internal elevation of bays A3 (left) & B showing blocked 19th century door flanked by incised apotropaic circles and windows.

The mid-19<sup>th</sup> century saw the addition of a narrow, single-storied vehicle shed of brick and flint rubble against the western gable, and of a pair of brick and timber-clad sheds to the east (D). The Flemish bond of these sheds contrasts with the English bond of the rebuilt southern elevation. The present clasped-purlin roof structure with nailed collars and a ridge board was built at the same time, and the northern elevation of the eastern compartment provided with a pair of doors and glazed metal-framed windows. Photographic evidence of 2008 suggests the eastern bays had recently operated as a general storage shed for The Limes, but the western part of the building was ostensibly a separate shed linked only to the field access which it adjoined on the south. Several incised apotropaic symbols in the form of concentric circles survive on the southern internal elevation of this shed with others in black pigment on the internal partition; these were intended to avert evil and are often found in 19<sup>th</sup> century stables and store rooms.

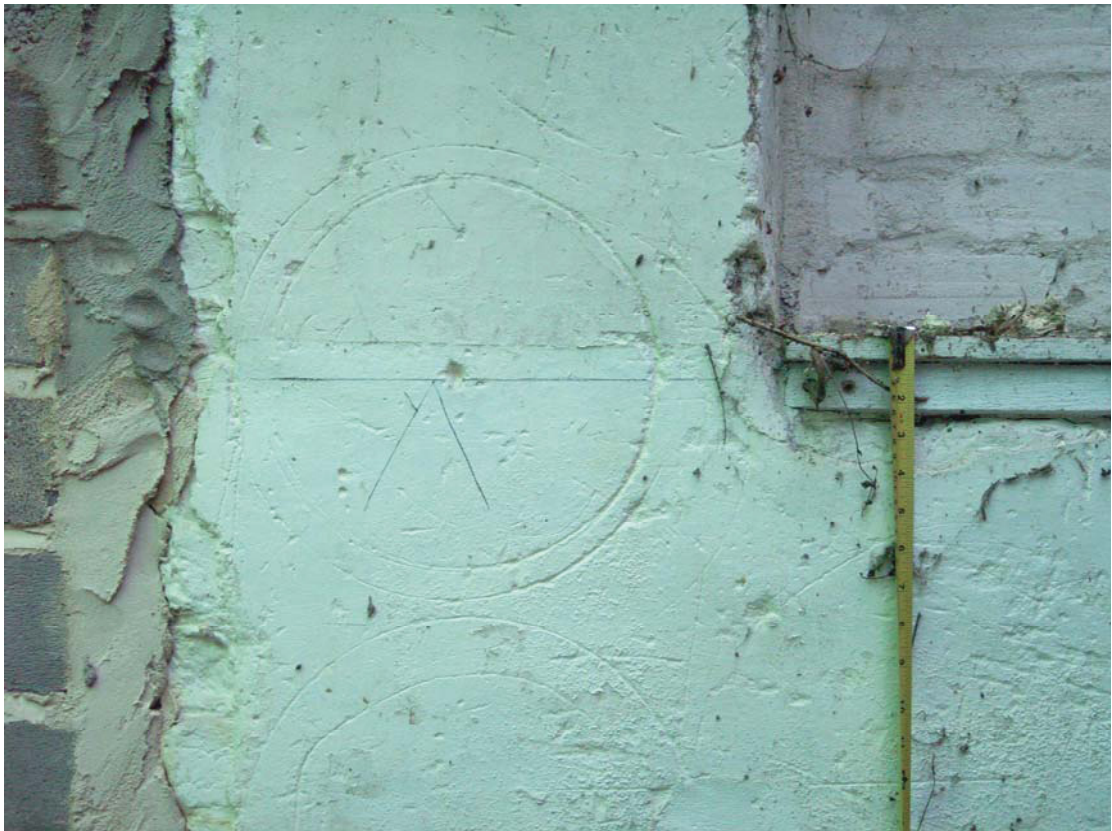
A2.12 Detail of apotropaic circles to west of door in southern elevation of bay A3.
