ARCHAEOLOGICAL MONITORING REPORT

SCCAS REPORT No. 2009/228

Church Bridge, Boxford BXF 022

An archaeological monitoring and building recording was carried out at Church Bridge, Boxford which identified and recorded the stone-built support piers of a medieval bridge, which was largely superseded in the 17th and 19th century by a brick and ironwork bridge.

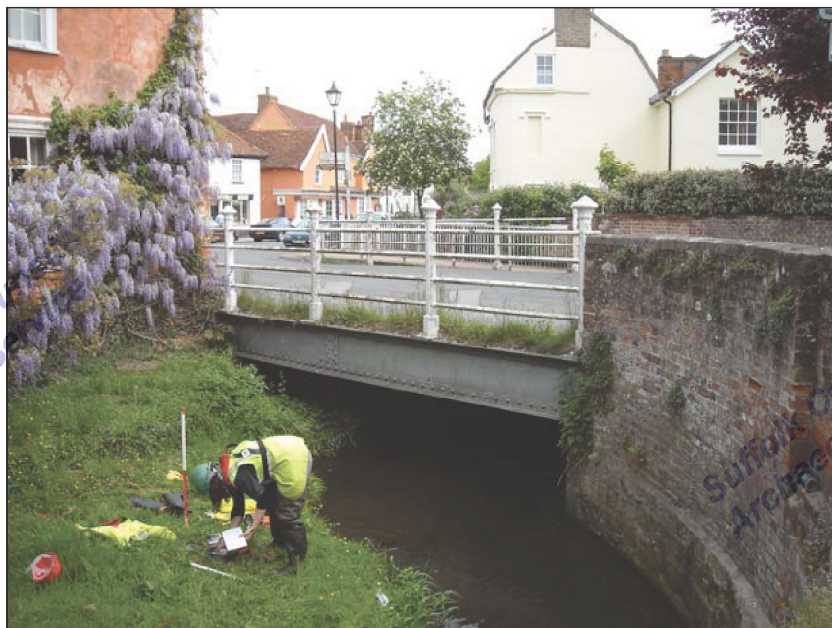
Plate 1. Boxford Bridge, facing north-east

The present Church Bridge (Plate 1) spans the River Box in the centre of the village of Boxford, just north of St Mary's Church (Fig. 2) (Plate 0245). It is a beam bridge and its visible aspect is constructed from reddish orange brick, laid in Flemish bond, and ironwork, with a modern tarmac road surface.

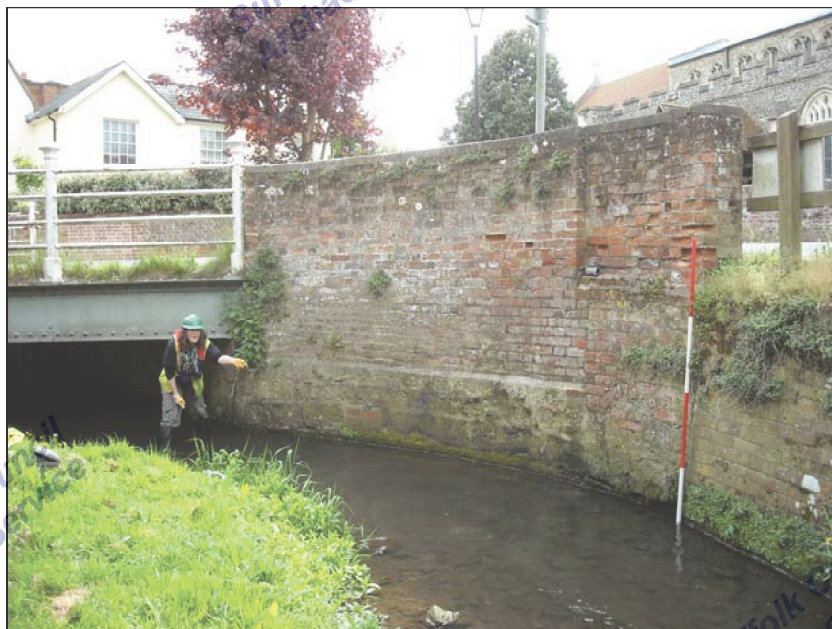
Plate 2. Brick revetment wall, facing south-east

The brickwork is the main load-bearing element of the bridge and is also used as a revetment of the south-west bank (Plate 2). Above the curving revetment the brickwork has been built upwards to form a protective wall twenty five courses high (Plate 0233). This section of the wall rests upon a stone base (see below).

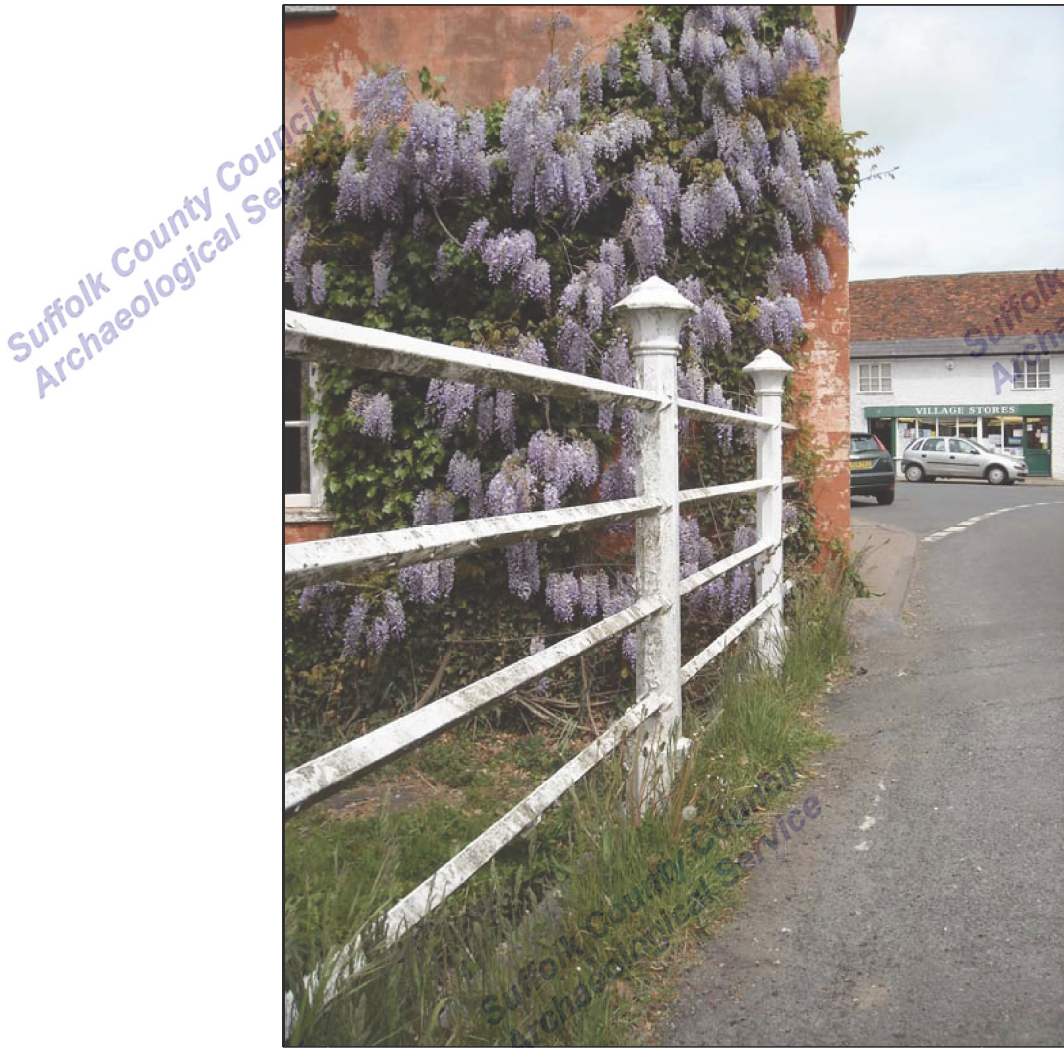
Plate 3. View of the west railings, facing north

Decorative post-and-rail type railings (Plate 3), also of ironwork, form the bridge sides (Plate 0245 and 0251) and are painted white. The west railings comprise four rails and four posts; the north end of the rails are keyed into the south external elevation of the Post Office and the post at the south end abuts a red brick wall which curves to the south-west and forms an integral part of the bridge's structure (Plates 0247 and 0252).

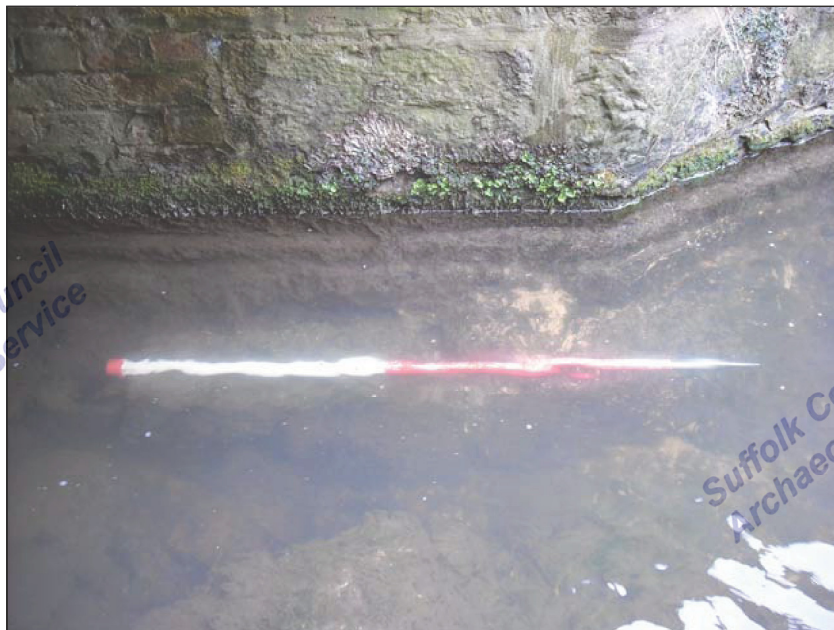
Plate 4. Stonework at the base of the bridge, facing south

Church Bridge rests upon stonework (Plate 4) that is best observed at the base of the revetment/wall (Plate 0233), although it is also visible on the south 'pier'. The stones are

large and roughly hewn and survive at four courses high above the stepped base (below the waterline) (Plate 0235 and 0236). It is not clear what type of stone was used, although it is probably limestone. A repair has been made to this part of the bridge using modern bricks (see Plate 0233).

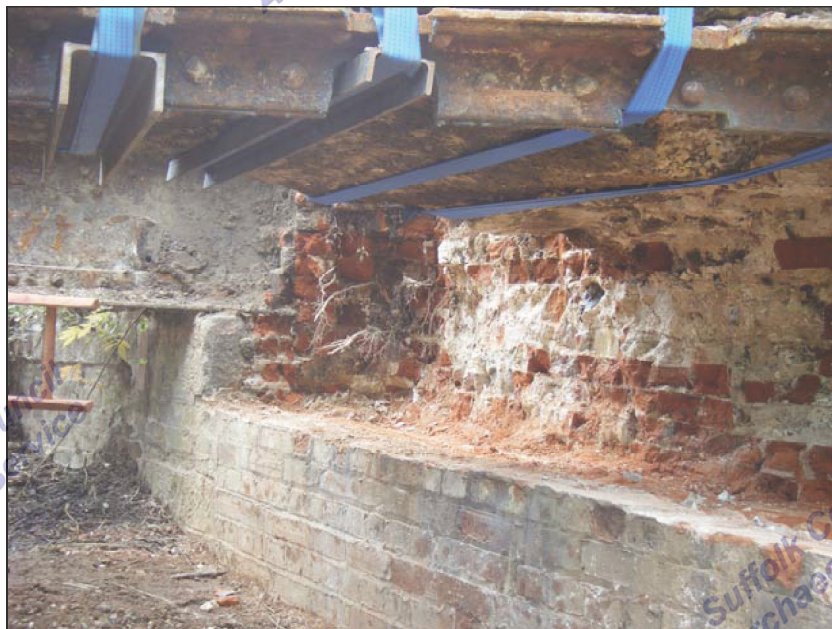
Plate 5. Exposed brick and flint construction piers, facing north-west

Monitoring demonstrated that the bridge rests upon the brickwork piers (Plate 2681) and that the latter are of substantial brick and flint construction with an outer facing of brick (Plate 2682) (Plate 5). No further recording of the stone structure was undertaken as the groundworks did not impact on that aspect of the structure.
