**Barn at Valley Farm Cottage,  
Higham,  
Suffolk  
HGM 022**

**Historic Building Record**

**Barn at  
Valley Farm Cottage,  
Hadleigh Road,  
Higham, Suffolk,**

## **Historic Building Record**

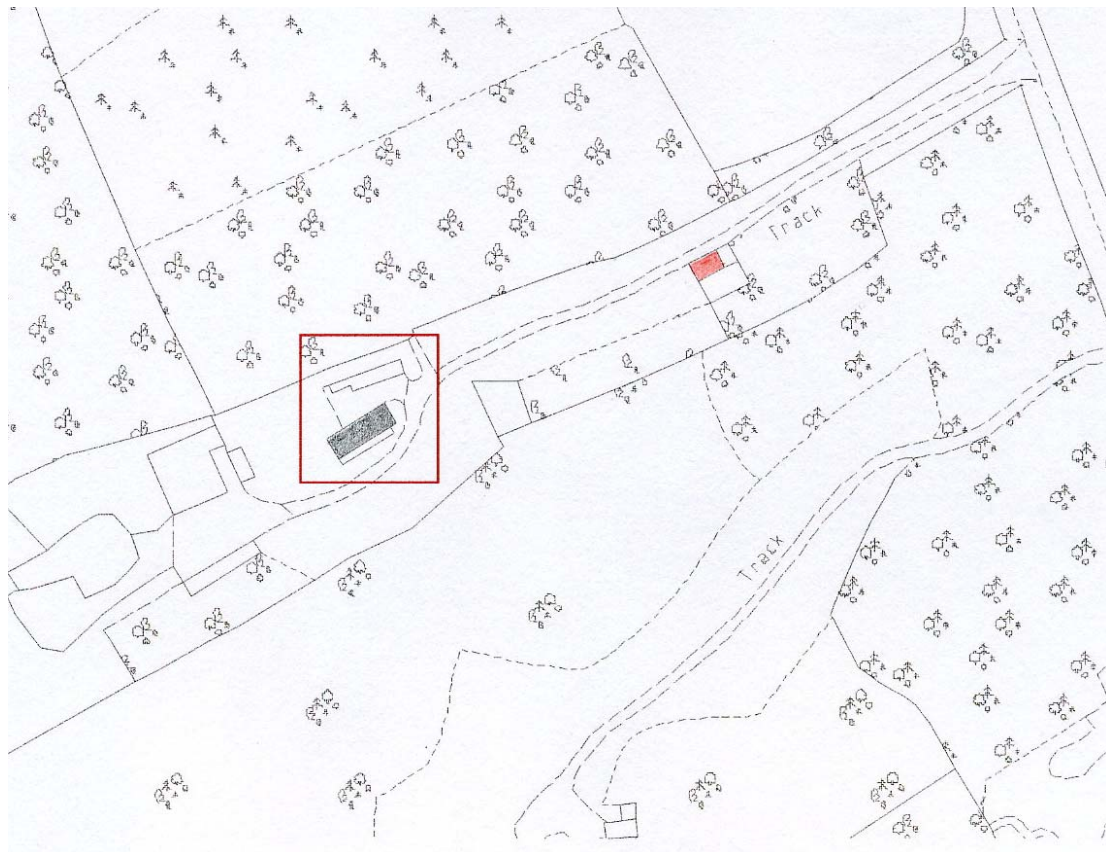
**Figure 1**

**Current Ordnance Survey Site Plan**

**Showing the barn in red and enclosing the house (shaded grey) and a 19<sup>th</sup> century rear brick outbuilding in a red square. Hadleigh Road in visible in the top right-hand corner, and the new Valley Farm of 1926 at bottom centre.**

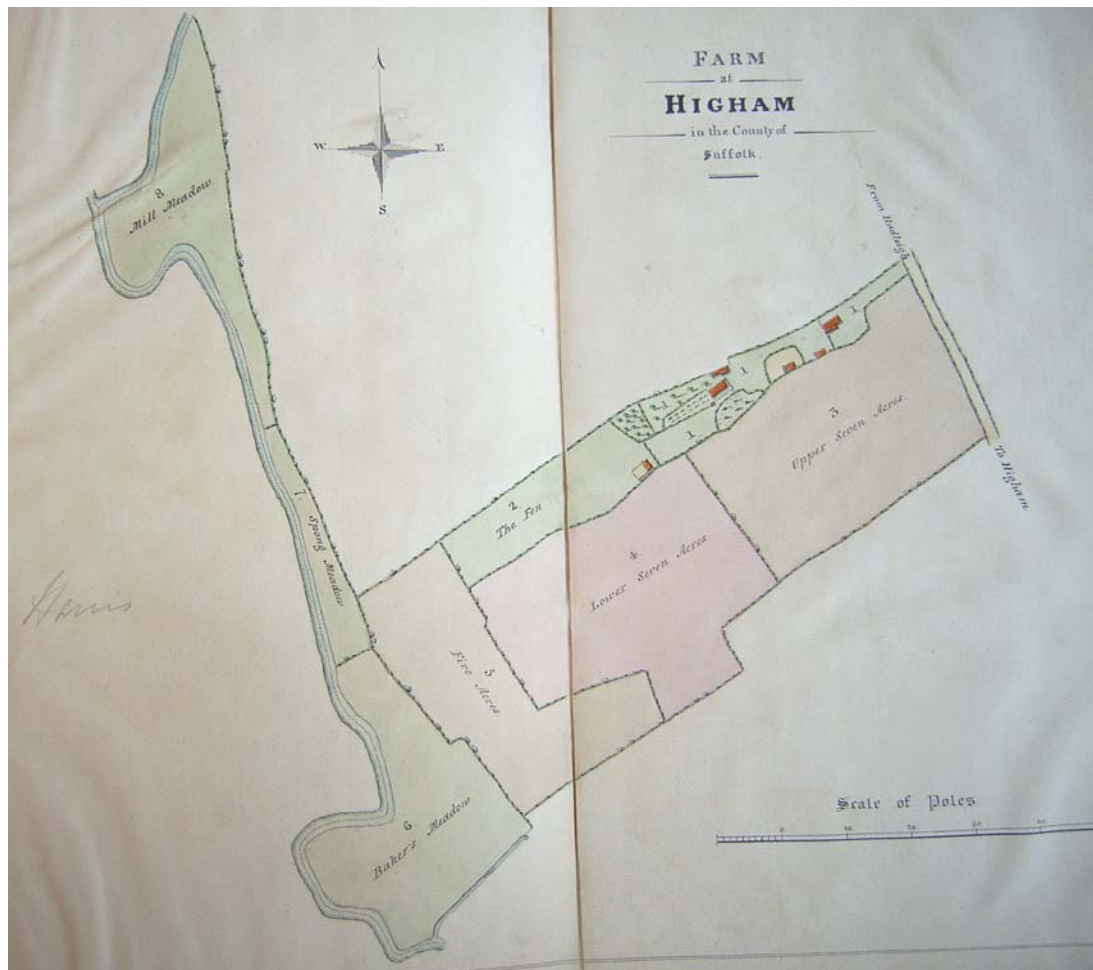
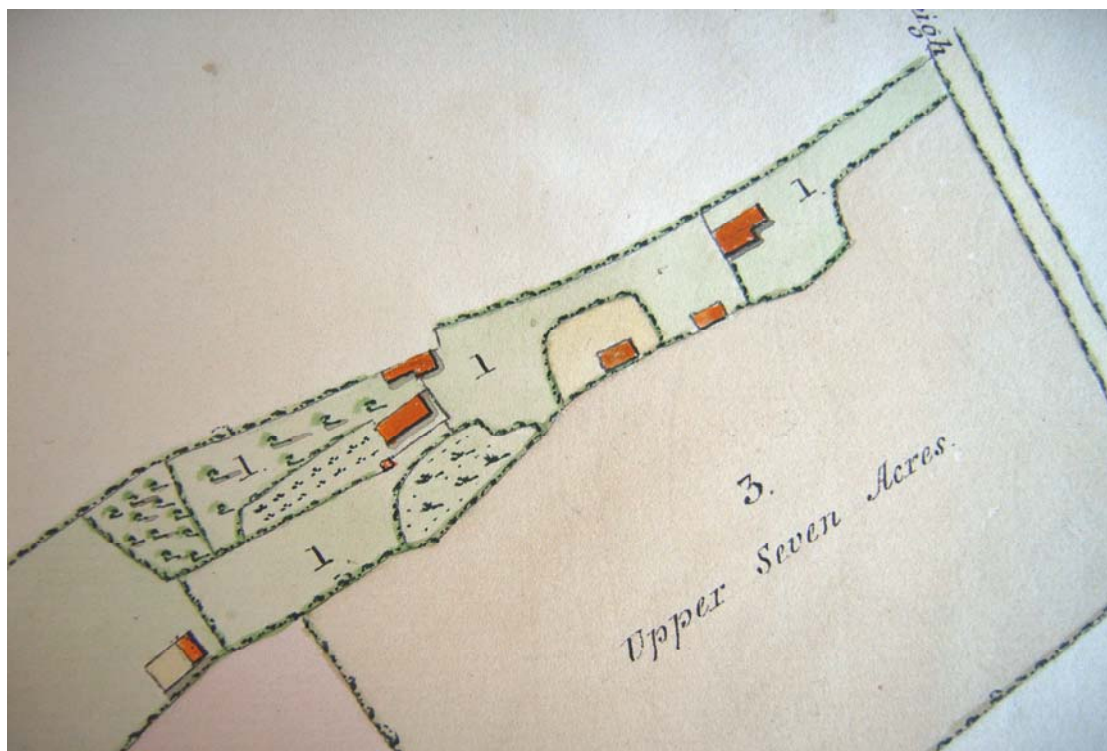
**Figure 2**  
Plan of Valley Farm drawn in 1832 with detail of buildings below (ISRO HA 108/10/5)

The farm is shown in a plan of 1832, when it contained just over 31¾ acres and formed one of many tenanted holdings on the estate of Sir Joshua Rowley of Tendring Hall in neighbouring Stoke-by-Nayland. The Tendring estate expanded rapidly by piecemeal purchase in the early-19<sup>th</sup> century, and the date of the plan probably relates to Sir Joshua's purchase of the property, which would have been small even by the standards of its day; many local holdings contained approximately 30 acres in the Middle Ages (i.e. a virgate, or one quarter of the Domesday carucate of 120 acres) and the farm boundary could have remained unaltered for centuries. A 19<sup>th</sup> century annotation records its subsequent sale to 'Pritchard Esq.', and the name 'Douglas Doyle Jones' was added in pencil. The plan shows an L-shaped building on the same site as the remaining barn, with two further structures adjoining the ditch to the south and an outbuilding behind the farmhouse. The site (no.1) is labelled 'buildings, yards and gardens', and the fields as 'The Fen' (2), 'Upper Seven Acres' (3), 'Lower Seven Acres' (4), 'Five Acres' (5), 'Bakers Meadow' (6), 'Spong Meadow' (7) and 'Mill Meadow' (8). The Tendring estate seems to have made rapid alterations to its new acquisition, as by the time of the tithe survey in 1839 three of the buildings shown in 1832 had been demolished (including the domestic outhouse). The farm was tenanted by Stephen Harris and contained the same acreage, but the fields are named differently with 'Upper Hill' and 'Lower Hill' replacing Upper and Lower Seven Acres, and 'Hole Meadow' instead of 'Bakers Meadow'. The land immediately to the north is indicated as church glebe, and it may be possible to trace the names of earlier owners in the abutments of any extant glebe terriers. Stephen Harris seems not to have relied on agriculture for his income as he and William Harris (perhaps his brother) were named as seed crushers and oil millers in White's Suffolk Directory of 1844 (producing oil-cake animal feed from linseed). The census returns would shed further light on the ancillary occupations of Valley Farm's 19<sup>th</sup> century residents.

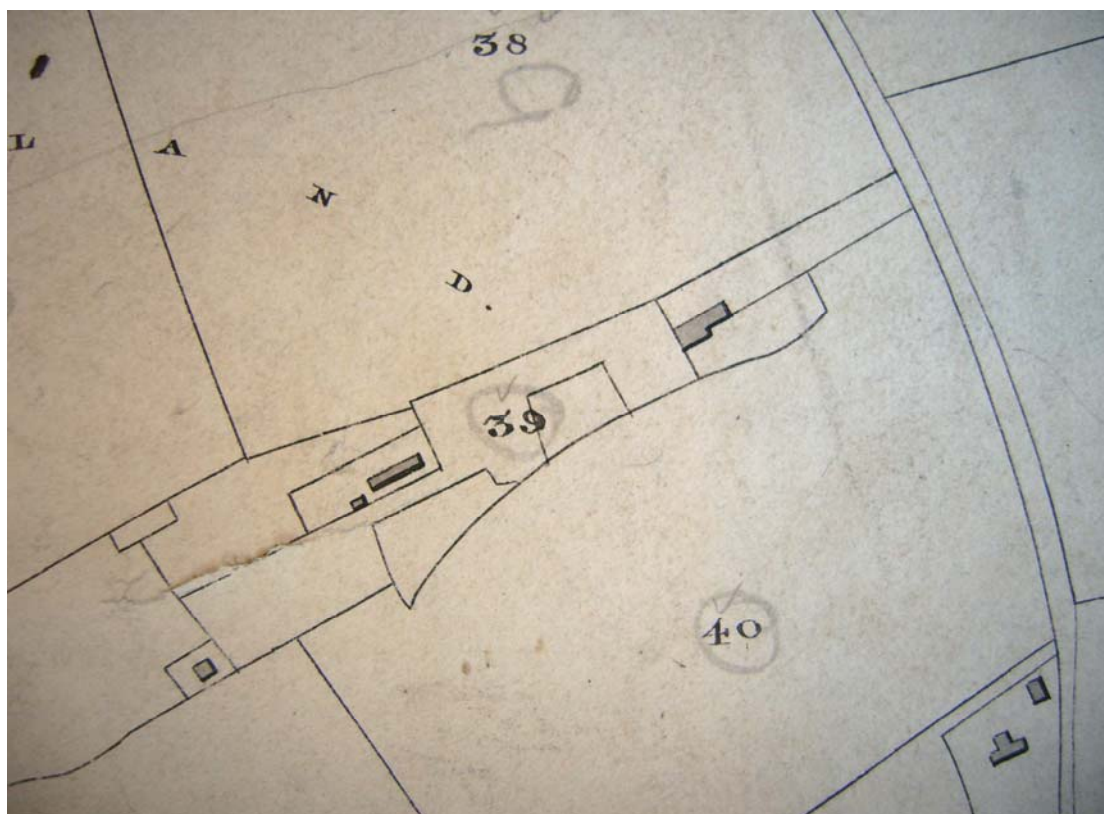
**Figure 3**

**The Higham parish tithe map of 1839, showing the loss of several buildings since 1832, and marking the land to the north as church glebe land. The L-shaped building to the east may have been a small barn and stable, and occupies the same site as the surviving 'barn' (which was built as a stable).**

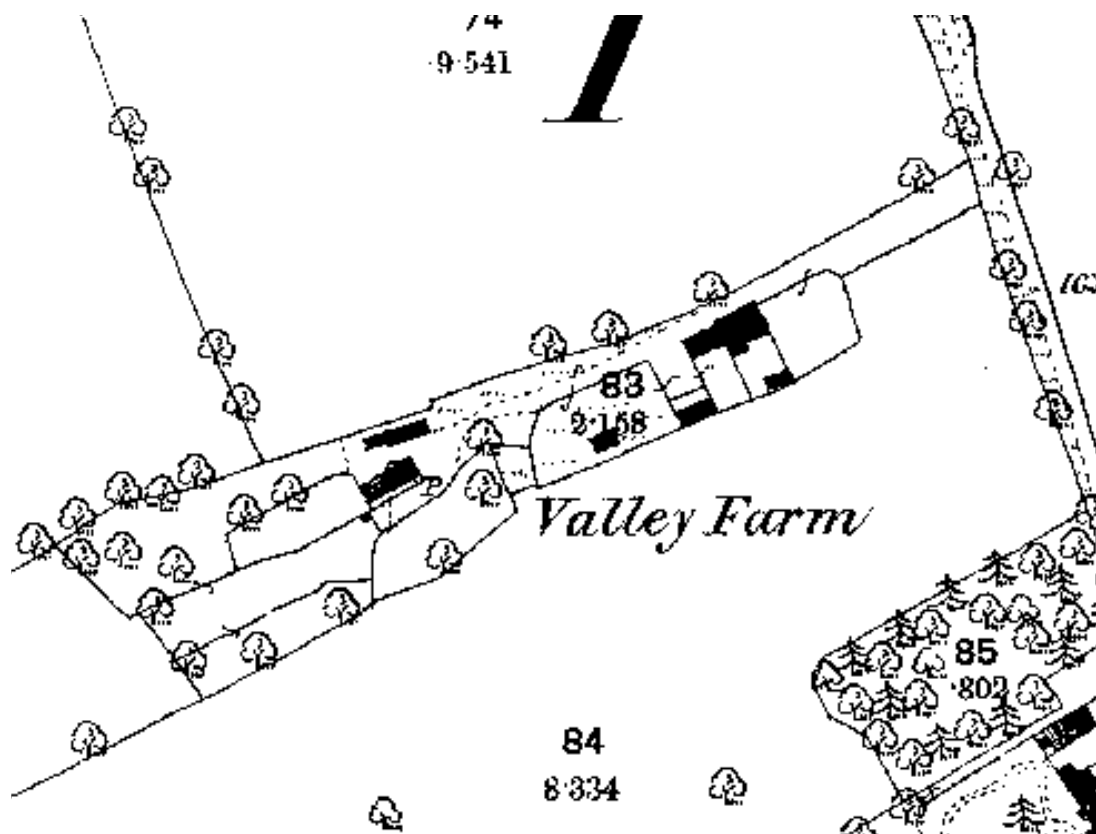
Figure 4

First Edition 25 inch Ordnance Survey of 1886, showing the present 'barn' as part of a new yard complex. The surviving building lies to the north of the westernmost of two rectangular yards, and adjoins a larger structure on the east that probably represents a grain barn. A new outbuilding behind the house had replaced that of 1832.

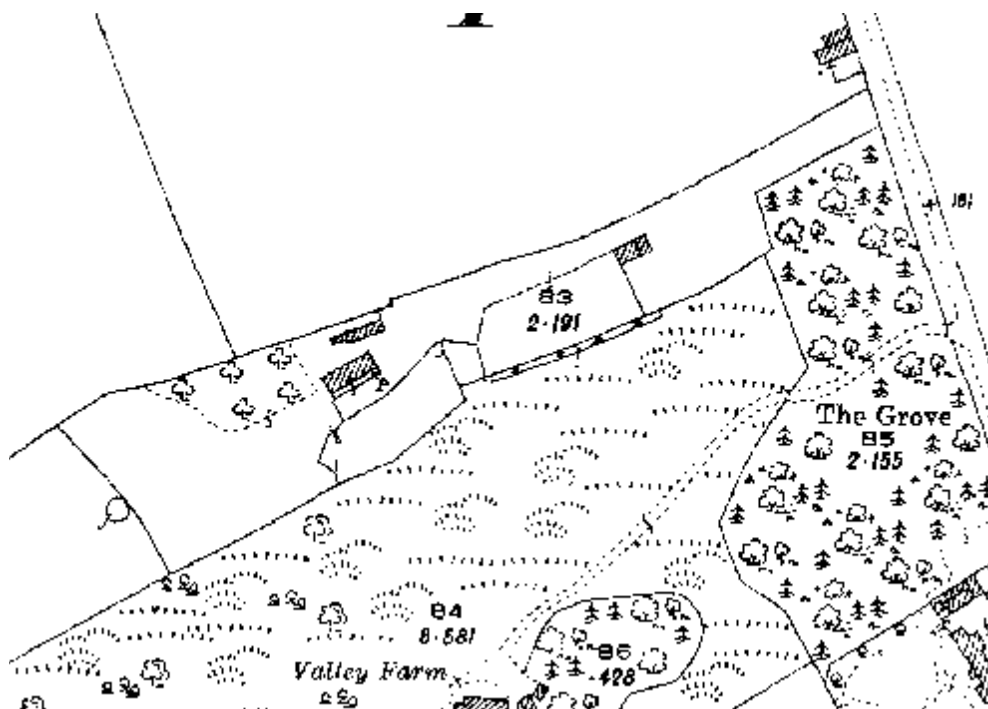
**Figure 6**

**Third Edition Ordnance Survey of 1926 showing the new farmhouse to the south and the loss of all the earlier farm buildings except the 'Studio Barn'. The situation remained unaltered at the time of inspection, although the heathland to the south had developed into woodland.**

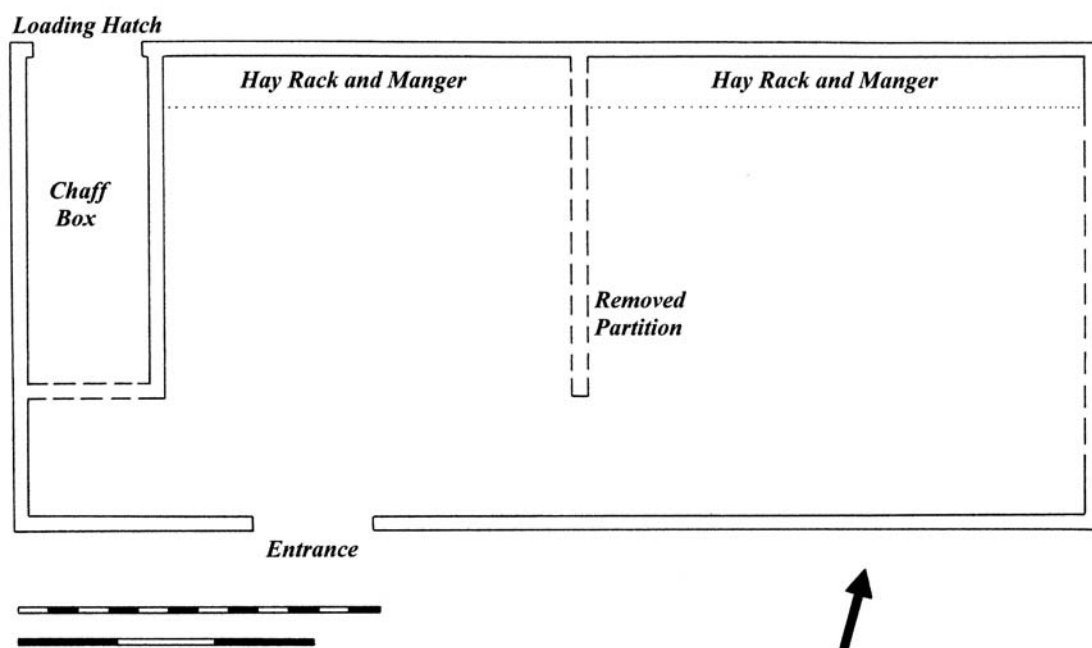
**Figure 7**  
**Ground Plan of the 'barn' showing its original layout. The northern elevation adjoins the farm entrance track, and the southern elevation an overgrown yard formerly enclosed by a brick wall**

The interior was originally divided into two unequal compartments of 5 m to the east and 4.25 m to the west, with a narrow third compartment in the north-western corner as shown in

figure 7. The internal partition now survives only at roof height, with empty mortises in the front and rear roof-plates for its removed tie-beam, but the small compartment remains largely intact and extends to 1.2 m in width by 3.4 m in length (4 ft by 11 ft); it was accessible only by hatches at both ends and is typical of the storage compartments for chaff found in many 19<sup>th</sup> century stables which lack hay lofts and known locally as chaff houses or chaff boxes. The identity of the 'barn' as a stable is confirmed by clear evidence of a removed hay rack against the northern internal elevation in the form of a diagonal scar against the boarded chaff box and corresponding notches in the wall posts. The bottom of this rack lay 1.6 m above the floor and rose to 2.4 m, with mangers immediately beneath (as indicated by an extant section of internal boarding between the plinth and rack of the western compartment). Such a rack would have been too high for cattle, although in other respects the building could have been designed as a cow-house. The building was entered from the southern yard by a doorway of 1.2 m in width (4 ft) in the same position as the present door (to the jambs of which the ground sills are neatly tenoned and pegged). The height and thickness of the brick plinth in the eastern gable is considerably greater than elsewhere, and the roof-plates and purlins extend beyond the corner posts in a manner which suggests they linked the stable to another structure that no longer survives; the former presence of such a building is demonstrated by the cartographic evidence above, and the stable probably abutted a contemporary barn in the normal pattern of local farms. The size of the stable is large for the holding of 31¼ acres shown on the tithe map, which would have required only a pair of plough horses, but the acreage may have increased by the mid-19<sup>th</sup> century, or the farm may have engaged in ancillary commercial activity as suggested by White's Directory of 1844.

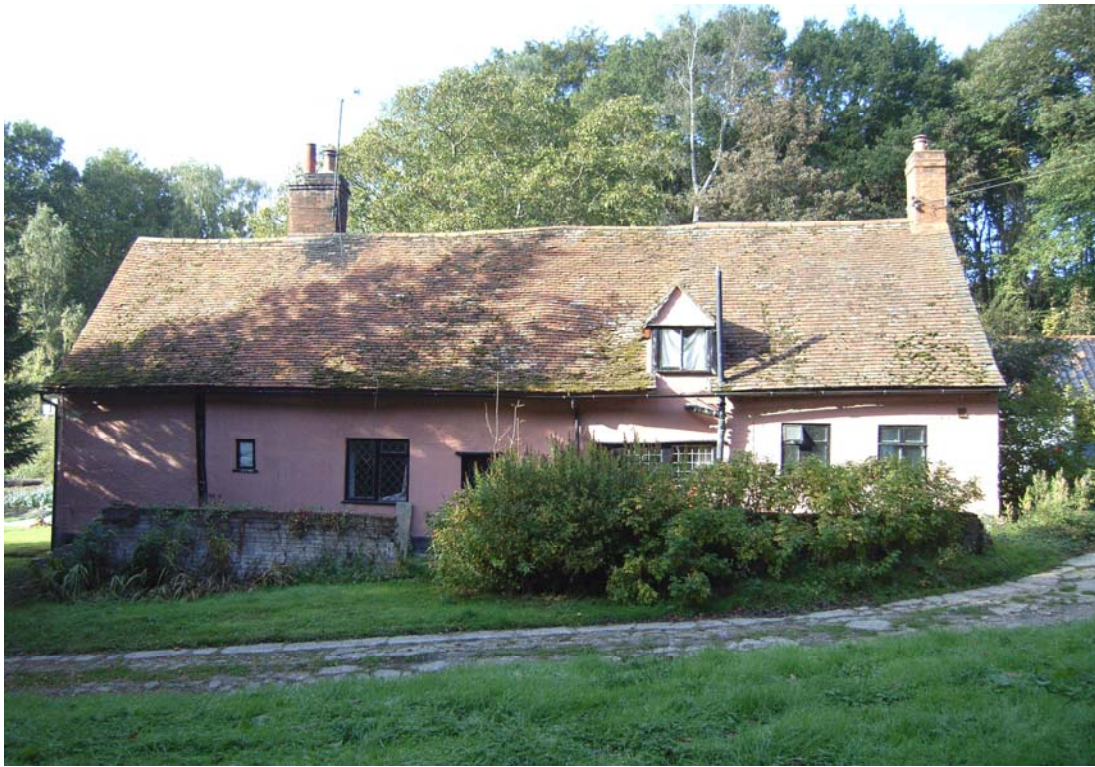
A2.1 Southern external elevation of Valley Farm Cottage (included for site context), showing the 17<sup>th</sup> century parlour & chimney to left, the early-16<sup>th</sup> century hall and original parlour in the centre and a 19<sup>th</sup> century brick extension to the right

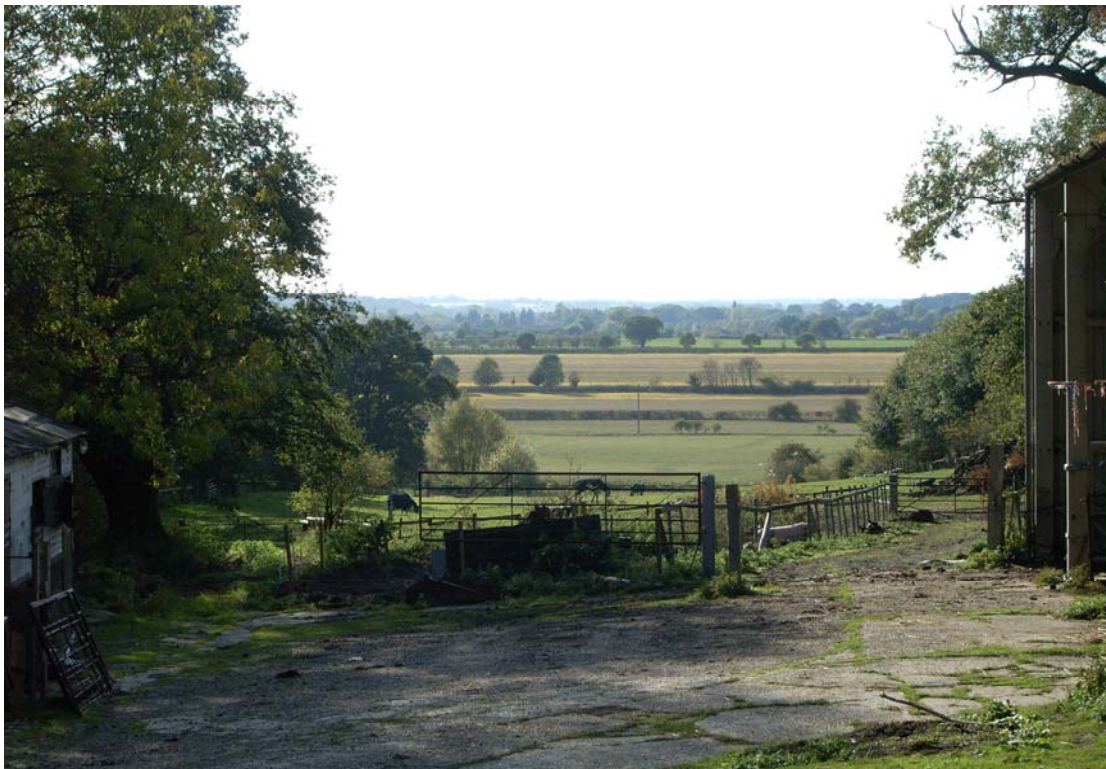
A2.2 General view from site showing the nature of its location in narrow valley overlooking the floodplain of the River Brett to the west

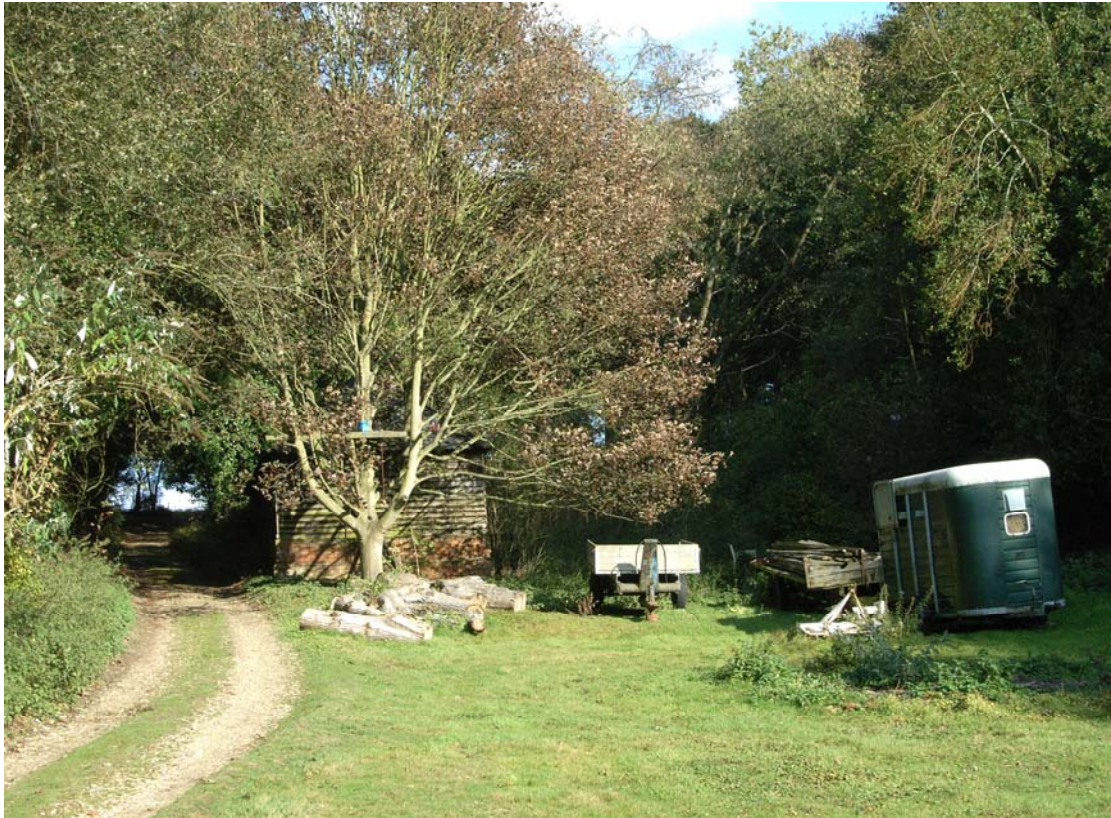
A2.3 General view of barn from west showing entrance track from Hadleigh Road to left and overgrown remains of enclosed yard to right

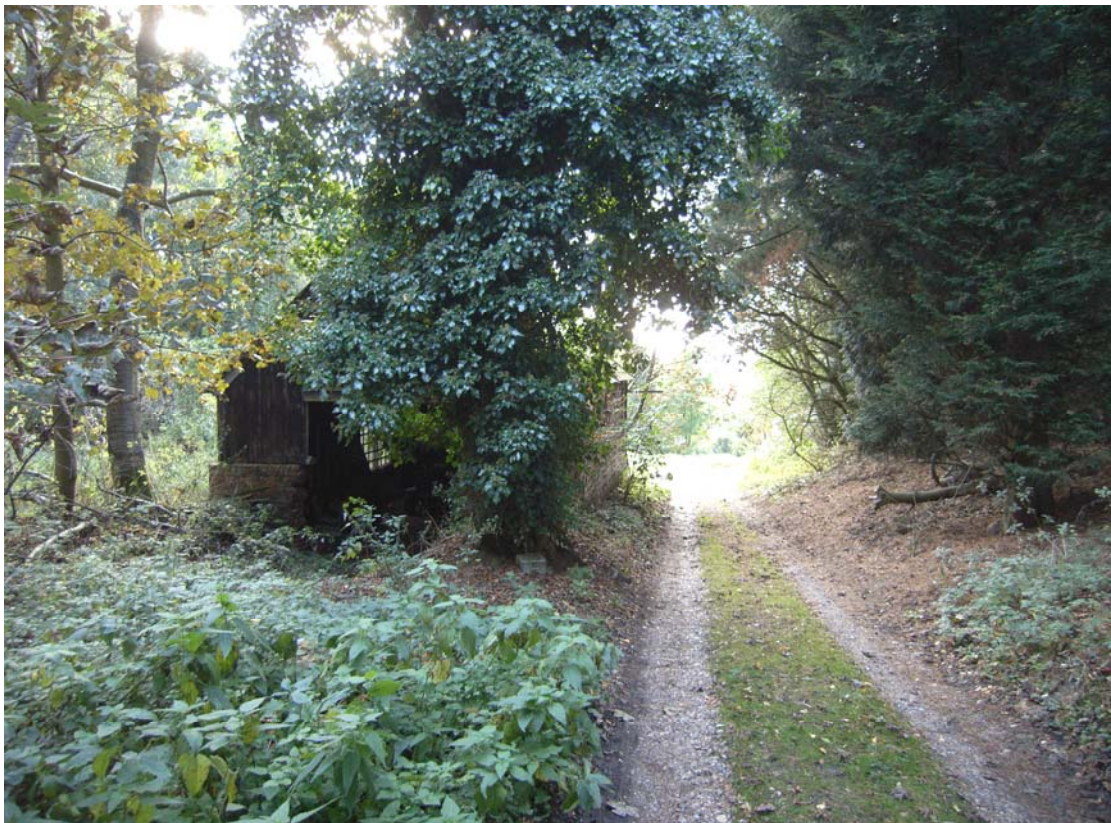
A2.4 Exterior of barn from east showing entrance track to right with remains of yard & site of demolished building to left & Valley Farm Cottage in distance to rear

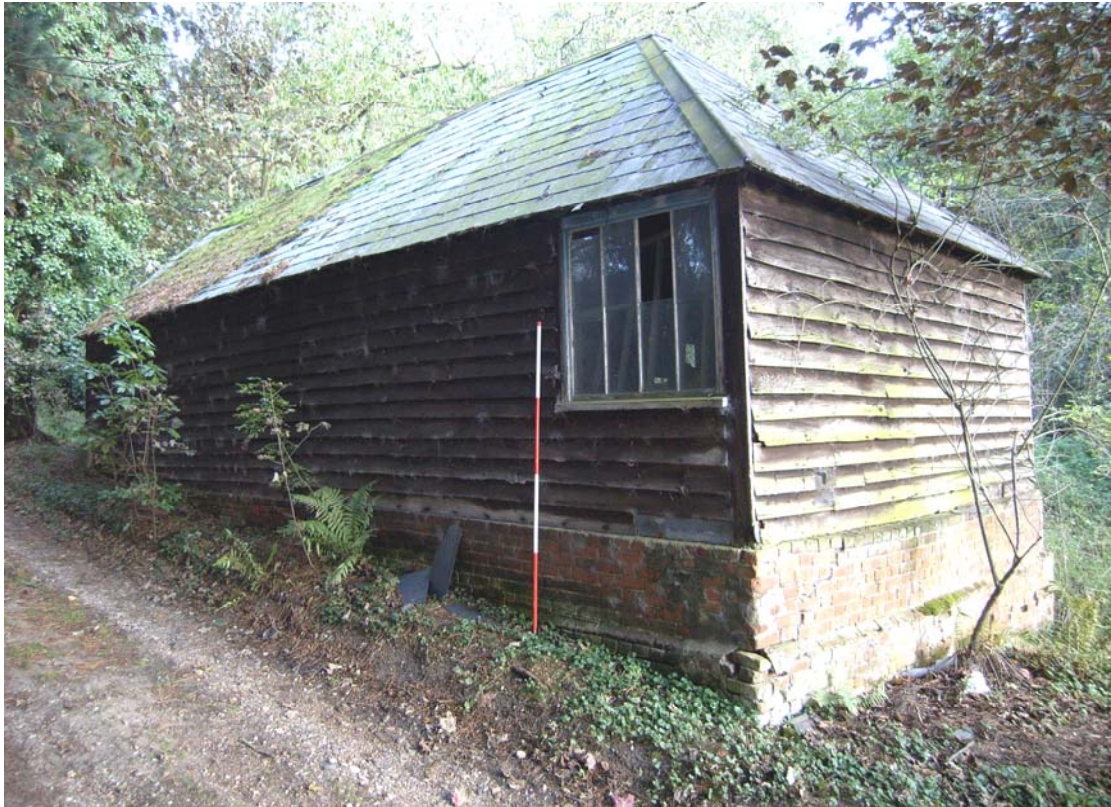
A2.5 Exterior from north-west showing the original slate roof and a secondary window replacing the hatch to the chaff box.

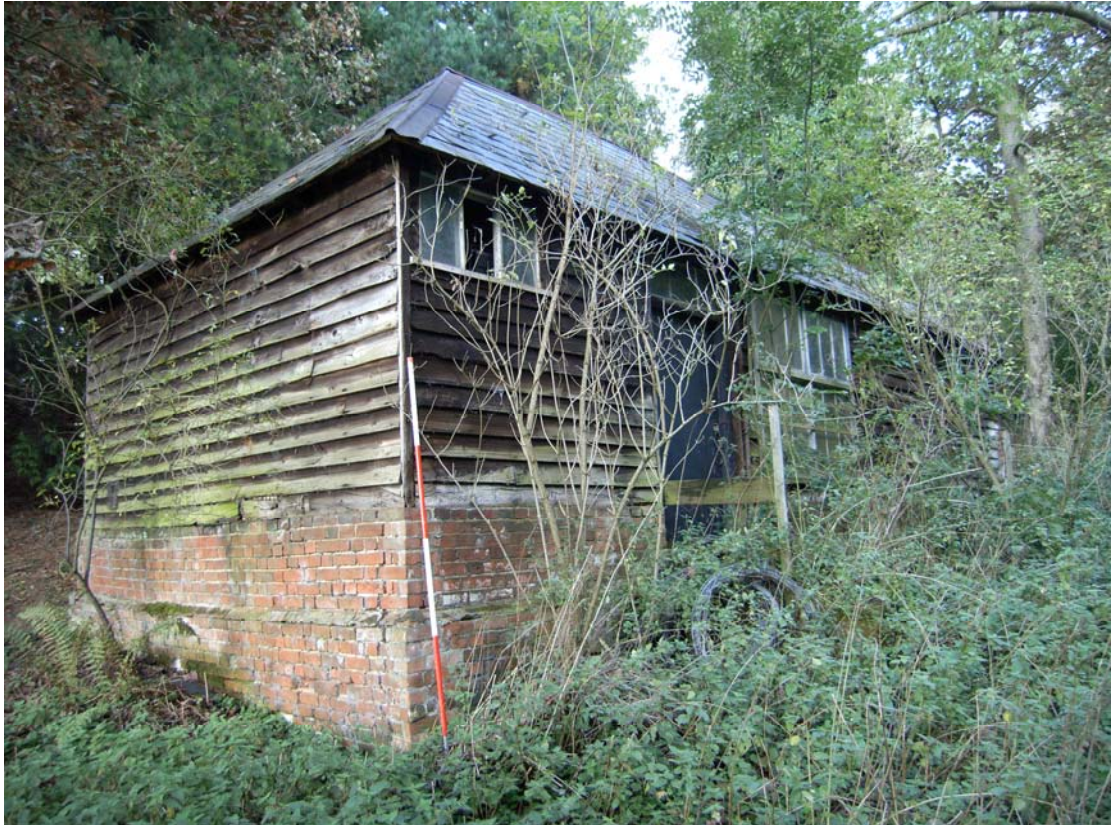
A2.6 Exterior from south-west showing the secondary windows, original entrance (with later door) and site of southern yard to right

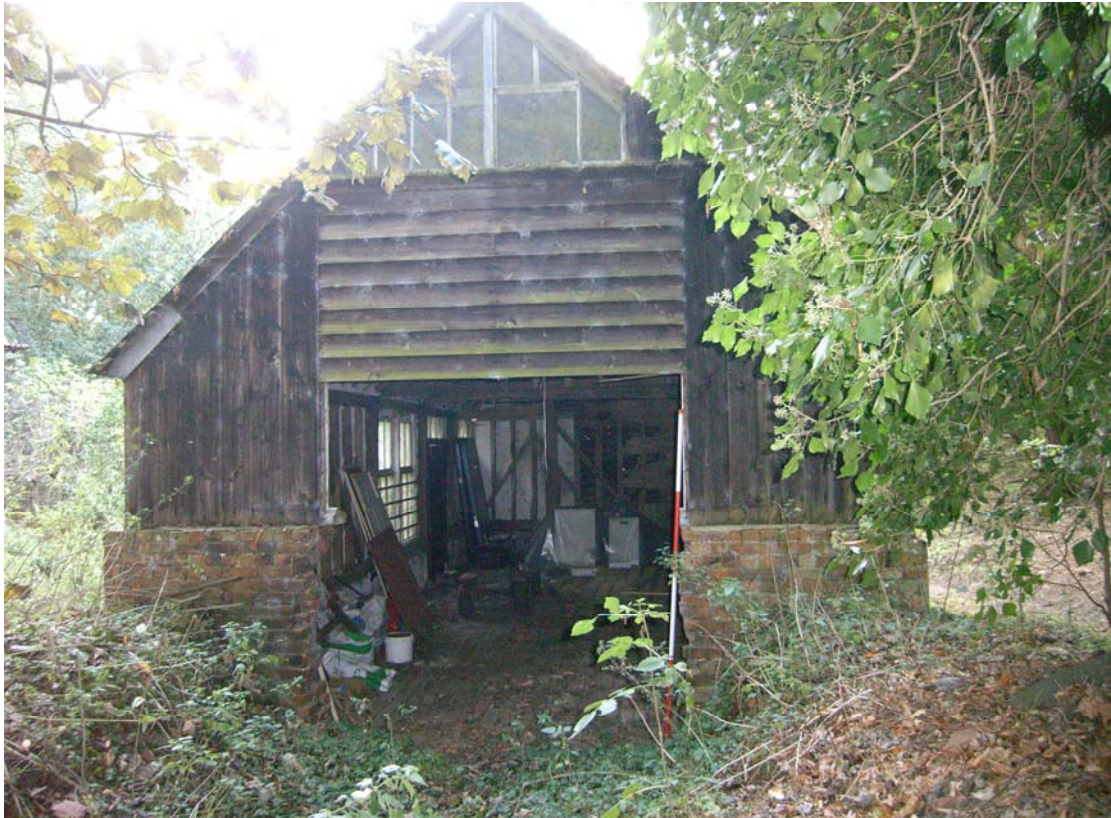
A2.7 Eastern external gable showing secondary vehicle entrance cutting tall brick plinth

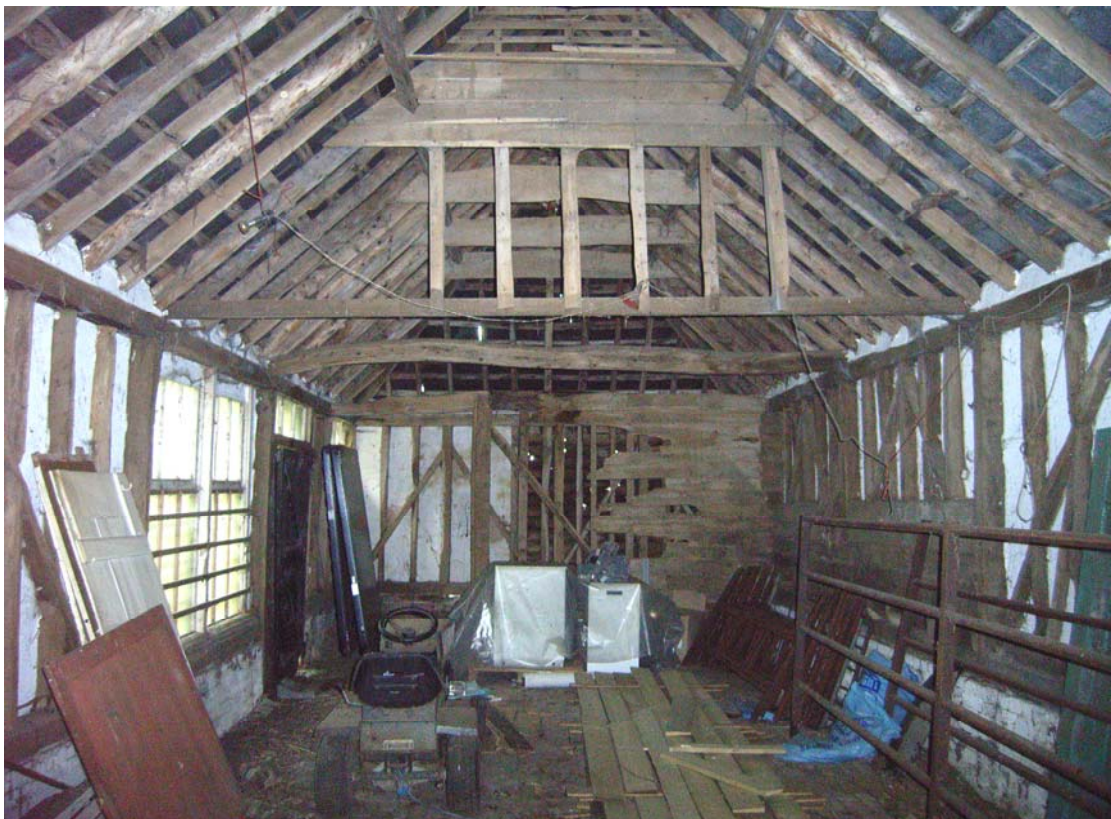
A2.8 General view of interior from eastern gable showing remains of internal partition in roof, site of hay rack and manger to right and boarded chaff box in rear

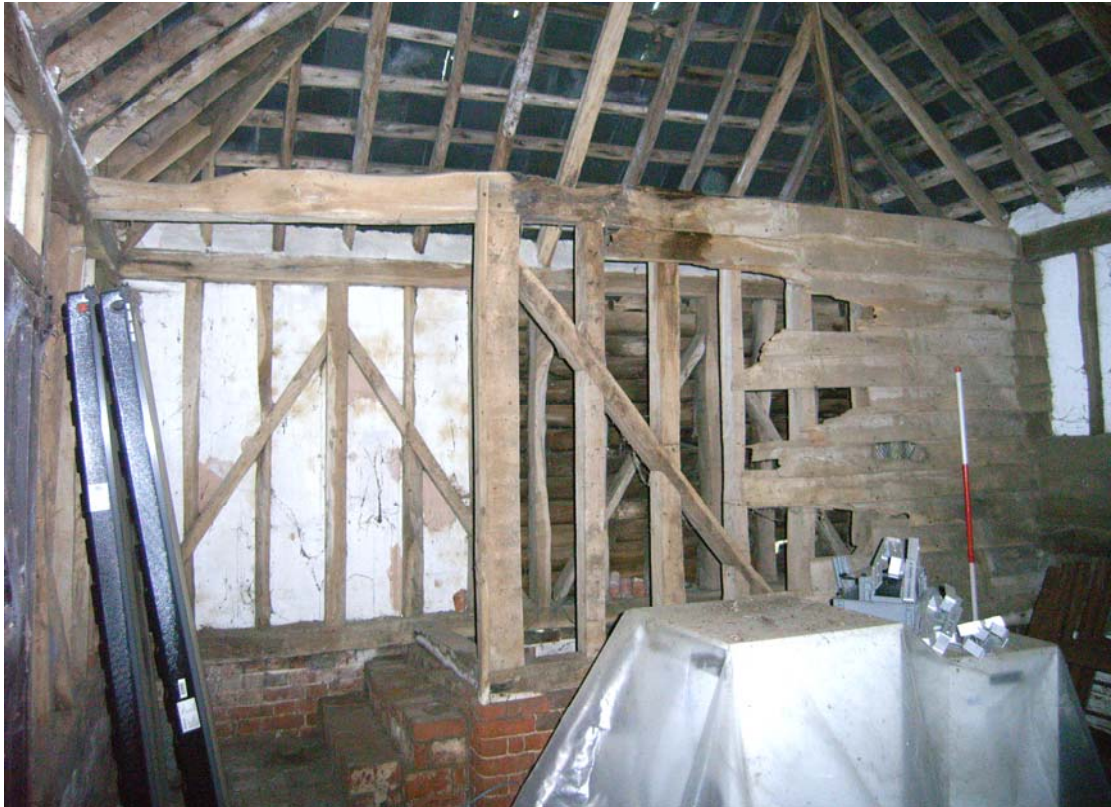
A2.9 Narrow boarded chaff box in north-western corner of interior with secondary brick steps to left and diagonal scar of missing hay rack to right

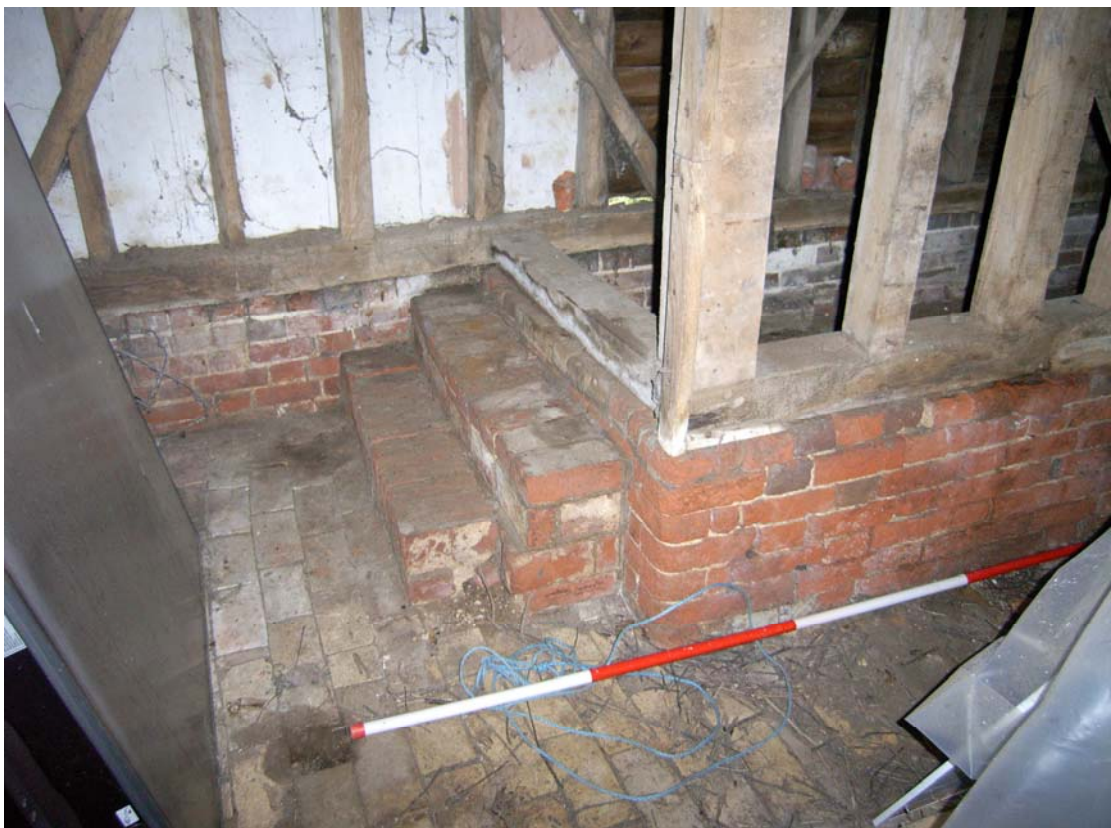
A2.10 South-eastern corner of chaff box showing secondary steps and renewed floor bricks

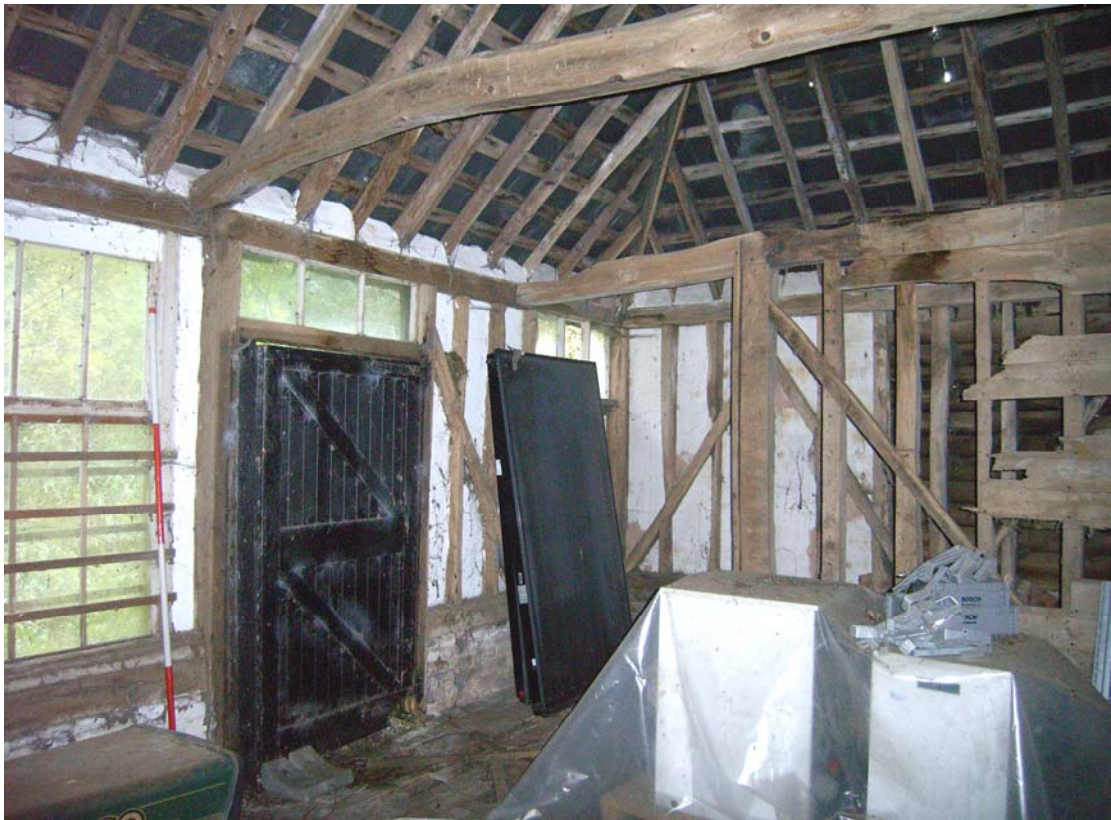
A2.11 Interior of south-western corner showing original southern doorway & secondary window to left with chaff box to right

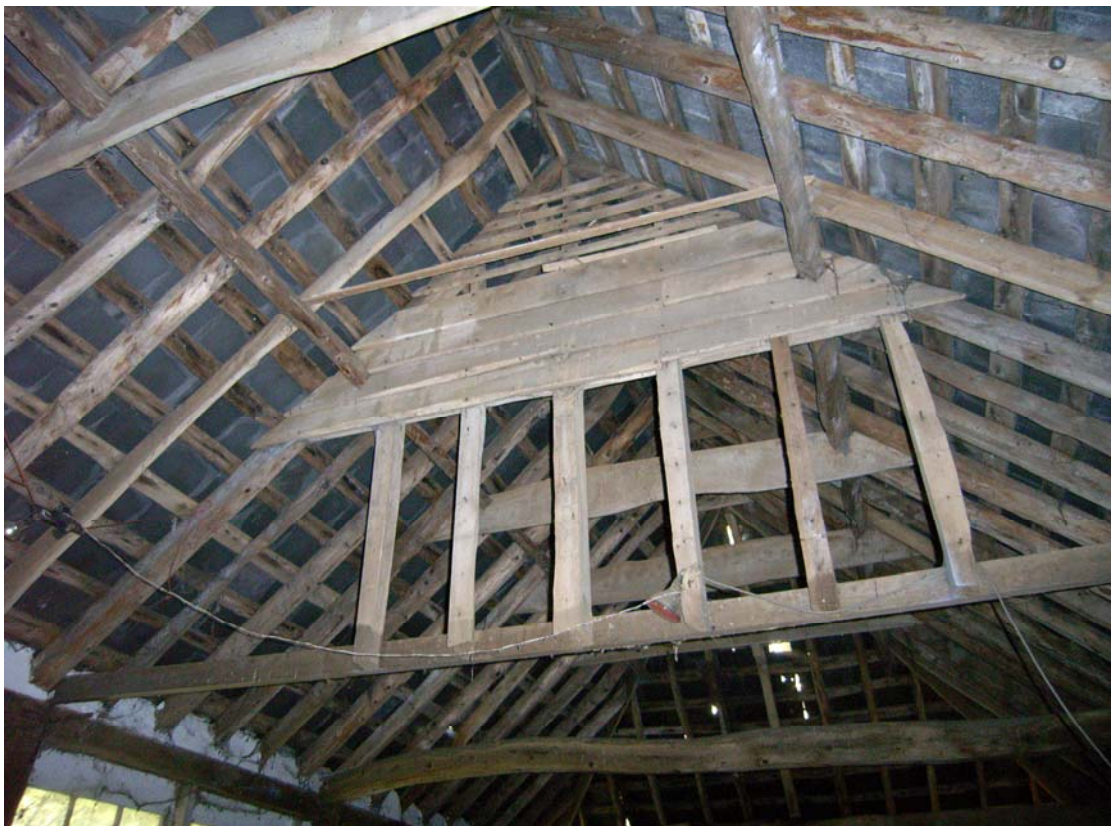
A2.12 Remains of boarded partition between original two compartments seen from east
