ARCHAEOLOGICAL REPORT

SCCAS REPORT No. 2009/237

Aviary Wall Recording, Abbey Gardens, Bury St Edmunds BSE 334

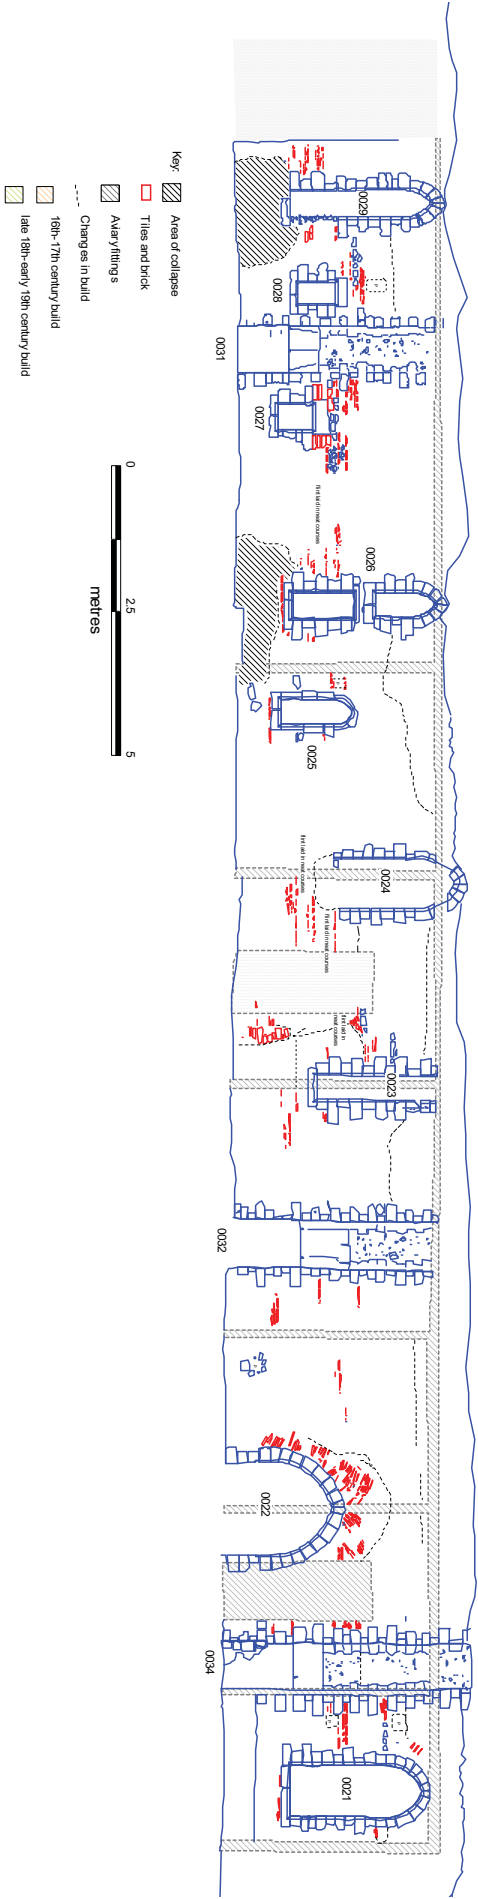
Figure 5. South elevation

The wall is 3.8-4.20m high from the current ground level and truncated at the level of window heads. The wall is constructed of bonded flint rubble core, faced with large, unworked flint nodules with occasional limestone fragments. The facing flints have been sorted with the largest cobbles being laid at the base of the wall. The limestone is in the form of unworked pieces of rubble and occurs generally above mid-wall height (but not exclusively so) and is most frequently seen in the wall fabric adjacent to the window surrounds. It is notable that the use of flint is more uniform across the lower half of the wall and generally the upper half is 'rubble' built.

Roof tiles occur repeatedly throughout the wall face and have been used extensively as pinnings to correct levels in the coursing; particularly at the start/end of lifts and the sills of the windows. They also seem to be used to cap lifts and this is most evident between window 0021 and buttress 0031 where the relationship between the putlocks and the tiles can be clearly seen

The recorded wall length is supported by five, full height, buttresses; these are constructed and completely faced with Barnack stone around a rubble core and keyed into the wall fabric with long-short work (Fig. 7a). They follow the same sloping stepped design suggesting that these are part of a single building or a single campaign of construction. In the wall to the west of the refreshments kiosk there is a variety of buttress styles including earlier short pilaster types.

The aviary wall buttresses are substantial and appear squat but this is due to them being part buried by a rise in the ground level. Comparison with similar styled buttresses elsewhere in the Abbey, where the change in the buttress face occurs at c.1.8m above the ground, suggests that the ground level south of the aviary wall has risen by about 0.5m. The buttresses are constructed within a sequence of paired buttresses spaced c.6.5m apart with an interval of c.14.5-15 m between the pairs; although the intervals are never exact. The spacing of the buttresses was determined by the internal layout of the buildings and, by extension, the position of the windows and doors. Where the remains are identifiable on the north face, the buttresses oppose the internal partition walls. The doors or gateways lie, eccentrically, between the paired buttresses.

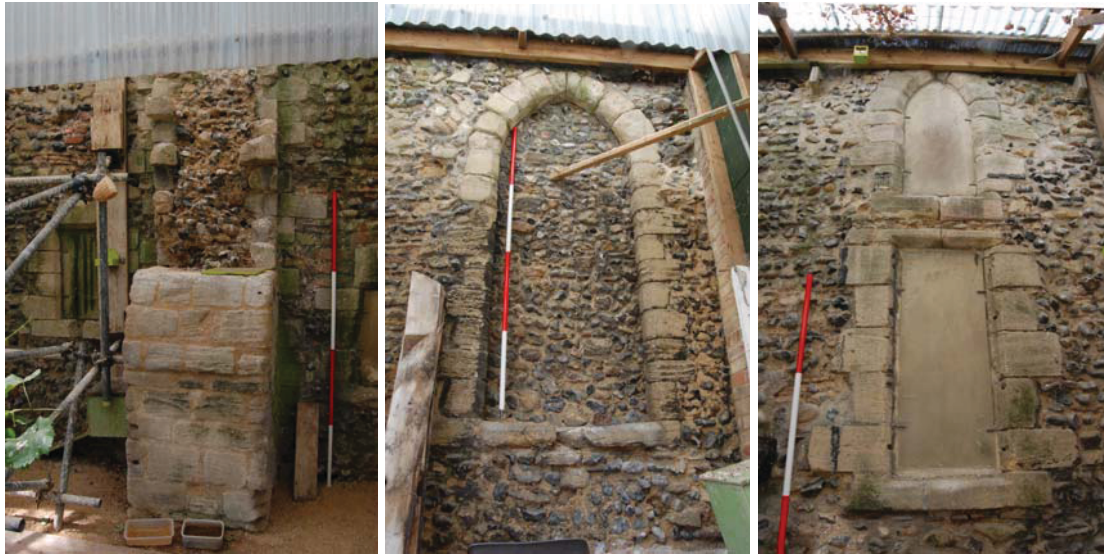
The windows all conform to a pattern of Early English style two-centred arches which date to probably the first half of the 13th century (Fig. 7b). All are the same height (2.28m) but fall into wide (0.8m) and half width (0.4m) variants; the outline of window 0026 shares the outline of the narrow window type but is divided horizontally (Fig.7c). The openings have all been blocked very neatly. The blocking seems to have been undertaken in two campaigns of work as the openings in the west half of the wall have been infilled with slabs of limestone fixed with bronze pegs, whilst in the eastern half flint has been used. The blocking is well recessed into the windows and there is no indication of tracery. On the inside of the window there is a shallow rebate, possibly for shutters. The distribution of the windows along the wall is irregular

Windows 0025 and 0026 are anomalous to the pattern of the other windows, being half-height and set lower in the wall. Notably however, the top of the window is the same level as the horizontal division in the adjacent split lancet 0026, suggesting that the two are related and respect the same feature; an internal floor or gallery at this level. The plan (Fig.4) shows that windows 0025 and 0026 pierce a section of wall that is thinner than the general wall depth. Despite the decay of the north face of the wall, this reduced thickness is a genuine feature and is demonstrated by the partly surviving east edge of the embrasure of window 0026. The internal reveal of 0025 has however been obscured completely by a later repair (Fig. 6). Although the outline of window 0026 is the same as that of 0023 and 0029 it is fashioned from two completely separate openings with a course of flintwork between the stone lintel and sill, but internally the two parts are within a single splay. There is a projecting stone sill within the splay, which suggests that it is divided from the window below but there is no definitive indication of a floor and the sill appears incongruous. There is however a short ledge (Fig.6: 0036), just to the east of the windows formed by the changing thickness in the wall and this coincides with the sill height. Externally the lower half of window 0026 has a small rebate around the inner edge and the fixings for horizontal bars, evidenced by eight, evenly spaced, paired holes within the rebate on the verticals, but this does not extend to the lower one.

a b c
South elevation buttress (a), window 0021(b) and window 0026(c)

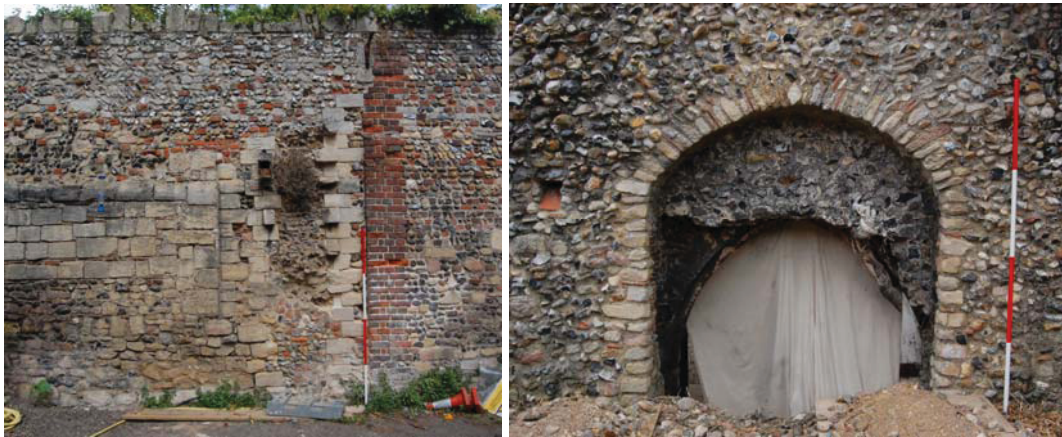
d e
South elevation Buttress 0034(a) and north elevation door 0021(e)

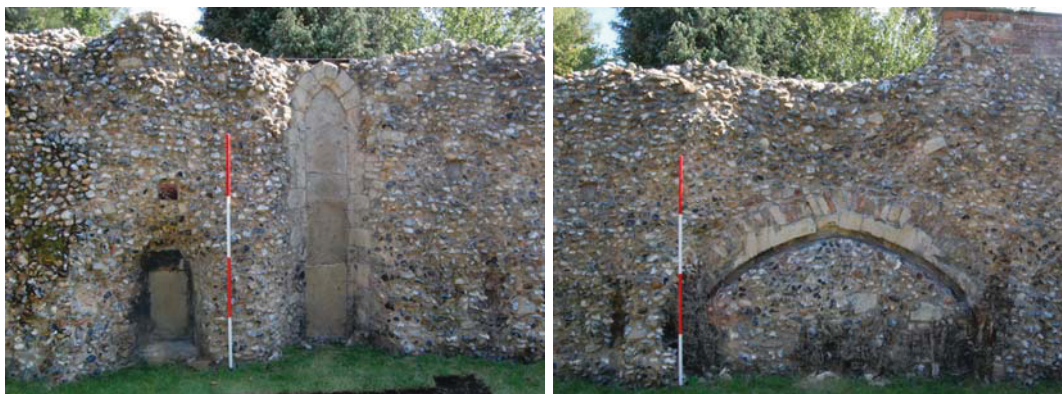
f g
North elevation windows 0028 (f) and 0029 and door 0030 (g)

Entrance 0030 (Fig. 7g) is a larger opening than 0022 and is interpreted as a cart entrance. The arch is a flattened two-centred form and the opening is 2.44m wide with an estimated height of about 3m. On the north elevation the entrance is recessed into the wall and a single moulded stone on the west side indicates the depth to the orders. The wall projects forward either side of the side of the entrance, suggesting that it opens into a passageway and there is a deep rebate cut into the stones of the north side of the arch for a set of heavy doors. Above the stone voussoirs is a second rough arch form made up of 1½ courses of mixed bricks laid on edge. Both red and white bricks are used and limestone rubble is included in the mix.

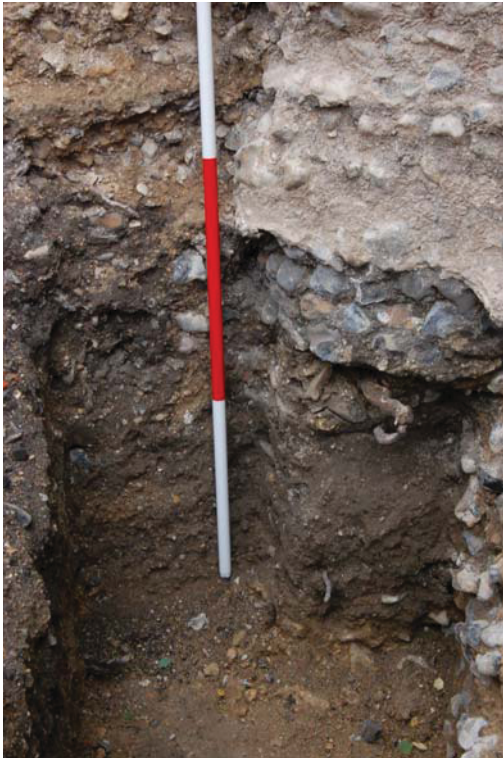
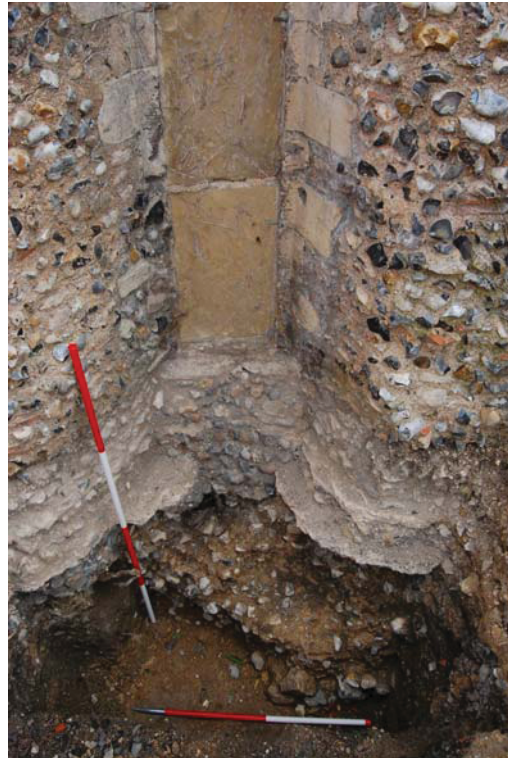
Test hole 1 showing unsupported masonry (h) and unrepaired medieval wall and limecrete blindings (i)

The surface of the south side of the wall has bulged and the face has started to collapse in two places and the causes of the failure were apparent within the test hole excavations. On the north side of the wall, the east side of the reveal of window 0029 has been reconstructed as part of a creative restoration; this is a substantial block of flintwork and is not built off any supporting medieval masonry. The soil immediately below the rebuilt reveal was probably deposited around the 18th century and is not well consolidated and as the result this part of the wall is dropping and has opened up a horizontal crack. The problems are compounded by root action.

The wall is in need of repair and underpinning of the collapsing section. It is recommended that there is archaeological input into this work to record any additional evidence that may be exposed. Much of the soil build-up to the

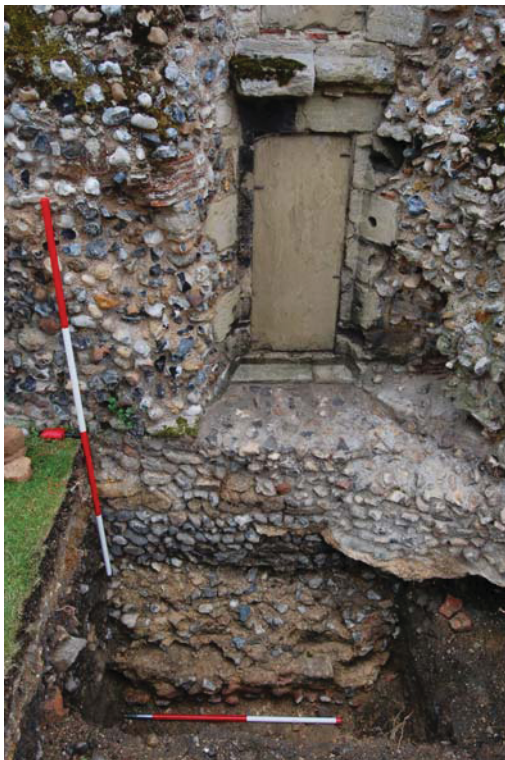
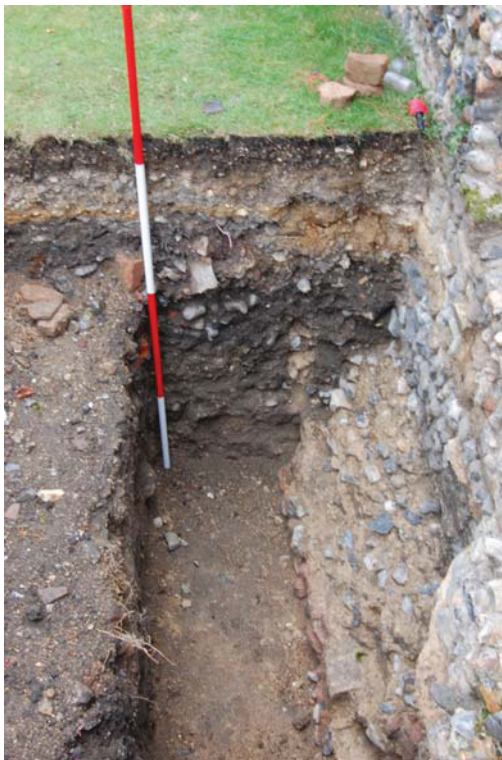
Test hole 2 showing projection wall below current ground level

The excavation found a stepped change to the internal wall face and this was interpreted as a floor height and probably close to the original external ground level at this point too. This level is 0.7m higher than the level at the east end of the building but the relationship between the relative floor and window heights is the same in the two parts of the building.
