ARCHAEOLOGICAL MONITORING REPORT

SCCAS REPORT No. 2009/243

**The Old Vicarage, Badwell Ash
BAA 023**

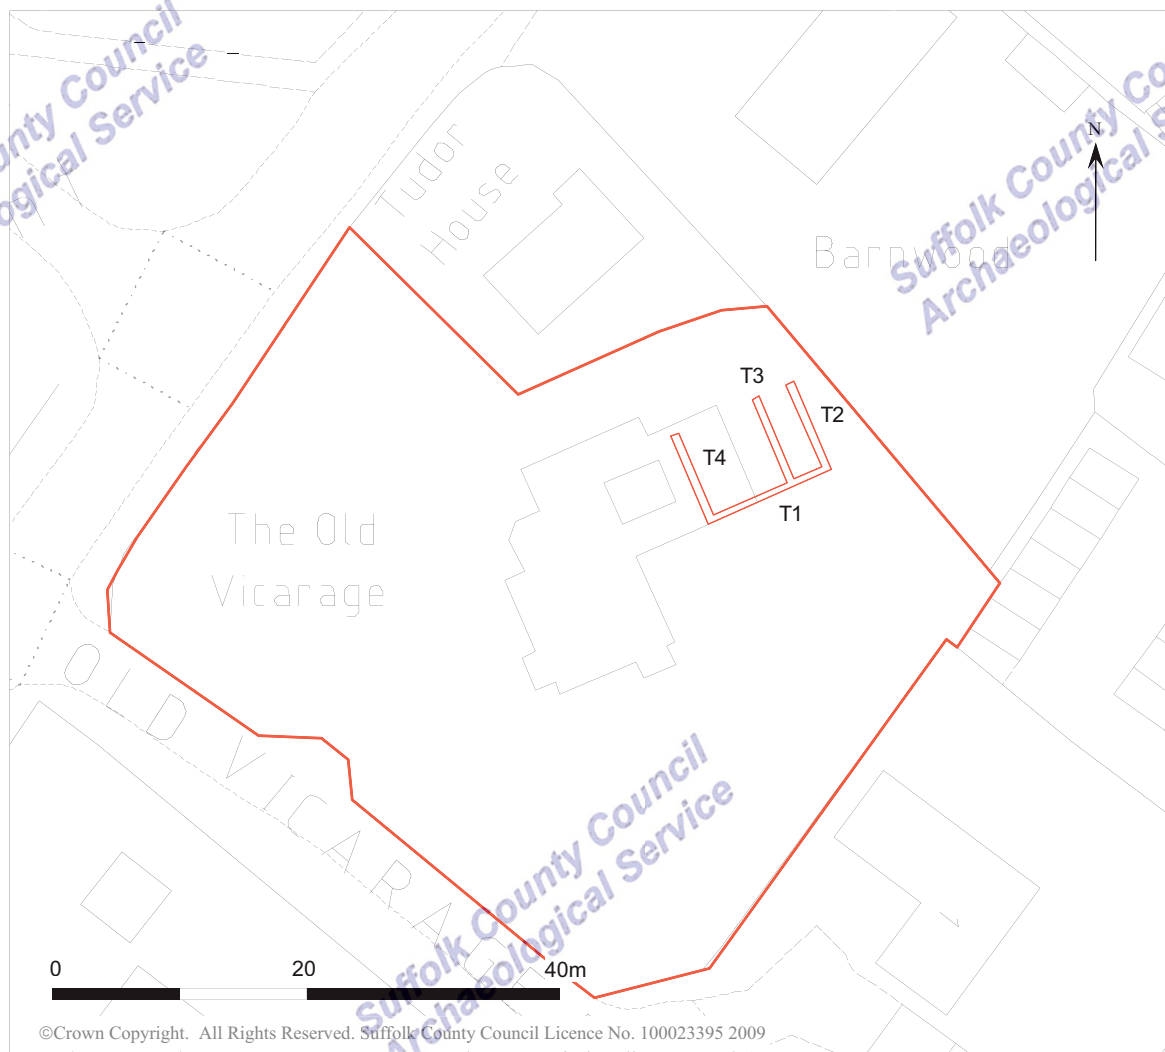
Figure 2. Trench location

The existing garage had been demolished and four 0.6m wide foundation trenches were excavated by a 3 ton, 360 degree excavator fitted with an 0.4m wide toothed bucket. The trenches were excavated to a depth of between 0.8m and 1m below modern ground level, except in Trench 1 where a modern brick lined pit/soakaway was removed to a depth of 1.4m. Trench 1 measured 10.4m in length, Trenches 2 to 4 were 7m long and together formed an uneven E shape (Fig. 2).

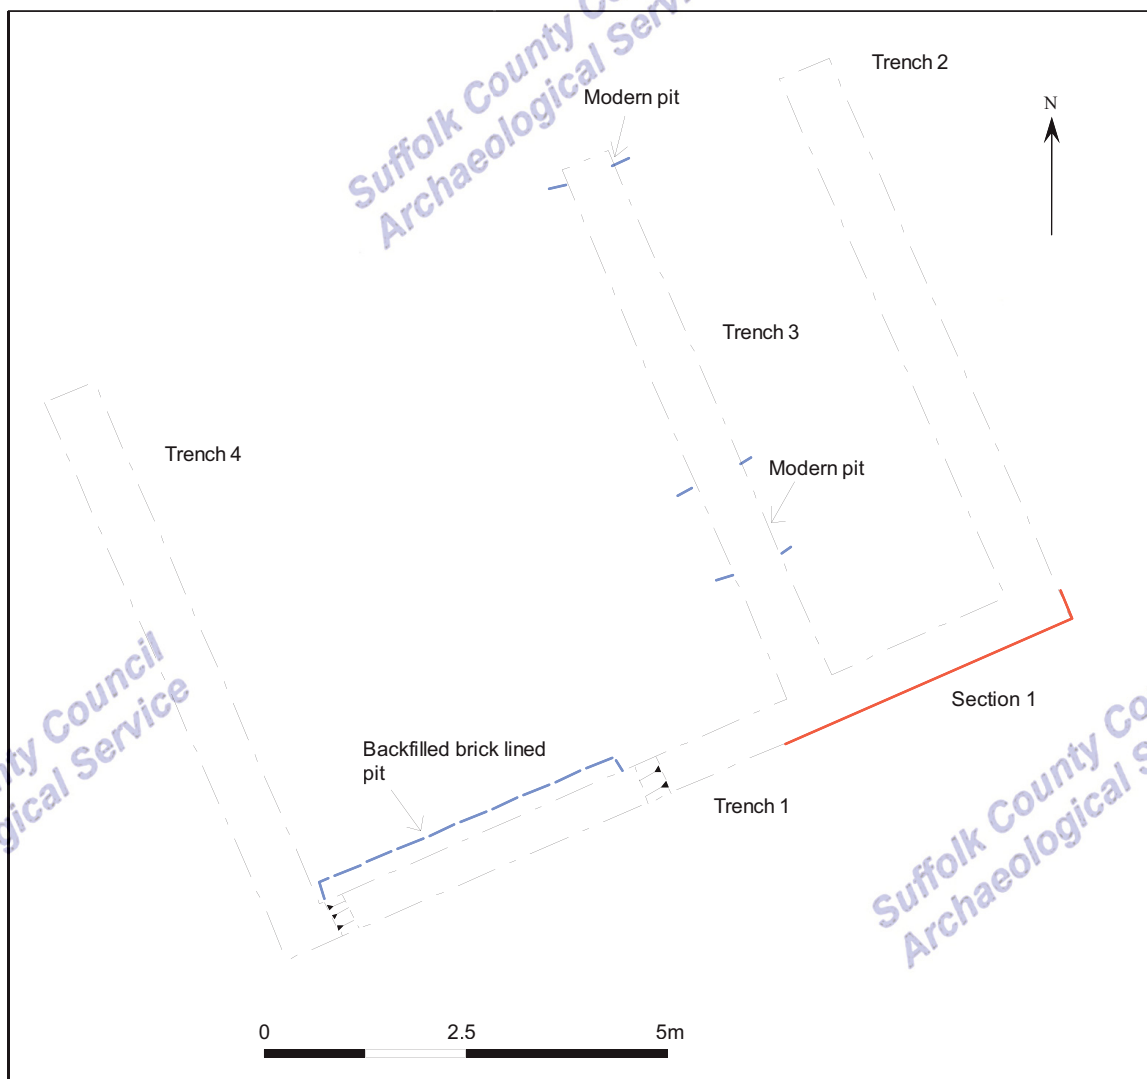
Figure 3. Trench plan

The majority of the development area appears to have been subject to substantial remodelling, probably prior to the construction of the Old Vicarage and probably resulting from quarrying gravels and flint for building work. A substantial posthole was recorded cutting the backfilled quarry pits, two modern backfilled pits were observed and a modern brick lined pit/soakaway was also recorded (Fig. 3).

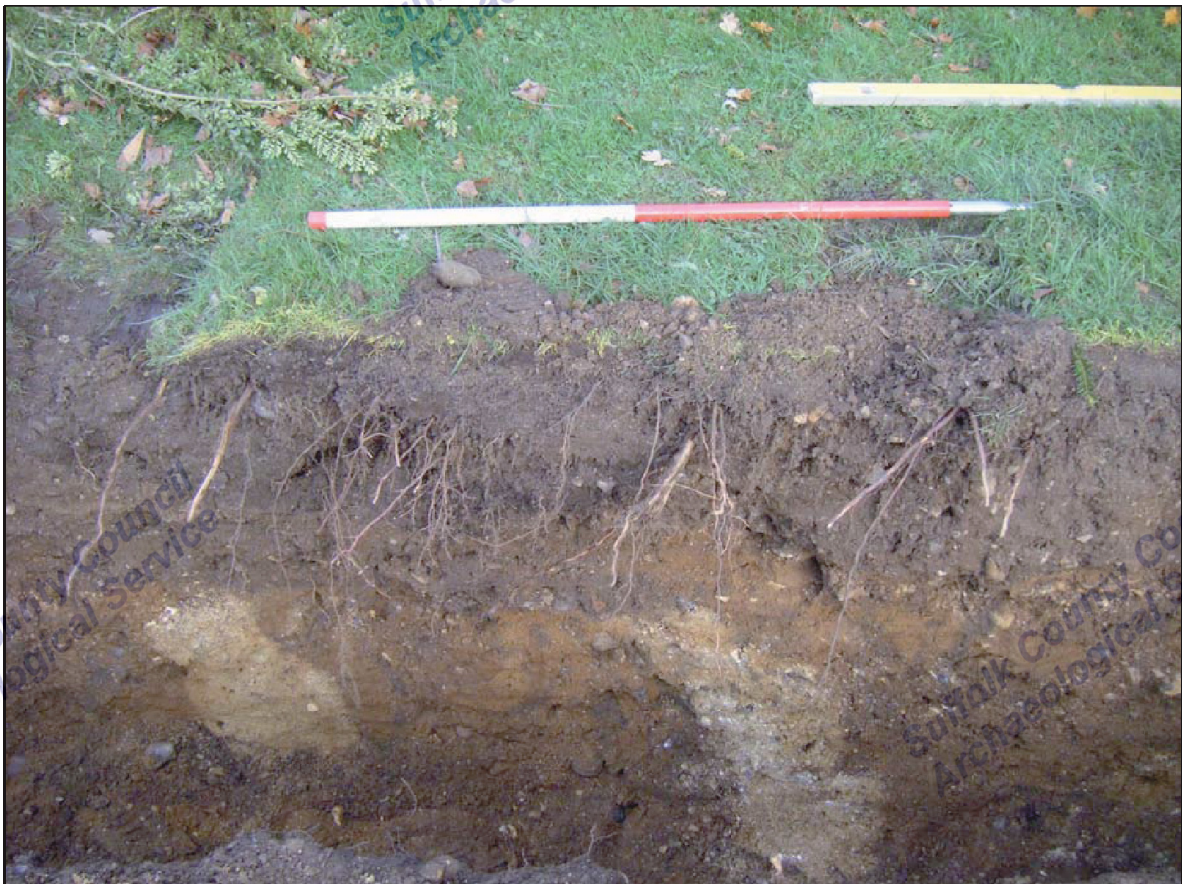
Redeposited material 0006, presumably derived from backfilling quarry pits was observed across the whole of Trenches 2, 3 and 4. The base of this material was not observed within the excavated foundation trenches and is therefore greater than 0.8m in depth. It was a mixed deposit of sorted gravels, peagrit, sand and pulverised chalk layers. The profile suggests that these represented dumps of material that had been tipped haphazardly into large pits (Plate 1). In places this backfill was sealed by mid grey brown sandy silt subsoil 0005 with moderate gravel inclusions (0.2m at

Plate 1. Possible quarry backfill in Foundation Trench 2 looking north-east, 1m scale

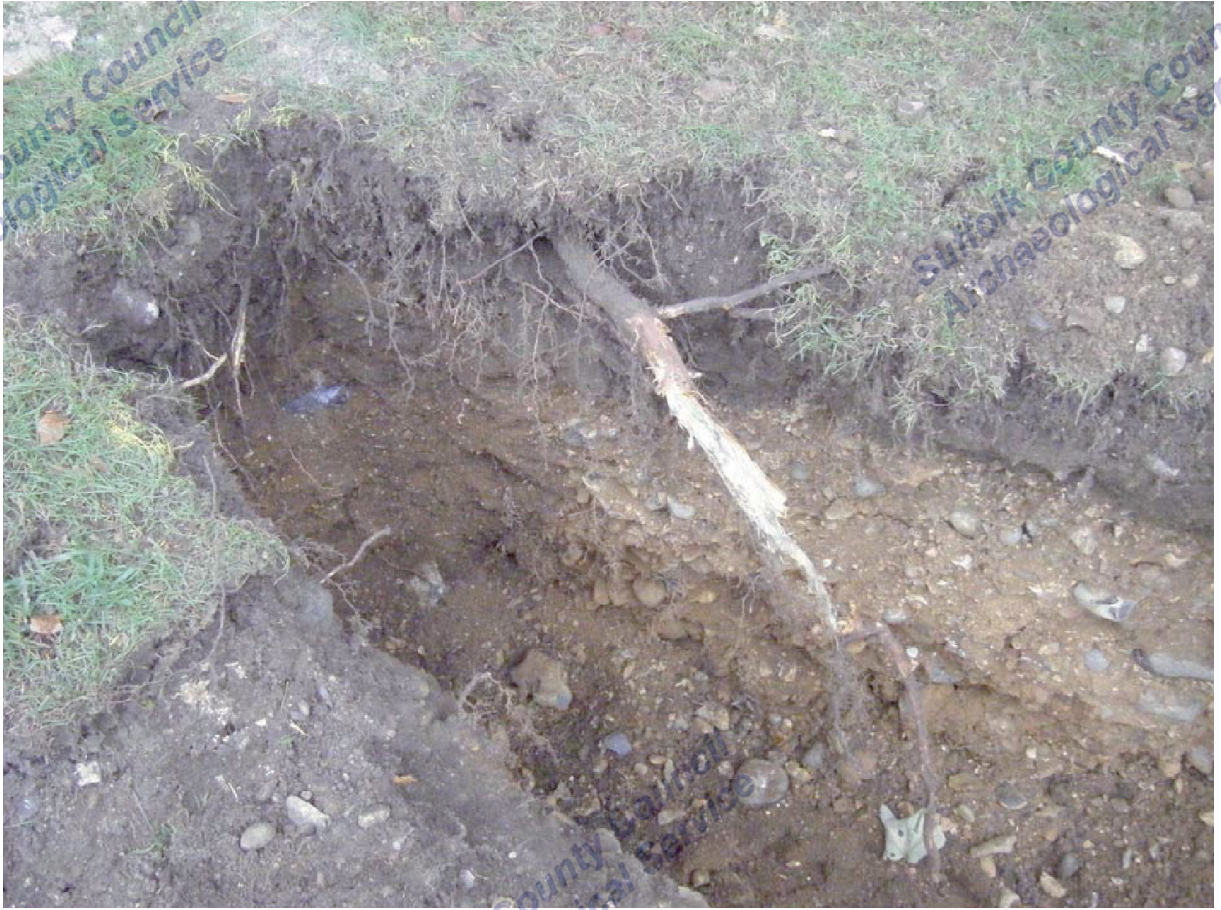
A large vertically-sided possible posthole 0003 obscured the relationship between the two sequences in the corner of Trenches 1 and 2 (Fig. 5). It was observed only in section and measured 0.5m+ in width and more than 0.75m in depth, and was filled with mid orangey brown loose sandy silt with abundant peagrit gravel and rare large flint fragments 0004 (Plate 2).

Plate 2. Posthole 0003 in Trench 1, looking east
