The Parish Church of All Saints & St Margaret's, Pakefield (LWT 030), Record of an Archaeological Evaluation

**Report No. 2005/10
Oasis ID No. suffolkc1-6796**

Detail of Blocked East Window

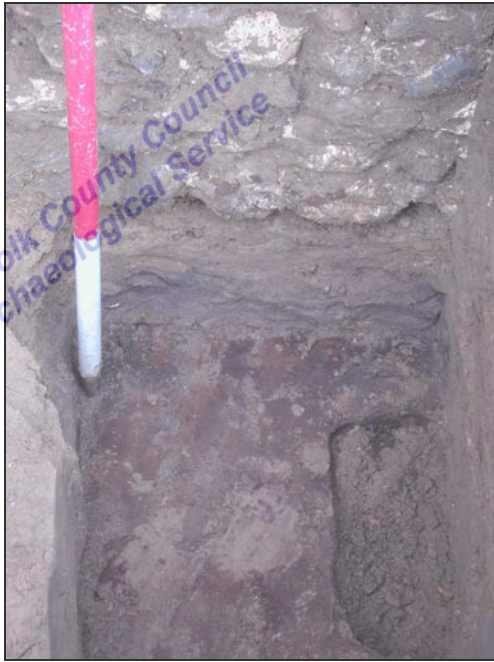
Plate 4: Test-Pit A, Grave & Base of Nave Wall

Below the topsoil a homogenous light brown silty loam, including some mortar flecks, was recorded. This layer continued down with little variation to a depth of 0.6 metres where the first hints of grave cuts were visible. When the naturally occurring subsoil, comprising, podsolised, orange/brown sand, was encountered at a depth of 0.98 metres, the eastern ends of two graves could clearly be seen cutting into it. The southernmost of these graves was excavated down to the level at which the toes of the burial and associated coffin nails were visible, at a depth of 1.04 metres below the present ground level (Fig. 3 & Plate 4).

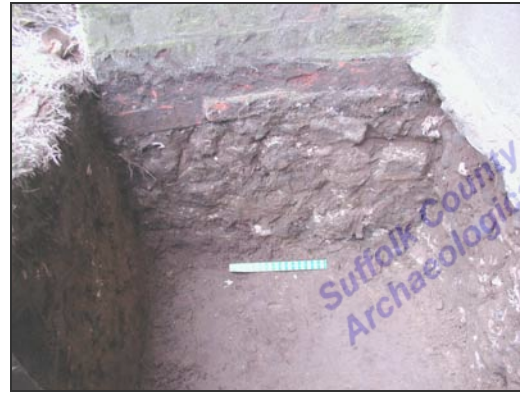
Plate 5: Test-Pit A. Buttress & Nave Wall

Test-Pit A also provided structural information regarding the north wall of the nave. Below the modern render, which had been lipped out to deflect runoff water away from the wall face, a further six or seven courses of relatively well coursed flint cobbling was recorded which were continuous with those of the buttress, with no discernible break (Plates 4 & 5). At this level there were no bricks included in either the wall of the church or the buttress. The base of the wall, recorded at a depth of 0.74 metres, appeared to lie directly on subsoil with no evidence for a formal footing, although there was a shallow depression cut into the naturally occurring subsoil on the line of the wall. However, the brown silty sand fill of this depression was effectively indistinguishable from the adjacent soil.

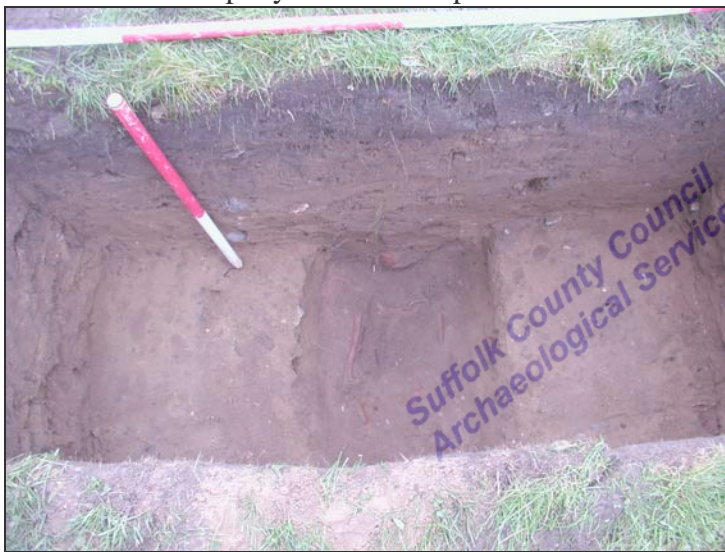
Plate 6: Test-Pit B, Grave with Exposed Skeleton

silty sand in which the hints of a grave cut were visible from a depth of approximately 0.7 metres (Fig. 4 & Plate 6).

Excavation within this cut revealed an articulated skeleton and coffin furniture (iron handle) at a depth of 1.08 metres. The position of the skeleton in a grave cut aligned with the standing gravestone suggests strongly that the two were associated, the latter in situ, and that the remains were actually those of Mr Bicker.

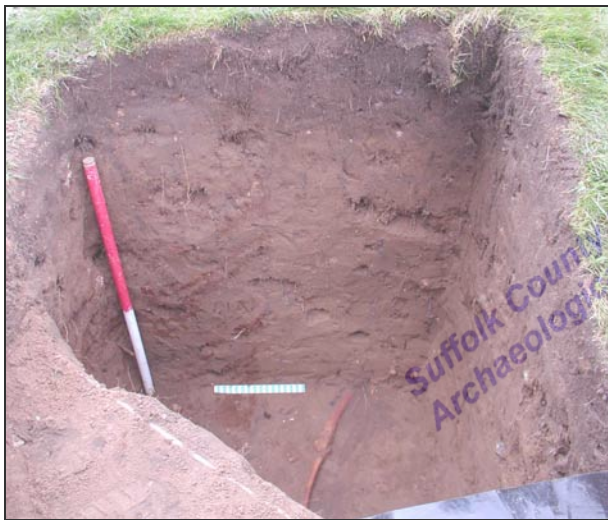
Plate 7: Test-Pit C, Grave With Exposed Skeleton

Topsoil depth varied between 0.18 and 0.35 metres, the difference caused by the landscaping associated with the path (Fig. 5 & Plate 7).

Below this was a relatively homogenous brown silty sand, although there was a suggestion of a vertical grave cut recognised immediately below the topsoil. Further excavation confirmed the presence of a grave when articulated skeletal remains were encountered at a depth of 1.36 metres.

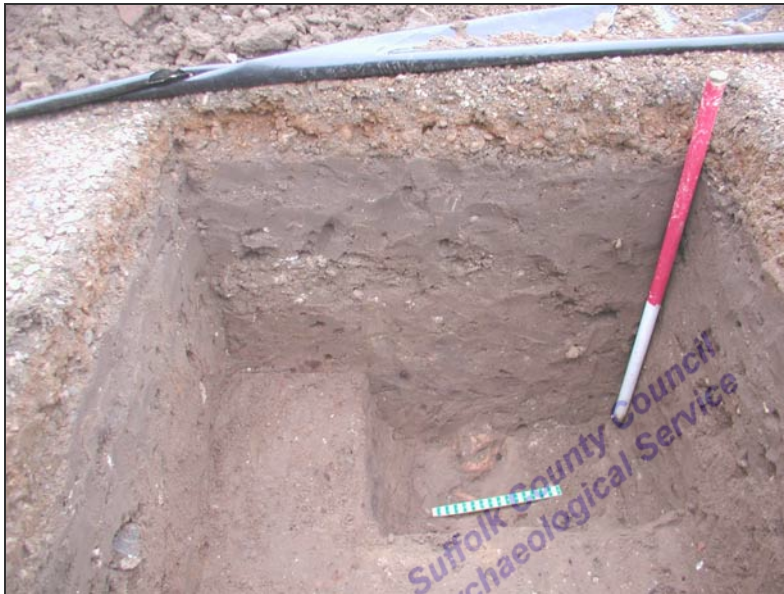
Plate 8: Test-Pit D, Grave With Exposed Skeleton the grave against the western side of the trench revealed an articulated skeleton at a depth of 0.9 metres below the present ground surface.

The beach gravel forming the path was found to be a uniform 0.18 metres thick. This accumulation was almost certainly the result of a number of repeated applications. Removal of the gravel revealed a relatively homogenous brown silty sand with a localised gravel and mortar layer (Fig. 6 & Plate 8). A clear grave cut was recorded at a depth of only 0.45 metres. A sondage excavated into
