ARCHAEOLOGICAL EXCAVATION REPORT

Eastgate Barns Area A, Eastern Way, Bury St Edmunds BSE 229

A REPORT ON THE ARCHAEOLOGICAL EXCAVATIONS, 2004
(Planning app. no. SE/04/3016/P)

Suffolk C.C. Archaeological Service

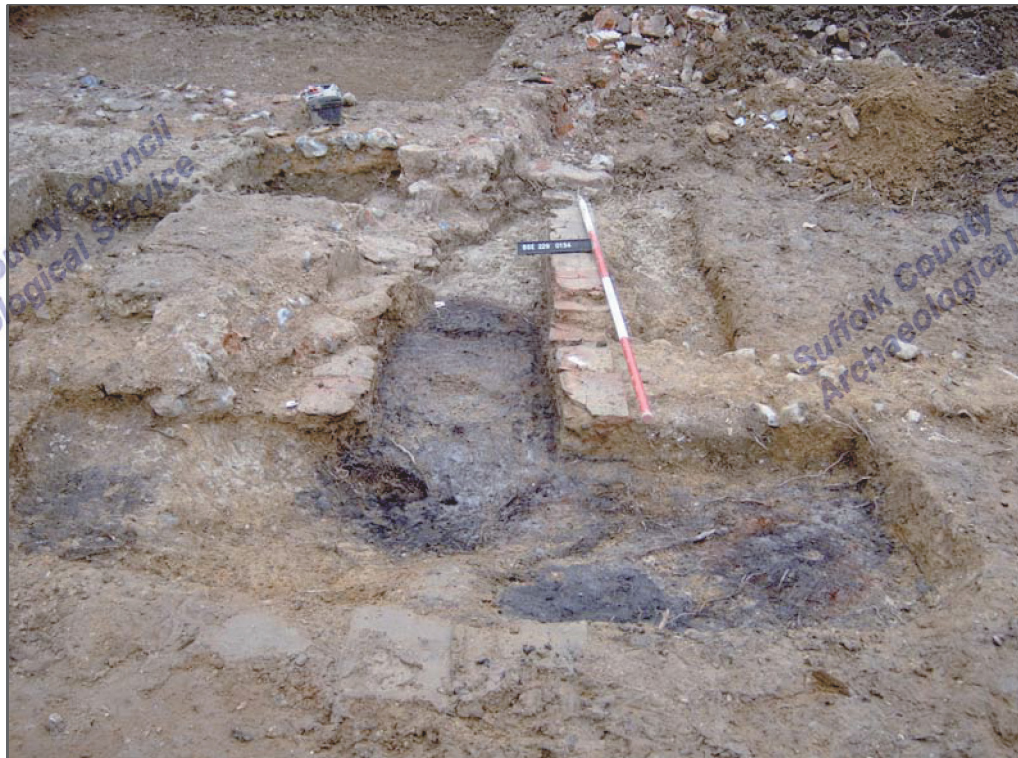
Figure 8. Photograph of oven 0134 looking west.

The structure consists of two L-shaped walls, 0183, with a tile lined flue, 0153 and 0154, and a pit, 0287, at the eastern end (Figures 7 and 8). The western end of the structure was not preserved and had been destroyed by the construction of the later farmhouses. The walls were constructed using flint and mortar (0183) and were also partly tiled faced, forming a flue running north-east to south-west. The tiles used in the construction were reused glazed roof tiles dating to the 13th-14th century and were high status, and probably recovered from a large domestic building (0153 and 0154) (Anderson this report). At the eastern end of the walls was a shallow semi-circular pit, 0287, filled with rubble, 0155. Reddened clay and charcoal was identified across the base of the pit, layers 0156 and 0157, and between the walls suggesting burning. However, the limited extent of the burning suggests that very high temperatures were not used.

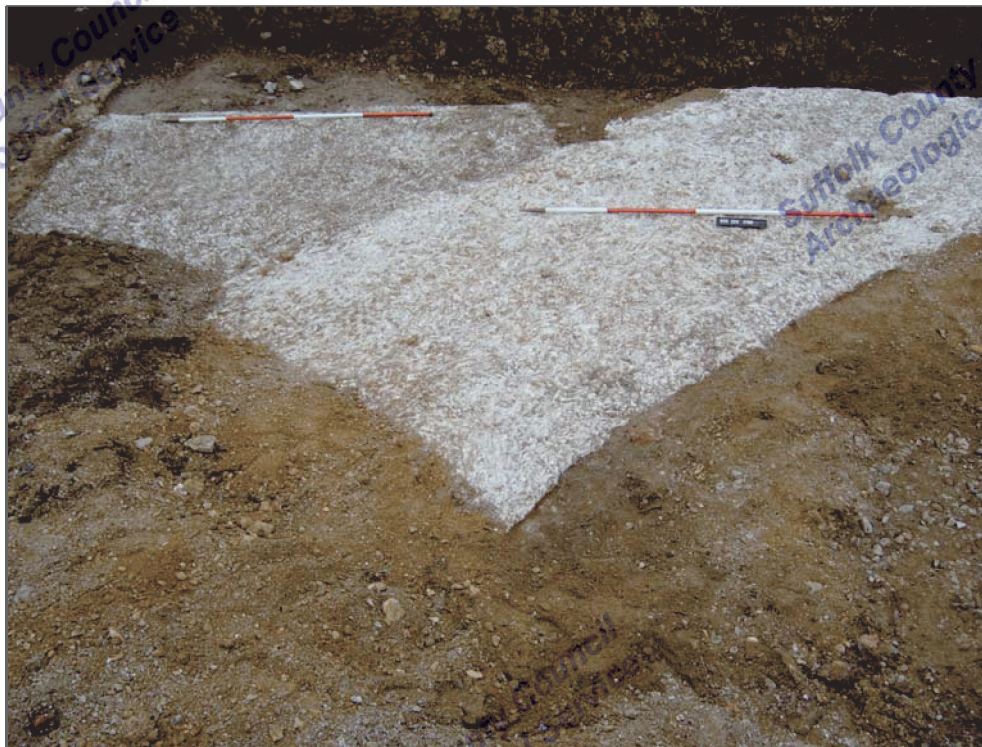
Figure 12. Photograph of chalk 0220 (part of roadway).

The chalk deposit has been interpreted as the base of a roadway leading from the post-medieval farm to Eastgate Street to the south (Figure 1). The chalk would form a stable base onto which gravel would be laid to create a weather and wear resistant surface. Gravel layer 0227 appeared to be the primary gravel surface with the later gravel layer, 0219, more likely to be a resurfacing. Examples of similar external chalk and gravel surfaces can be seen elsewhere in post-medieval contexts in Bury St Edmunds. Examples include the rear of the Angel Hotel (BSE 231 – Duffy 2006) and to the rear of Greene and Greene, 80 Guildhall Street (BSE 224 – Duffy 2007). The direction of the road indicates it may link up with Barn Lane to the south and therefore extends below the current A14 embankment. This suggests that the road is older than the late 19th century construction of the railway embankment, now the A14 road. A road in a similar location can also be seen on Warren's Map (dated 1747) suggesting this road dates back to at least the

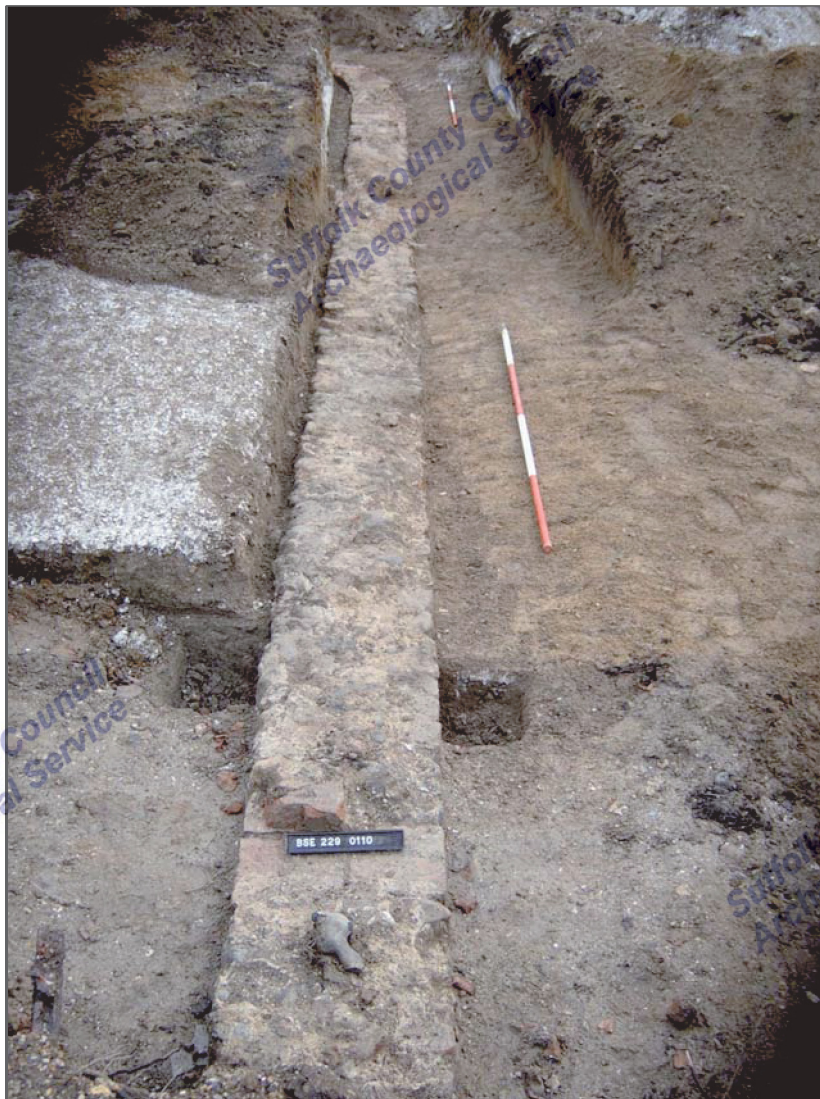
Figure 13. Photograph of wall 0110 looking south.

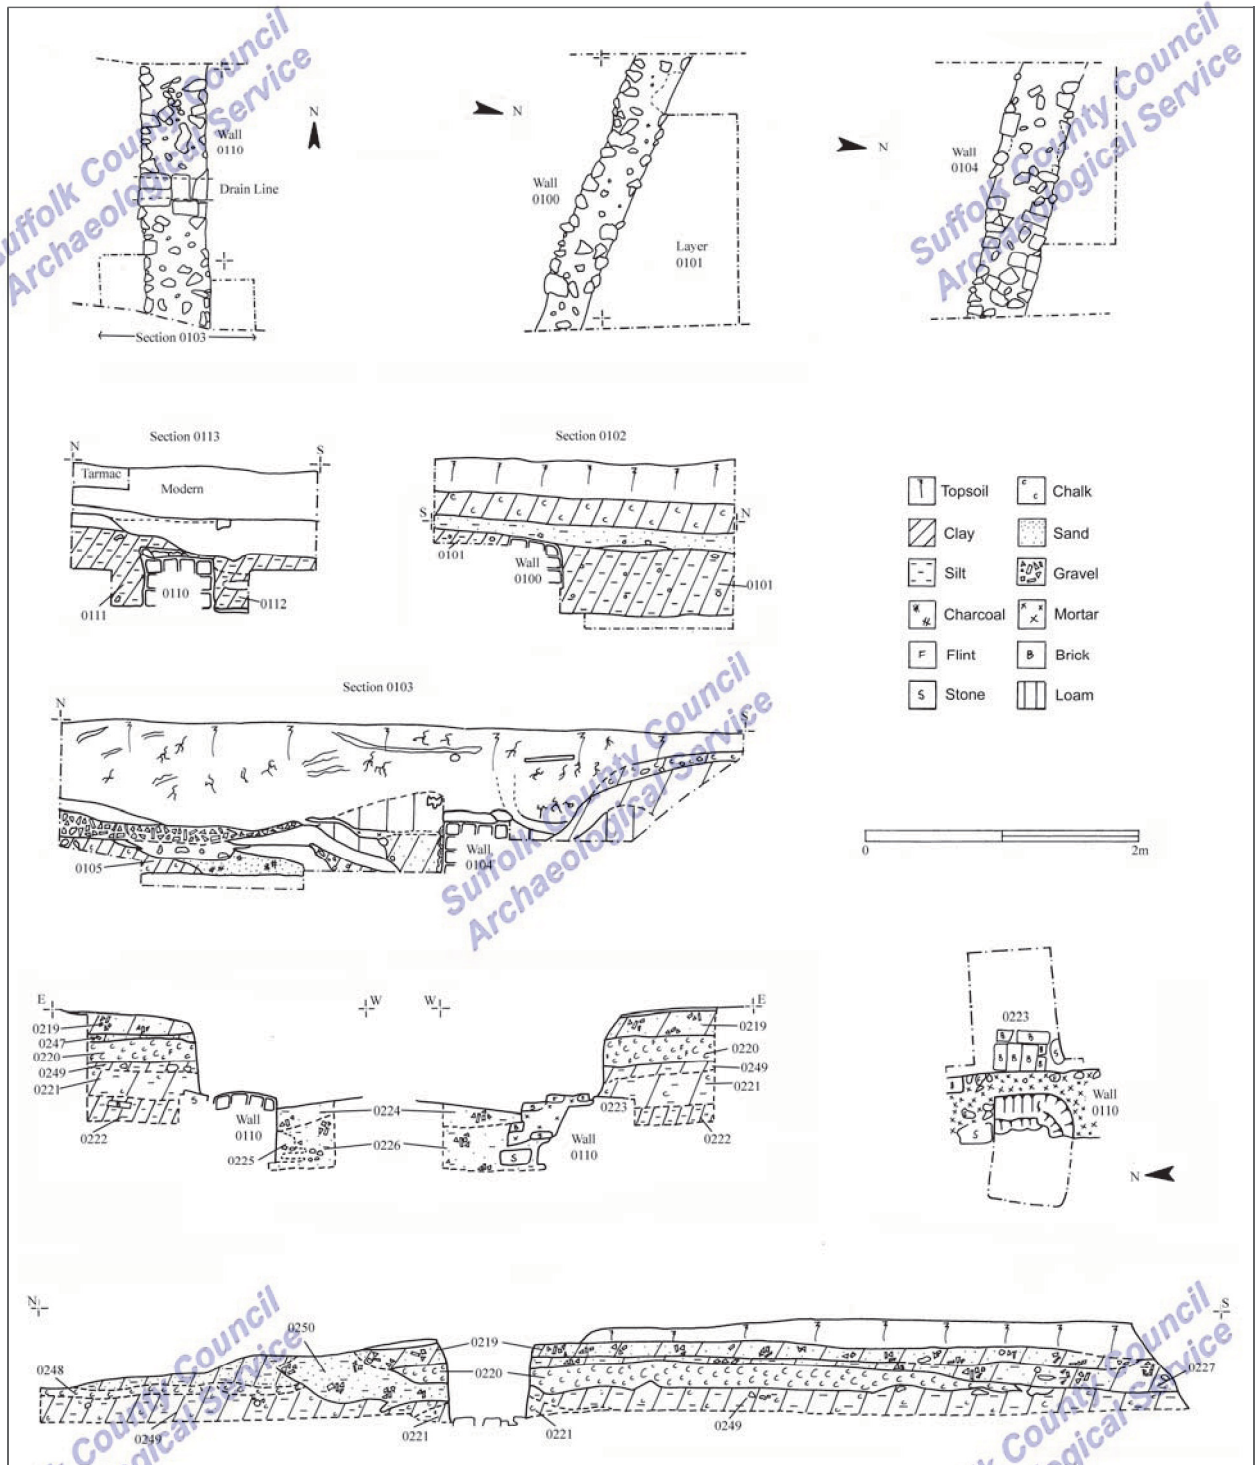
Figure 14. Plans and sections of walls 0100, 0104 and 0110.

flint, with occasional broken bricks, bonded with a yellow mortar, measuring 0.5m wide. A possible brick lined drain through the wall was identified in Trench 1 (Figure 14). The drain did not appear to have been inserted and was probably part of the original build. A second drain was identified further to the south where bricks, 0223, were laid against the eastern face of wall 0110 and the wall appeared cut away on its western face (Figure 14). Both would have allowed draining of the land to the east of the wall into the River Lark to the west. In Trench 1 the wall was sealed by layer 0111, which contained 18th century pottery, and by 0221 to the south. These layers were probably laid to level the area of the farmyard as there was a slight natural slope down to the river to the west. Wall 0110, although of a similar build and size, did not appear related to wall 0104 at the northern end of Trench 4 and was not related to wall 0100.
