**Outbuildings at,  
Forge Cottage,  
Cockfield, Suffolk  
COK 058**

**Historic Building Record**

# Outbuildings at Forge Cottage, Great Green, Cockfield, Suffolk

## Historic Building Record

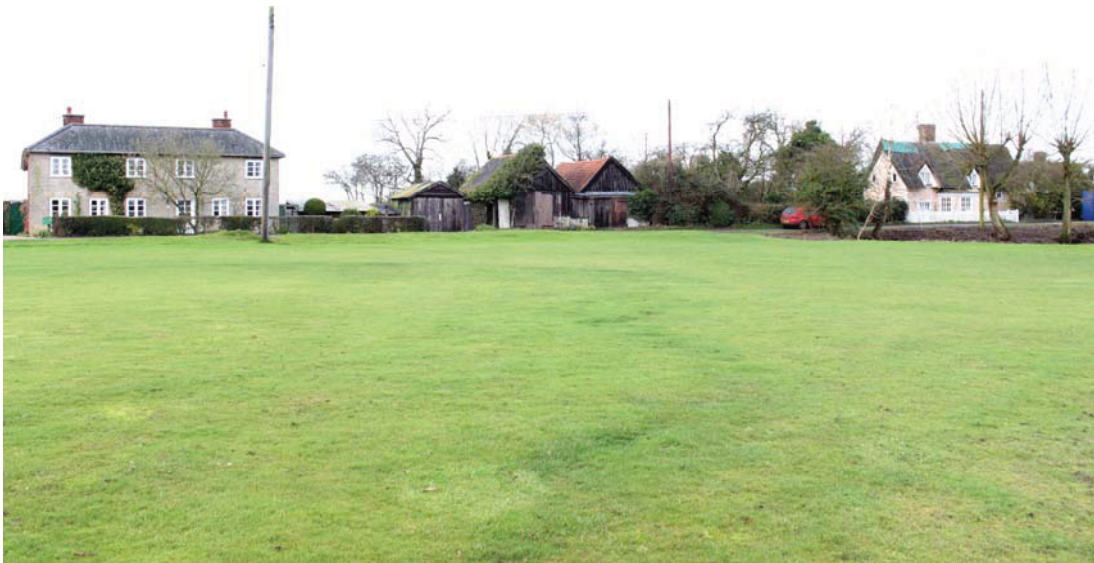
A2.1 General view of site from Great Green to east showing the two sheds (1 & 2) in centre with Holly Cottage and its garage to the left and Forge Cottage behind the pond to the right.

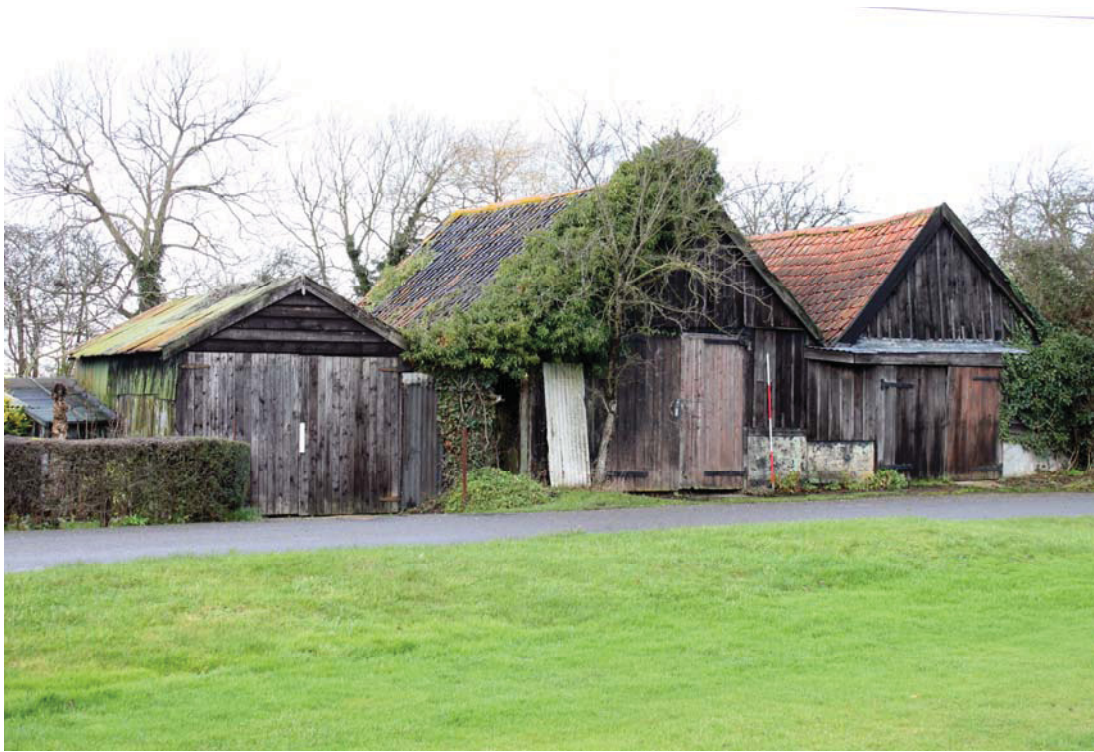
A2.2 Exterior from south-east showing the black glazed pantiles of shed 1 to left and the red pantiles of the later shed 2 to the right. The smaller shed to the extreme left is the garage of the neighbouring property (Holly Cottage)

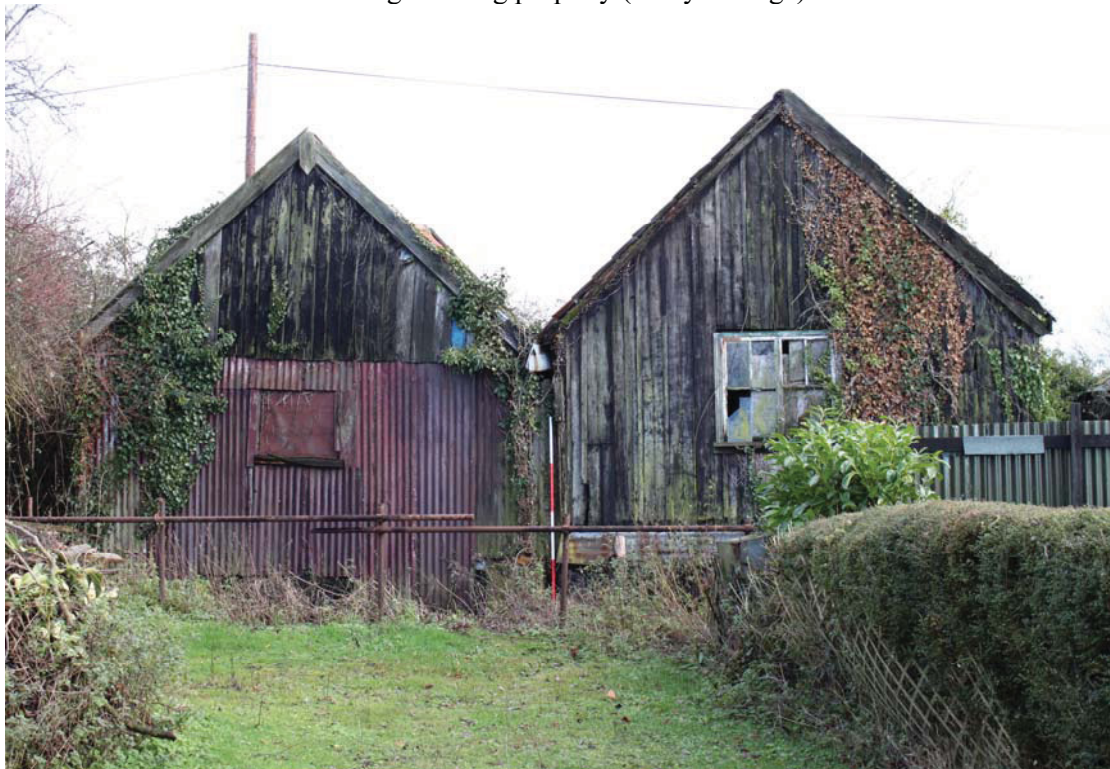
A2.3 External rear (western) gables showing the original cladding of vertical boards to shed 1 (right) and the roof gable of shed 2 (left). The secondary weatherboarding of shed 2 (which was originally open-sided) is hidden by corrugated iron.

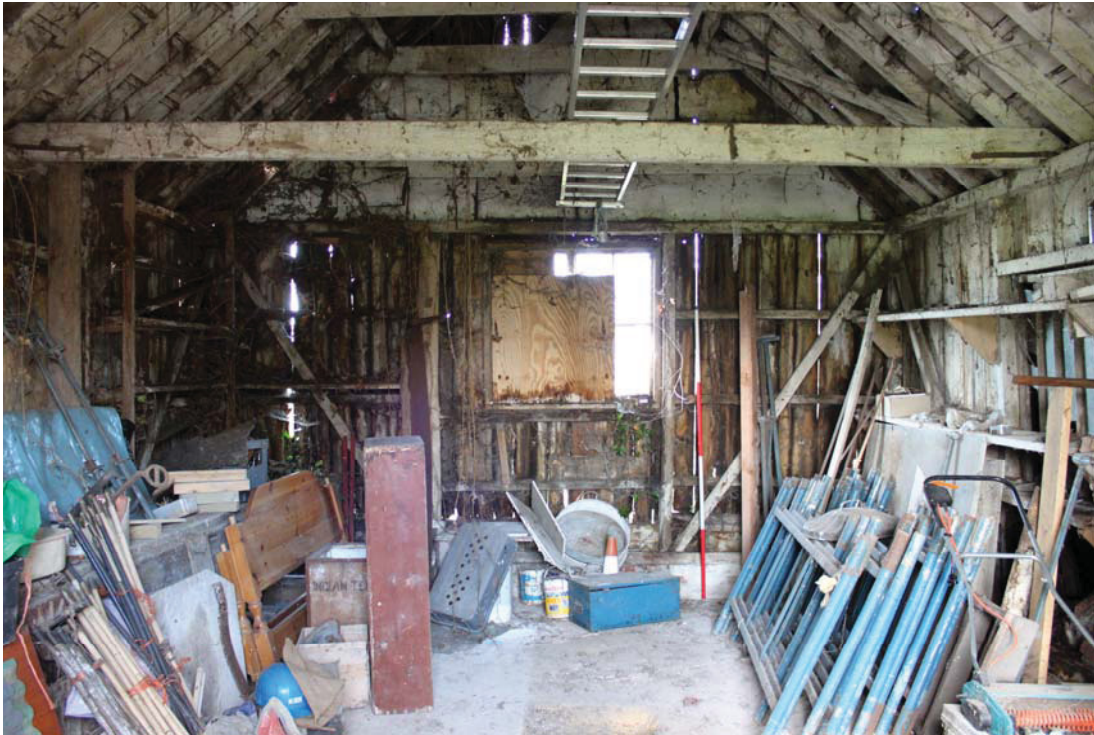
A2.4 Shed 1. General view of interior from east showing original wall fabric of horizontal rails with diagonal bracing to corners and external cladding of vertical boards. The framing of the two windows in both the northern and southern elevations is original, as is that of the central window shown here in the western gable, but the original glazing survives only to the north (right). Note the secondary shelving.

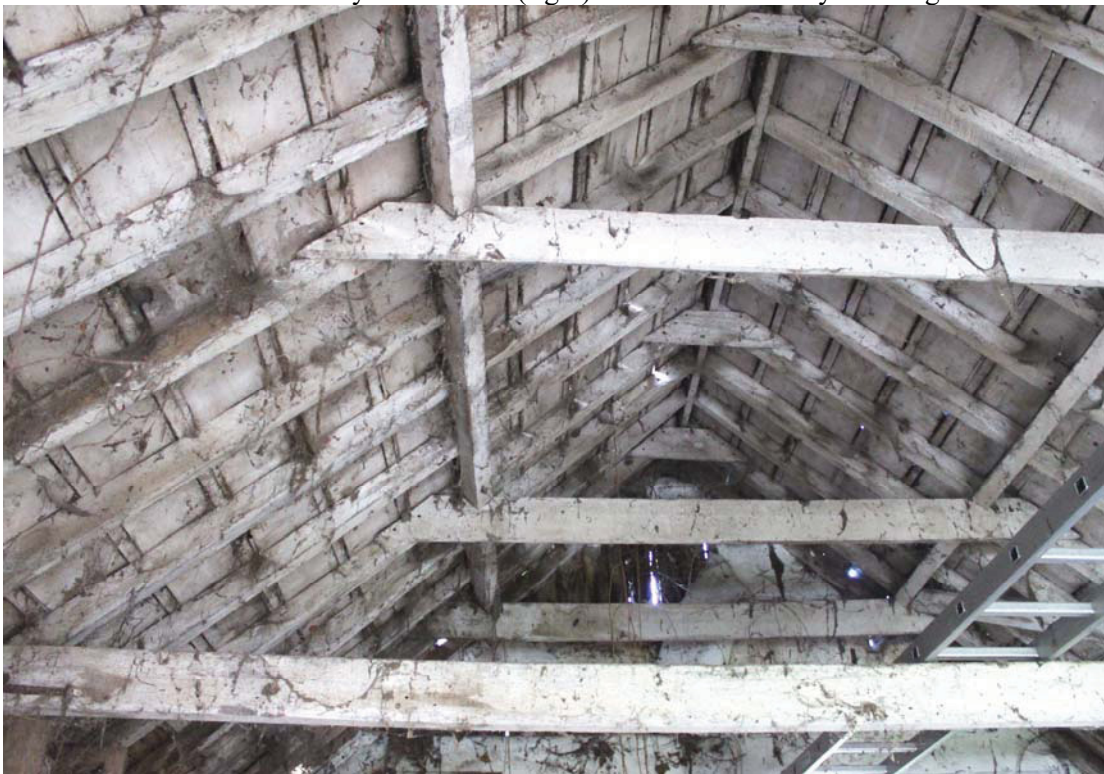
A2.5 Shed 1. The well-built clasped-purlin roof structure from the east, showing original rafters with boards between the tile battens.

in length on an east-west axis (16.25 ft by 24.25 ft), and its walls rise to 2.4 m in height at their roof-plates (7.75 ft). The roof of black-glazed pantiles is a clasped-purlin structure with nailed collars and a ridge-board, and is sealed by horizontal boards laid across the rafters and between the battens (photo A2.5). The studwork walls consist of three horizontal rails between the roof-plates and ground-sills, strengthened by diagonal corner braces, to which the external cladding of vertical boards is nailed (A2.6). Each board abuts its neighbour, but the external joints are hidden by narrow fillets (A2.9). The sills rest on shallow plinths of red brick, each 22 cm in height (9 ins) above the internal concrete floor, and there is evidence of grey pigment beneath the internal whitewash. The external surfaces are tarred.

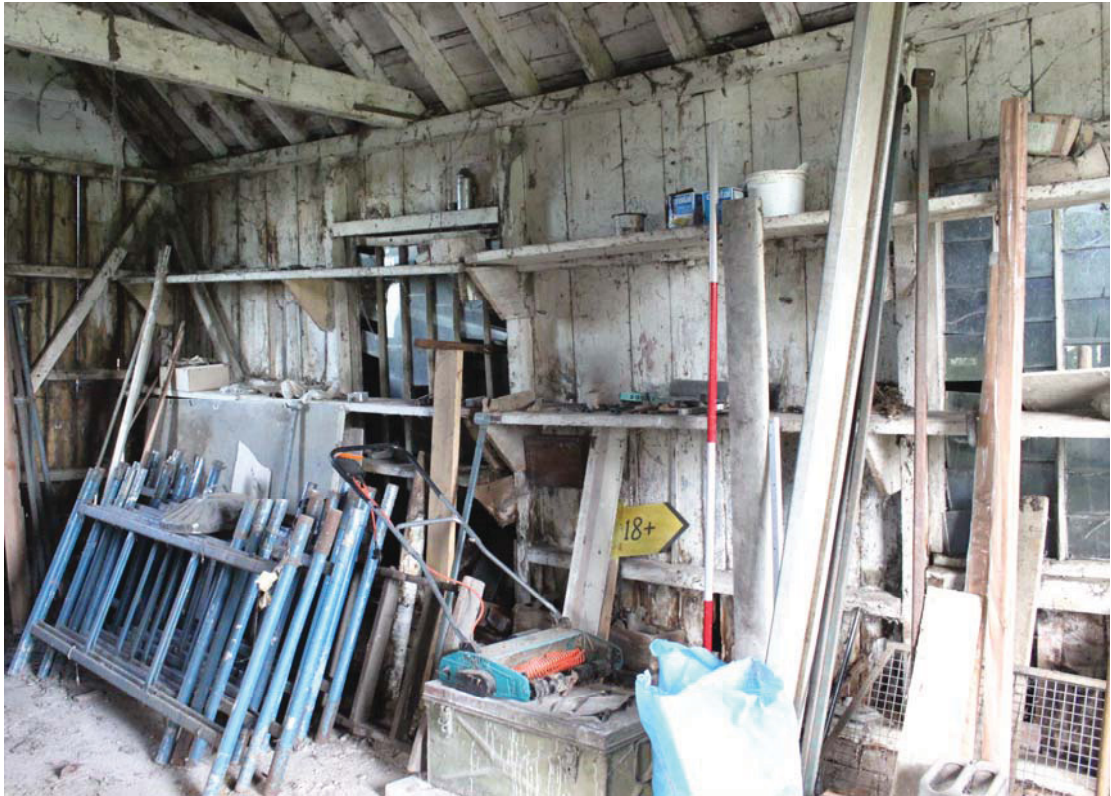
A2.6 Shed 1. Internal northern elevation seen from the south-east, showing two windows with original glazing now blocked by secondary shelving.

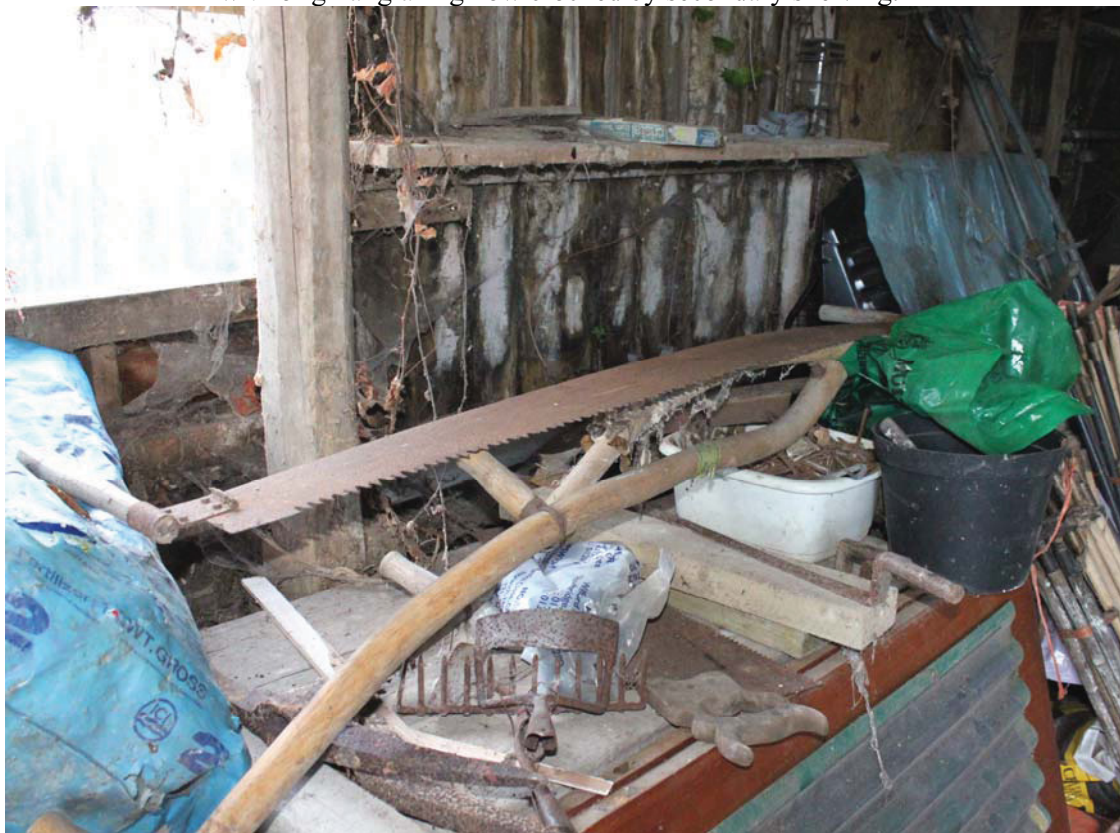
A2.7 Shed 1. Detail of pit saw and scythe on work bench adjoining southern wall (seen from north-east).

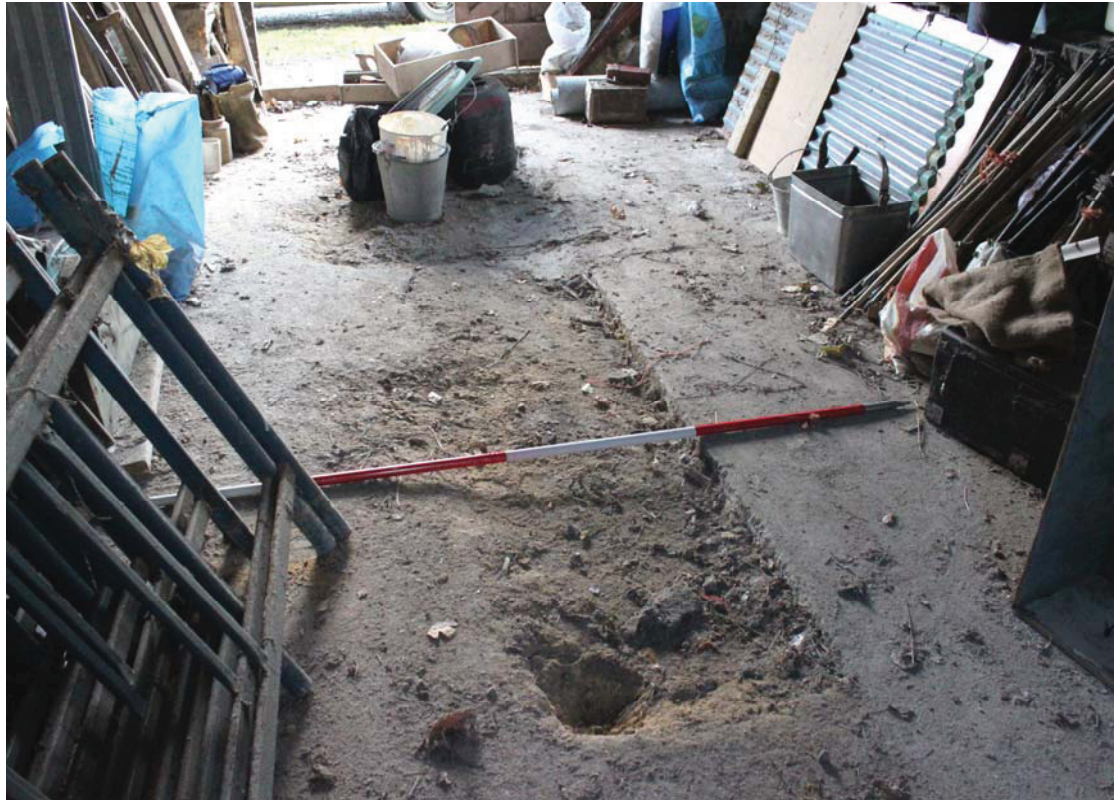
A2.8 Shed 1. Concrete floor from west showing area of collapse possibly caused by infilled saw pit.

There is no physical evidence of the building's original purpose. Its internal walls are now lined with secondary shelving which extends across the northern windows and contains a variety of tools that are consistent with the building's documented use as the workshop of a local builder since the 1930s. A two-man pit or trestle saw lay on a work bench against the southern elevation, together with a mowing scythe, and a second was propped against the western gable at the time of inspection. The concrete floor has partly collapsed along the axis of the shed, and this may indicate the position of a reputed saw pit which the present owner understands to have been filled in by his grandfather in the mid-20<sup>th</sup> century (A2.8).

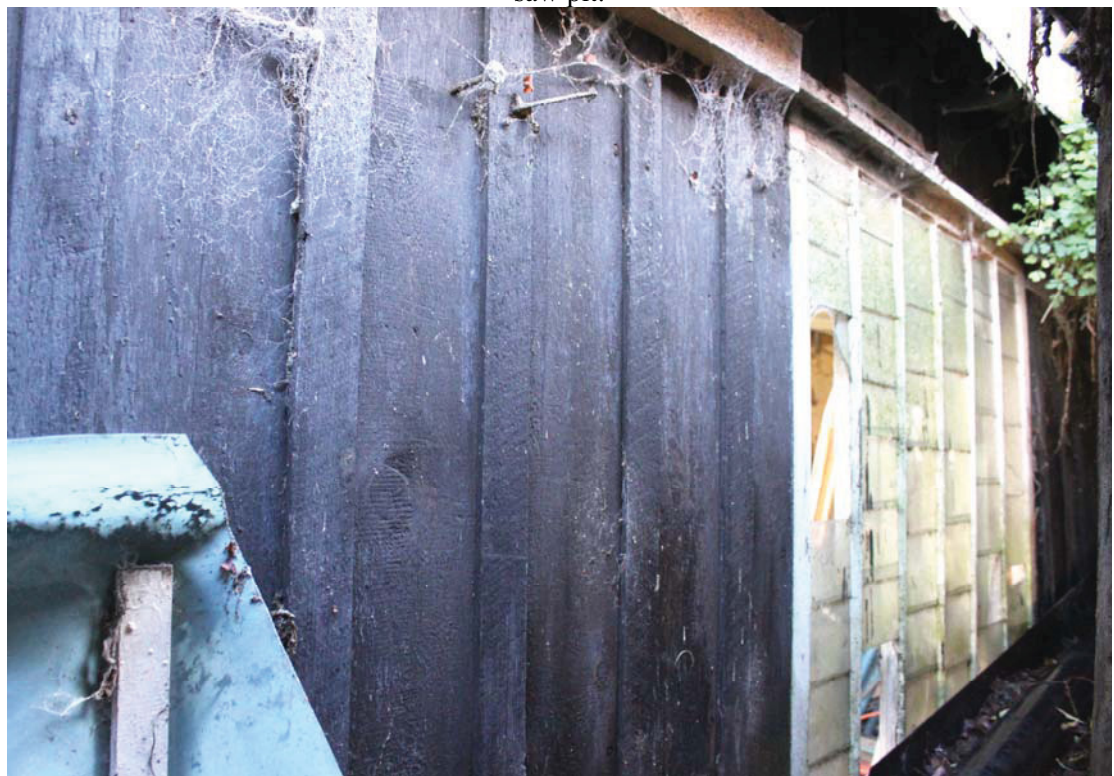
A2.9 Shed 1. Detail of original tarred external northern cladding showing vertical boards with fillets concealing abutments (seen from shed 2).

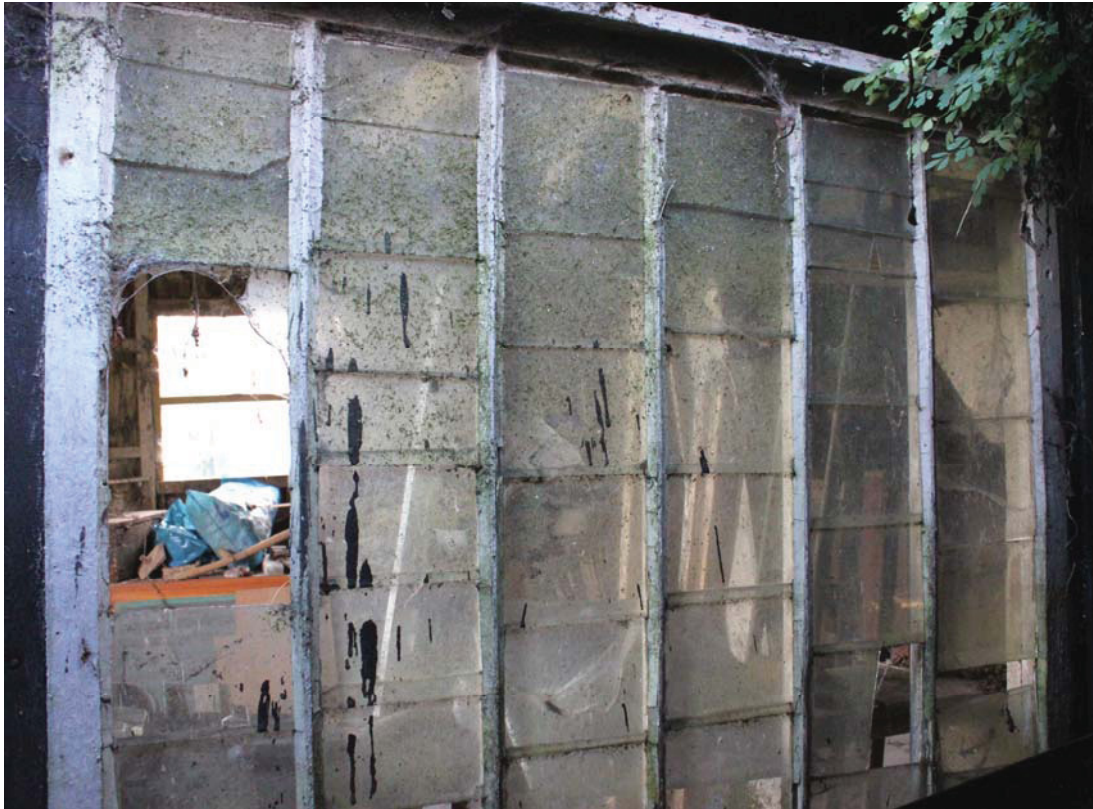
A2.10 Shed 1. Detail of original lapped glazing to eastern window of northern wall (seen from shed 2).

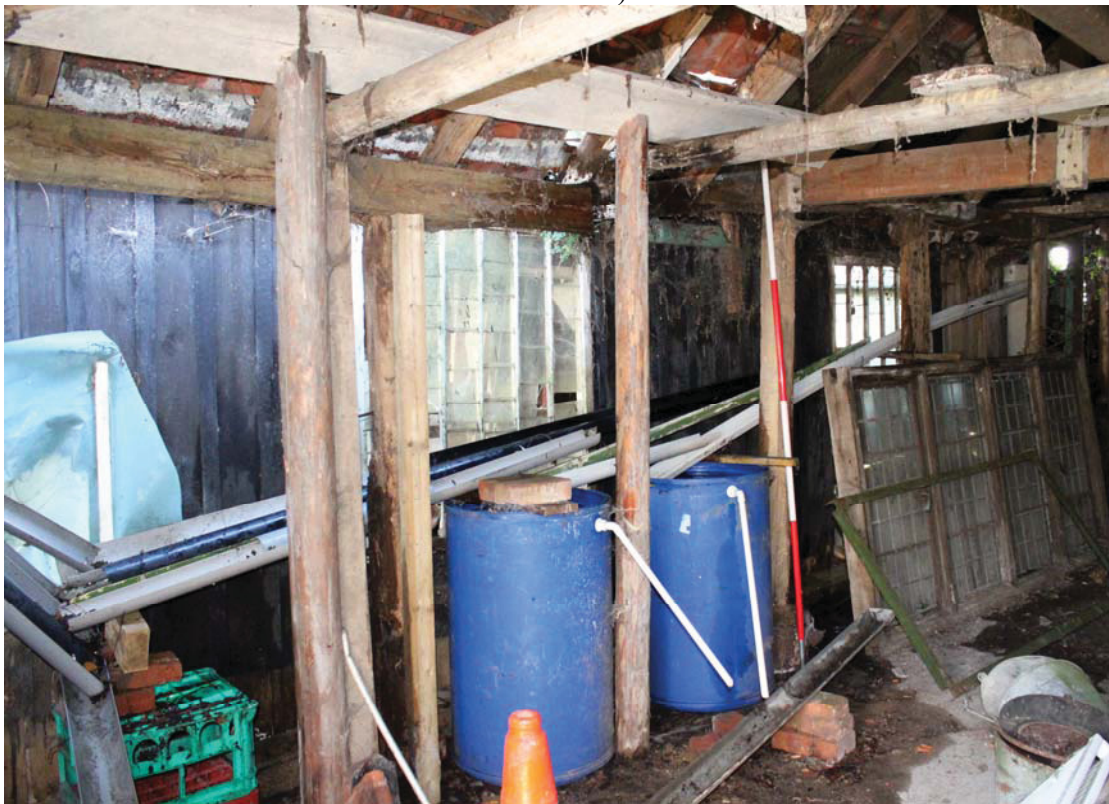
A2.11 Shed 2. Interior of open southern elevation from north-east showing original northern exterior of shed 1.

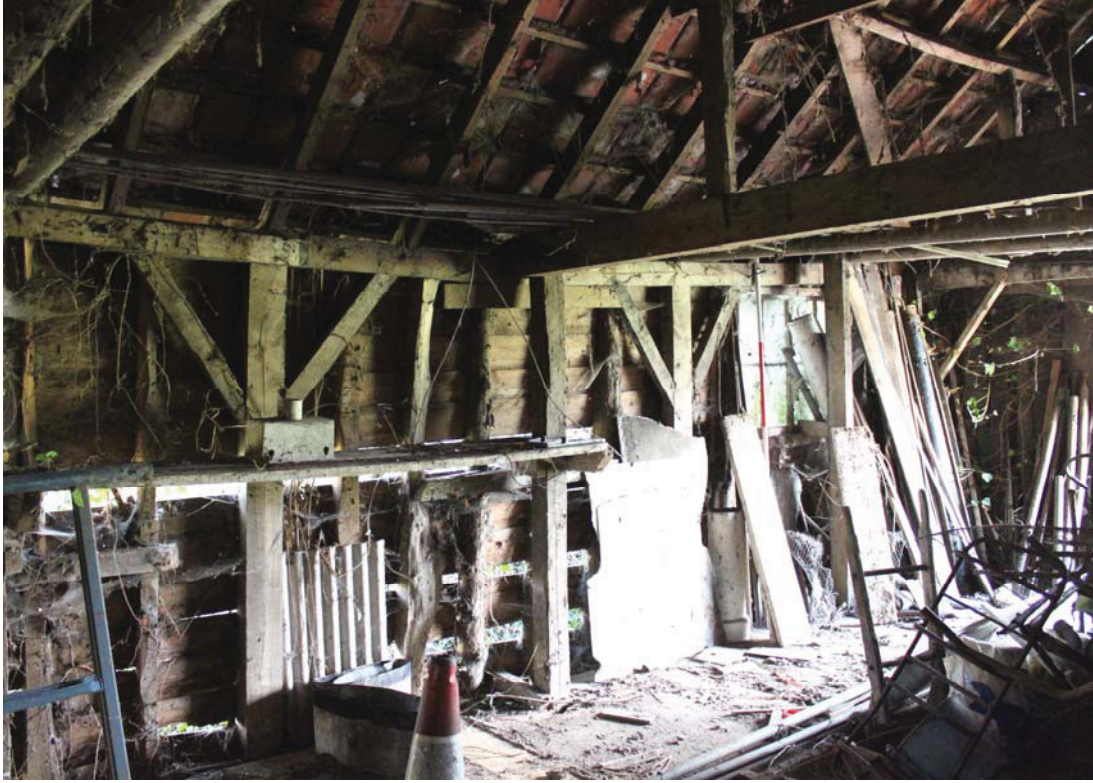
A2.12 Shed 2. Internal northern elevation from south-west, showing posts and braces or original open arcade with secondary outer weatherboarding.
